## **8 Wind Street, Neath**

Proposed Office Refurbishment

Structural Condition survey

*June 2019*

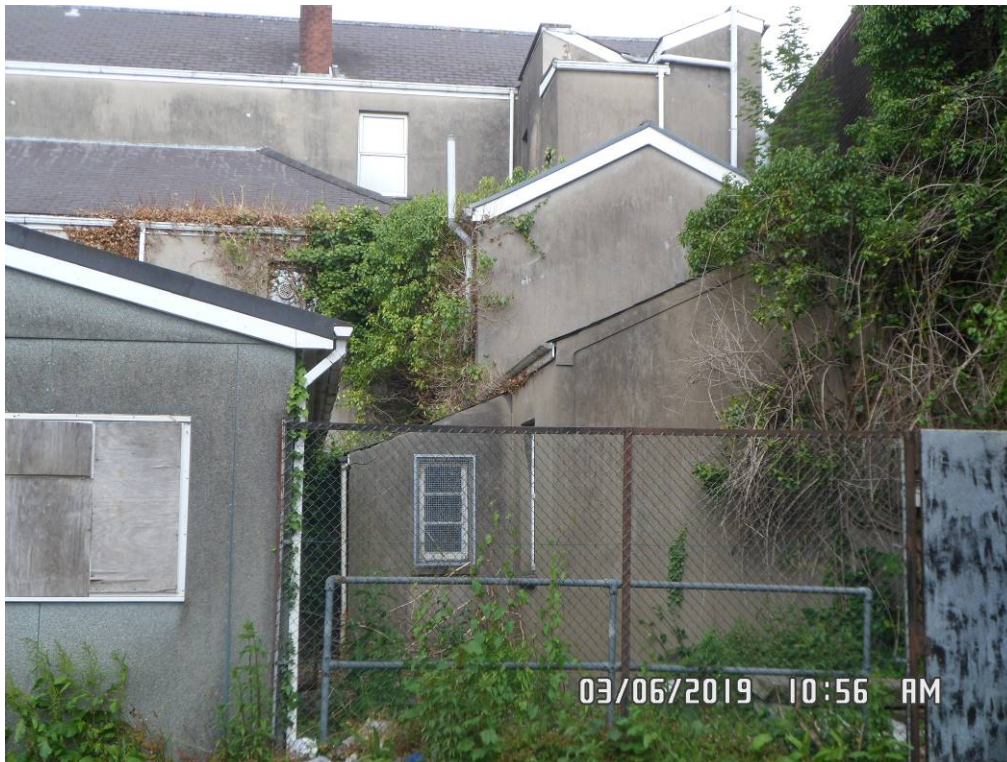
Photograph 1

The rear yard is heavily overgrown with substantial growth up the walls and into the eaves of all the rear annexes (refer to photographs 1 and 3). The extent of this can also be seen in photograph 9 taken from the 1<sup>st</sup> floor rear window,

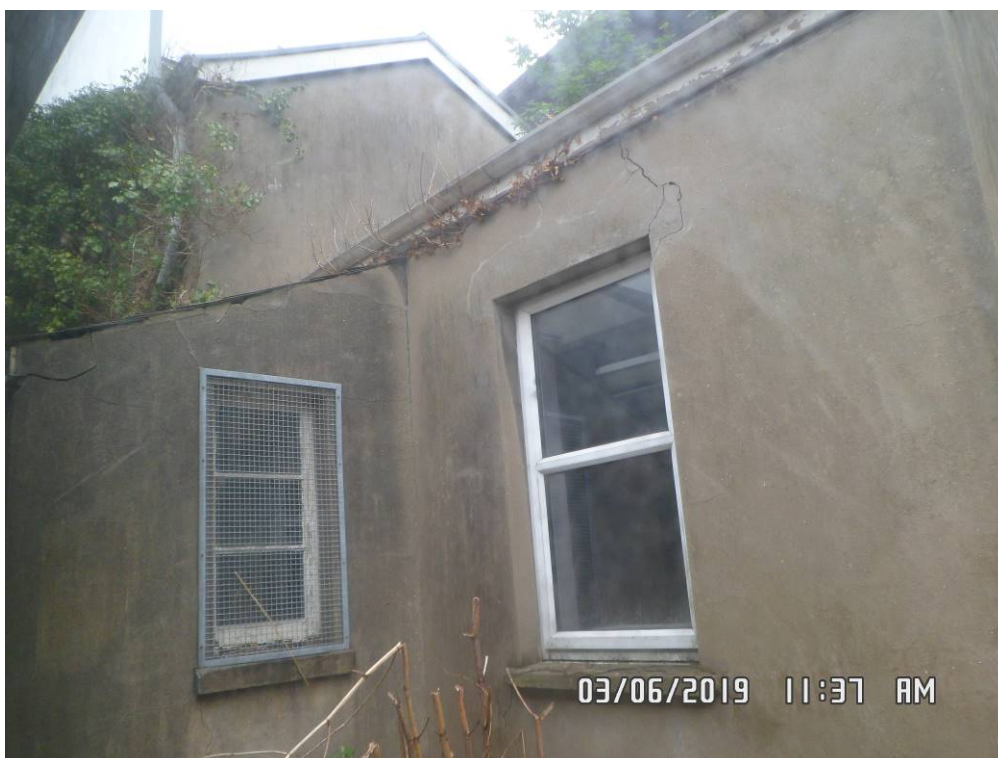
Photograph 2

There are also substantial cracks in the walls of the 2 storey annex and lean-to link into the demountable building (refer to photograph 2). These also manifest themselves internally where there is evidence of water ingress and damp causing damage to the plasterwork (refer to photograph 7)

- The cracking in the lean-to and office wall at high level appears to have been filled internally and the crack looks as if it has opened up since. Without having the benefit of hindsight or evidence of monitoring over the last 10 years it is difficult to assess whether this is an ongoing issue. Either way there is clearly a structural defect that carries inherent risks if this element were to be retained as part of any future development. Given the unknown cause for this cracking it may be worth considering investigating the foundations/ground conditions with the potential need for underpinning or even re-building.

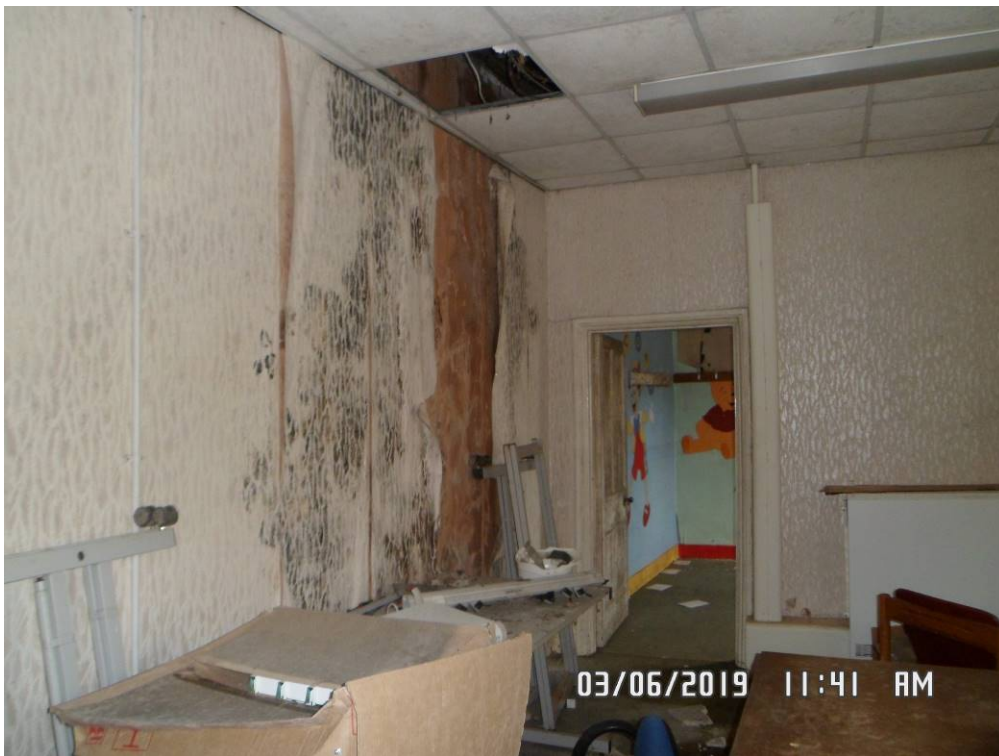
Photograph 6

There is further substantial damp/water ingress in the rear filing room adjacent to 'Boots Pharmacy' party wall (refer to photograph 6). It can be seen from the external photographs that there is substantial vegetation growing on the roof by this location where there could be damage to the building caused by the vegetation root system.

- The rear annexes are all suffering from water ingress and damp caused by vegetation growing on the walls and into the roof spaces. Of particular concern is water ingress along the party wall (Boots) where it appears to have been happening for a number of years with untold damage to the structure. In order to ascertain the damage the wall and roof would have to be taken down with the view to re-building which would essentially mean demolishing the majority of building.
