Repair Detail K  
Renovation of shaft capping plates | Not to scale

| Drawn | Designed | Approved | Revision Date |
|---|---|---|---|
| <div>Cefn Coed Colliery Museum</div> <div>Renovation of two Grade II* Listed headgear frames</div> | | | |
| <div>Repair details K + L</div> <div>Various detail, to be read in conjunction with Repair Schedule documents</div> | | | |
| CD-V-C8458.60 | 104 | R1 | |

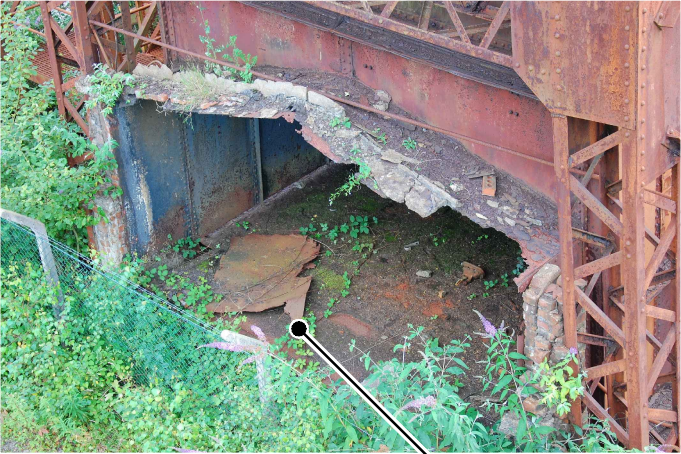
Elevated view showing typical condition of Headframe 1 shaft capping plates. Steel framing below of similar arrangement to that denoted on Headframe 2 (right).

HEADFRAME 1:  
Accumulation of debris over plates to be removed. Fallen metalwork from within ventilation shaft to be retrieved for inspection.

BOTH HEADFRAMES:  
It is understood that the existing shaft capping sheets were installed circa 1975; their condition is unknown.

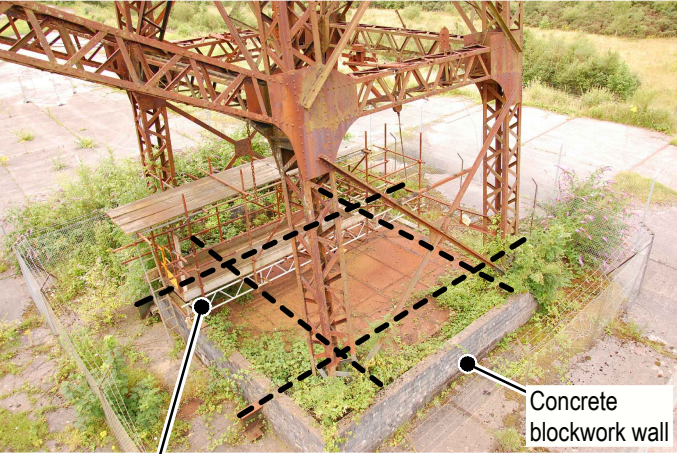
Elevated view showing typical condition of Headframe 2 shaft capping plates. Steel framing below denoted by dashed lines.

HEADFRAME 2:  
Safety and robustness of scaffold platform cannot be confirmed; platform to be dismantled and removed to accommodate anticipated working platforms erected by the Contractor.

Following closer visual inspection, it appears the sheets have been welded to the grid of steel beams supporting them, making their removal for investigation of the structure below difficult without 'hot works' (grinding or flame cutting) and the hazards that presents over historic mine workings (risk of explosions). Furthermore, investigation work or partial dismantling of the existing structure may disturb the upper extents of the mine shaft opening with potentially significant consequences.

1. A new access platform will be constructed over the existing capping structure.
2. In the first instance, the new access platform will allow the renovation works to take be undertaken safely, requiring the following elements of work:
  - a. Clearance of vegetation and debris and removal of the existing scaffold walkway;
  - b. Partial dismantling of the concrete blockwork wall to the eastern side of the shaft (which conflicts with new platform footprint);
  - c. The new structure takes support off the visible ends of the existing steel support beams, which are of sufficient cross-section to support the additional loading;
  - d. The original structure will be cleaned to receive an application of protective paint, accessed by removing individual open-grid deck panels of the new structure.

5. The following works are therefore proposed to realise these benefits:
  - a. The concrete blockwork wall is removed around the full perimeter (in lieu of rebuilding) to expose the original brick plinths that are largely obscured from view by the wall; the plinths will be subject to masonry conservation work in line with that already agreed by the LPA.
  - b. The new platform is retained permanently.
