# Technical note

| <b>Subject:</b> | Swansea Bay Campus – Rock Revetment Survey | | |
| <b>Reference:</b> | 5104896-SBC-OUT-0191 | <b>Author:</b> | Andy Wareing / Huw Richards |

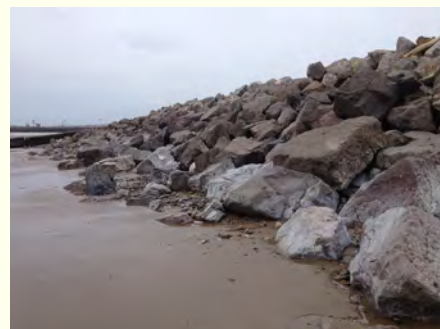
IP10 - South Westerly View

Slope slackens approaching outfall

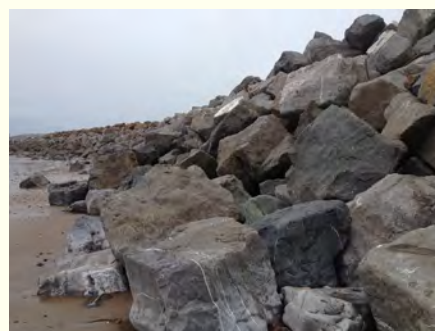
IP11 - Westerly View

Sinuuous profile as crest and toe levels vary and slope alters

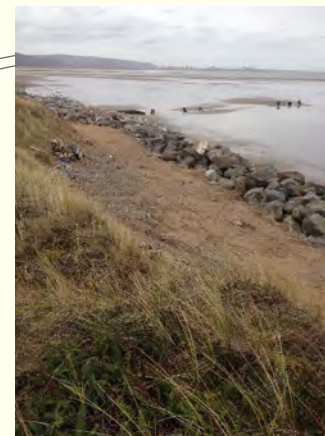
IP21 Easterly View

There has been some observed erosion of the dunes landward of the revetment. The area between revetment crest and dunes looks has been trafficked by construction plant. This is evidenced on sheet 2, east, photo references IP15, 16 and 21.

Area looks to have been trafficked by construction plant, possible mechanical cause of dune face failing

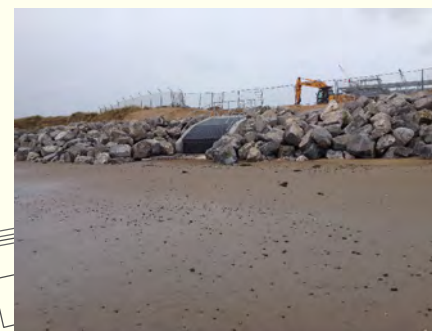
IP14 North Westerly View

The new outfall, part of the development works, has been constructed. This is evidenced on sheet 2, east, photo reference IP14.

New outfall construction, part of site development

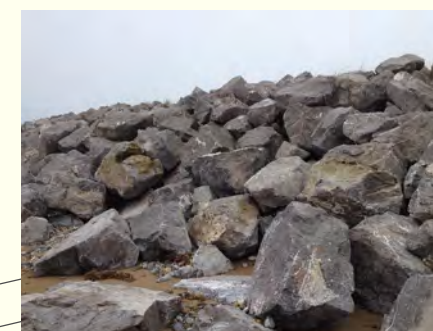
IP18 North Westerly View

The rock comprising the eastern end of the revetment has been formalised. The structure here has been consolidated with rock brought from further east, increasing the packing density. There are no gaps and the previously observed dune grass can be seen sticking out from under the newly placed rocks, particularly in the upper part of the slope. This is evidenced on sheet 2, east, photo references IP18 and IP19.

Revetment has been formalised, voids previously evident have been filled.

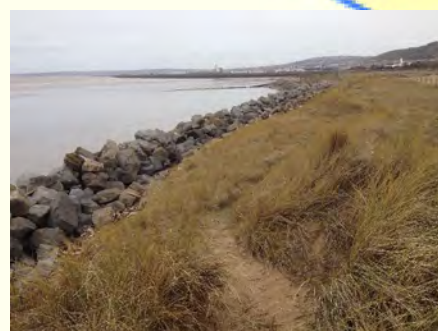
IP20 Westerly View

Highest point on the survey reach. Reverse slope to landward on the revetment crest

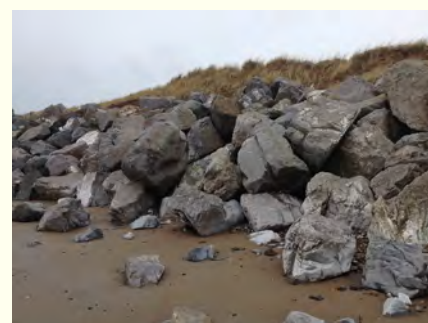
IP12 Westerly View

Crest level lowers

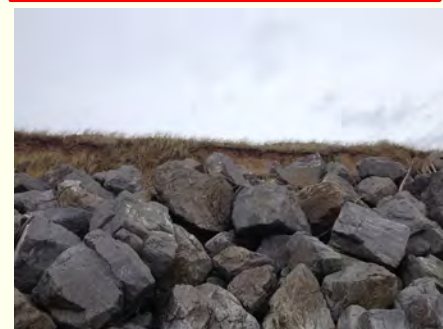
IP15

Evidence of dune erosion behind rock revetment

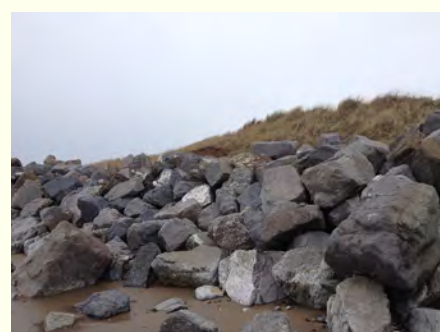
IP 16

Evidence of dune erosion behind rock revetment

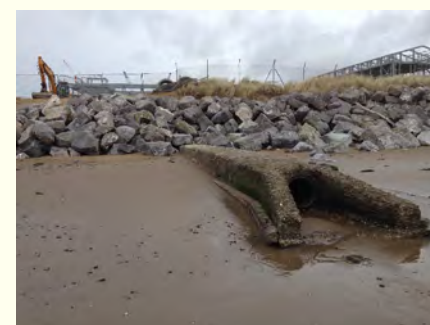
IP13 North Westerly View

Outfall (operational)

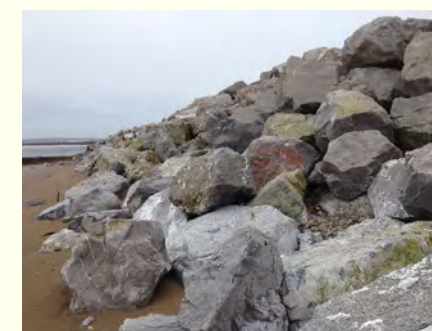
IP17 Westerly View

Example of poor packing density and large number of voids throughout

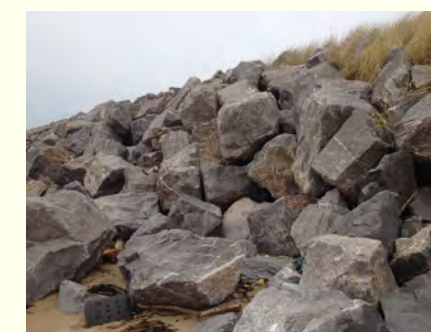
IP19 Westerly View

Eastern extremity of revetment and survey
