# Technical note

| <b>Project:</b> | Swansea Bay Campus | <b>Client:</b> | St Modwen Developments Ltd |
| <b>Subject:</b> | Rock Revetment Survey | | |
| <b>Date:</b> | 19 <sup>th</sup> August 2016 | | |

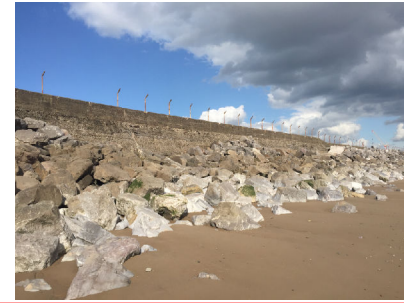
**P23 (Prev 469) - Easterly View**

2. The rock armour revetment has generally slightly worsened since the previous inspection in 2014. The revetment has settled in places, with rocks moving from the central part of the slope to a lower level (evidenced in Sheet 1 - West, P16, P17, P22 and P23) and the elevation of the crest reducing. However based on a qualitative assessment, the relative number of rocks moving is not over a significant extent and therefore it is not thought that the effectiveness of the sea defence has been altered significantly.

Two areas of reduced crest elevation;  
worse condition since previous inspection

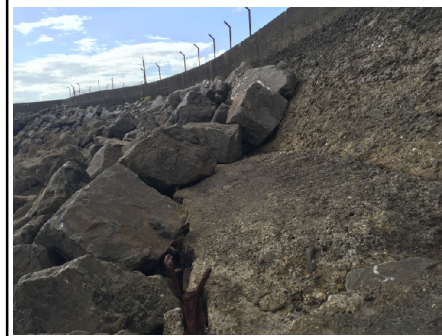
**P21 (Prev IP1) - Westerly View**

Strong smell of diesel

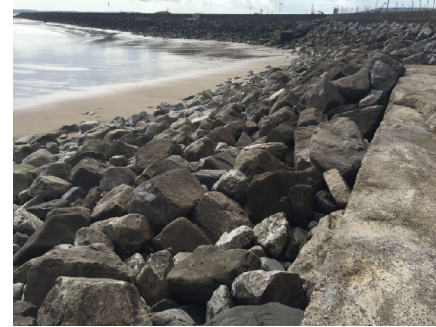
**P 20 (Prev IP5) South Westerly View**

1. During the survey in January 2014, additional damage was noted to the top of the base of the concrete wall. Two tabular sections of concrete had been displaced by wave action damaging the top of the base of the wall and these concrete pieces were found located seaward on the rock revetment. During the 2016 survey, this damage to the wall is still evident. The tabular concrete pieces could no longer be found on the revetment. They have most likely been moved or broken up due to wave action. This is evidenced in Sheet 1 - West, P20.

Tabular shaped concrete pieces  
located on the rock revetment  
are no longer present.

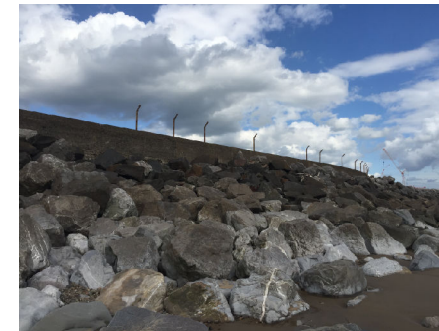
**P17 (New) - North-easterly View**

Worse slope failure exposing  
a large amount of the vertical wall.  
Bits of masonry in rock.

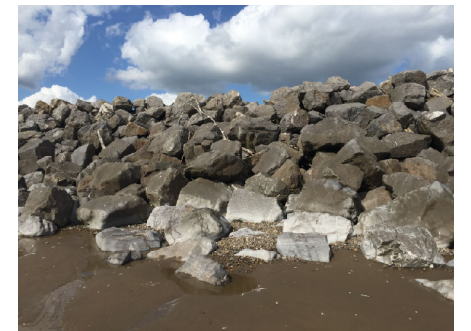
**P15 (Prev IP7) - Northerly View**

A lot of the smaller historic beach  
material (cobbles) has been washed  
away or buried by higher beach level.

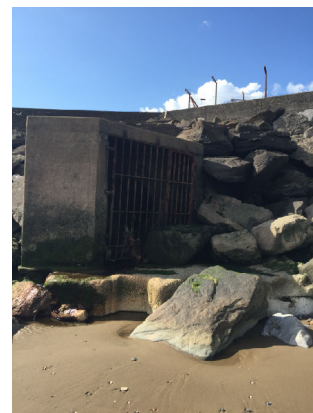
**P24 (Prev 468) - Westerly View**

Western extremity of revetment  
and survey.

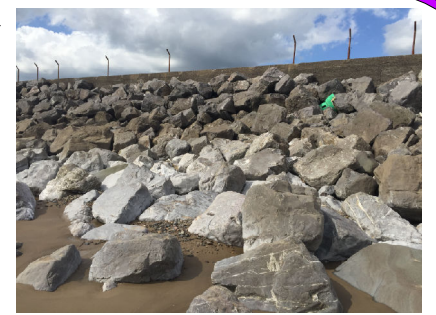
**P16 (Prev IP6) - Northerly View**

Worse condition since previous  
inspections. Slope in worst condition  
for approximately 30m east of P16

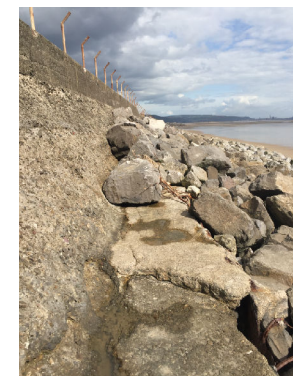
**P22 (Prev IP2) - Easterly View**

Rock slope has failed,  
reducing in height and  
slipping out at the toe;  
condition has worsened  
since last inspection  
and a small number of rocks  
have been lost off the face.

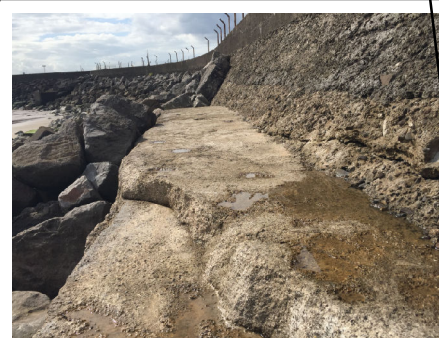
**P18 (Prev IP3) - Westerly View**

Rock slope has failed, reducing  
in height and slipping out at the toe.

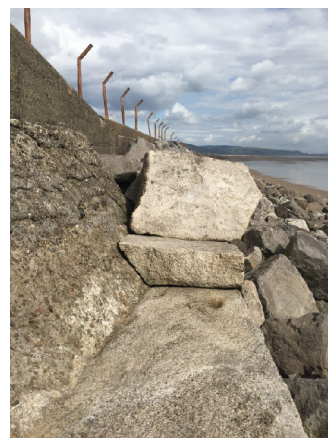
**P19 (Prev IP4) - Easterly View**

Removal of the base of the  
concrete wall by wave action.

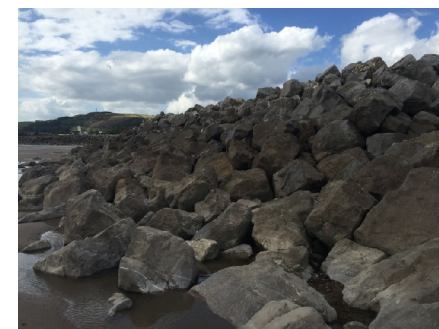
**P14 (Prev IP8) - North-easterly View**

Smaller rock present to the west,  
packing improves.

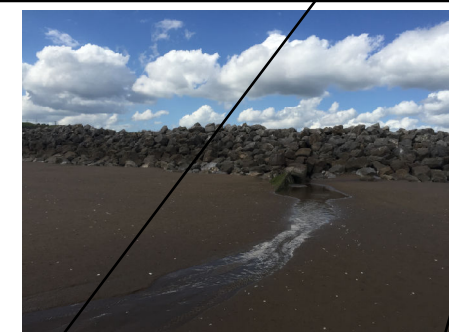
**P13 (Prev IP9) - Northerly View**

3. The outfall at P13 is not currently visible and it is likely to be buried under sand forming a comparatively higher beach level. Based on visual observations alone it is hard to tell definitively if the beach level has increased locally or across a larger extent of beach foreshore.

Outfall (defunct). Part of outfall  
either removed for buried by  
change in beach level.

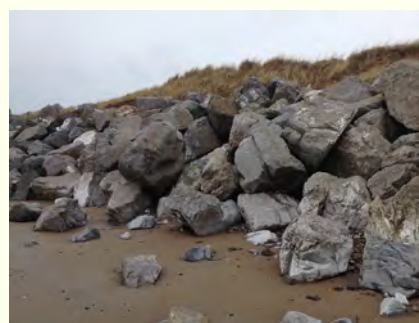
IP12 Westerly View

Crest level lowers

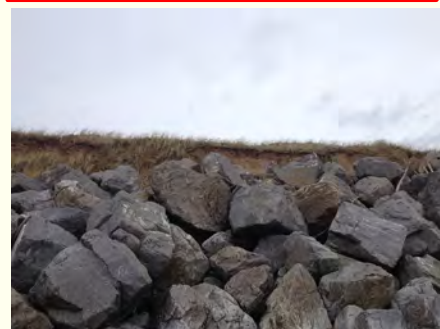
IP 16

Evidence of dune erosion behind rock revetment
