**Plaza, Port Talbot**

**HISTORIC BUILDING RECORDING**

(385)1902-GWP-A-2A-HBR-P00

Date: 06.01.20

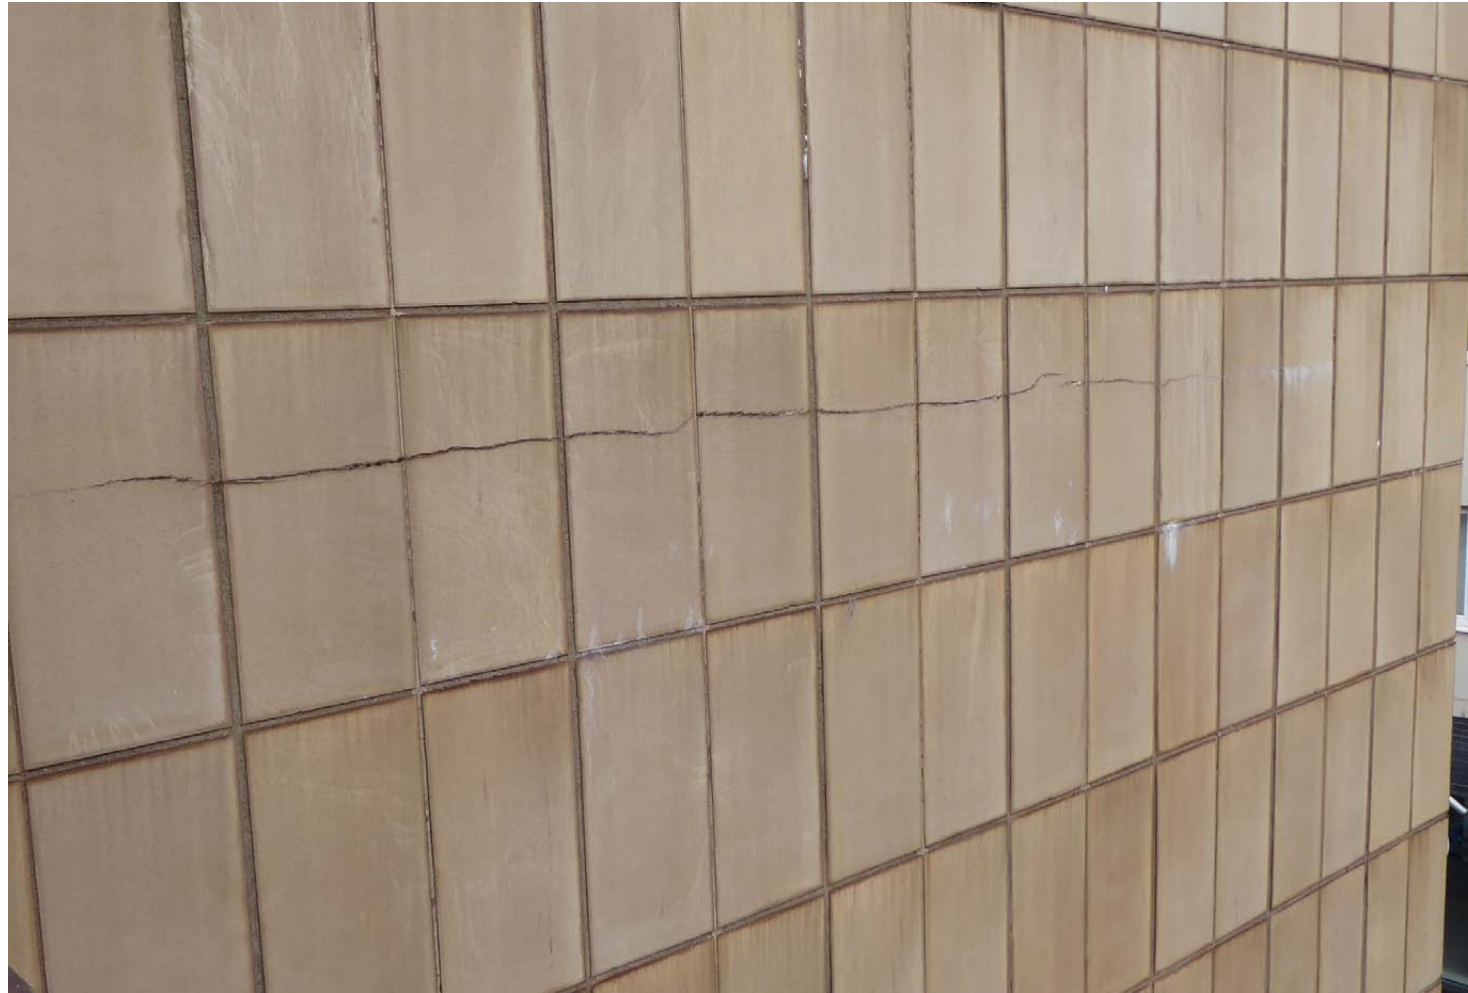
*View of one of the cracks running through a series of faience tiles*

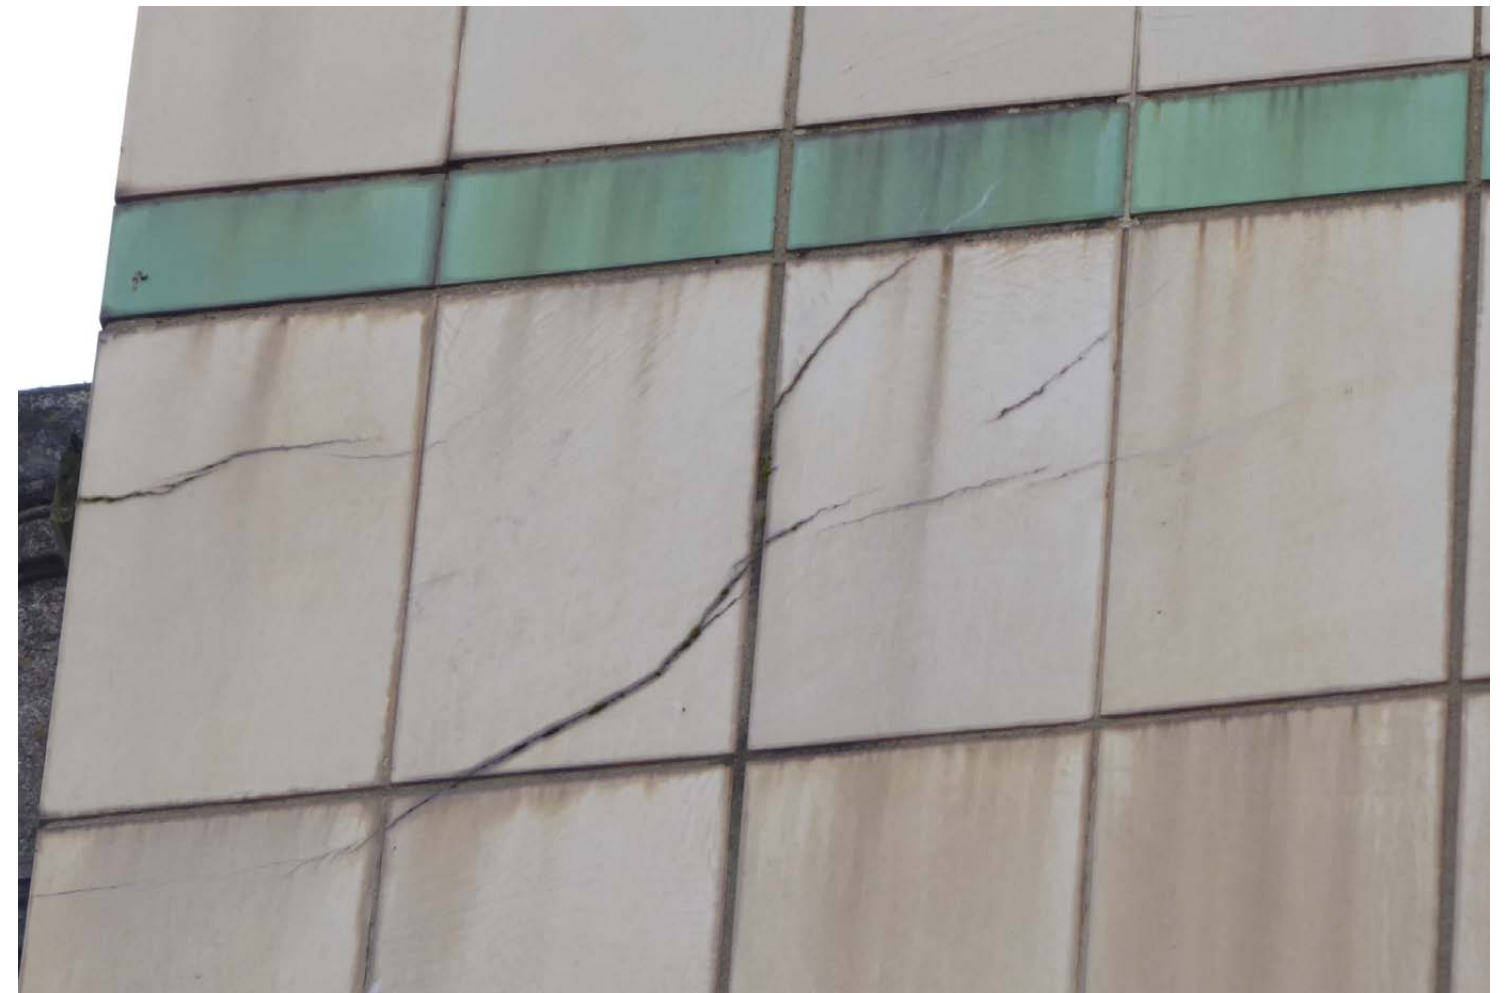
*View of one of the cracks running through a series of faience tiles near the top*

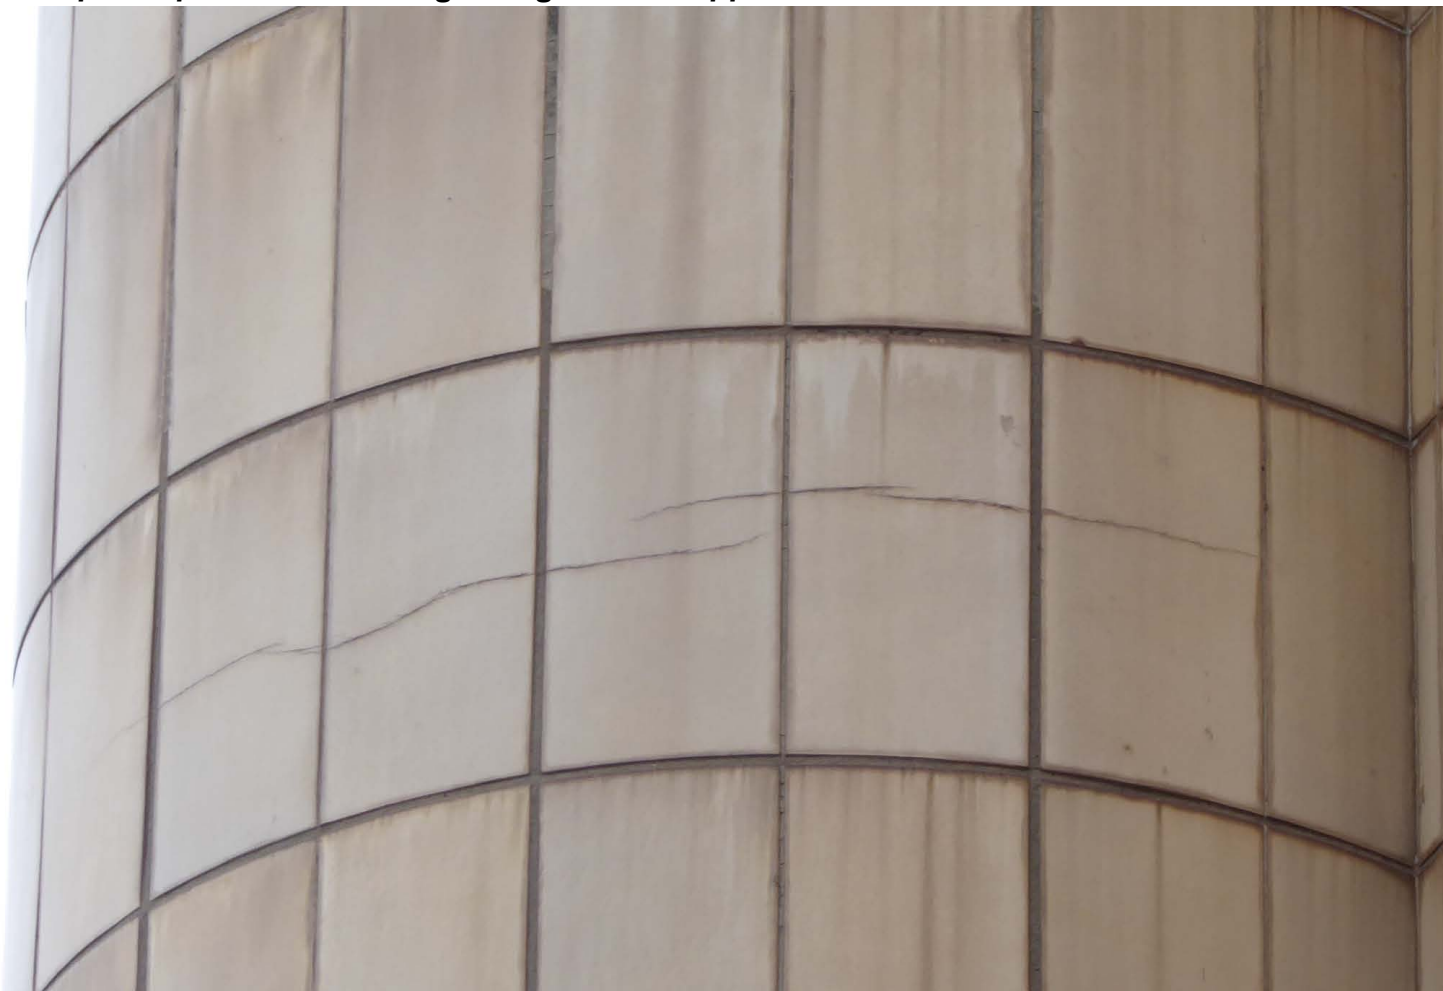
*View of one of the cracks running through a series of faience tiles on one of the curved ends*

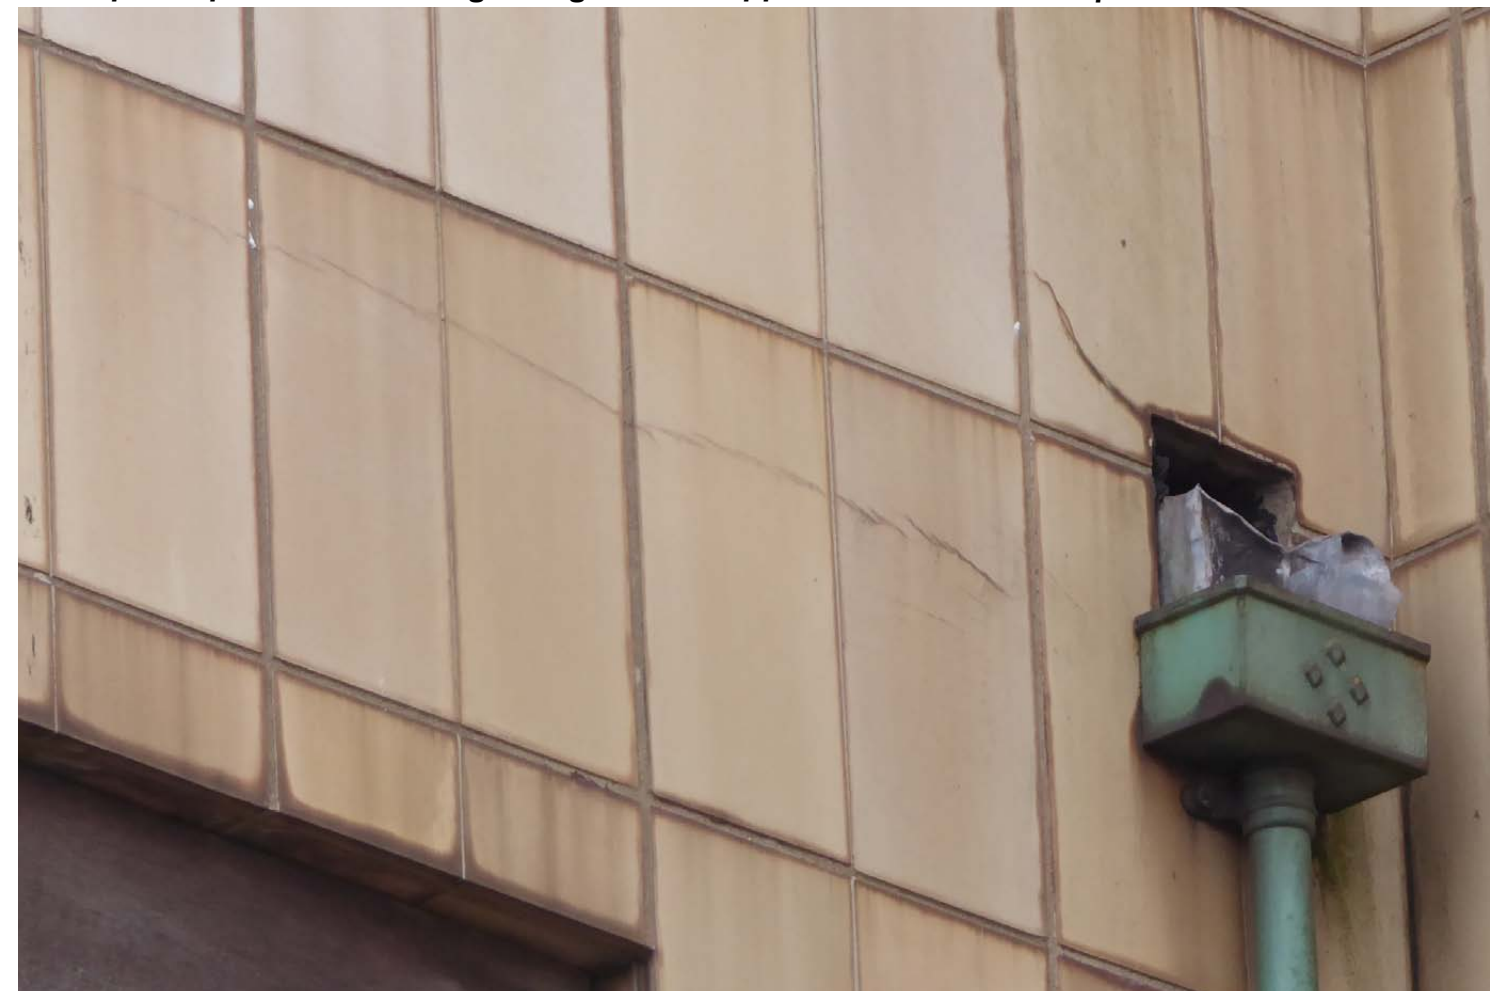
*View of one of the cracks running through a series of faience tiles by the rainwater hopper*

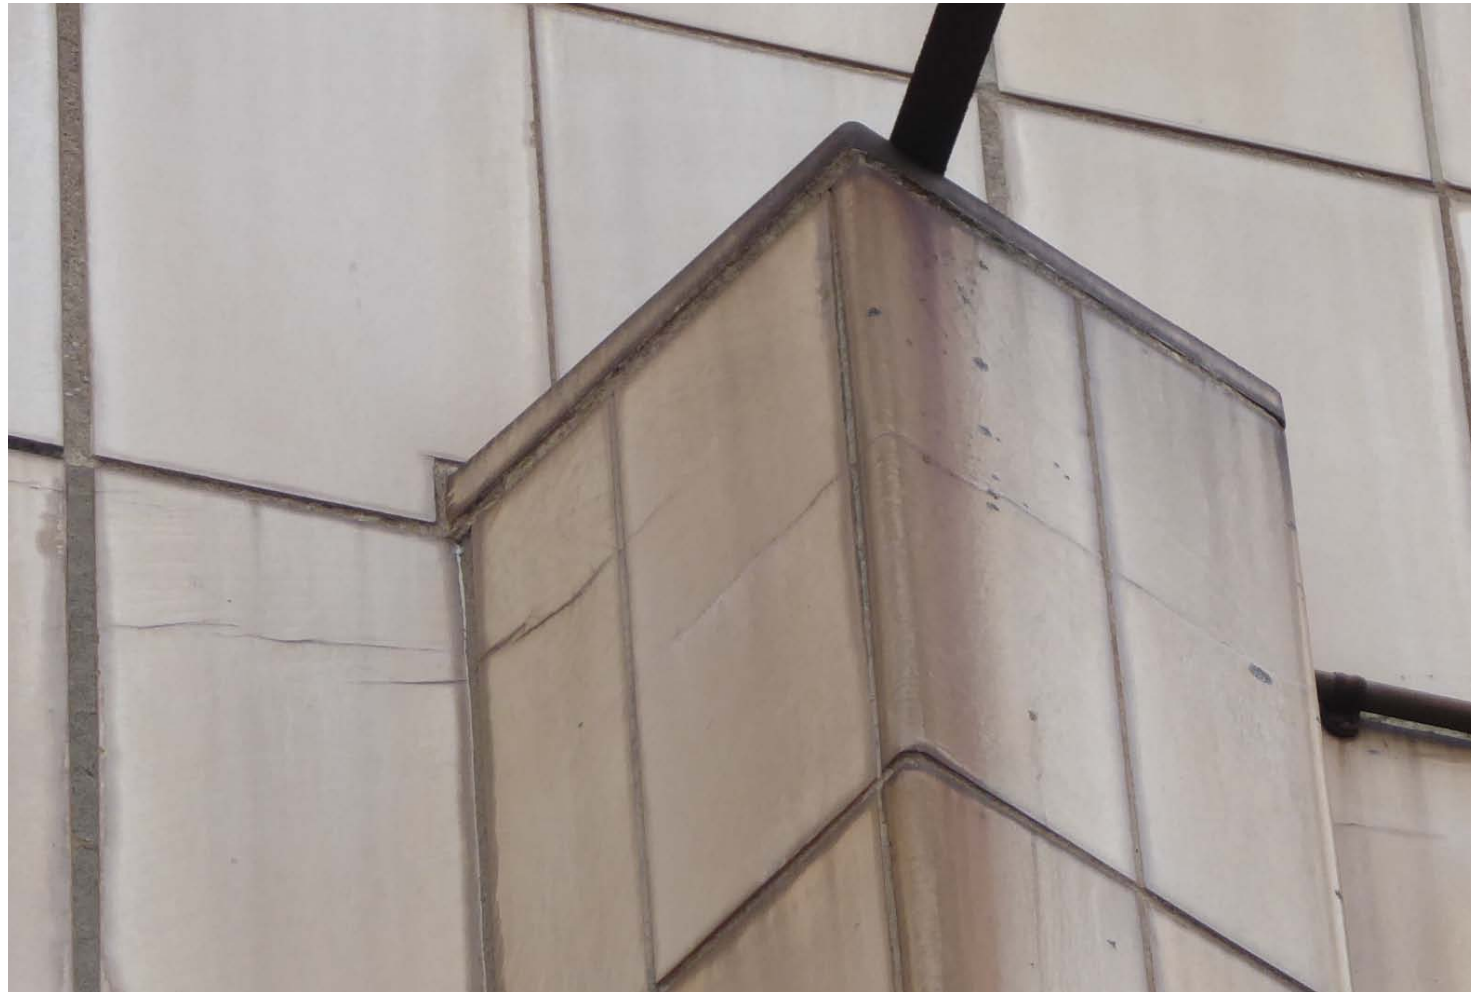
*View of a crack running through a series of faience tiles on the top of one of the lighting columns*

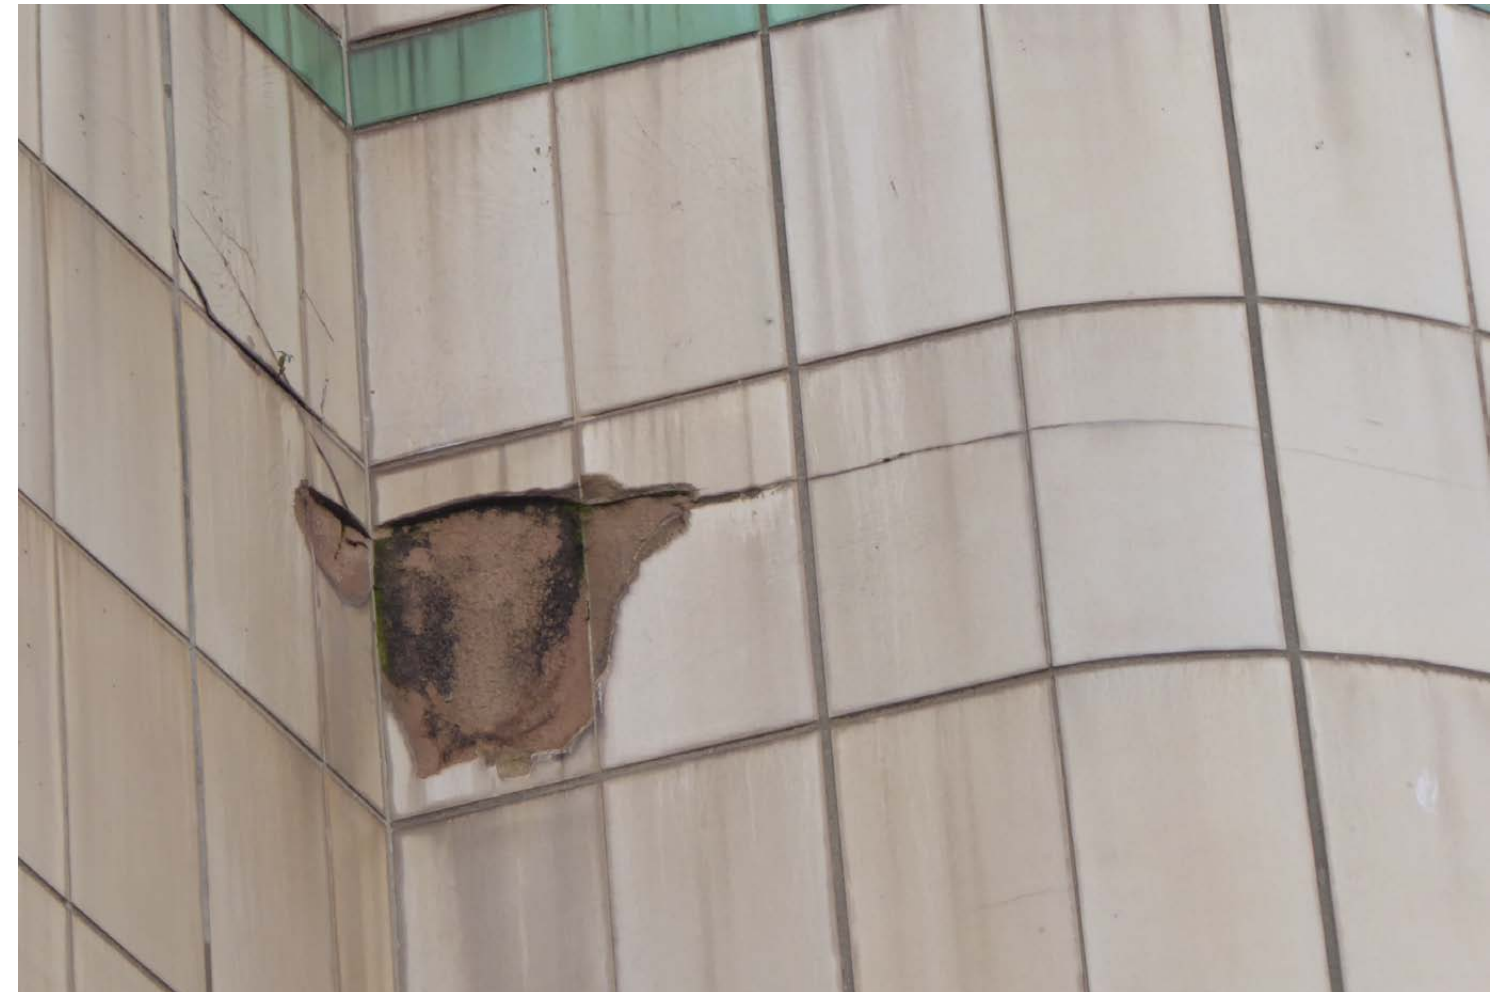
*View of a badly defaced series of faience tiles*

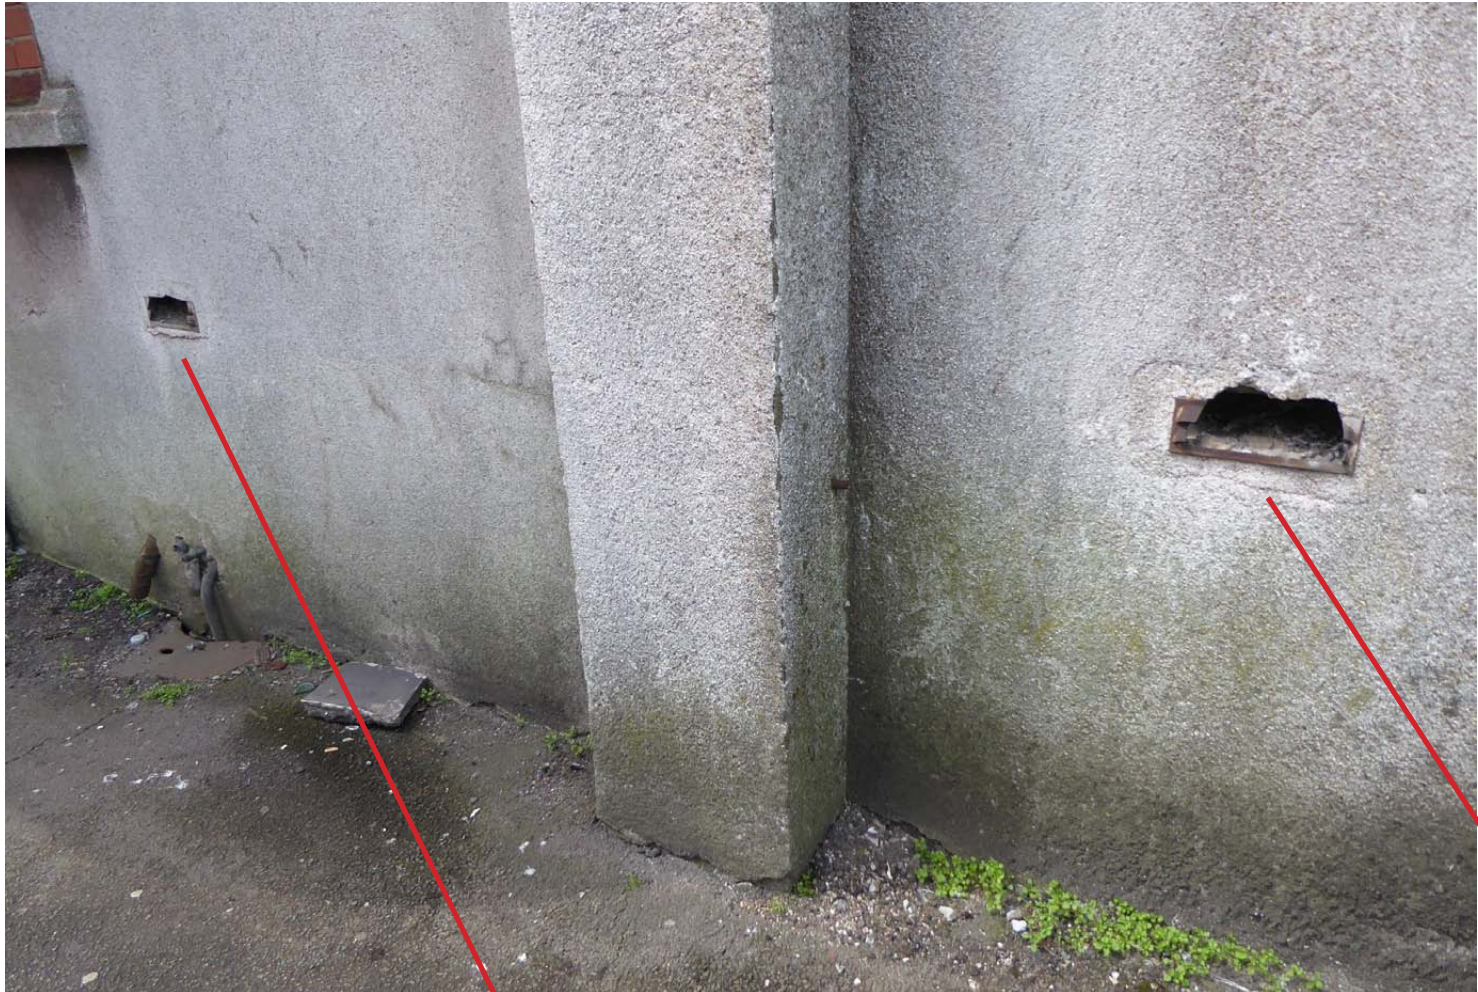
*View of two of the broken low vents to the auditorium and cinema*

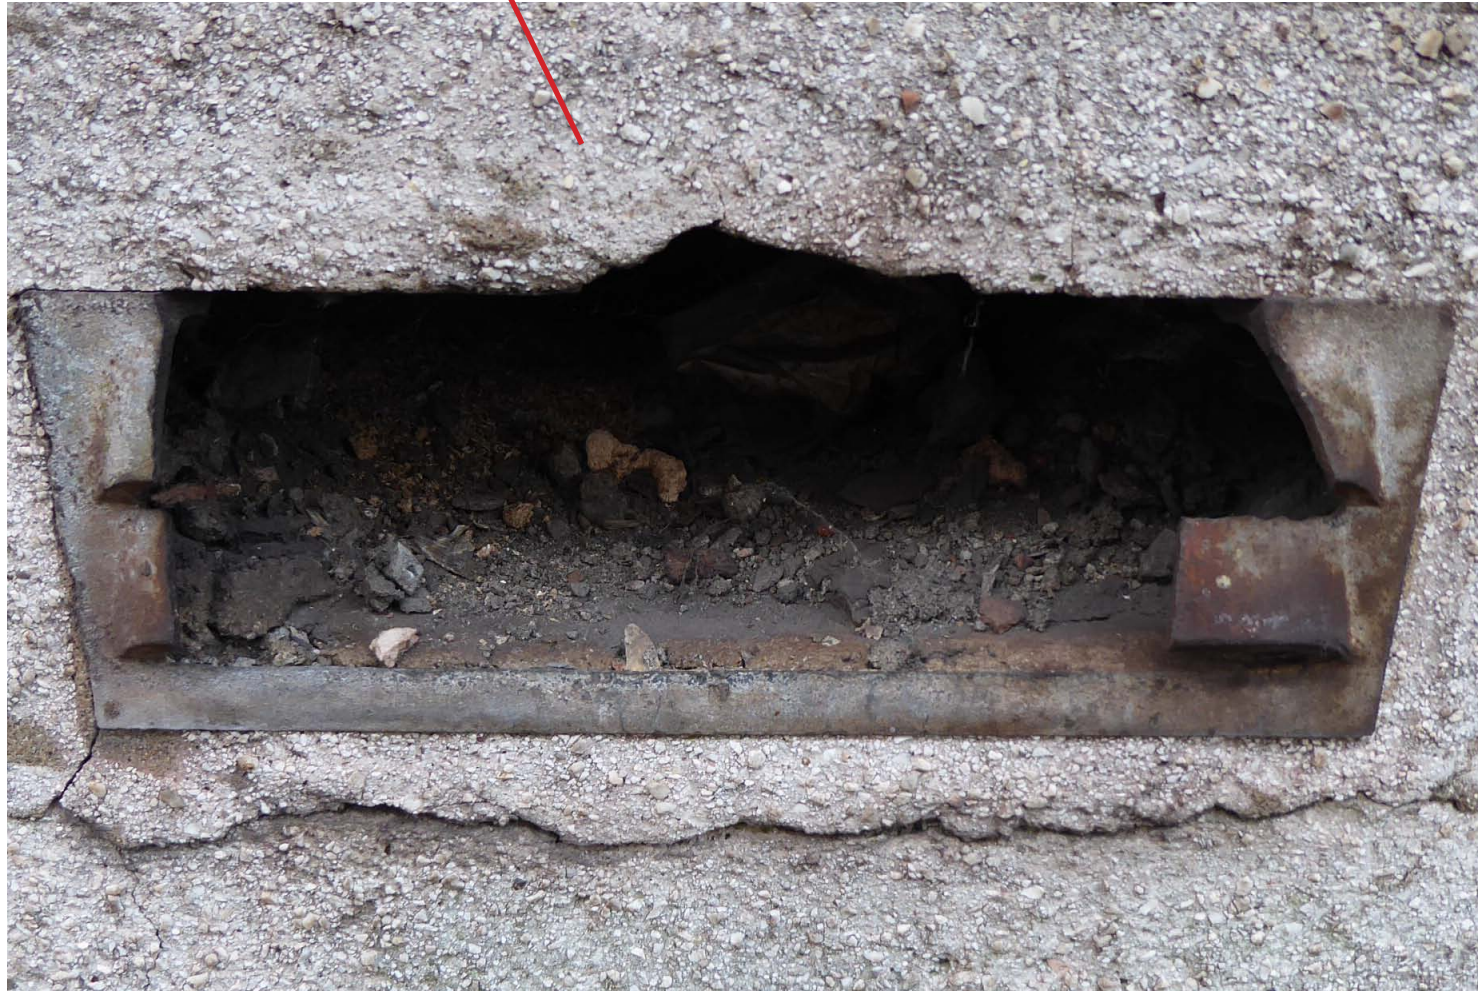
*View of one of the broken low vents to the auditorium and cinema*

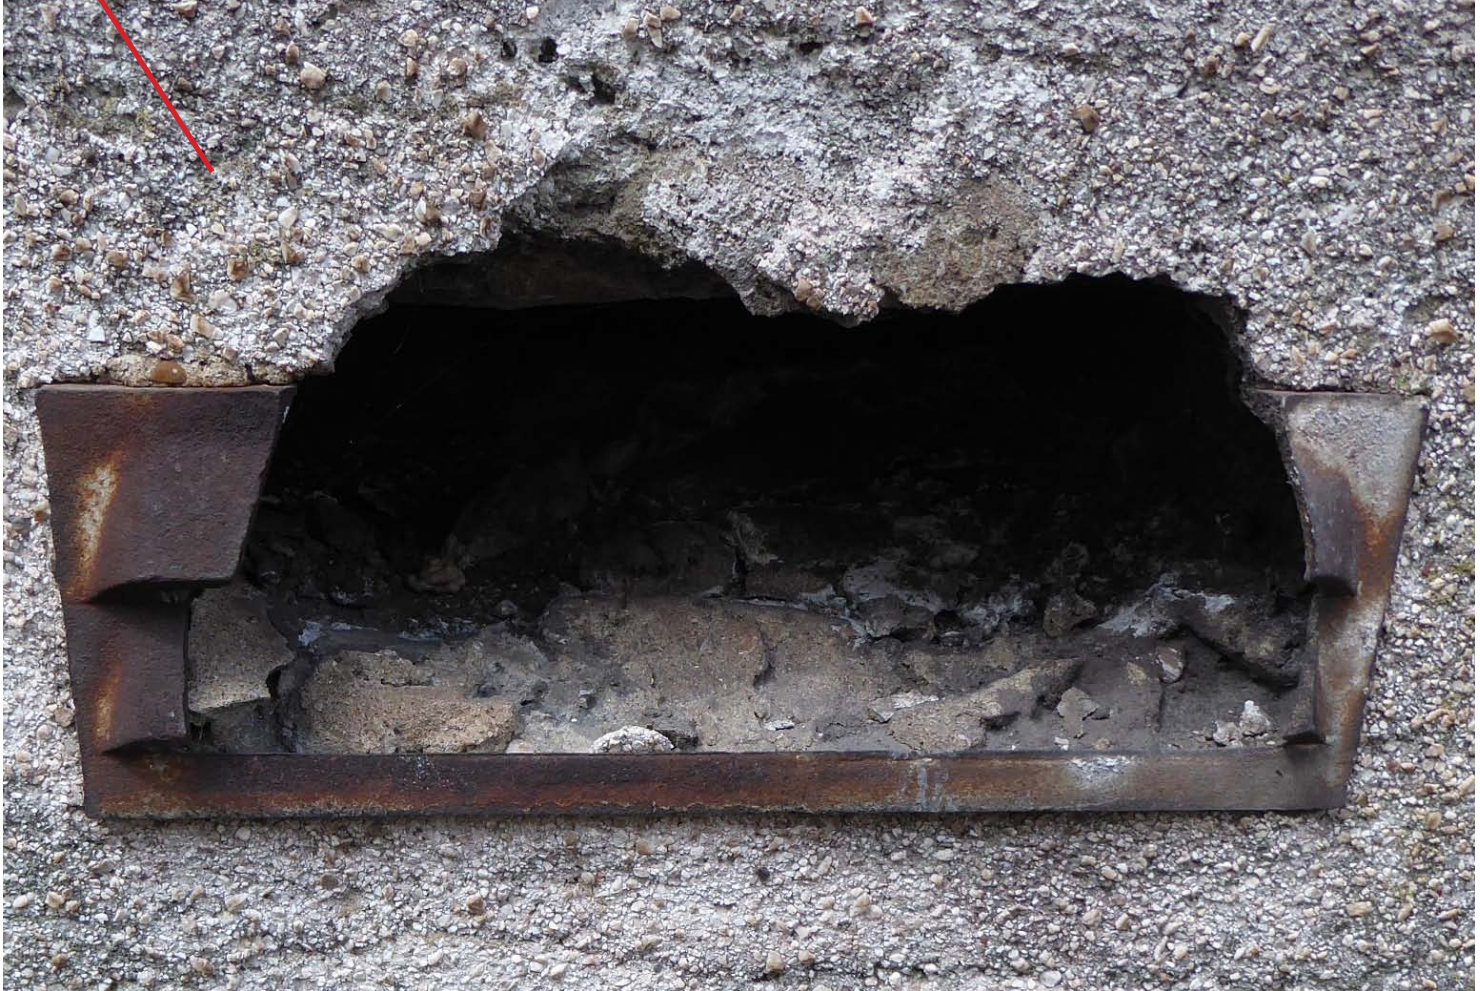
*View of one of the broken low vents to the auditorium and cinema*

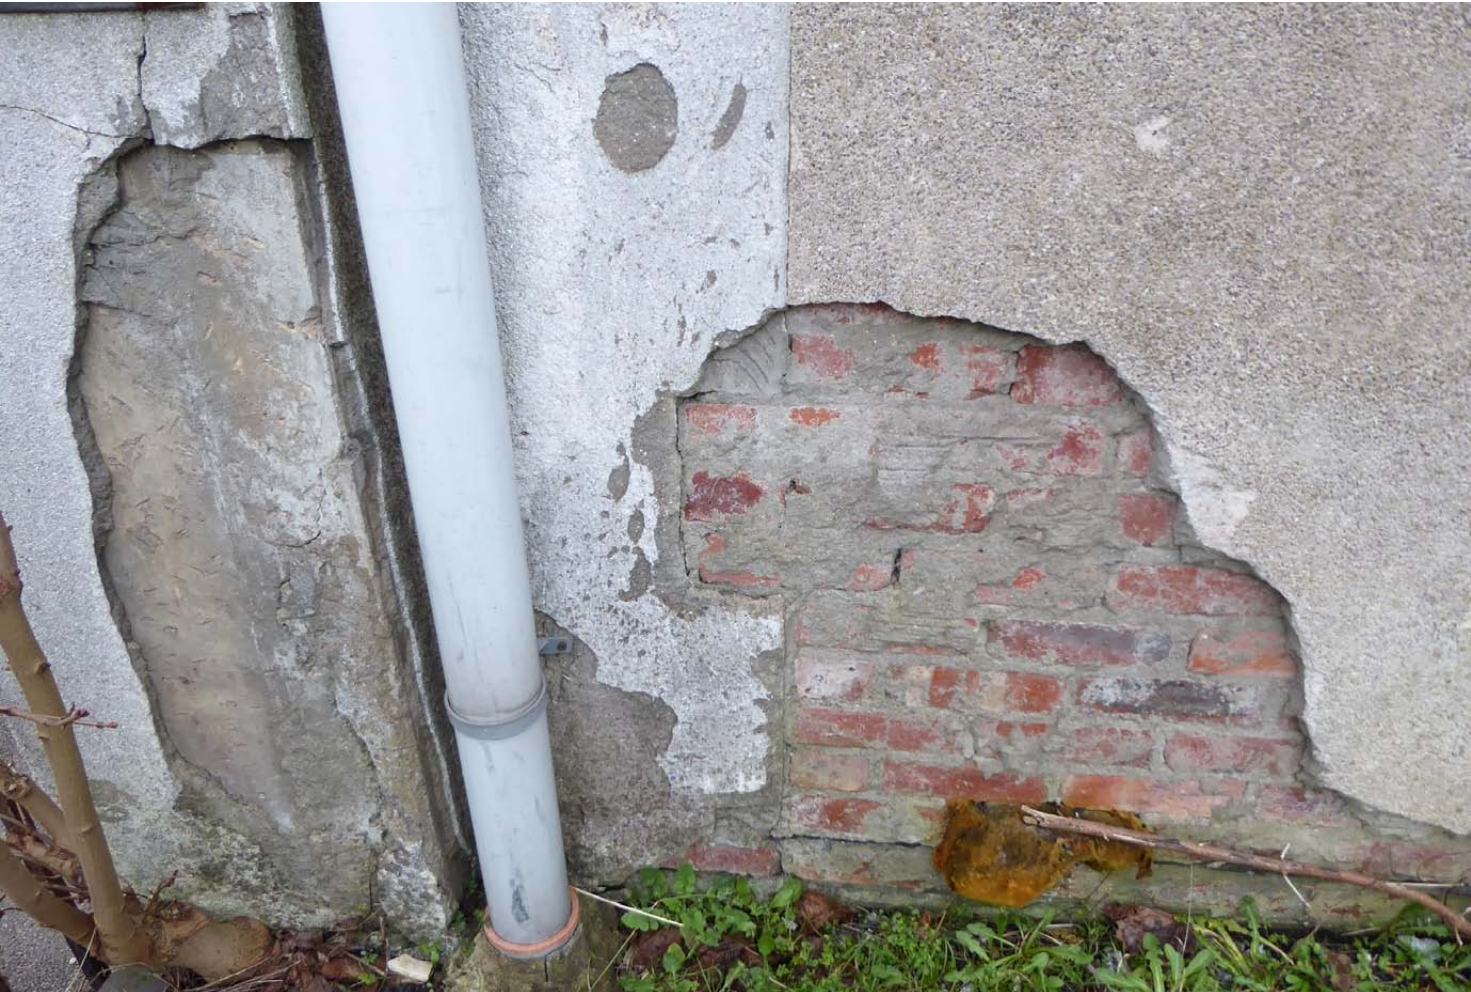
View of damaged render to the rear elevation showing the concrete frame and brick infill

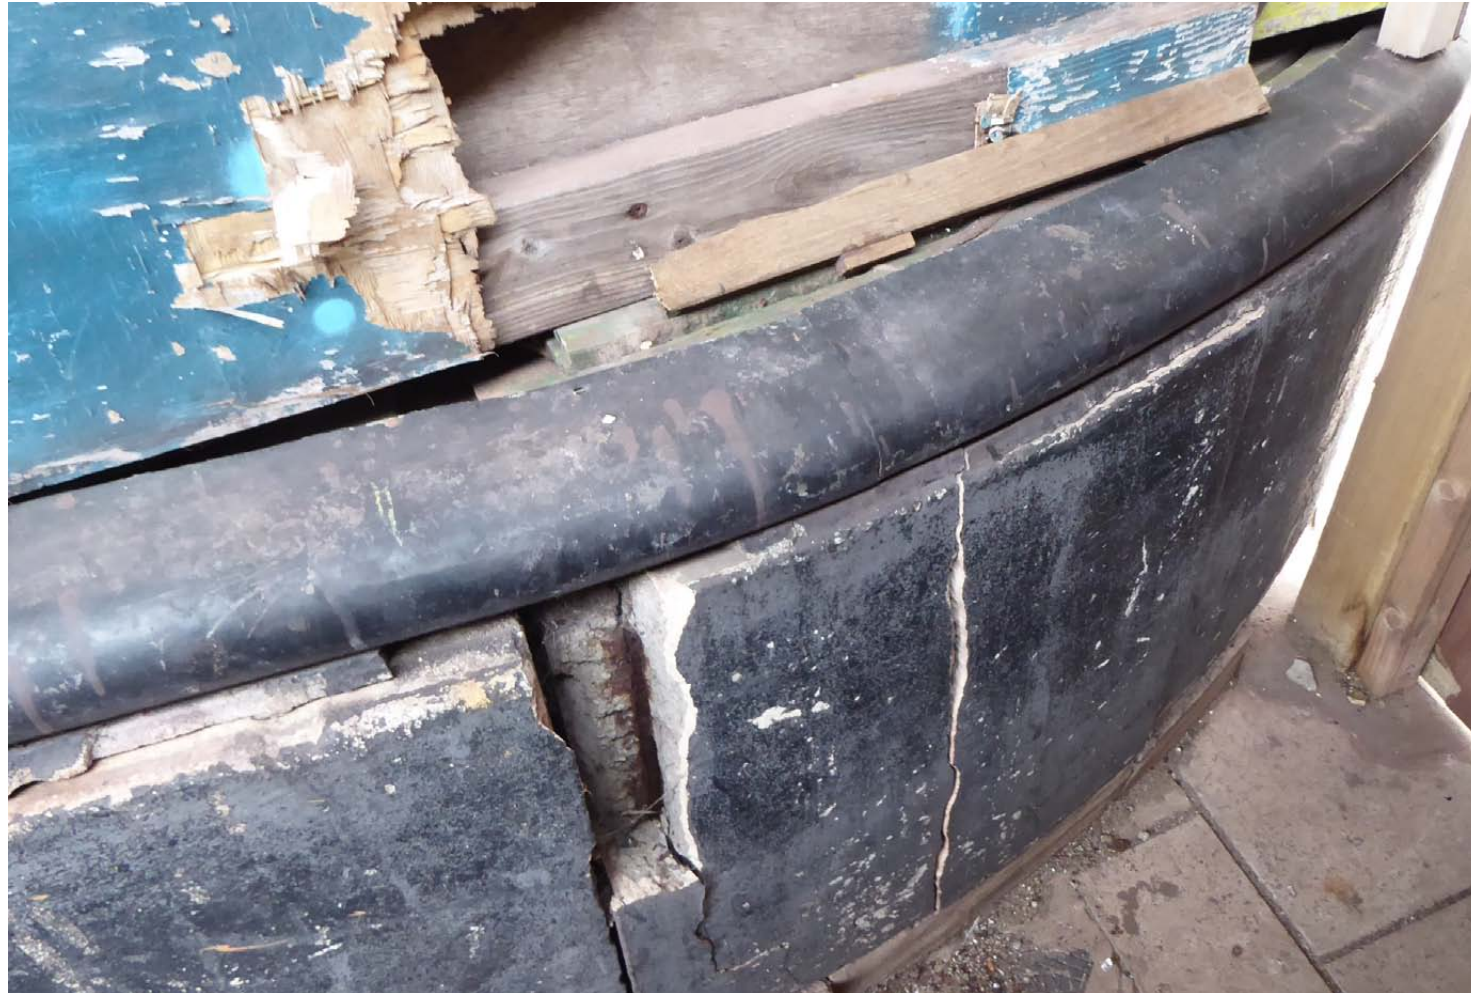
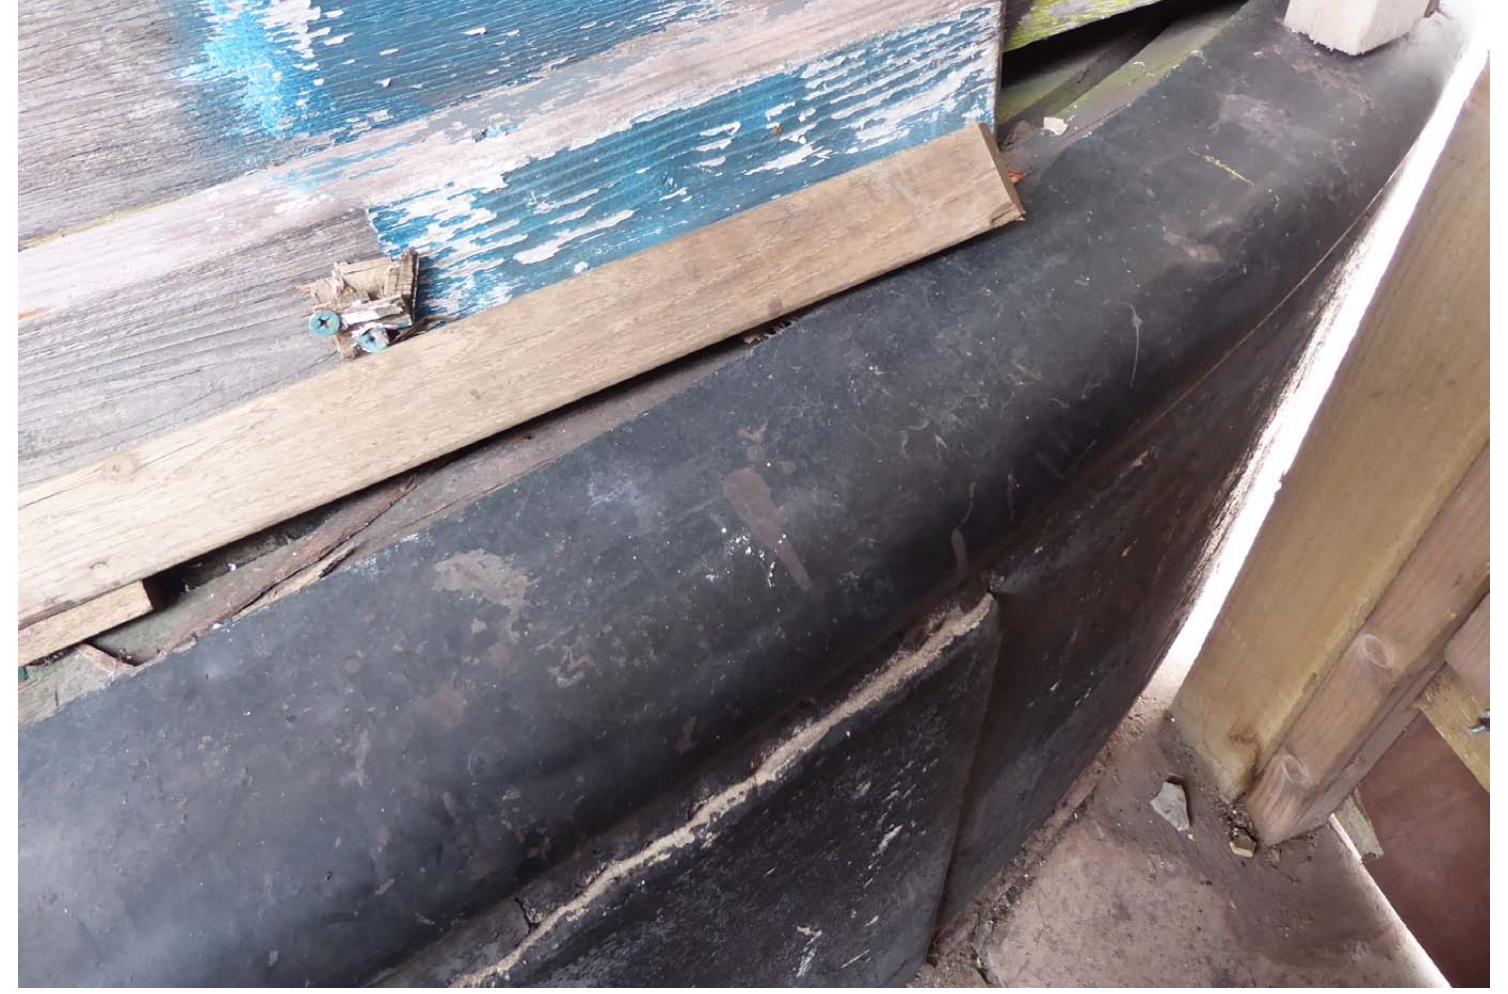
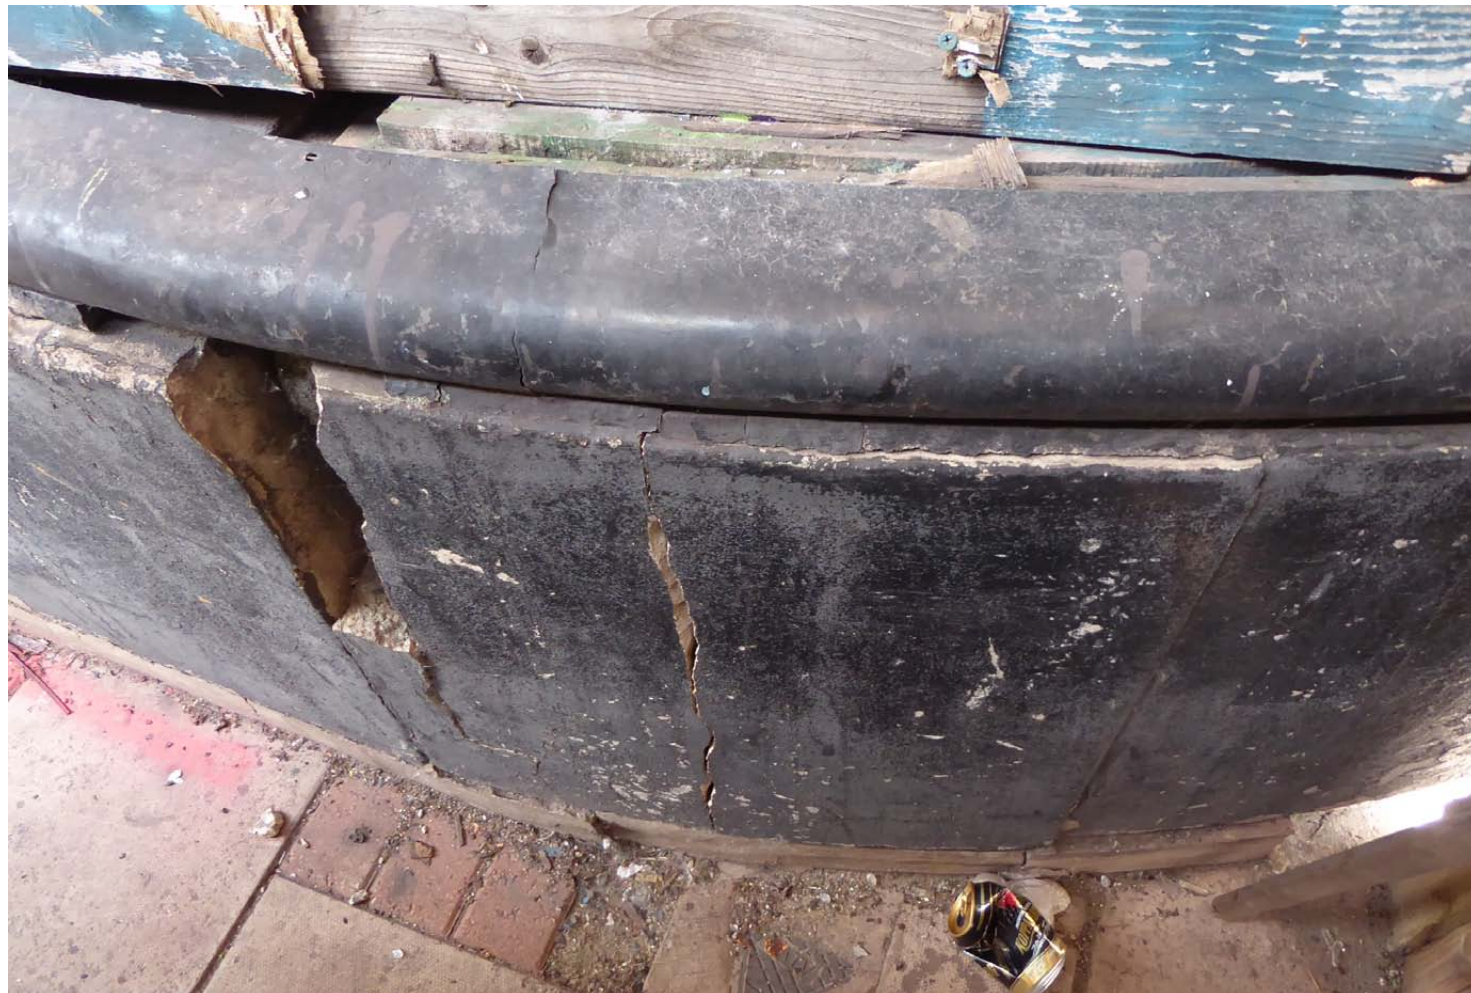
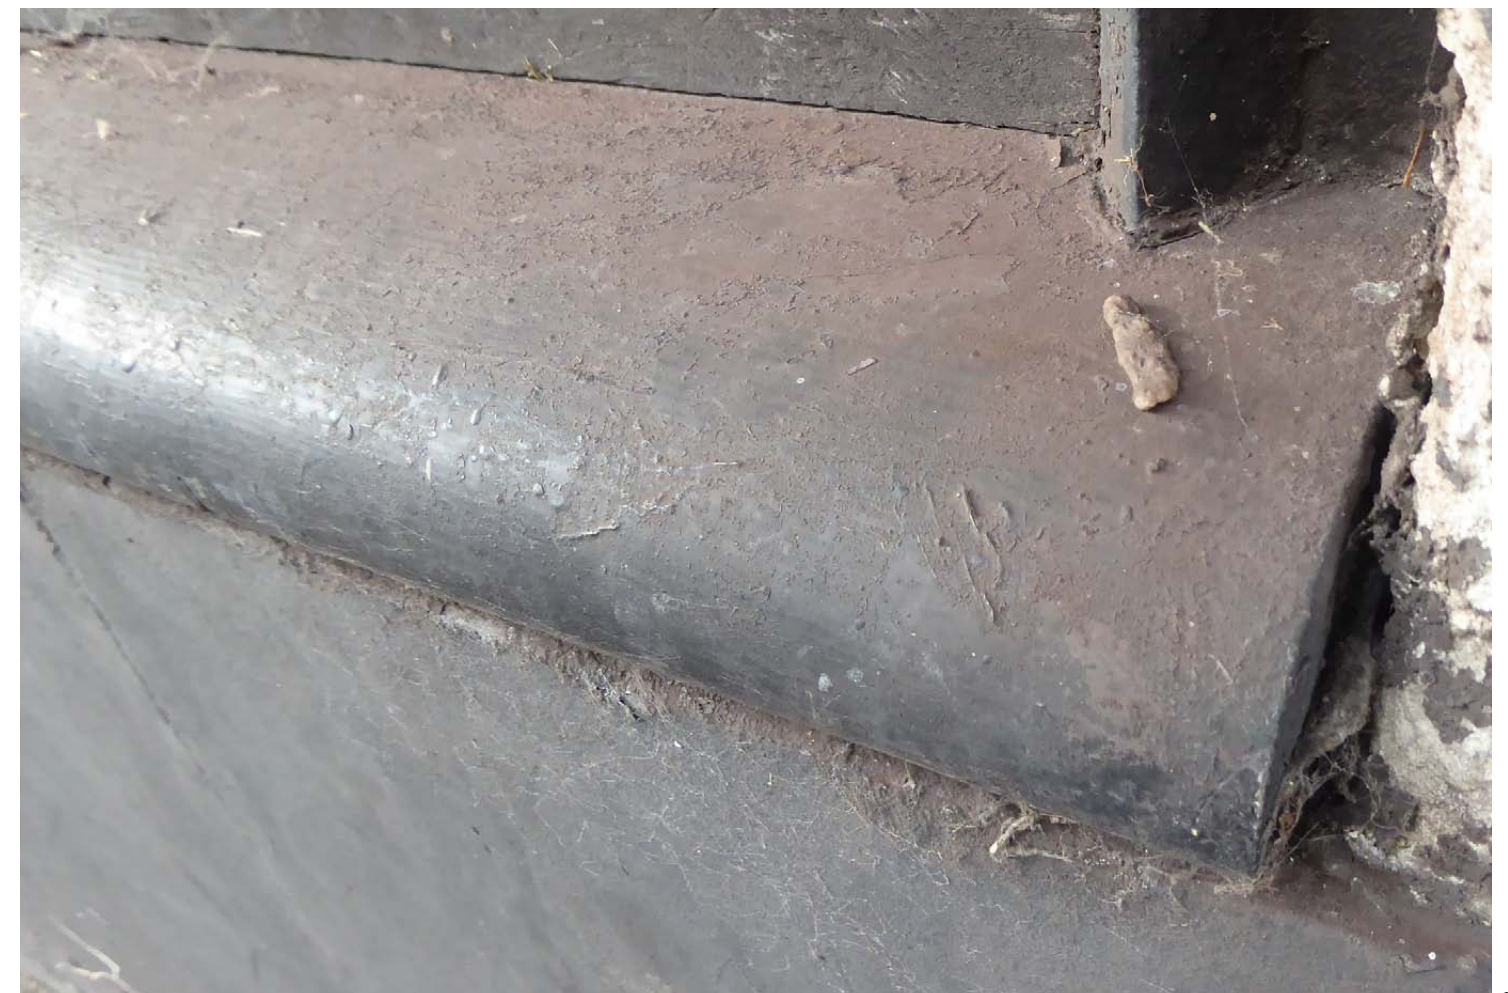
**6.1 The Exterior of the Plaza - the Frontage** - These photographs show the curved & rounded black painted metal cill to the retail units' glazing with the black painted reconstituted stone / concrete plinth, damaged in areas
