**Plaza, Port Talbot**

**HISTORIC BUILDING RECORDING**

(385)1902-GWP-A-2A-HBR-P00

Date: 06.01.20

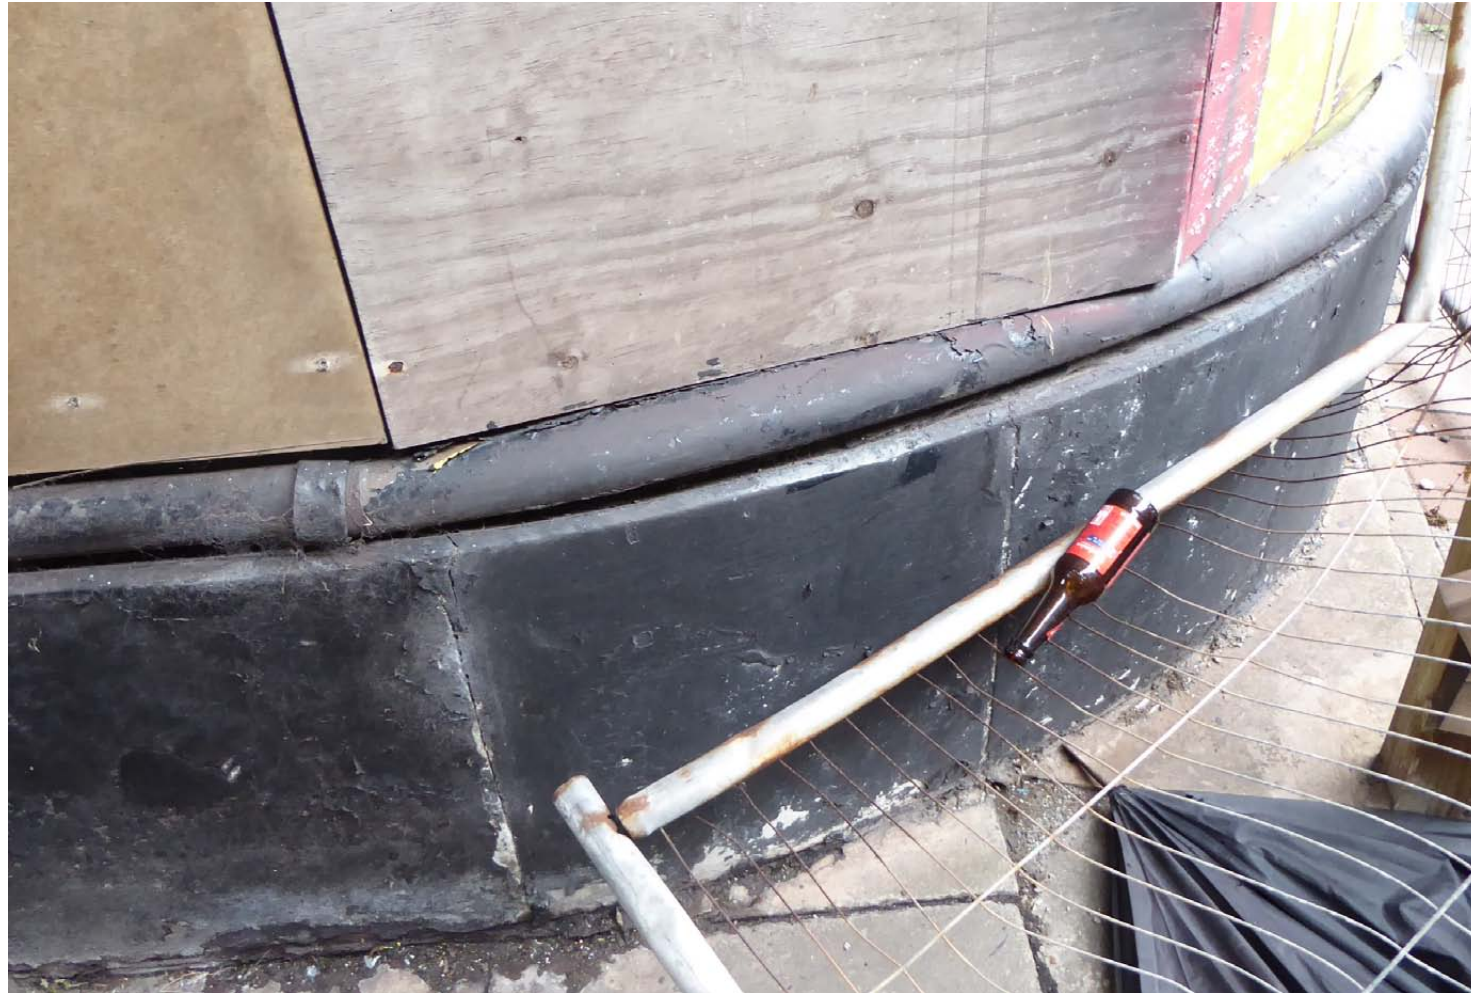
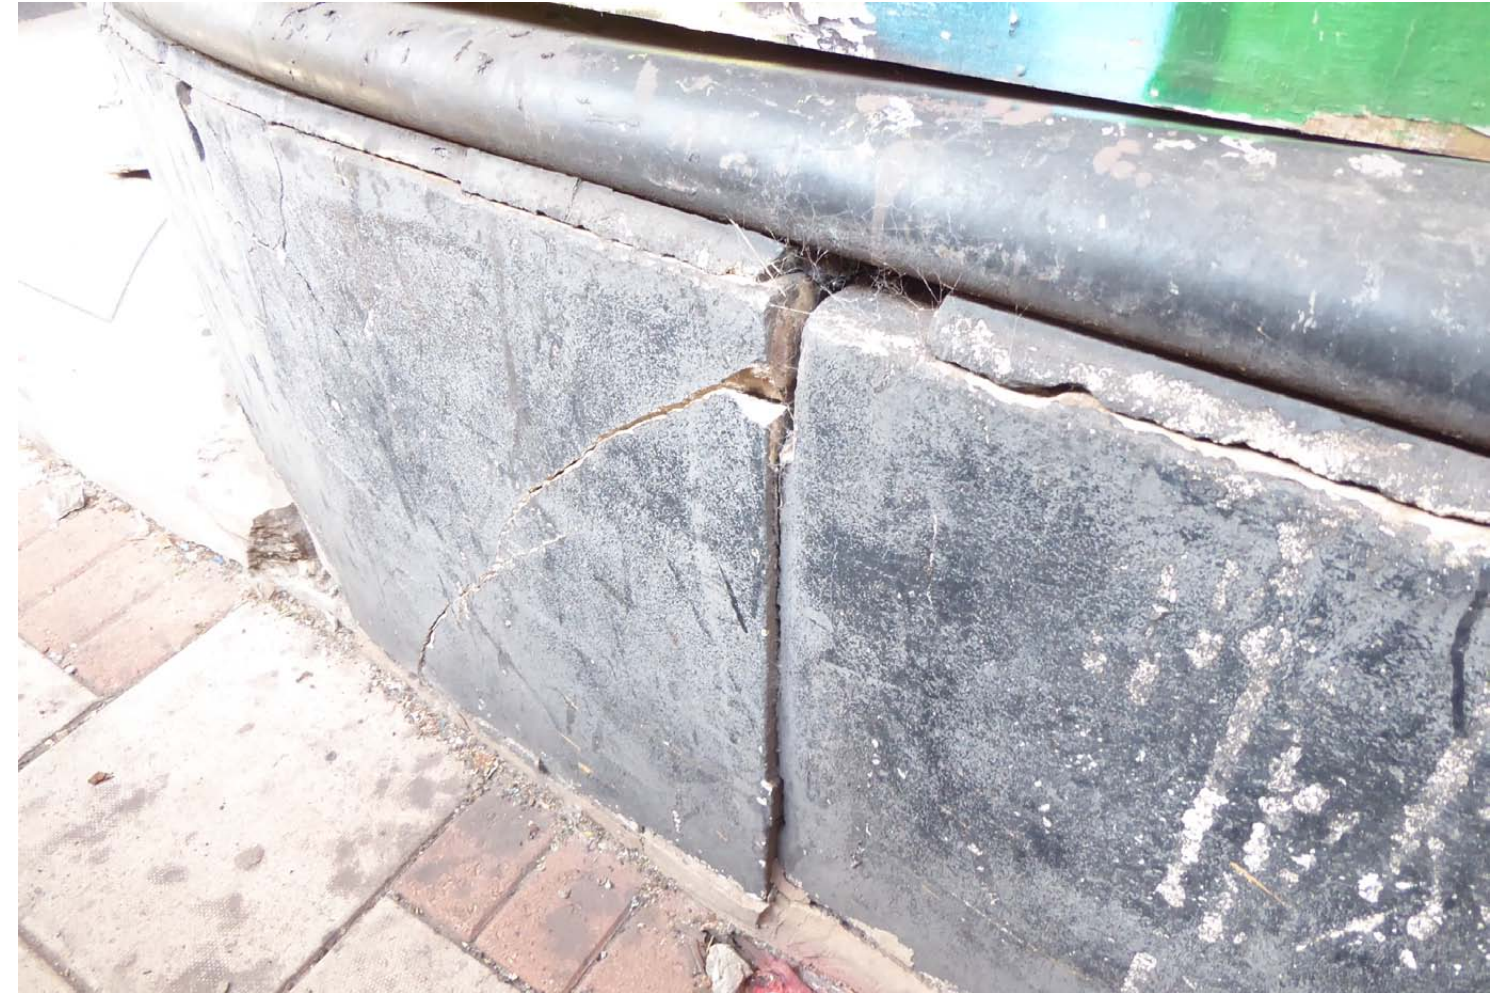
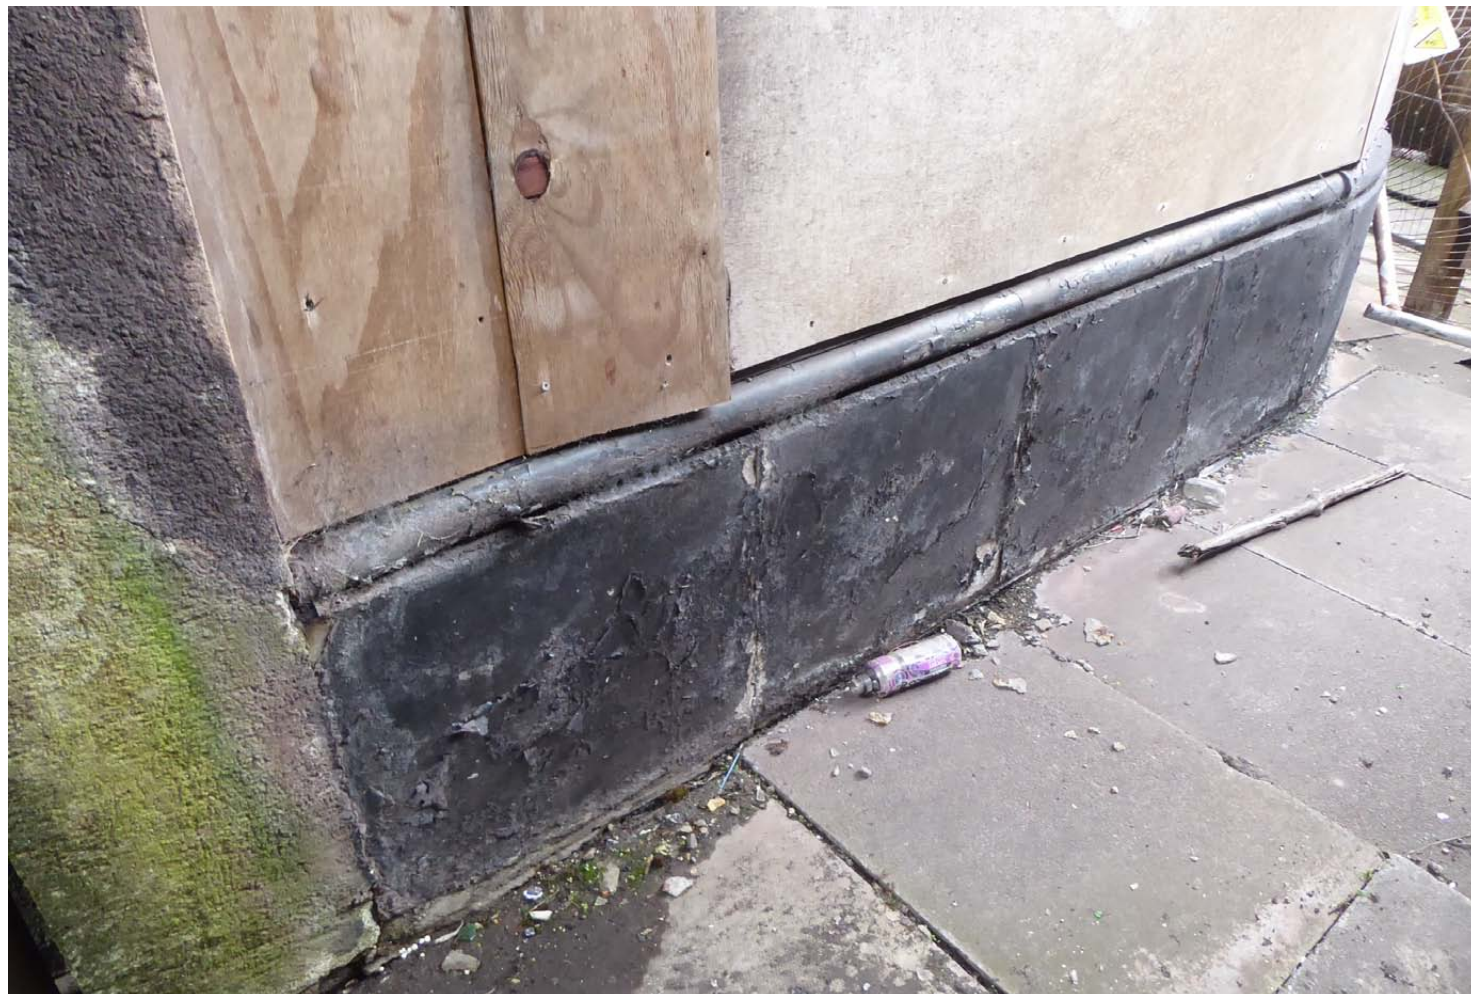
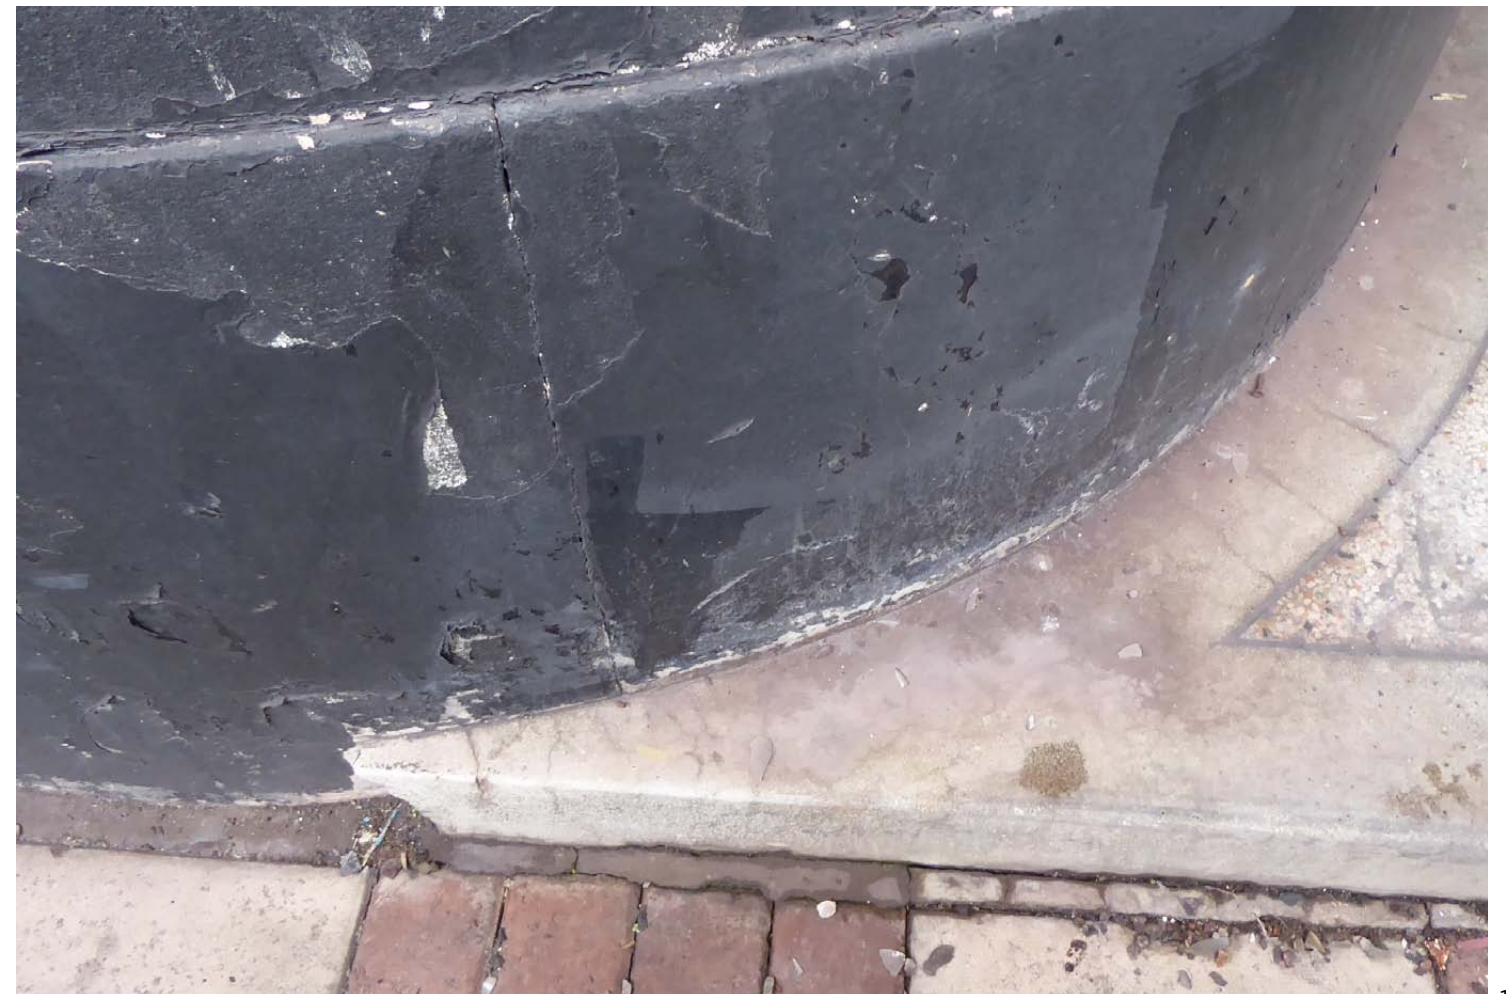
**6.1 The Exterior of the Plaza - the Frontage** - These photographs show the black painted reconstituted stone / concrete curved plinth underneath the metal cill which is cracked & damaged in a number of areas

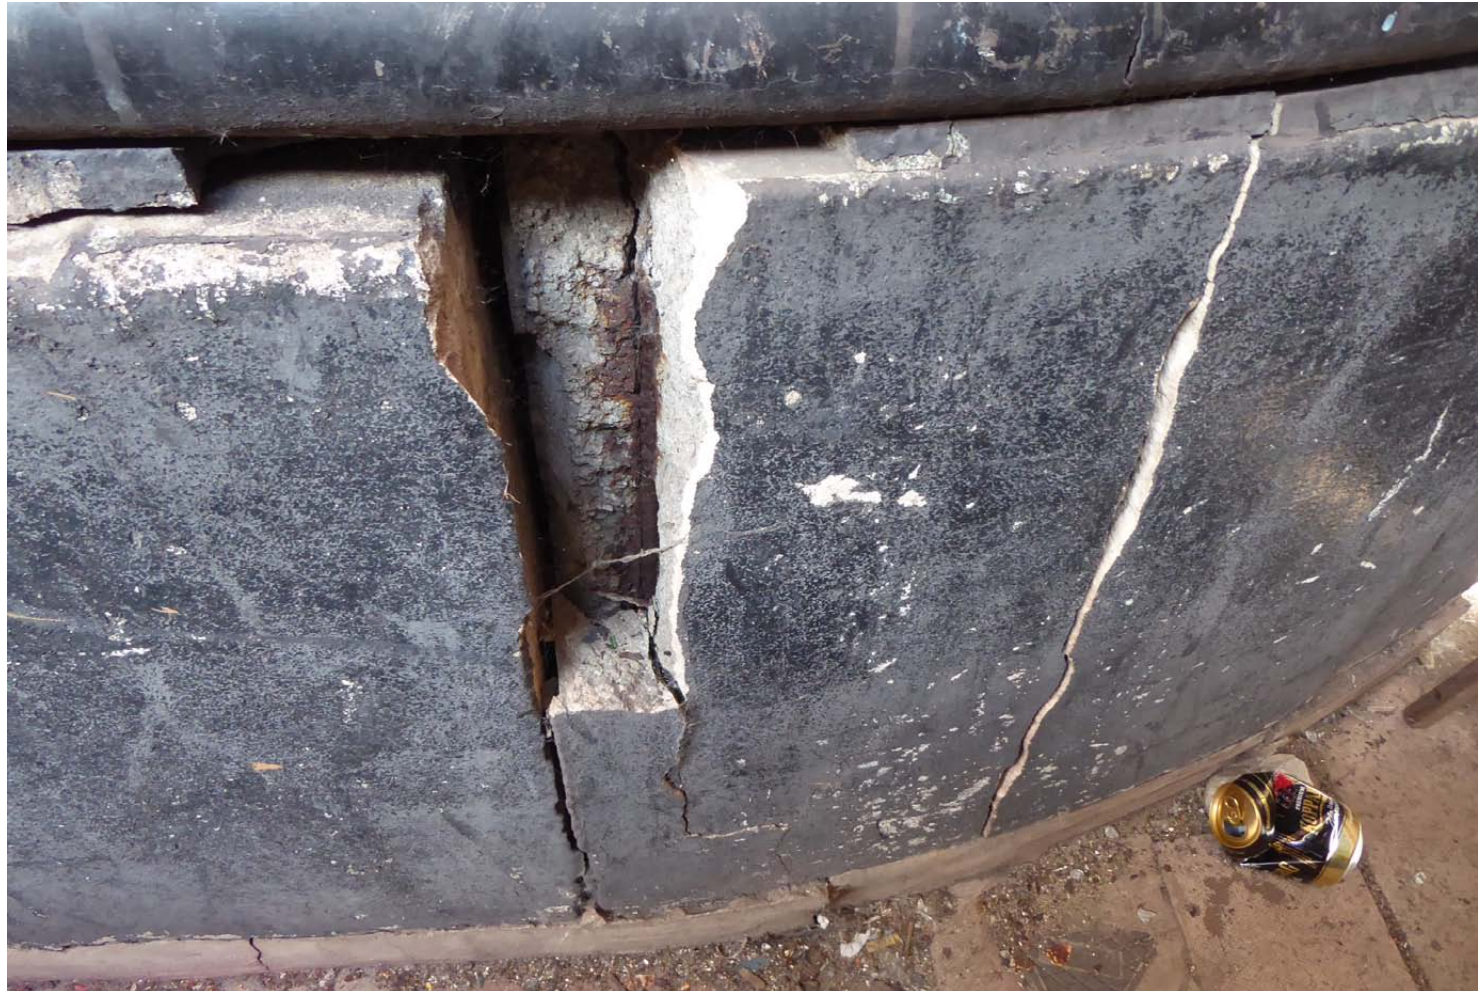
*View of spalled surface to plinth showing corroded steel behind which presumably caused the spalling*

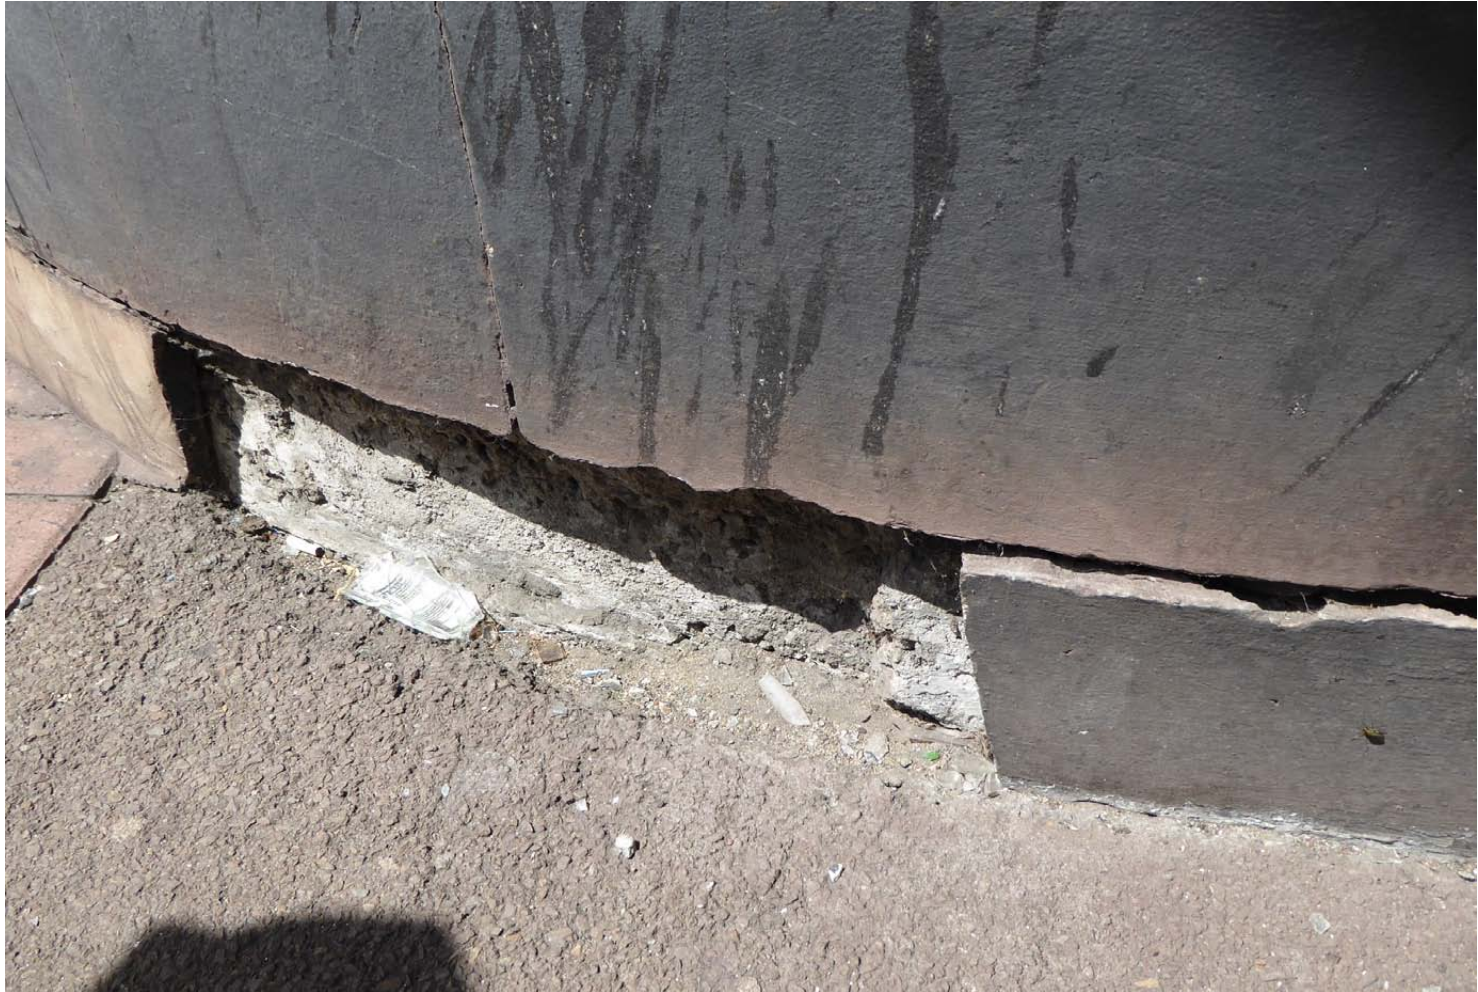
*View of spalled surface to plinth*

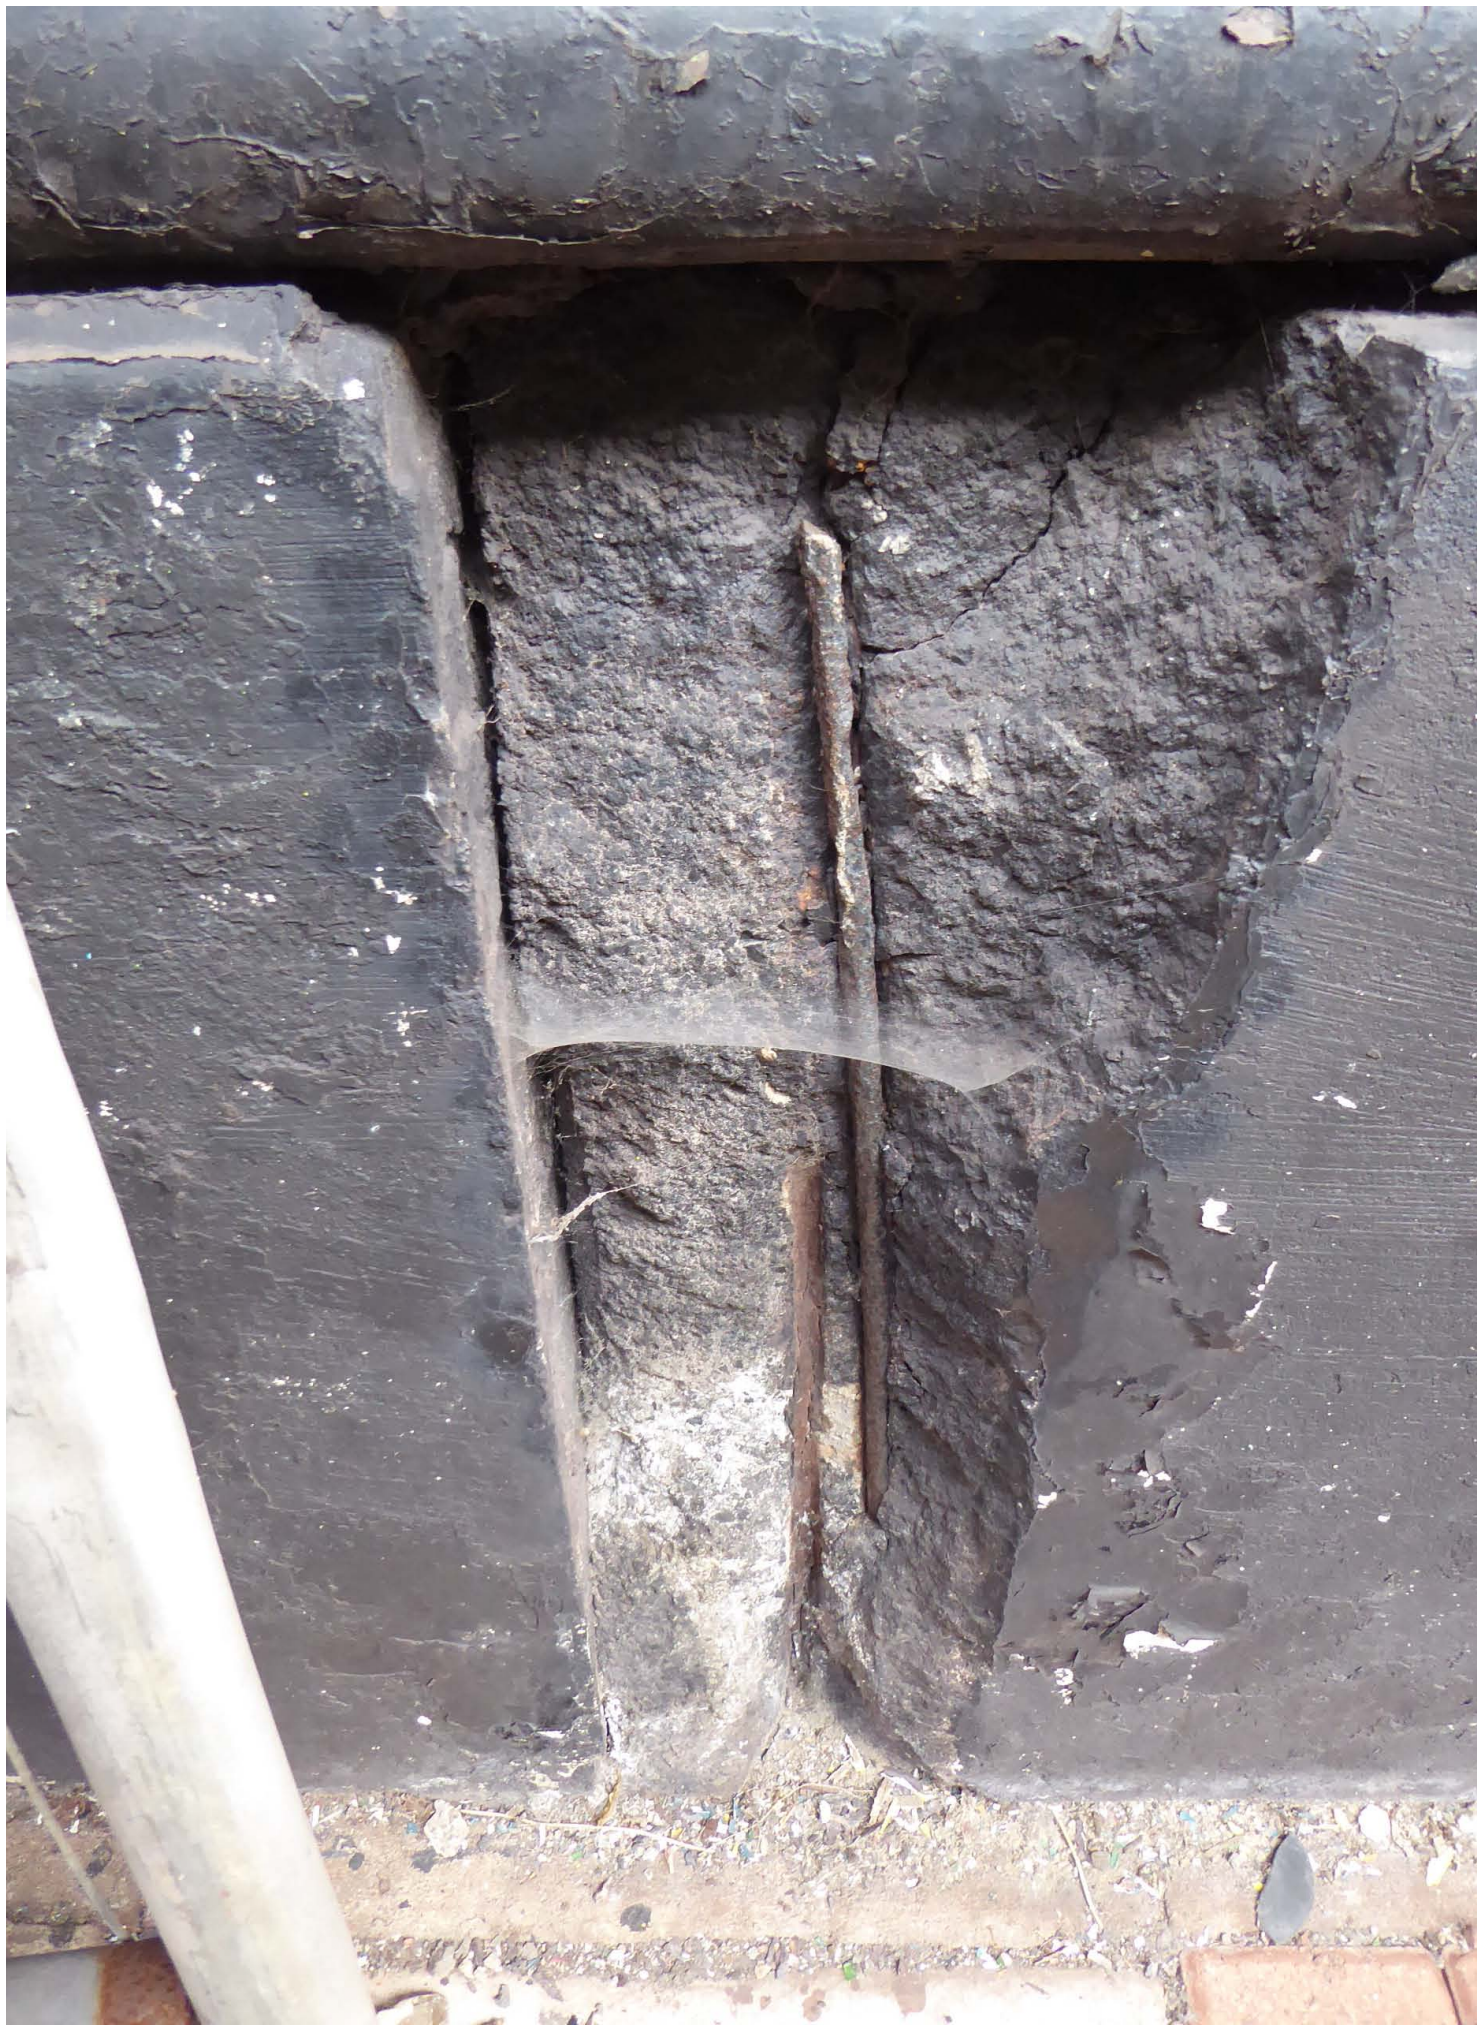
*View of spalled surface to plinth showing corroded steel behind which presumably caused the spalling*

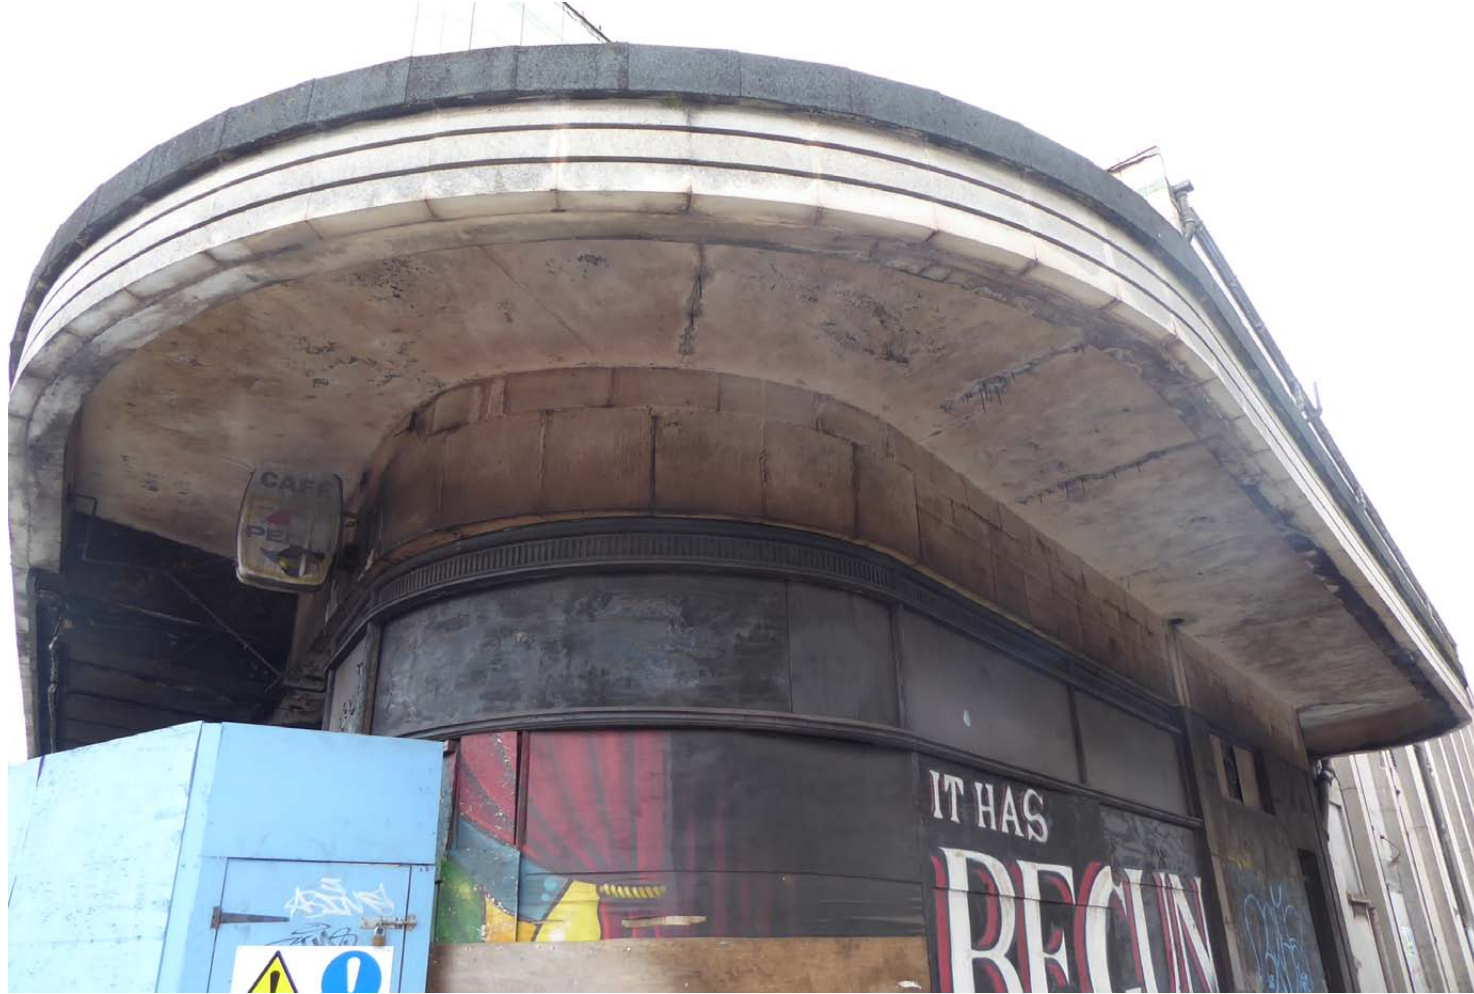
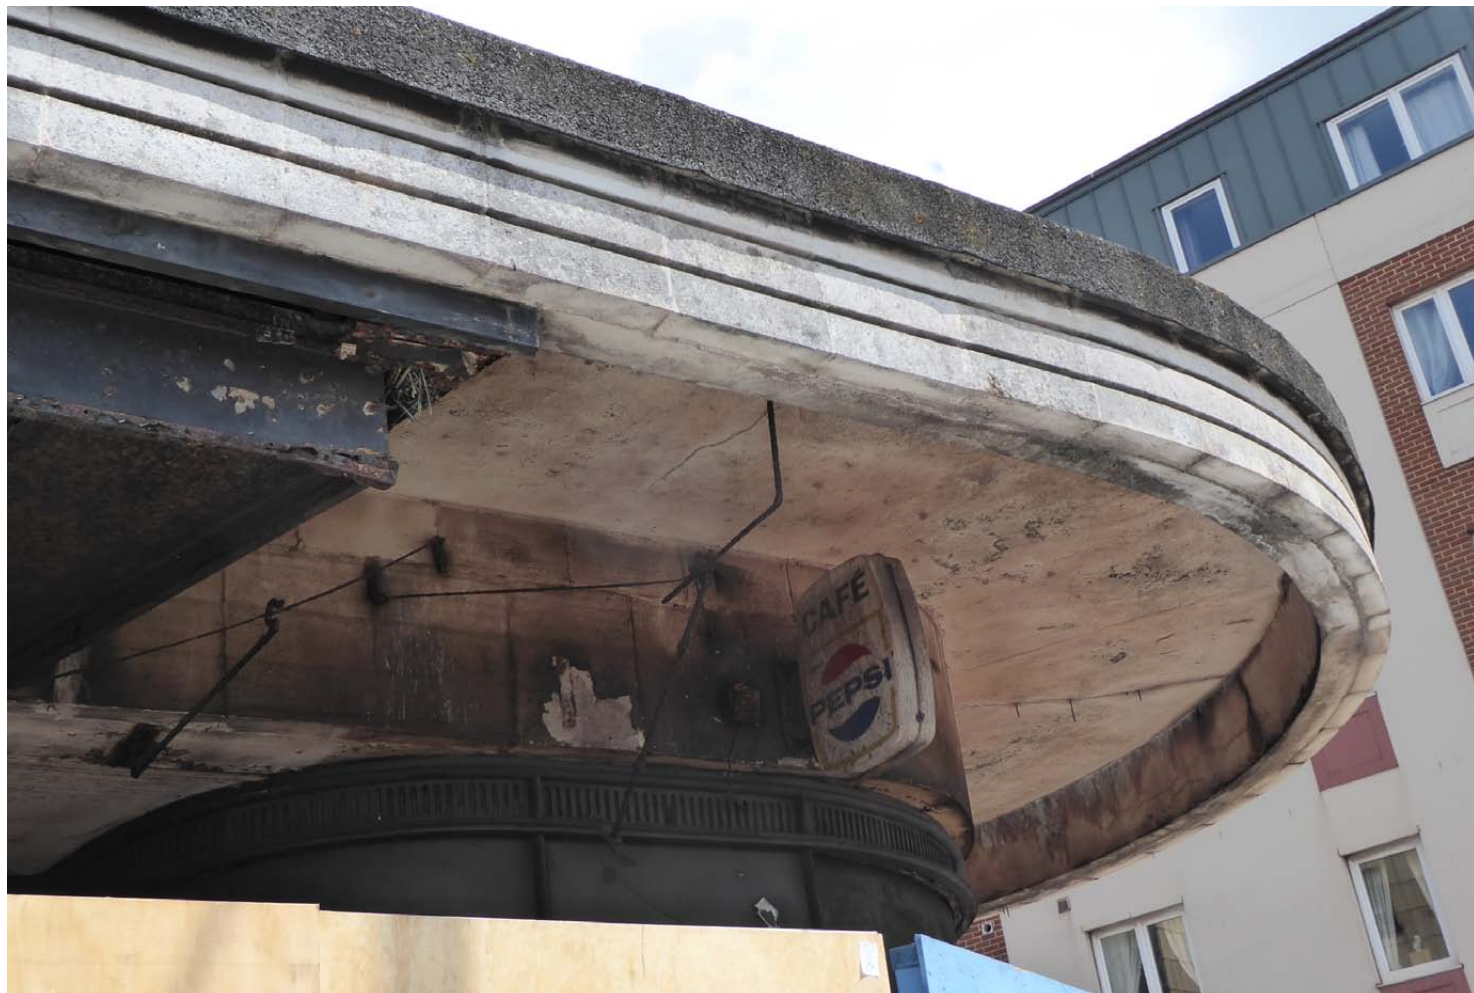
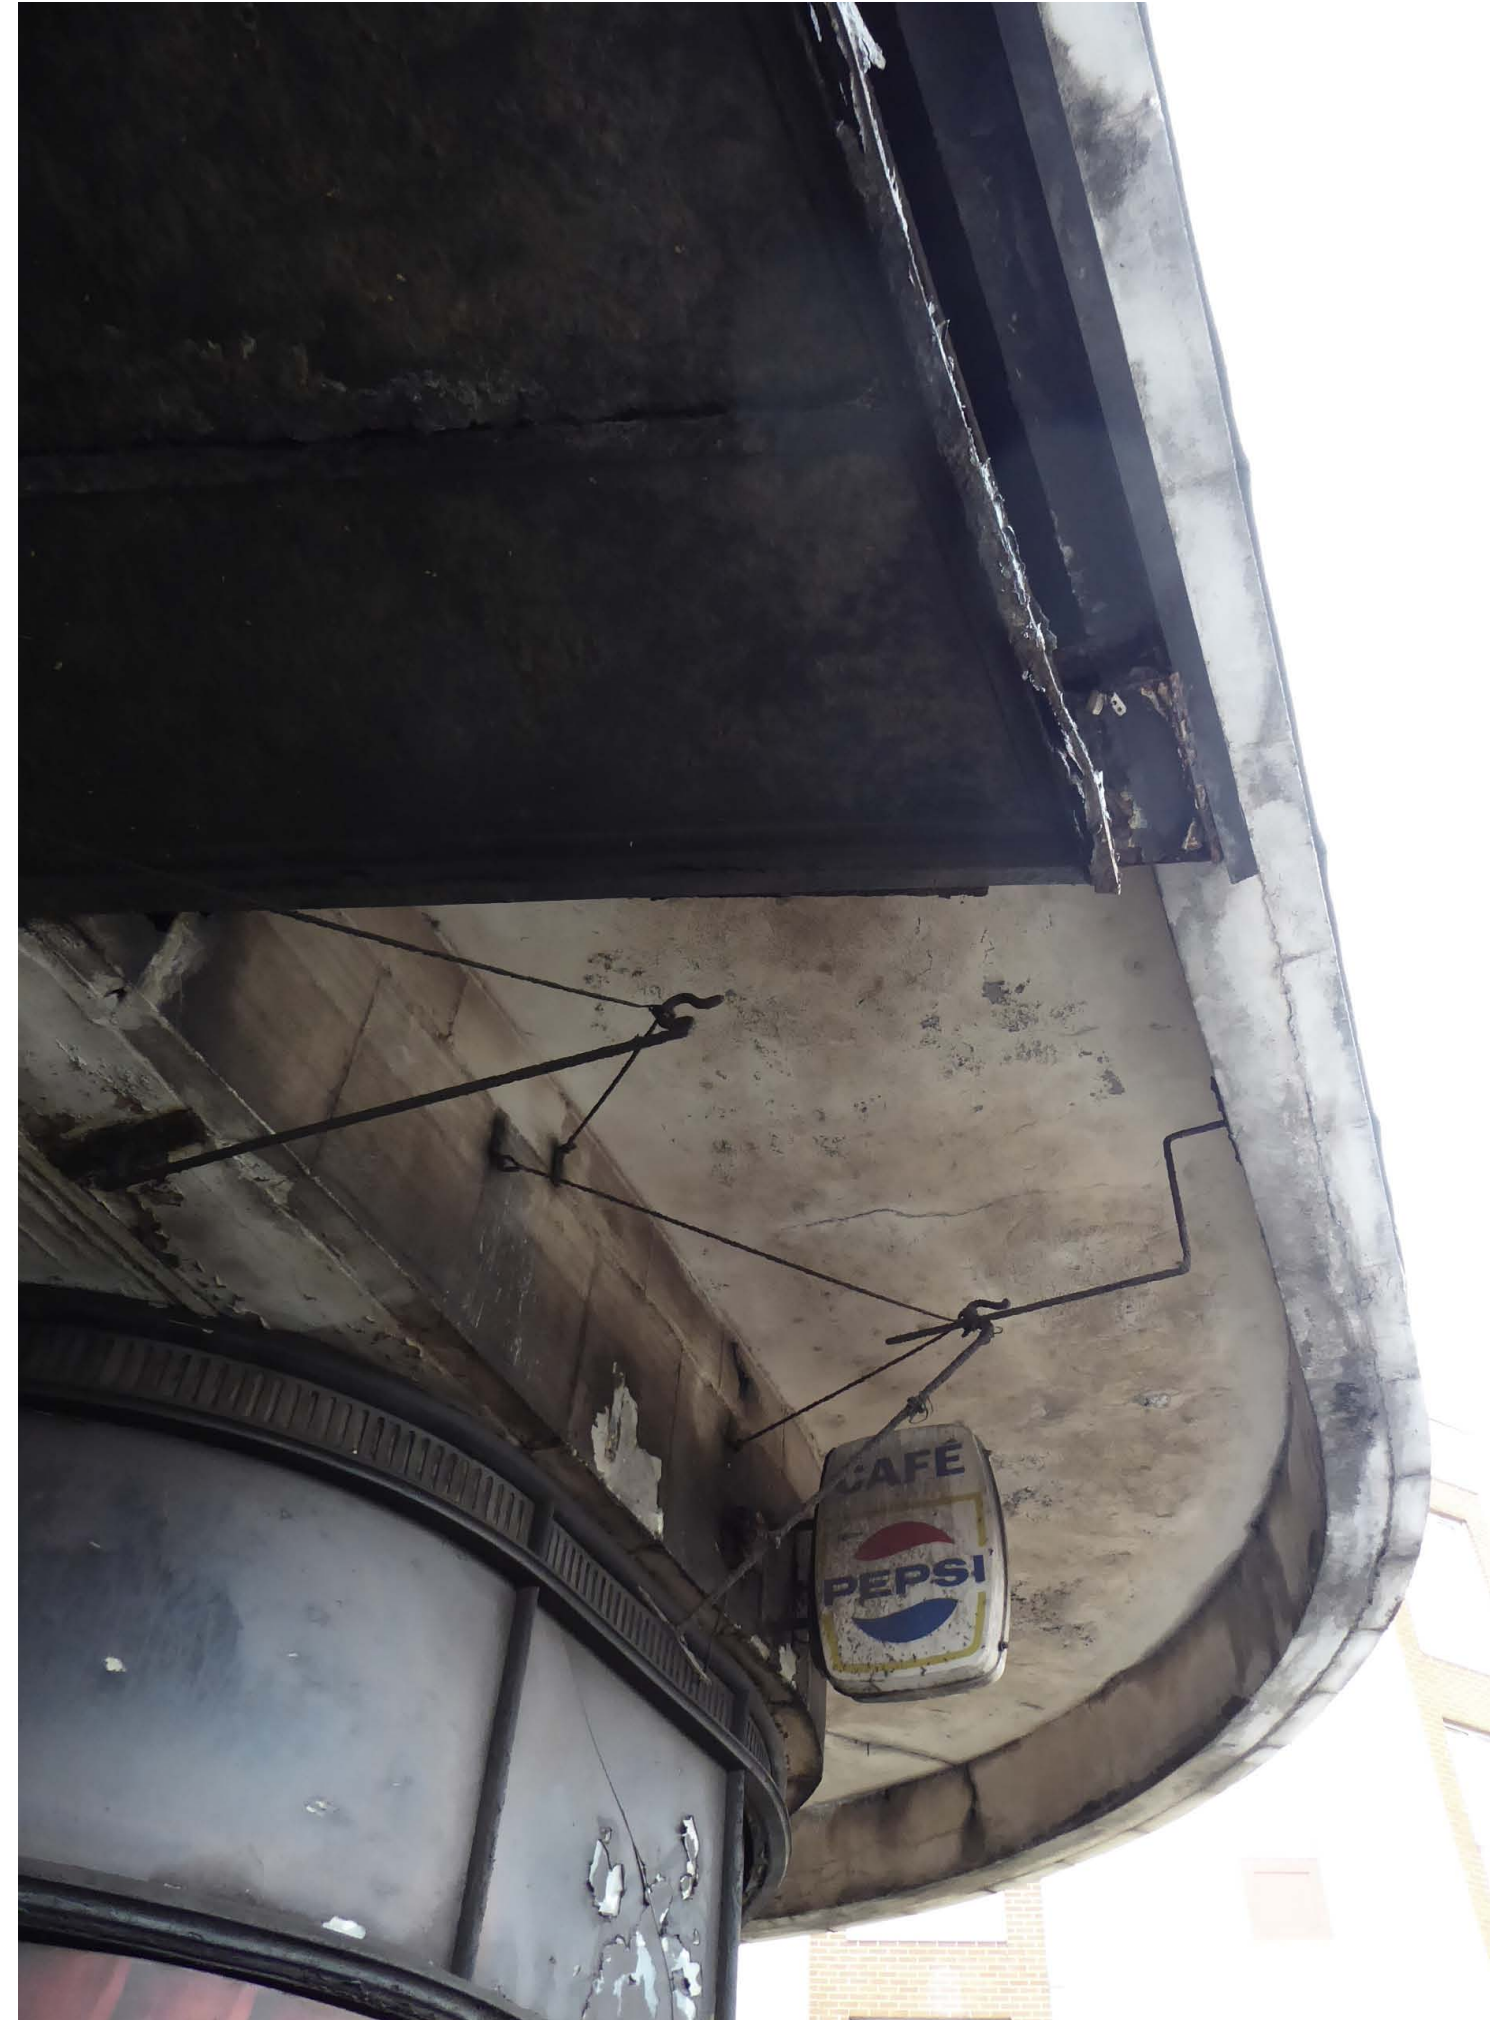
**6.1 The Exterior of the Plaza - the Frontage** - The photographs below show the underside of the reinforced concrete canopy over the frontage (in poor condition) with its rebated canopy edge and asphalt dressed over
