**Plaza, Port Talbot**

**HISTORIC BUILDING RECORDING**

(385)1902-GWP-A-2A-HBR-P00

Date: 06.01.20

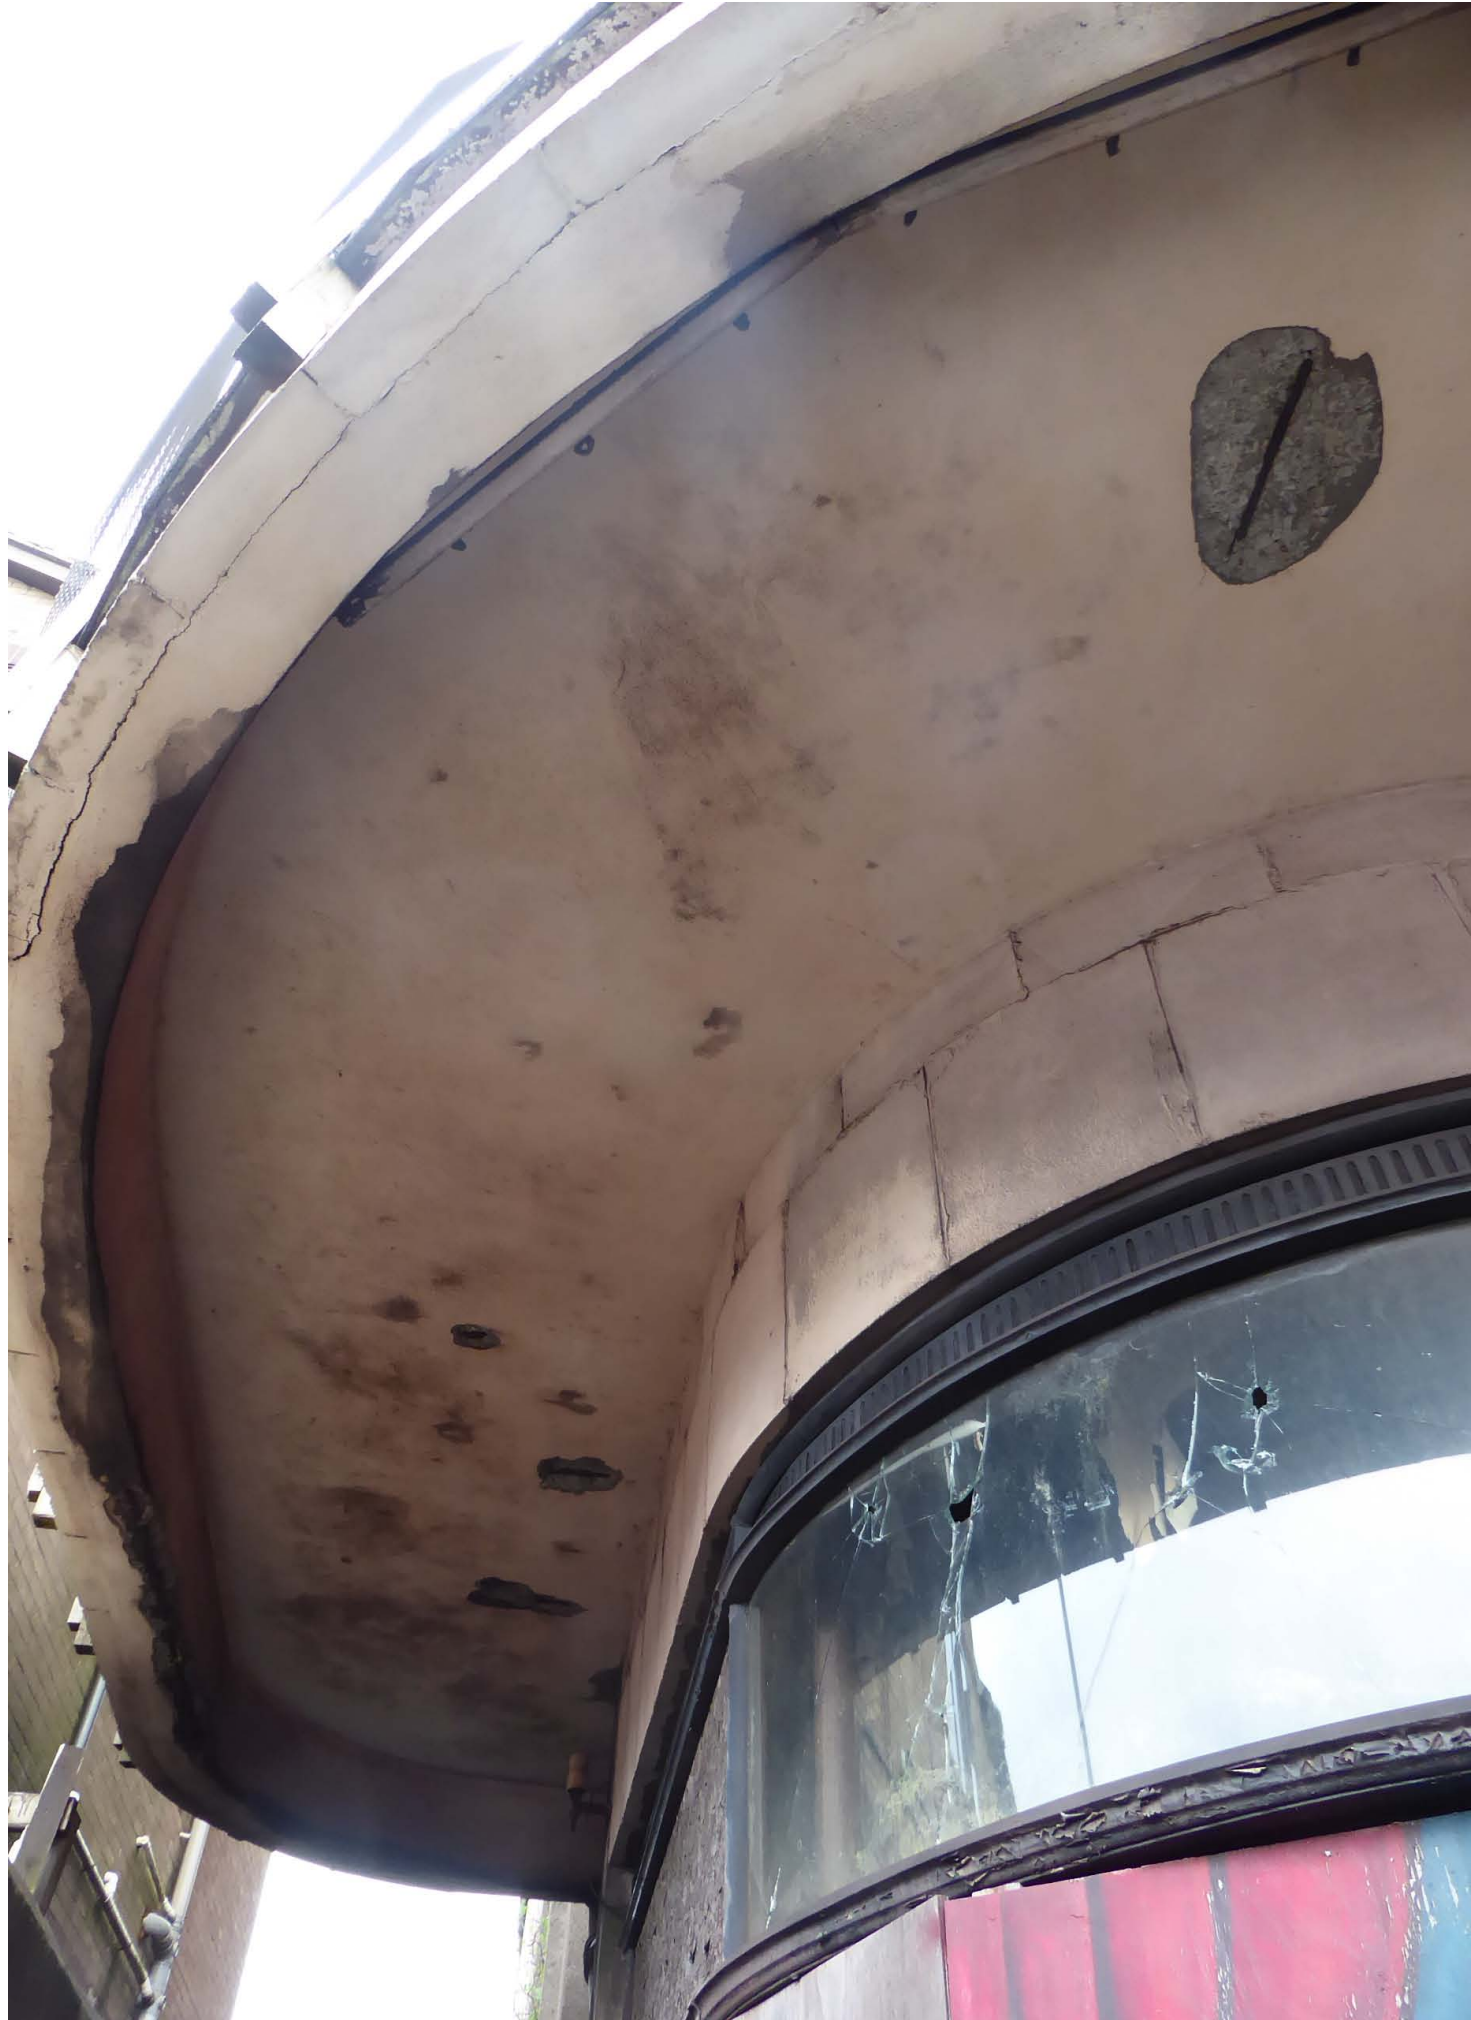
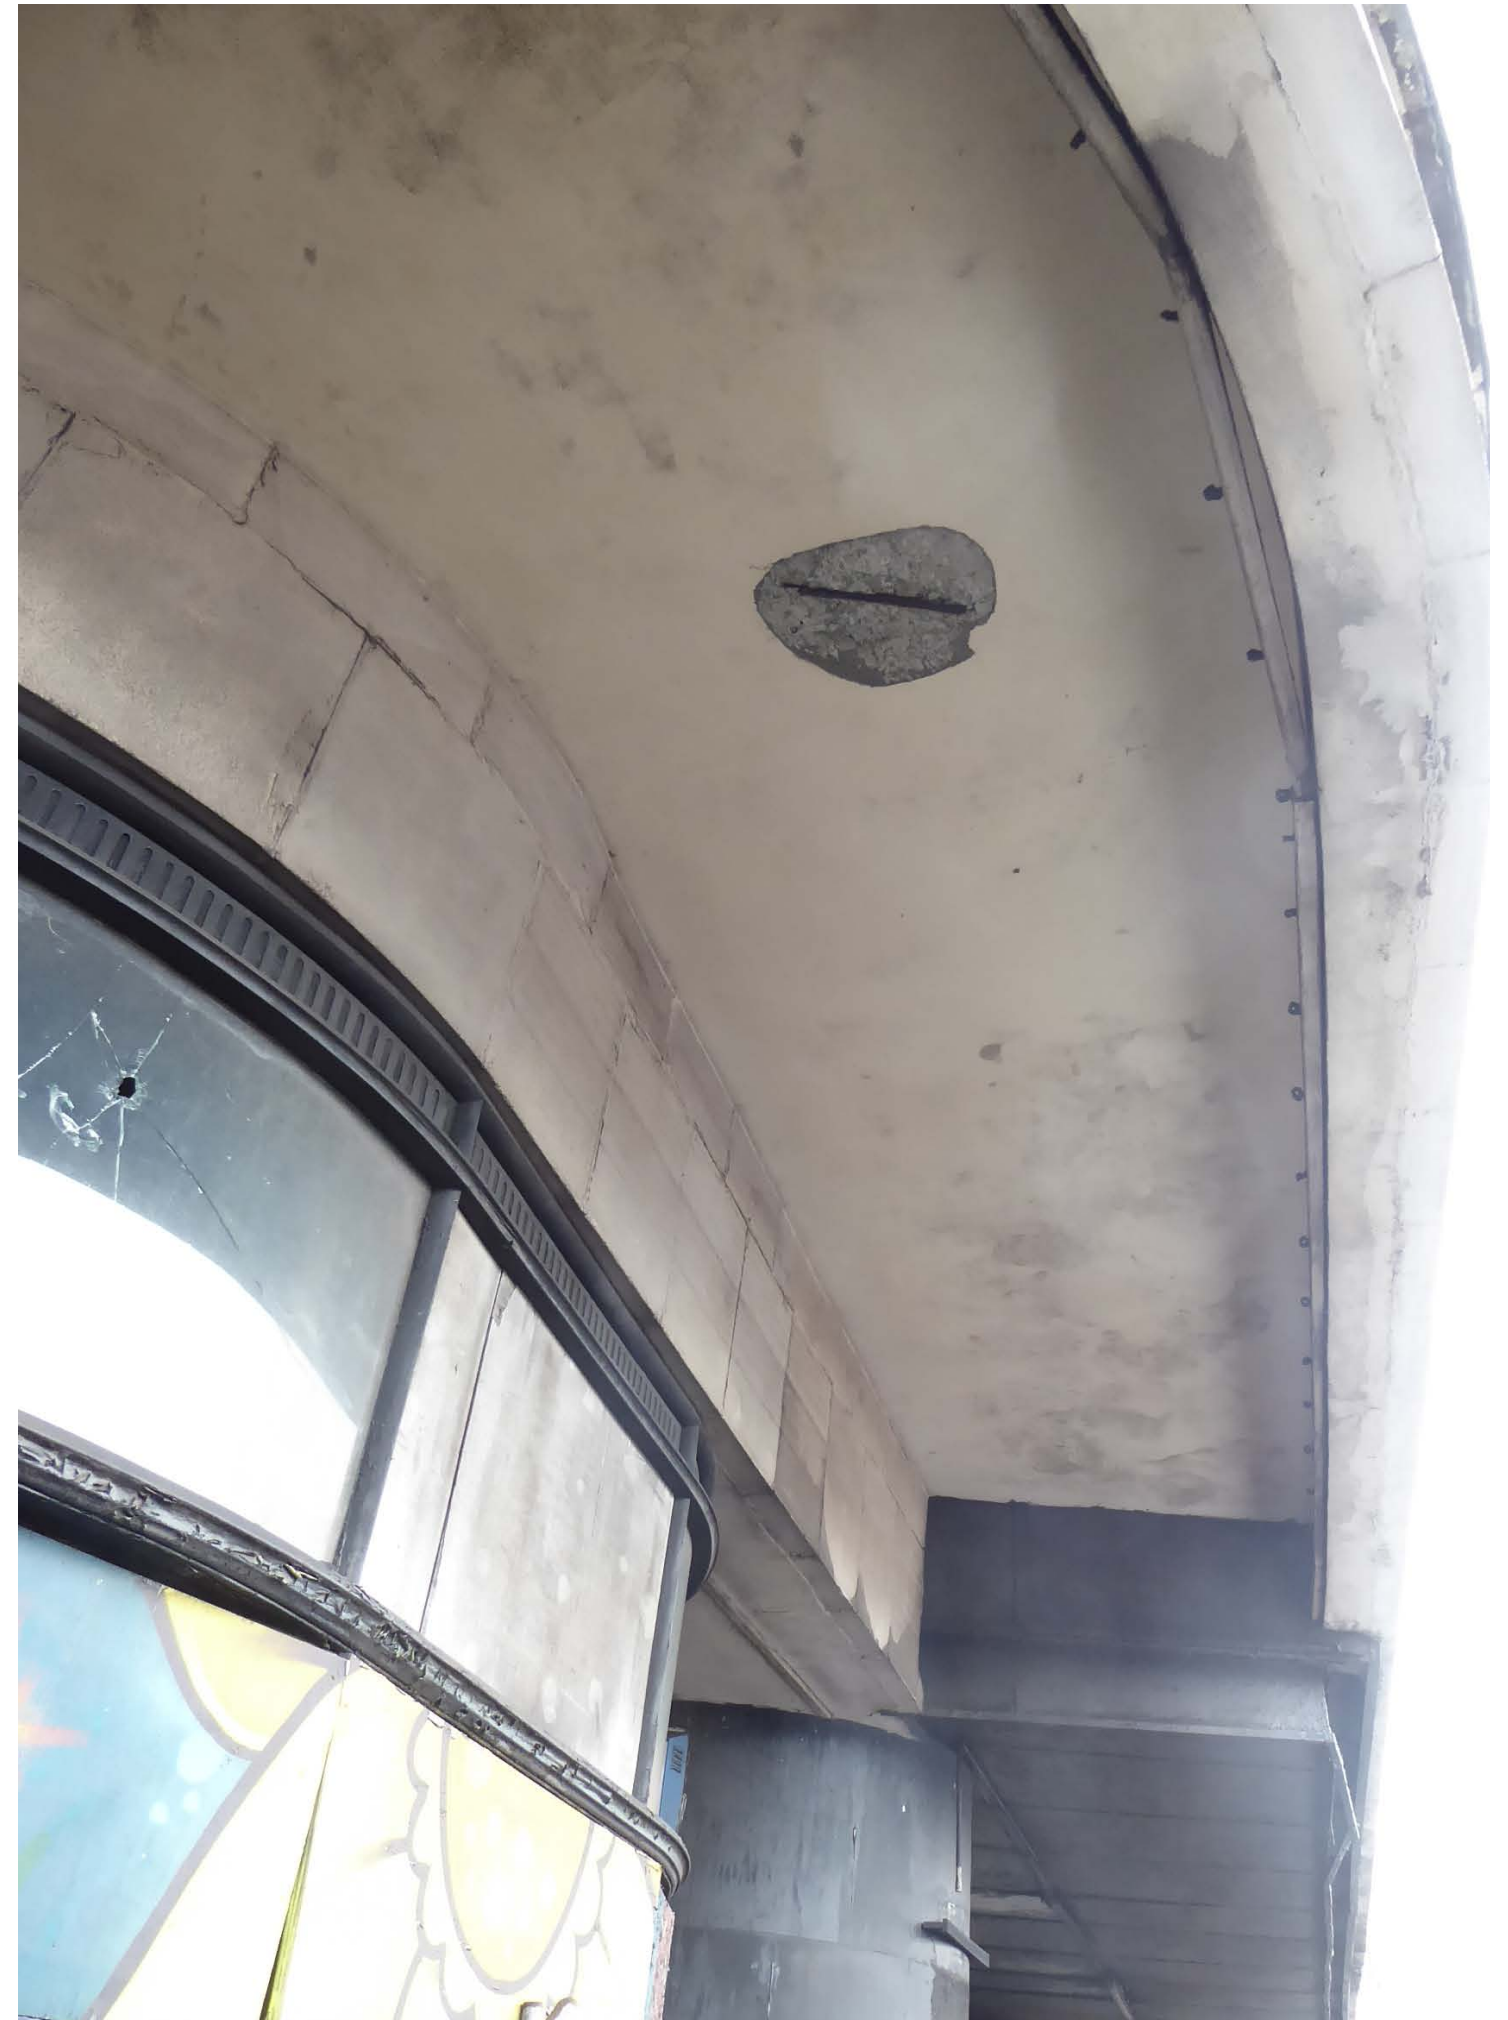
**6.1 The Exterior of the Plaza - the Frontage** - The photographs below show the underside of the reinforced concrete canopy over the frontage with examples of the lost plaster, spalled concrete & exposed re-bar

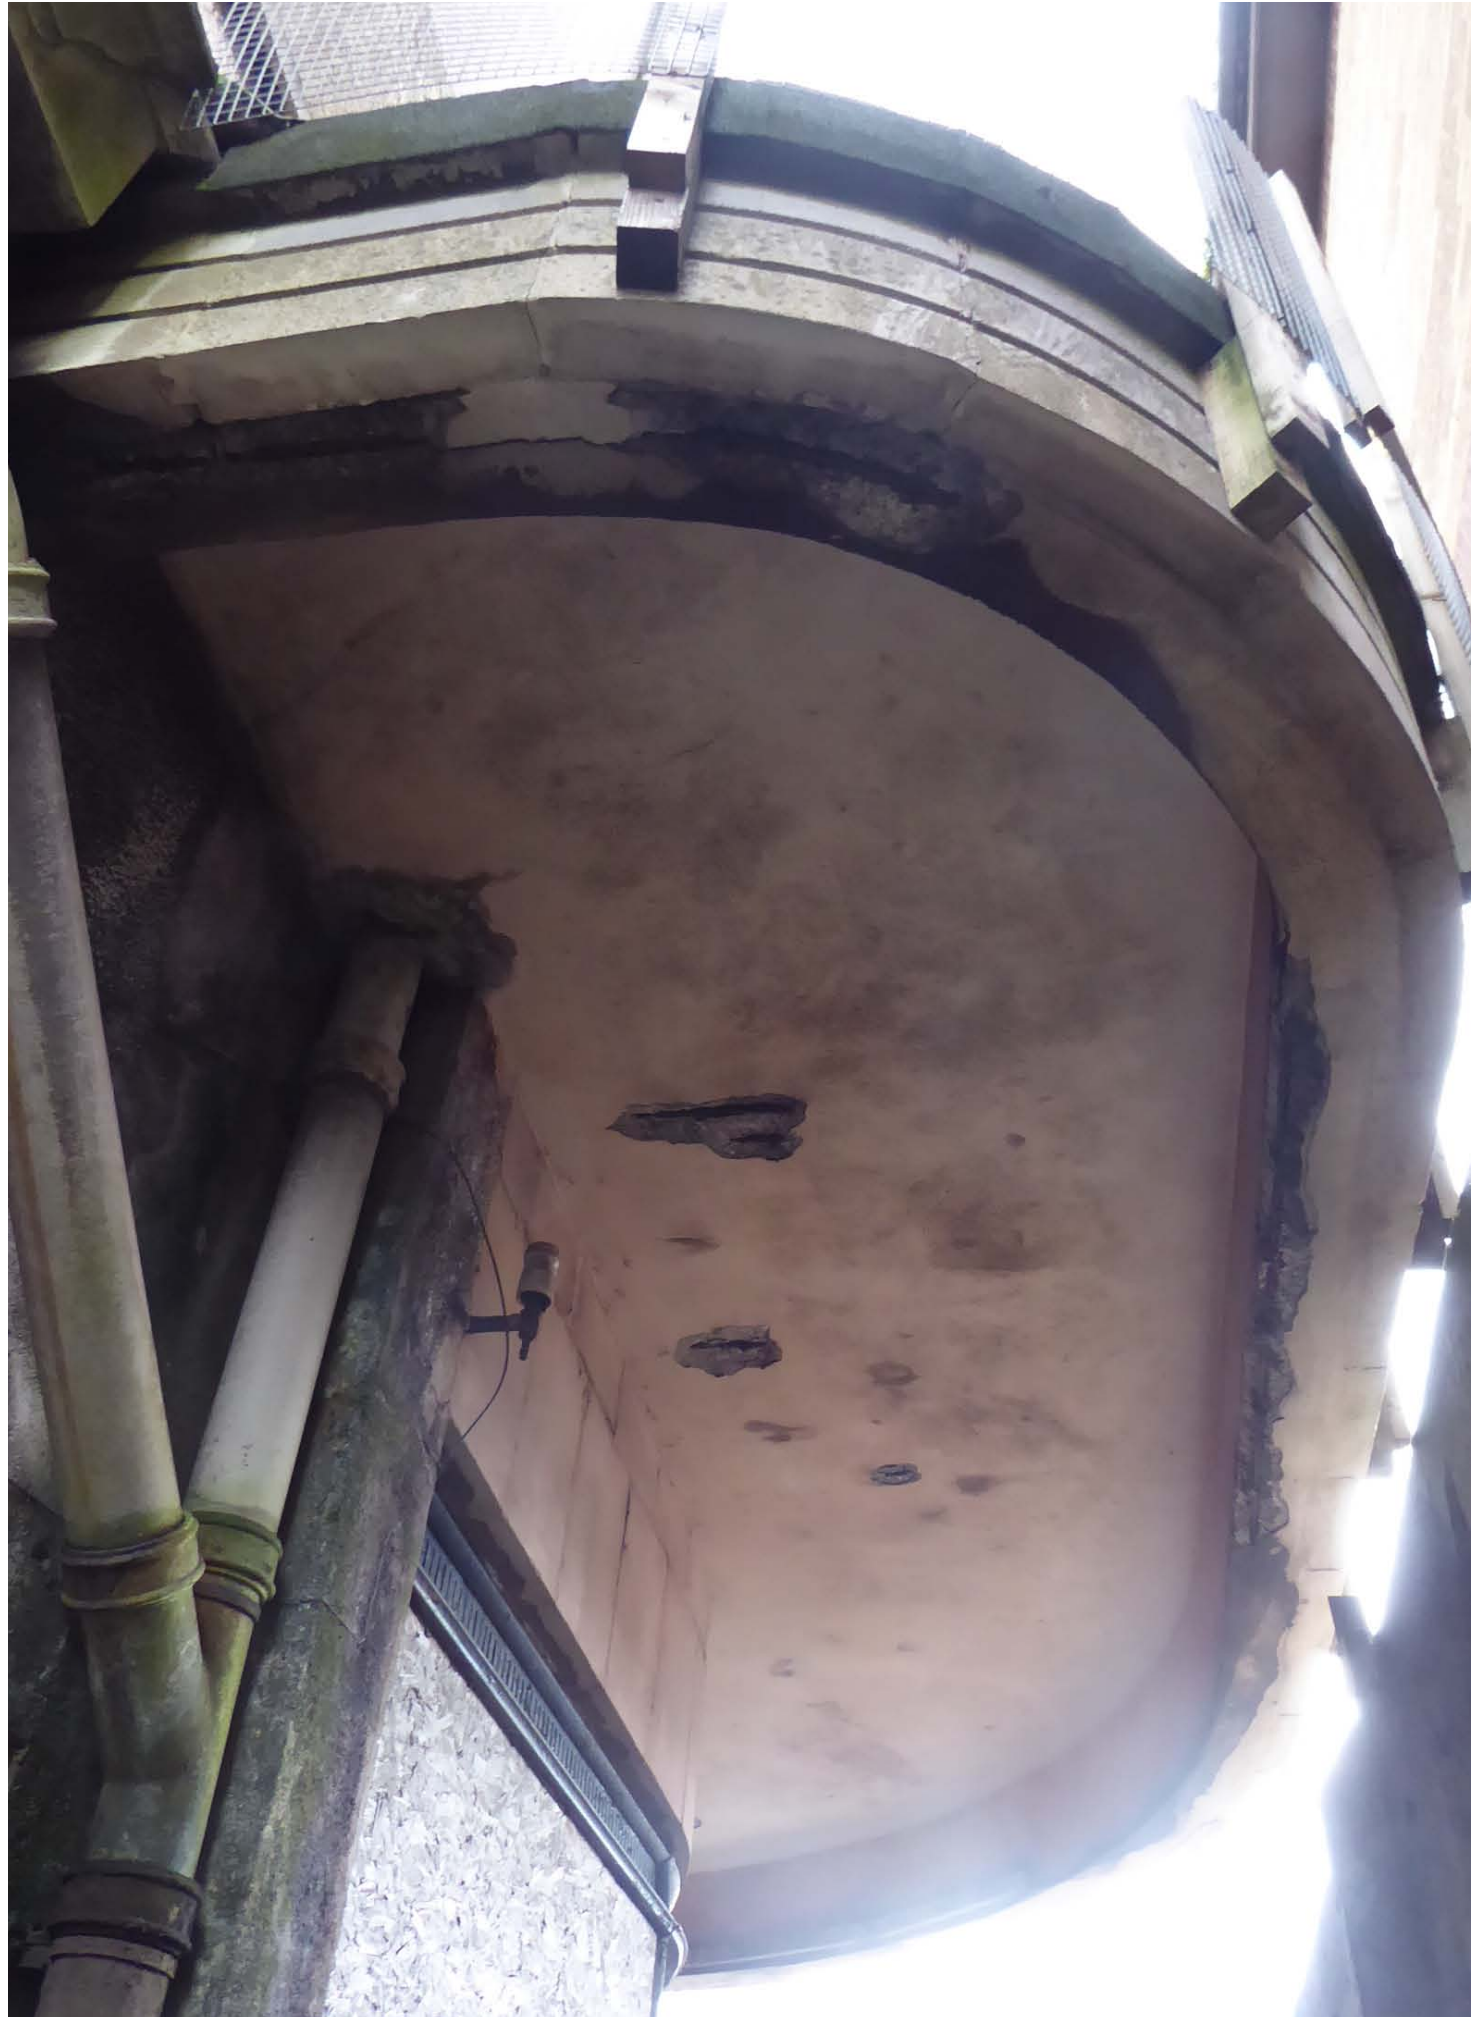
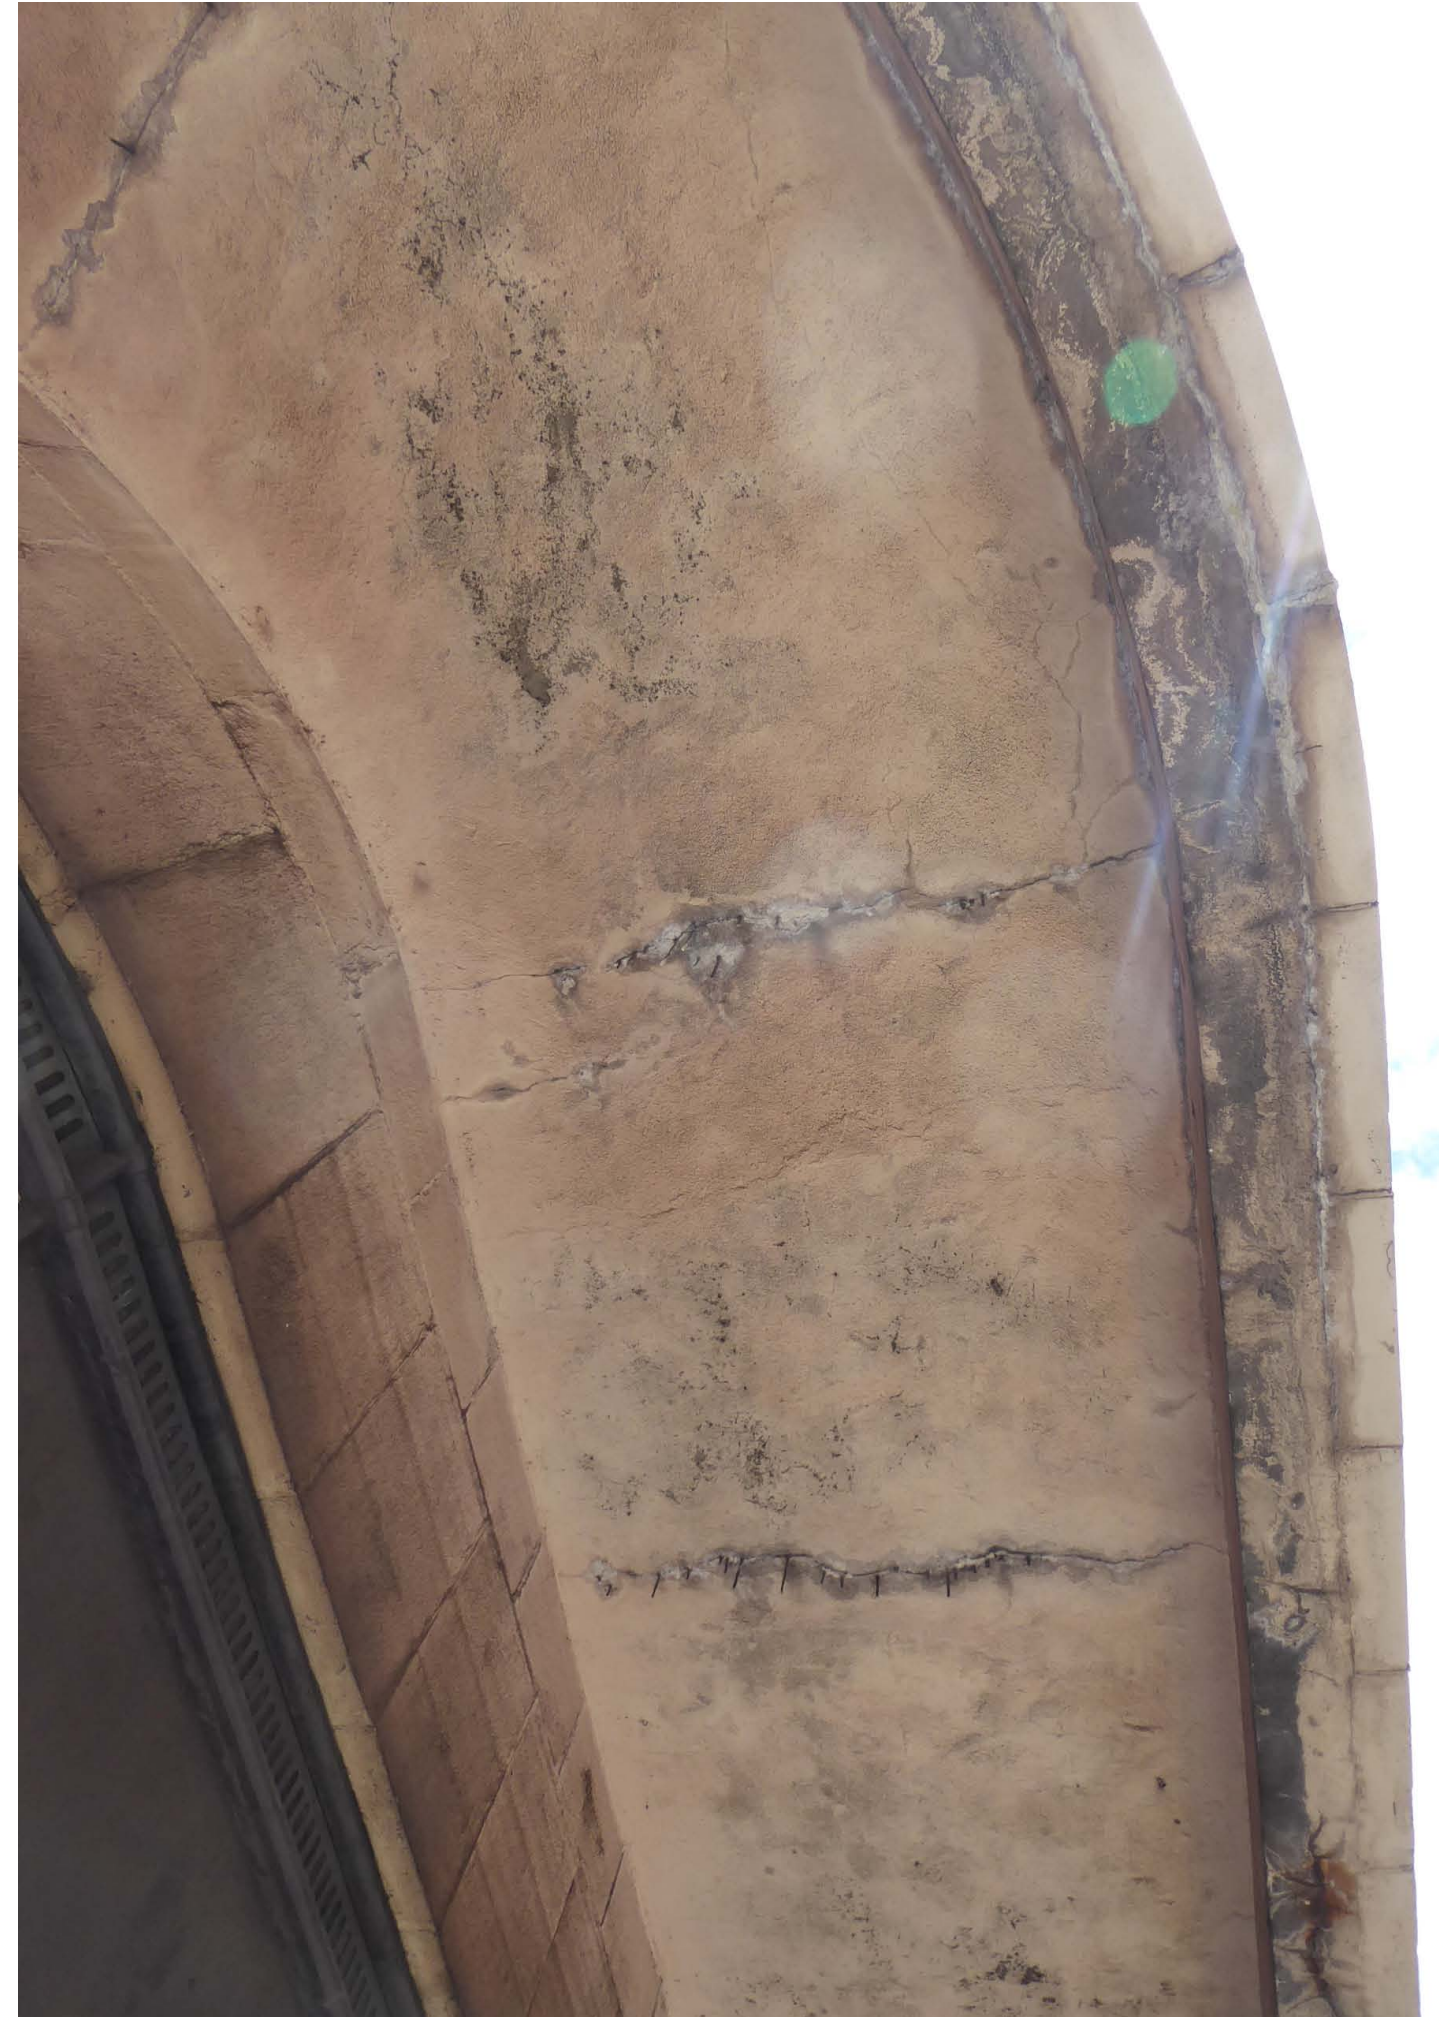
**6.1 The Exterior of the Plaza - the Frontage** - The photographs below show the underside of the reinforced concrete canopy over the frontage with examples of the lost plaster, spalled / cracked concrete & exposed re-bar

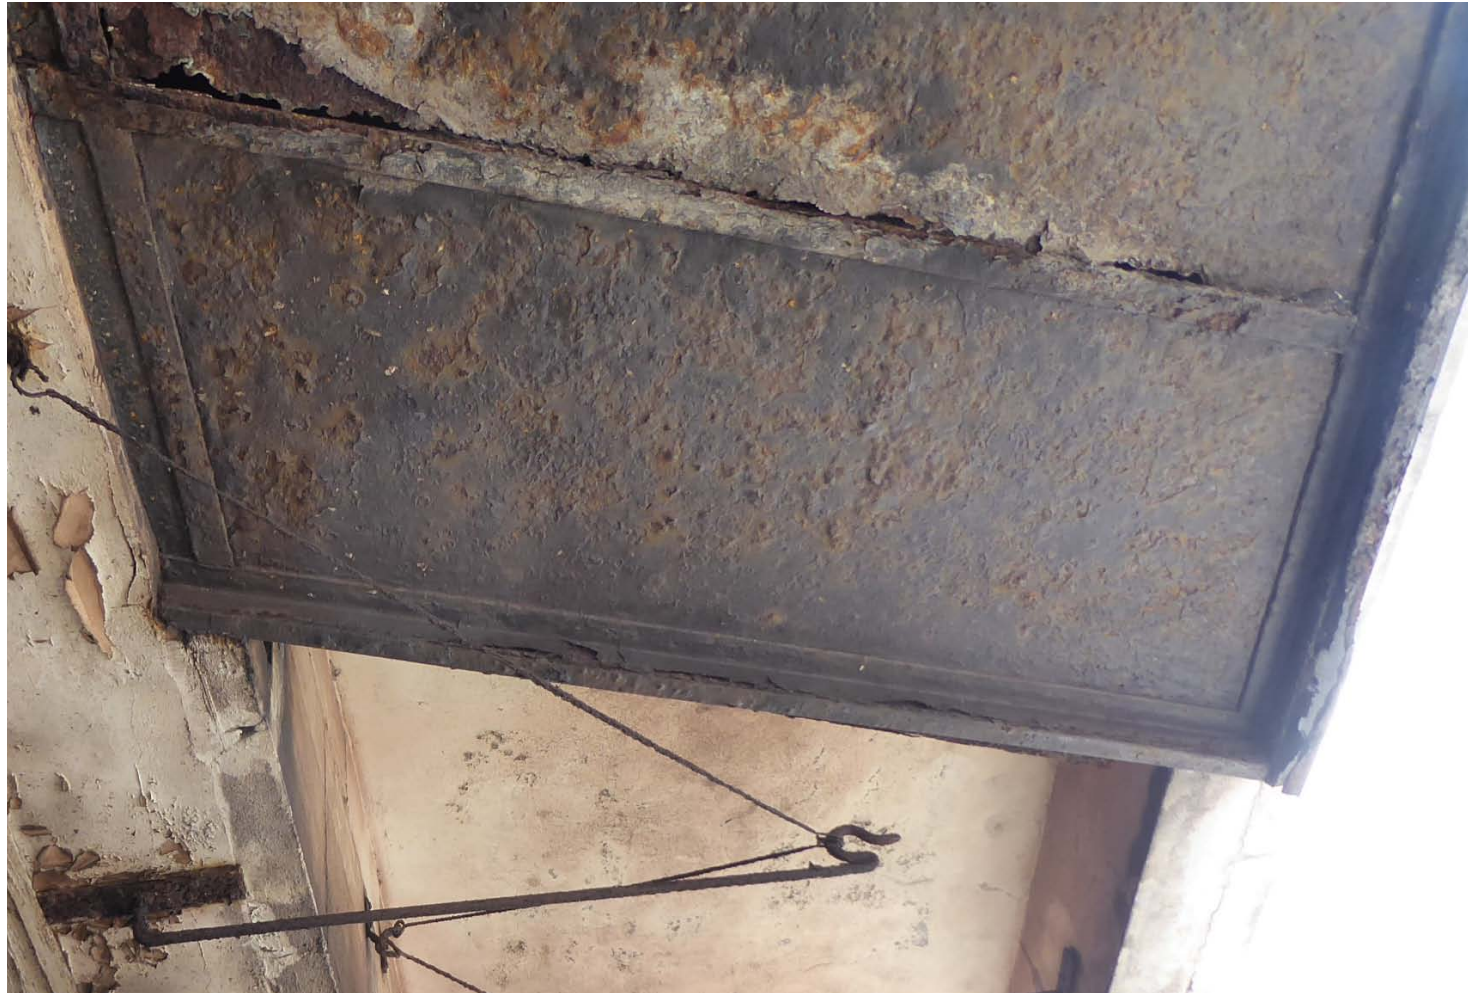
*This photograph show how badly the panels and frame have been corroded*

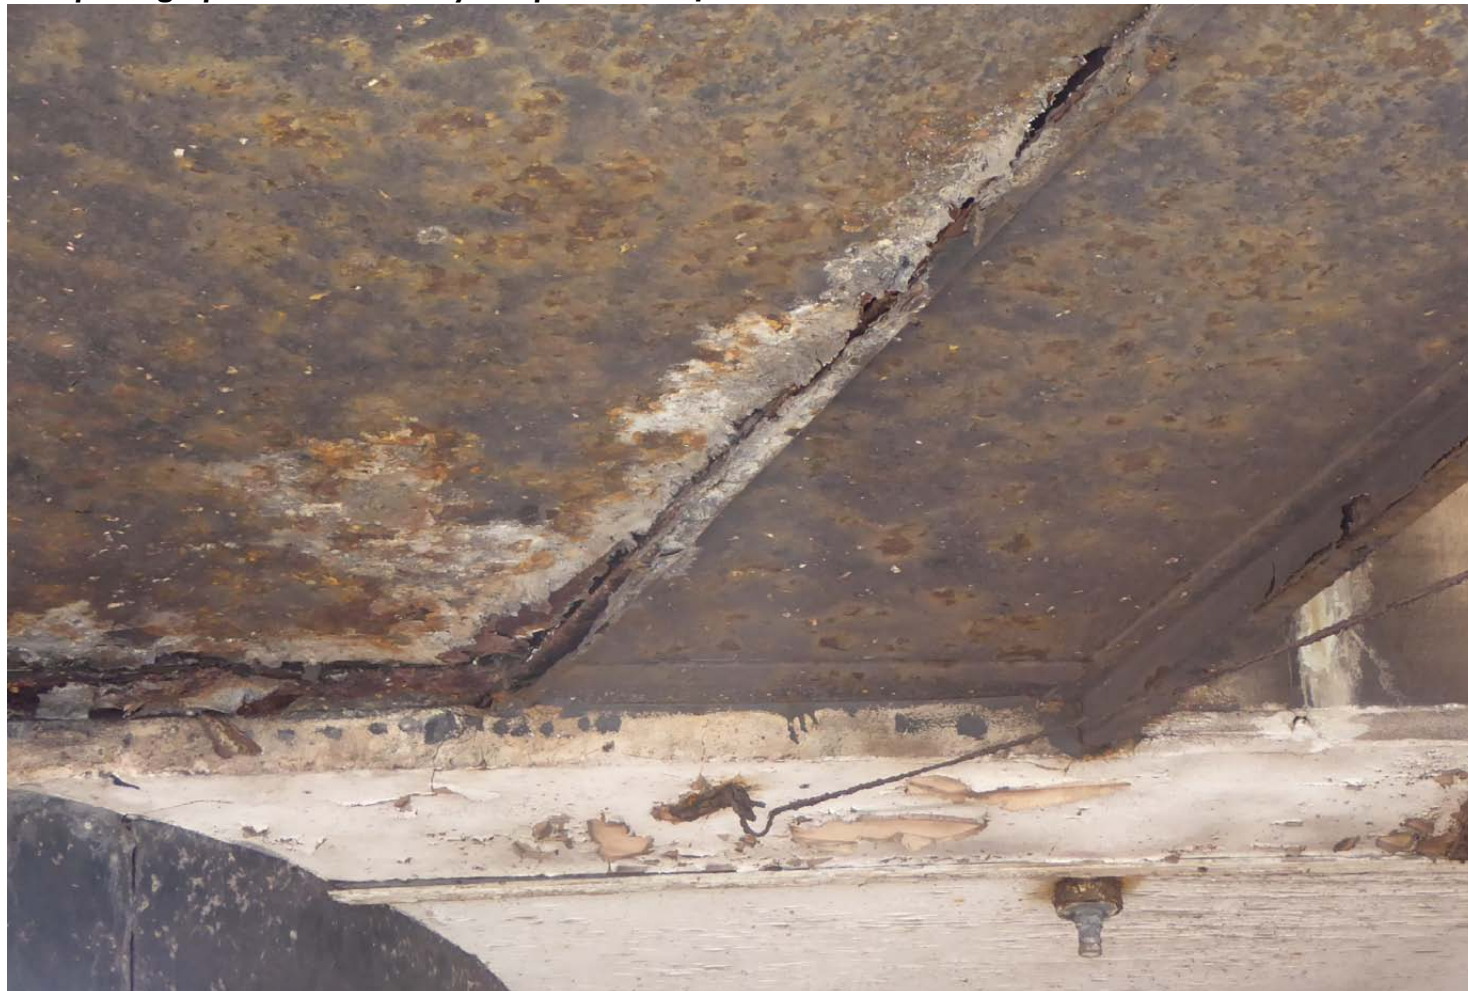
*This photograph show how badly the panels and frame have been corroded*

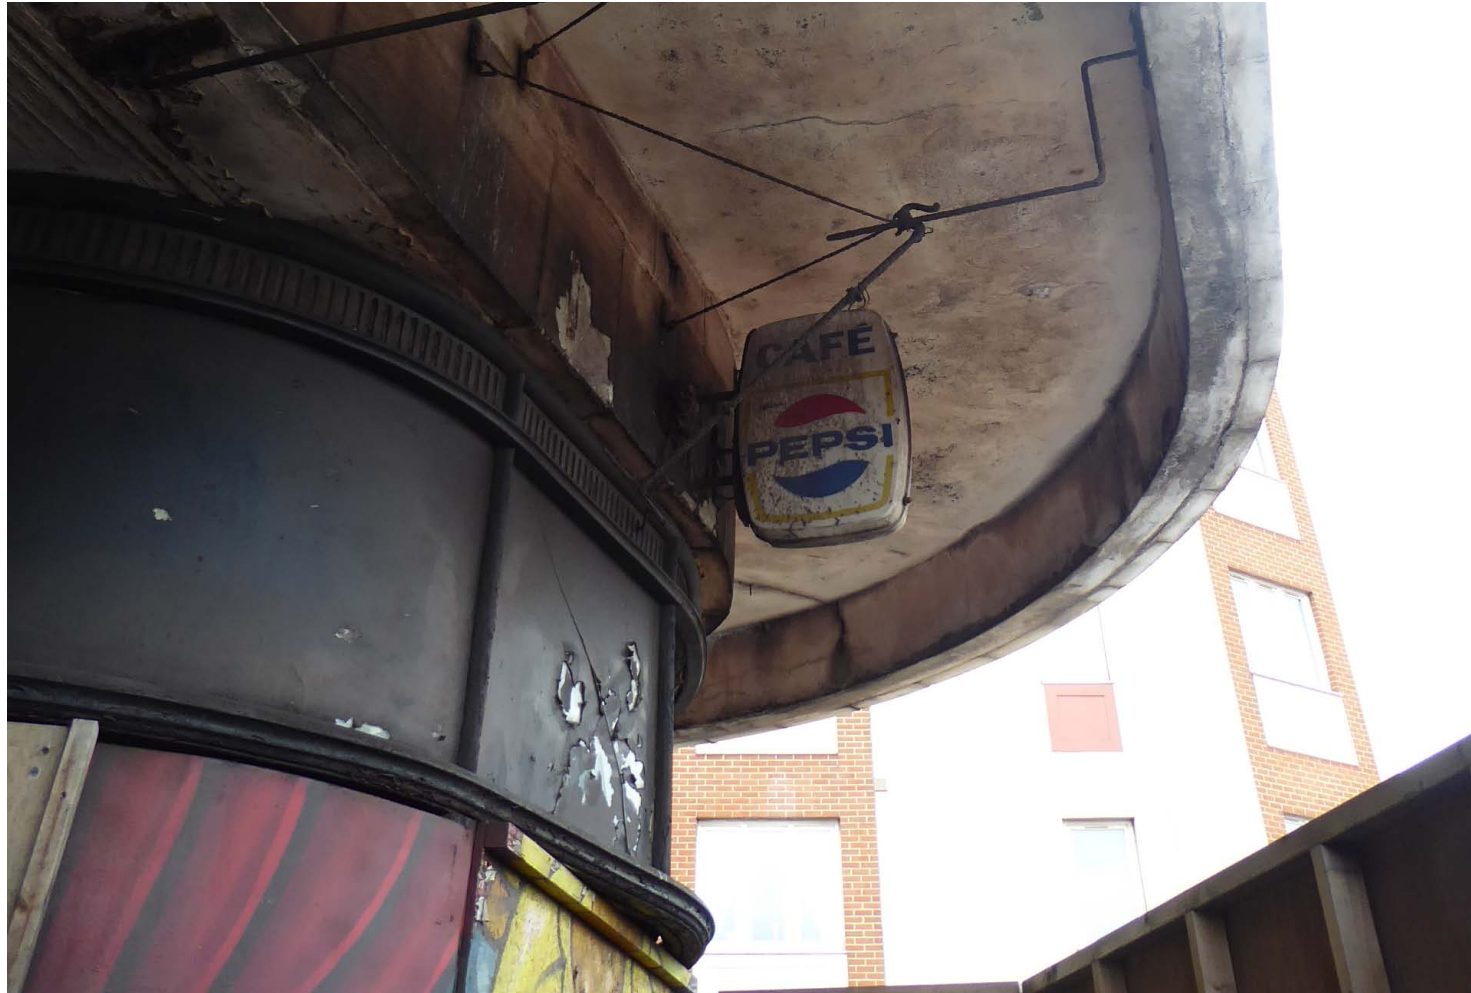
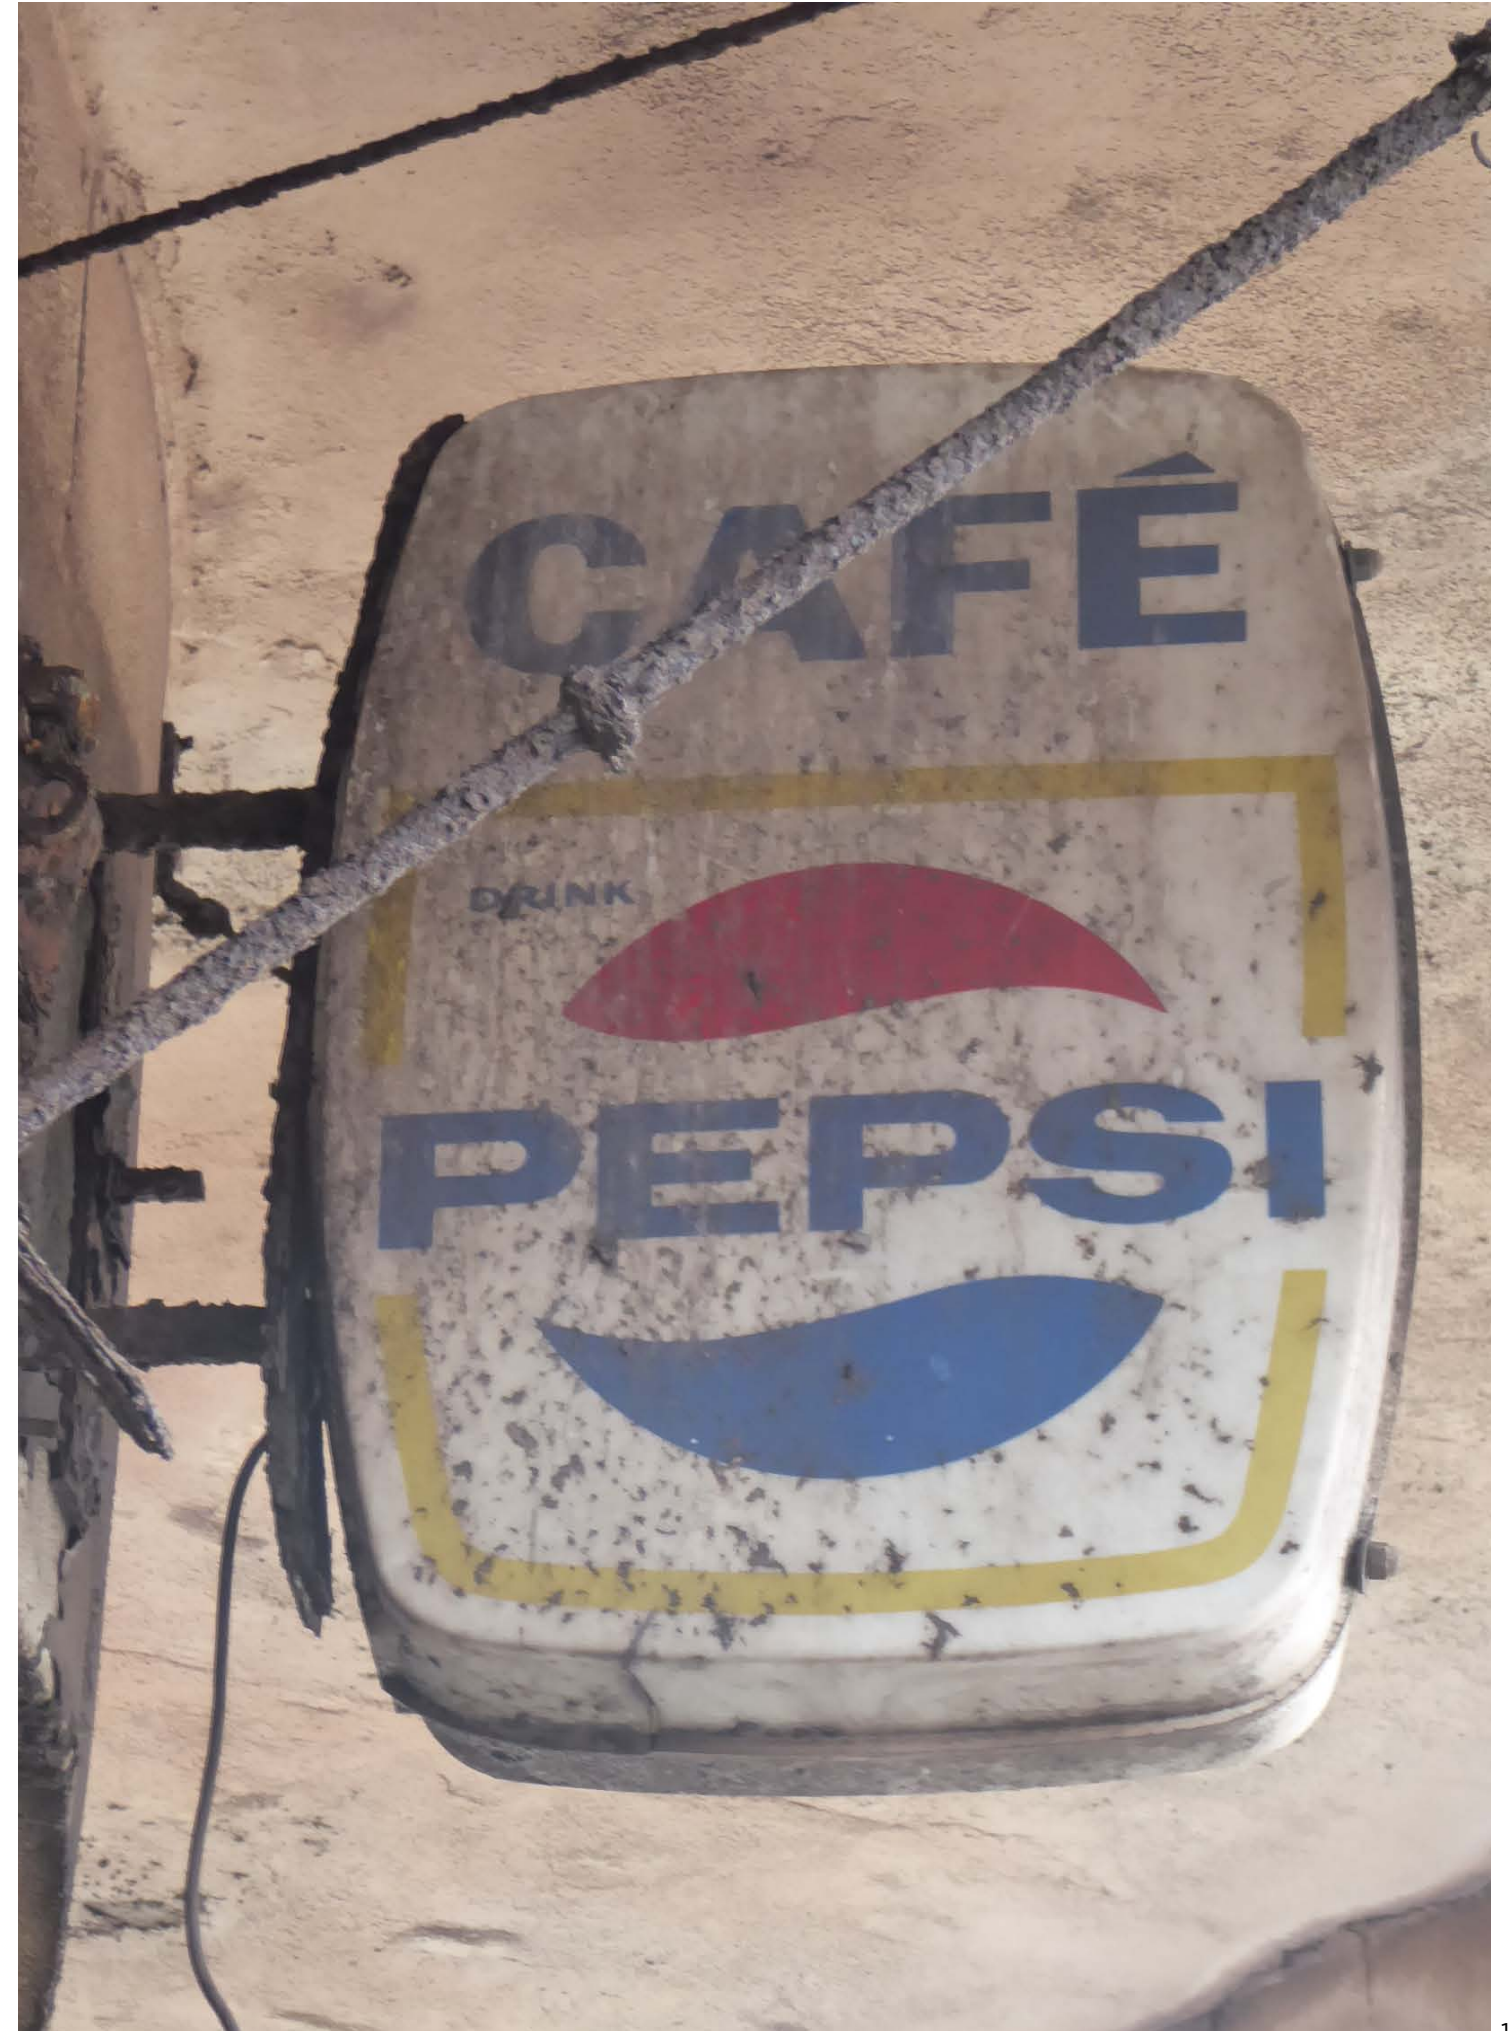
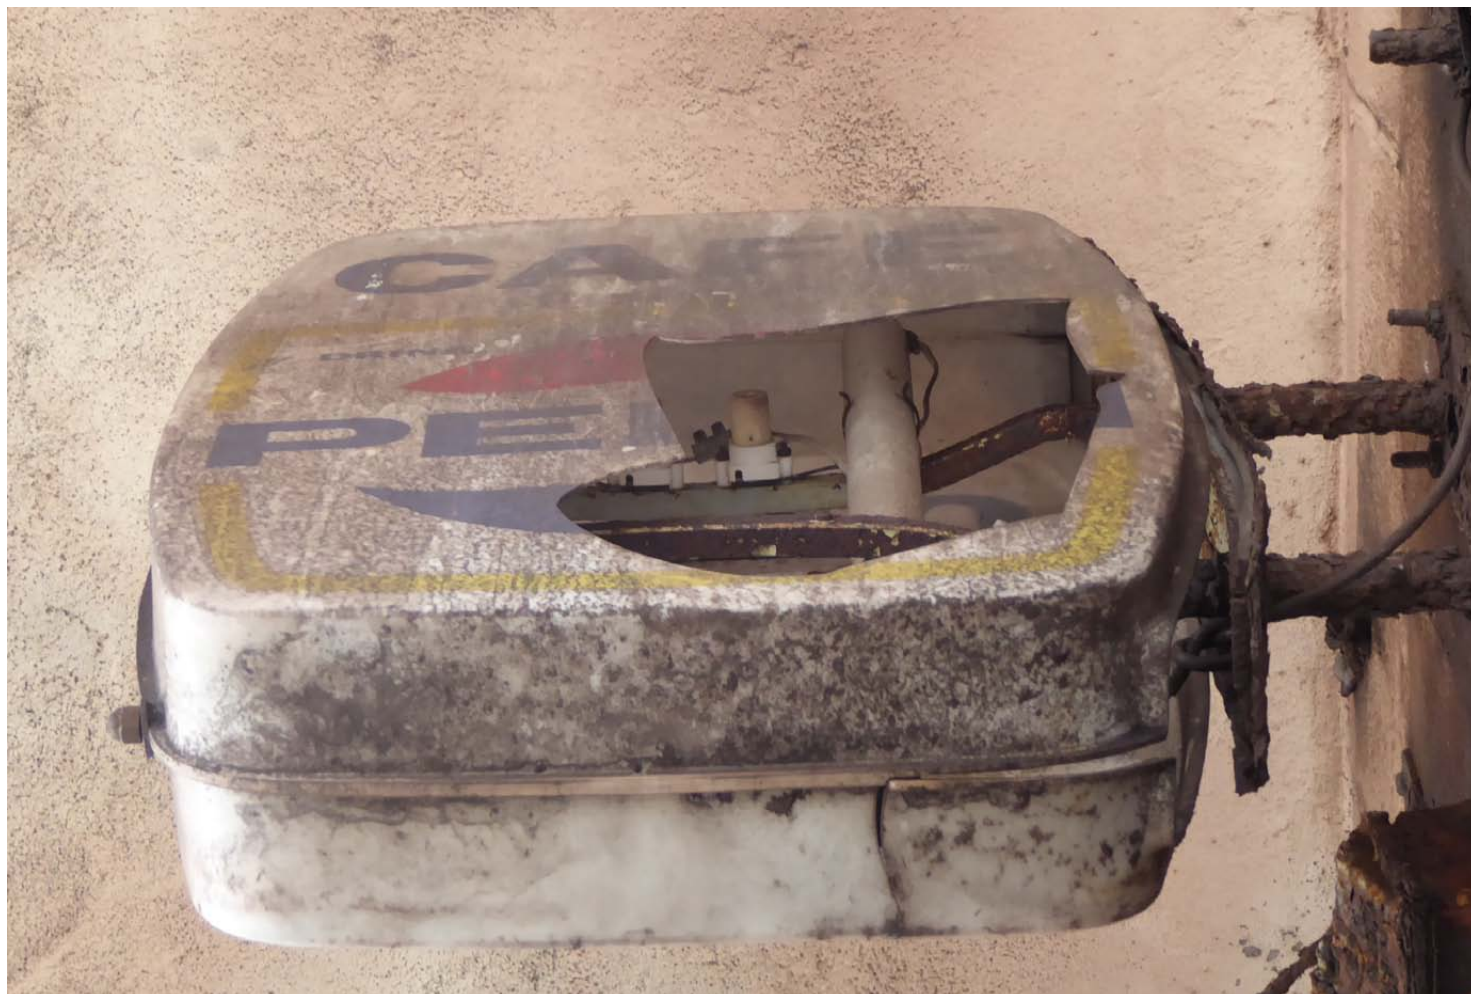
**6.1 The Exterior of the Plaza - the Frontage** - To the south east corner of the canopy, in front of the large retail unit, is a part-damaged plastic internally illuminated 'Pepsi' sign identifying a 'Cafe'

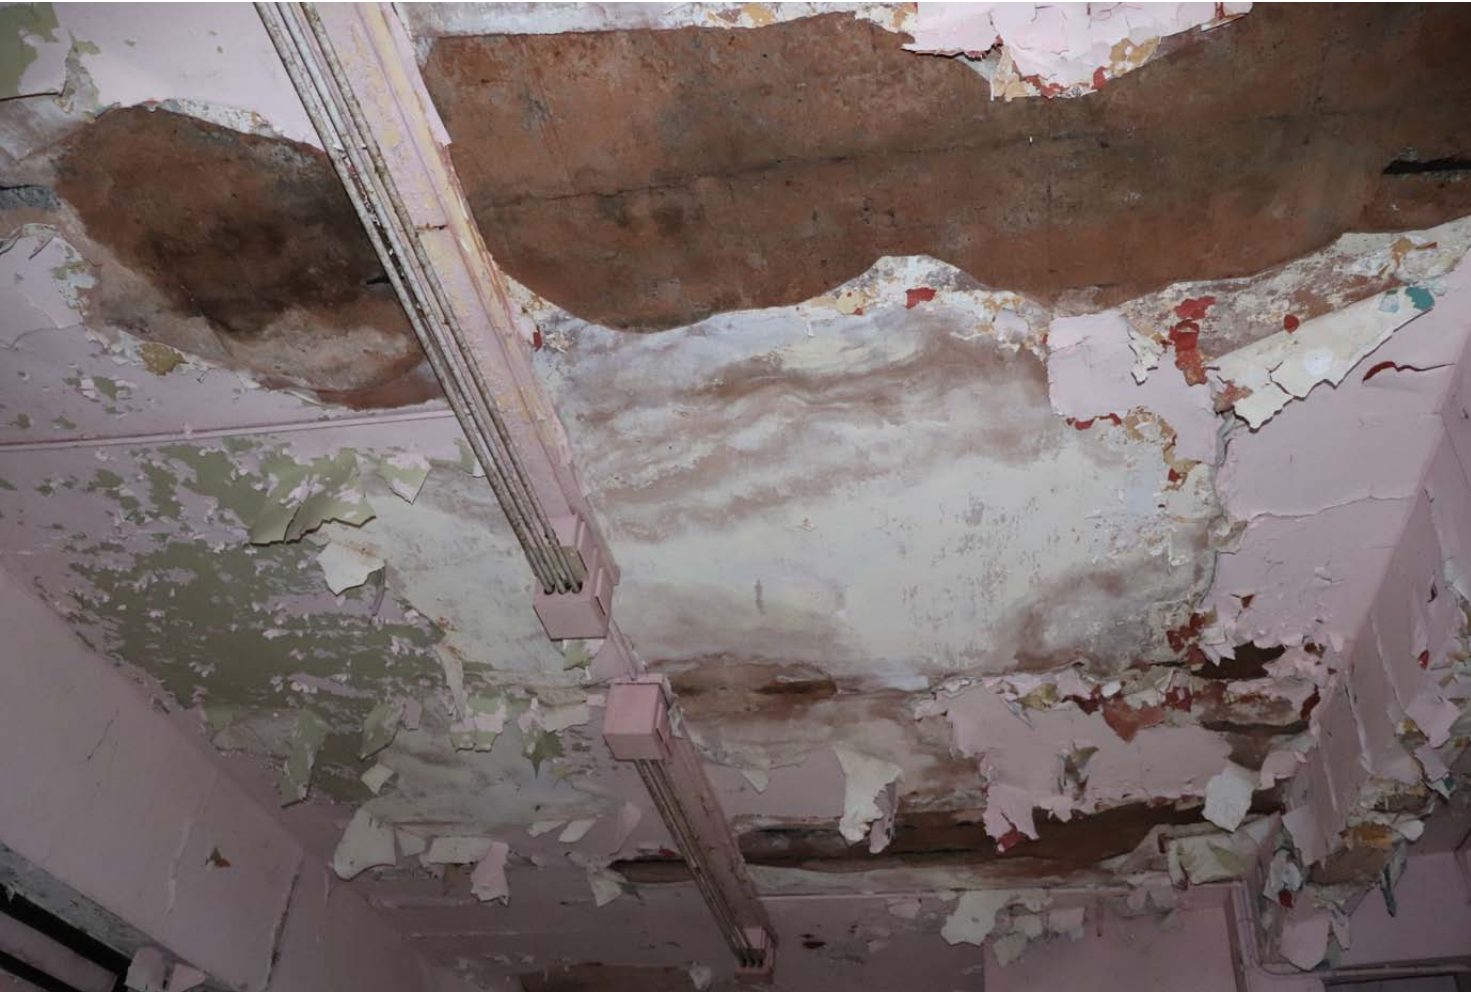
**G1 - South Retail Unit**

*View peeling Paint, damaged Plaster and damaged Concrete Soffit to Ceiling*
