**Plaza, Port Talbot**

**HISTORIC BUILDING RECORDING**

(385)1902-GWP-A-2A-HBR-P00

Date: 06.01.20

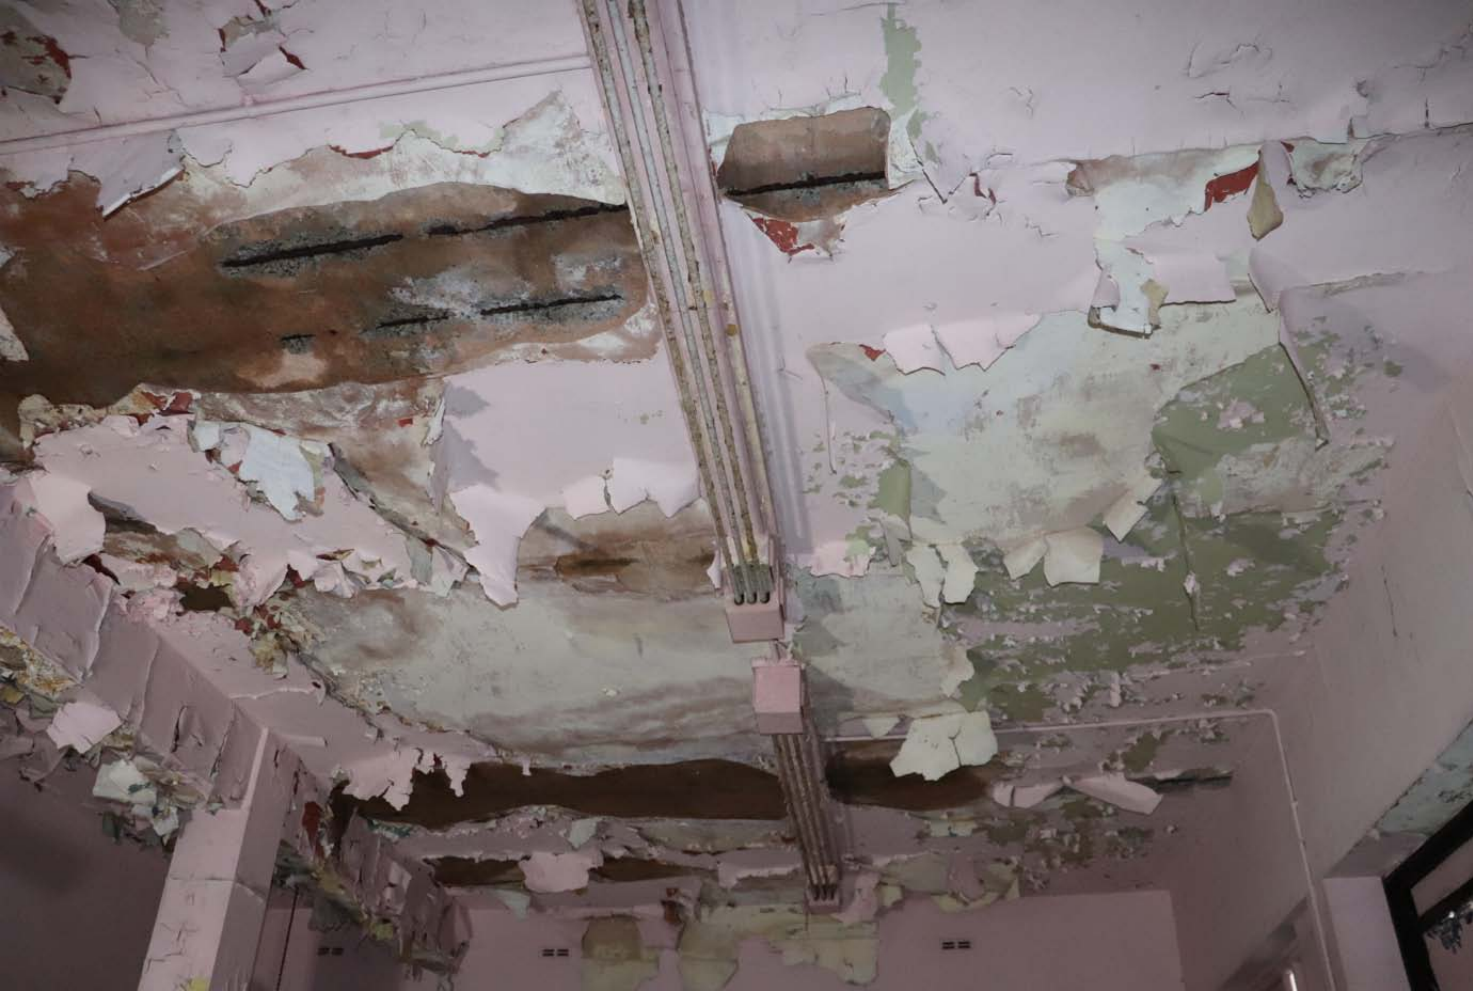
*View peeling Paint, damaged Plaster & damaged Concrete Soffit to Ceiling with exposed Reinforcement*

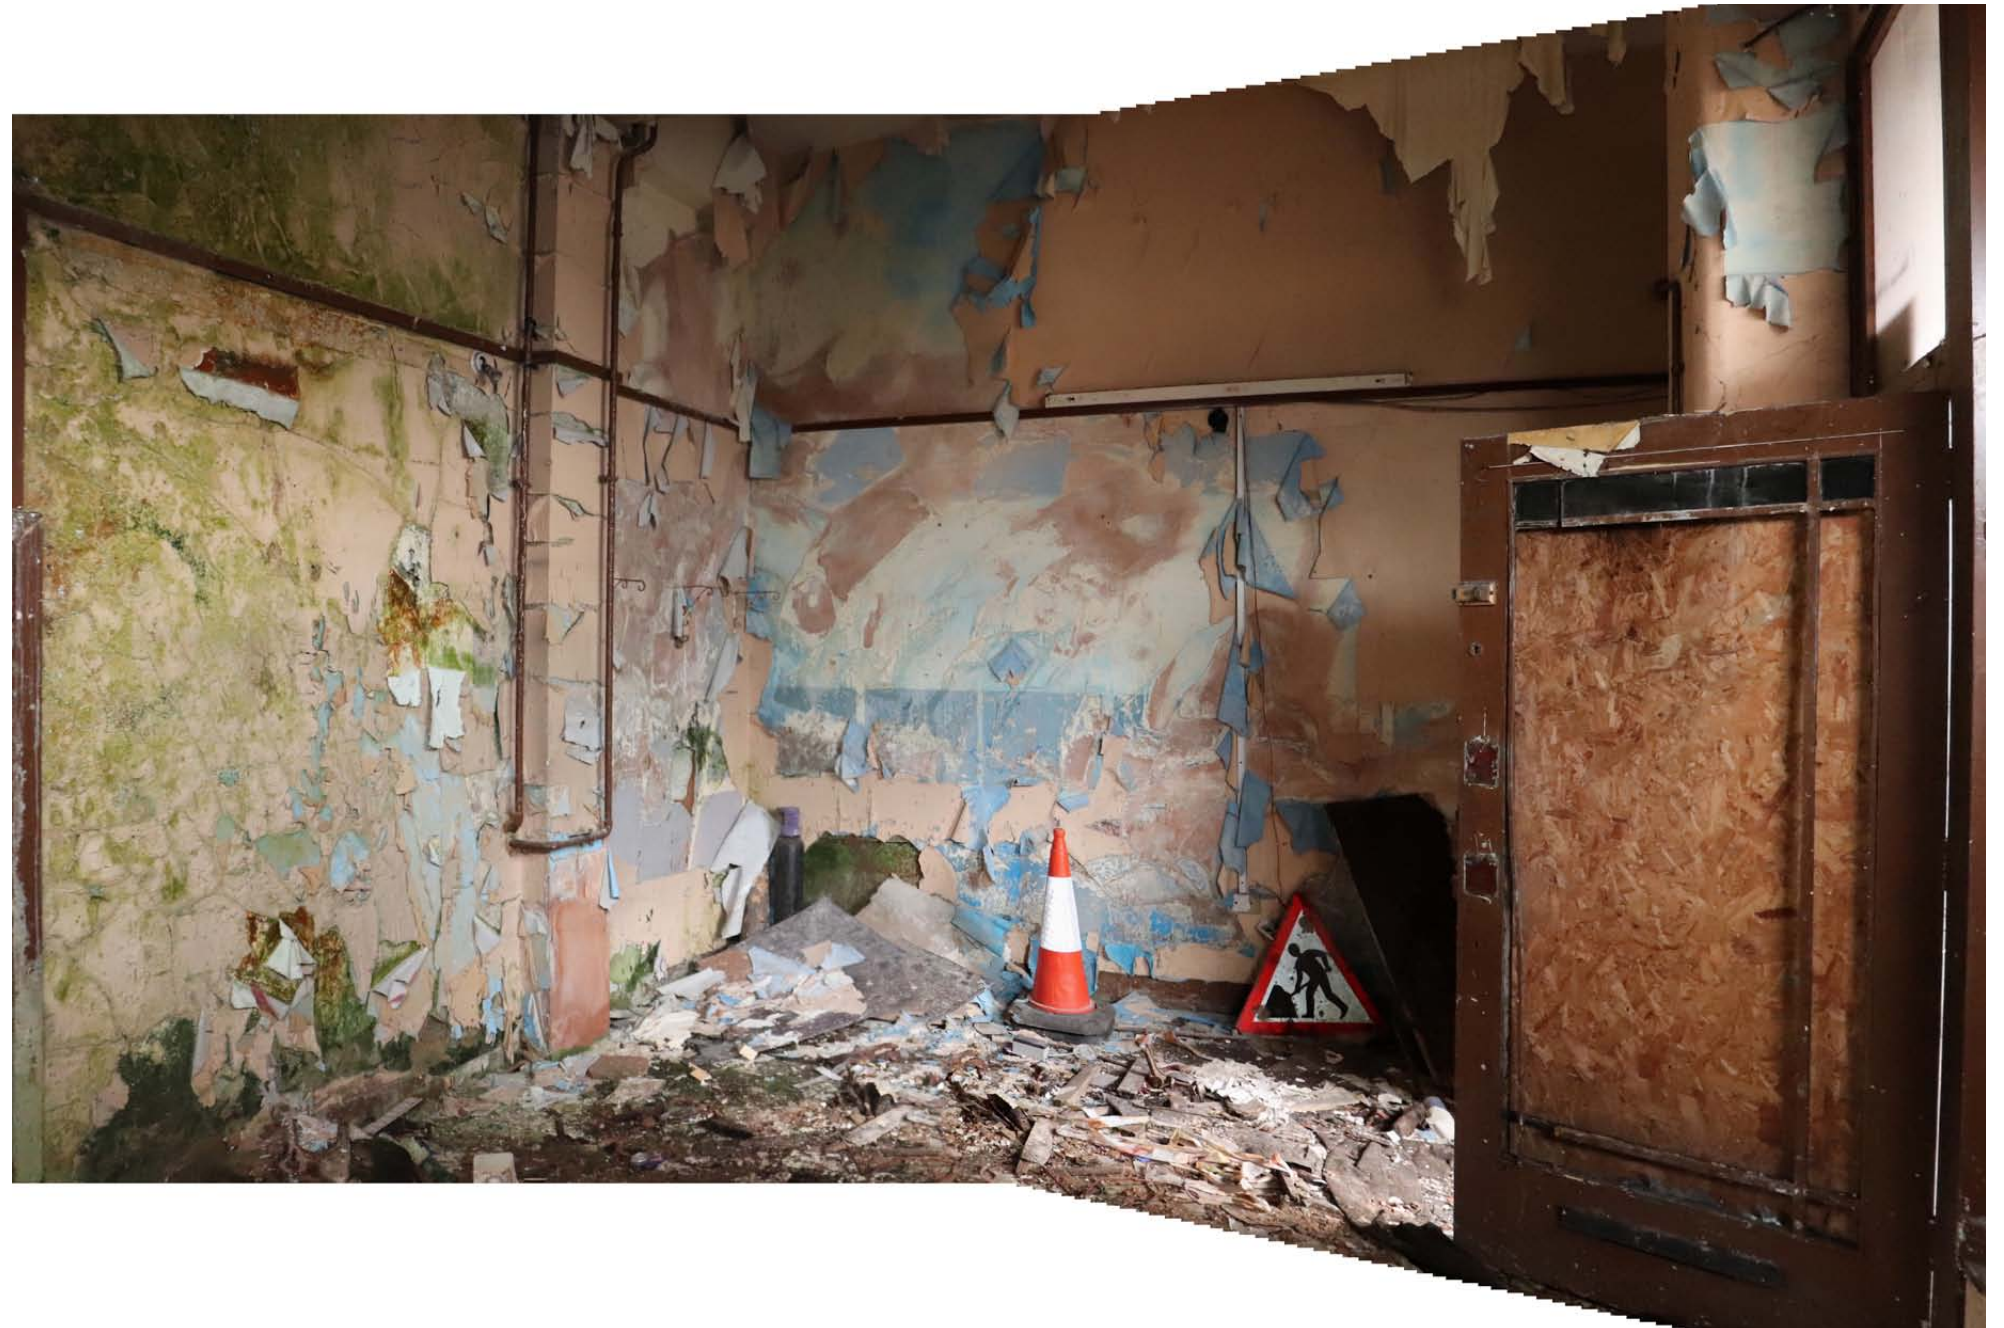
*View east end of Retail space, with external door to right, showing painted plastered walls in poor condition*

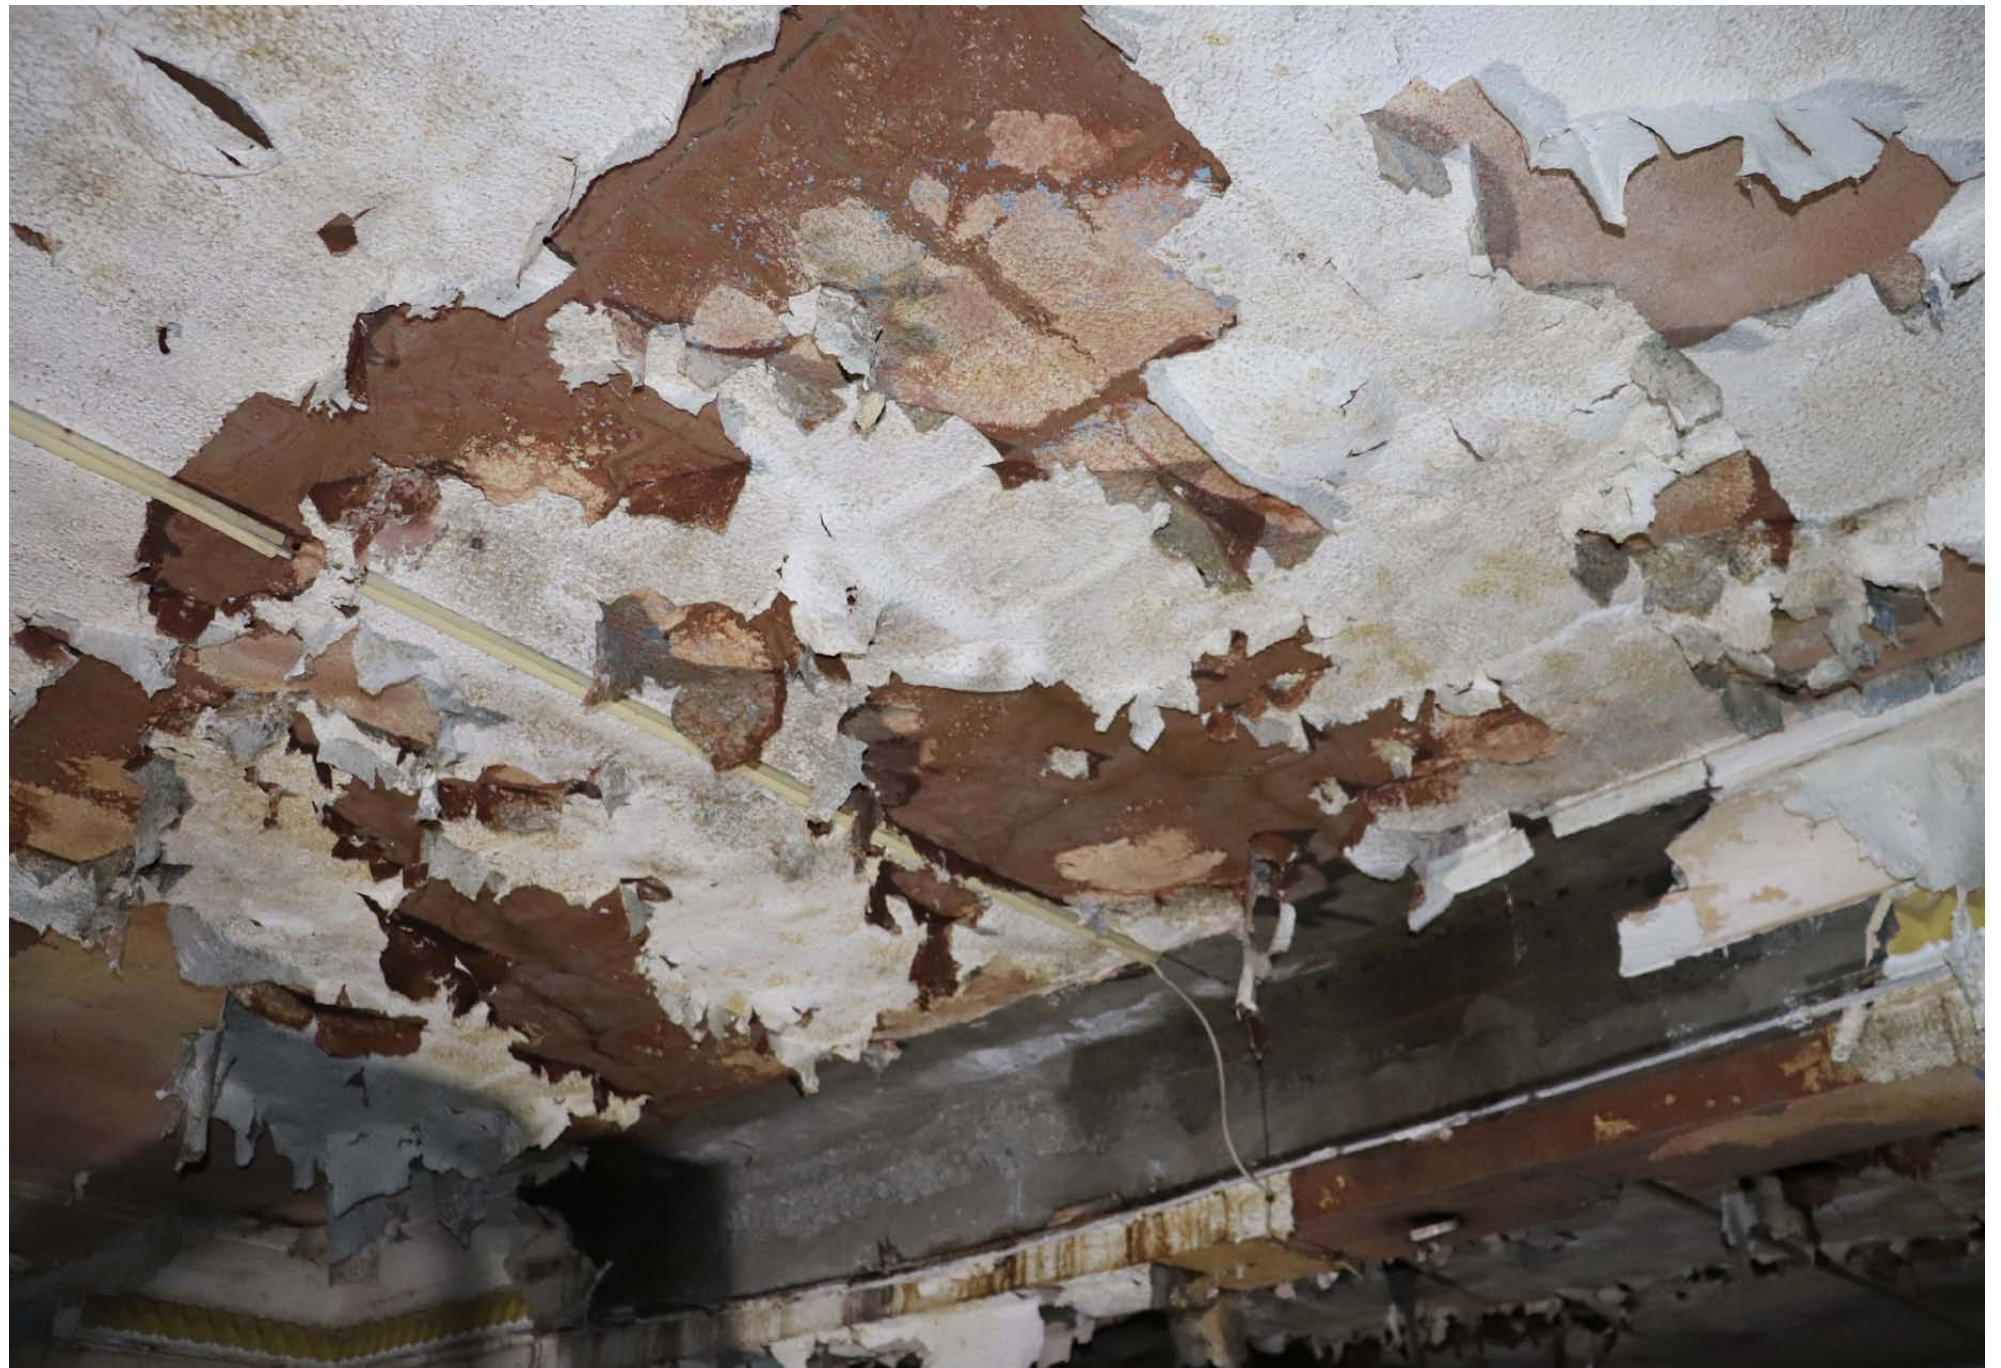
**G8 - Foyer**

On this page is a series of photographs of the ceiling to the Foyer, showing the extent of peeling paint, damaged plaster and cracked and spalling concrete soffit and downstand beams caused, in the main, by water ingress from above.

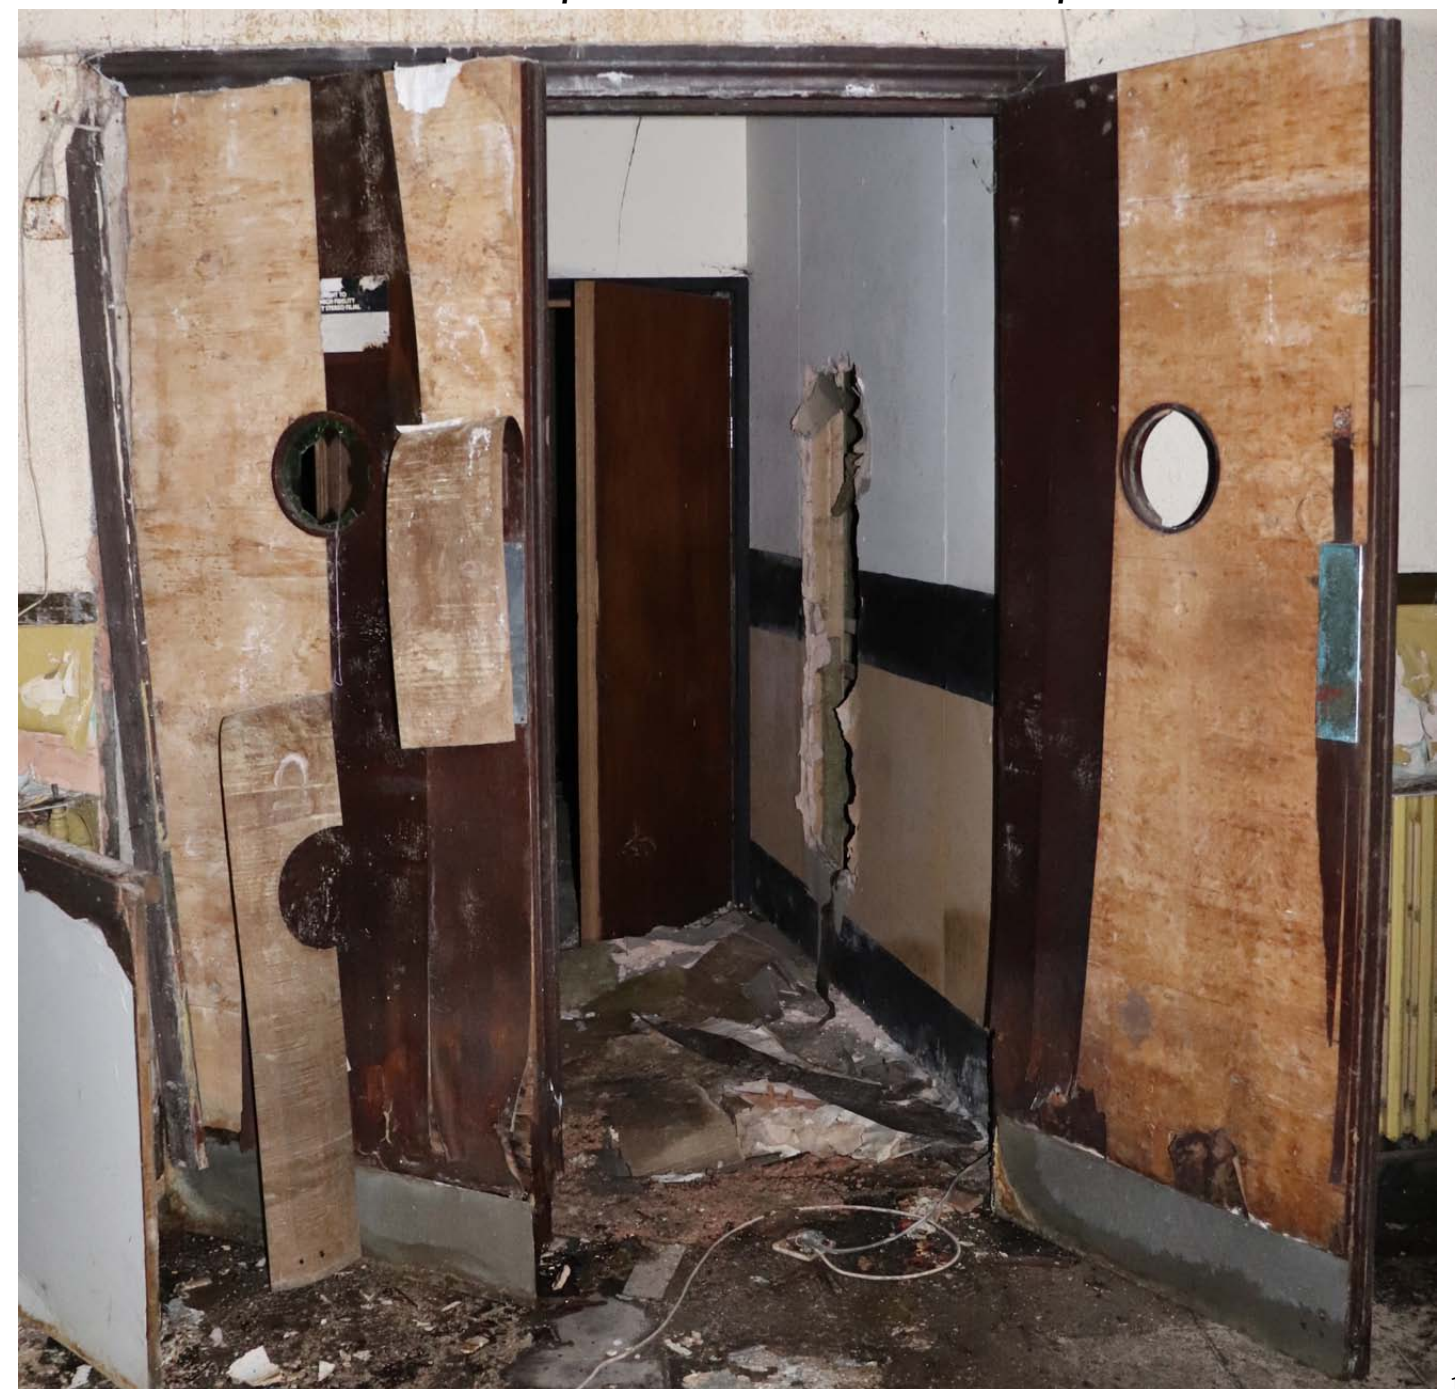
*View of one set of doors - to the central corridor to the auditorium - which is in a very poor condition*
