# Tree Report

1 Wern Olau, Cilfrew, Neath. SA10 8LX

October 2019

Prepared by  
S G Hill RFS Cert Arb  
118 Pen Y Bryn, Ystradgynlais, Powys.

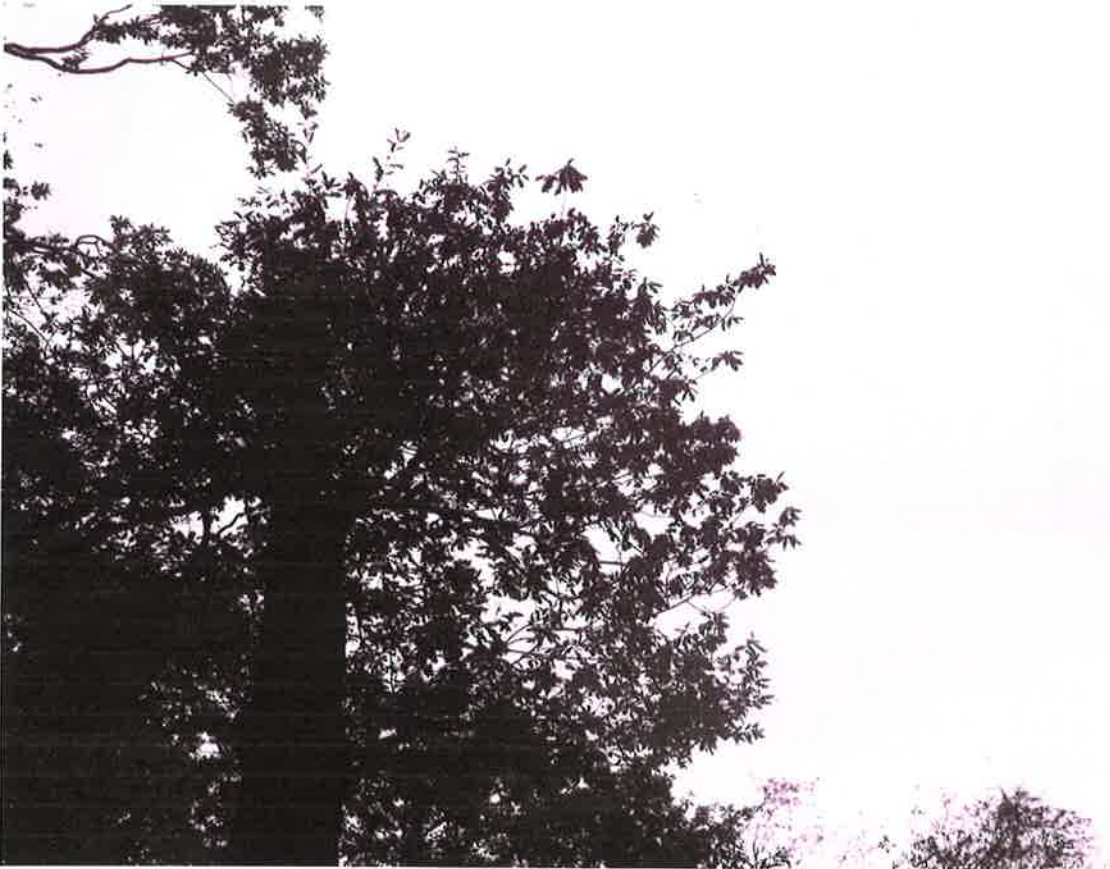
Figure 1: Tree 1

This tree has lost the crown and a 3-meter stump is remaining with some epicormic growth (figure 1). There is currently no risk to the property at this time but should be watched in future, as the new growth will be weak and prone to shear off onto the public foot path.

**Recommended Action:** Observe to ensure new growth does not pose risk to public footpath or property.

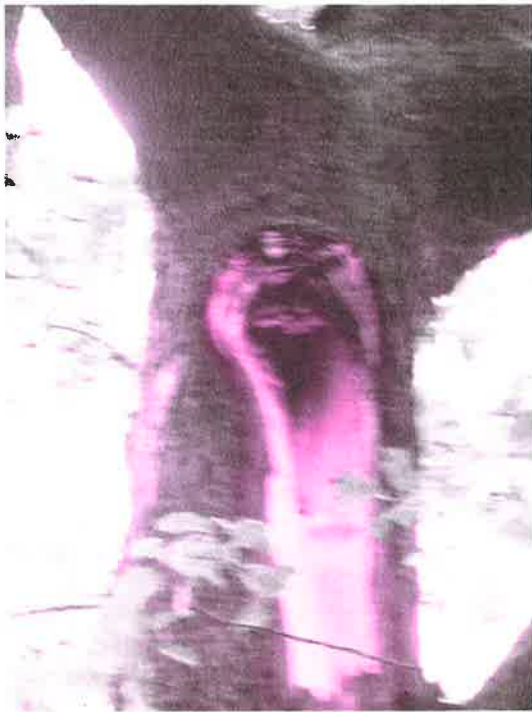
This is a large mature Sessile Oak. It has shed a number of branches common to this species of tree leaving some spurs and one scar which could be a sign of some decay (figures 2, 3, 4). This tree is overhanging the property, and if it should shed any more they would damage the new building to be constructed. The tree is leaning away from the land, so is unlikely to fall on to the property under normal situations (not accounting for any extreme weather condition).

*Figure 2: Tree 2 - Top Scar*

**Recommended Action:** Crown reduction and thinning; and removal of any heavy overhanging branches as a safety measure. Removal of all branches overhanging the property boundary. There is also some difference in leaf cover in the crown therefore continuing monitoring for disease is required.

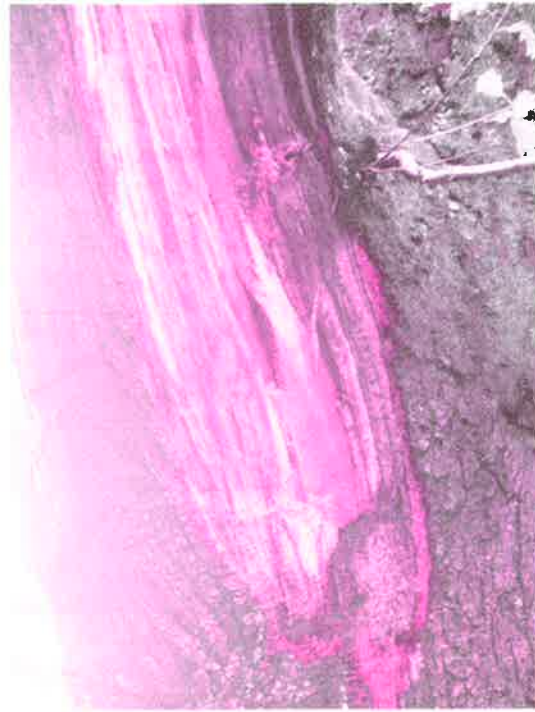
*Figure 3: Tree 2 - Second Wound*

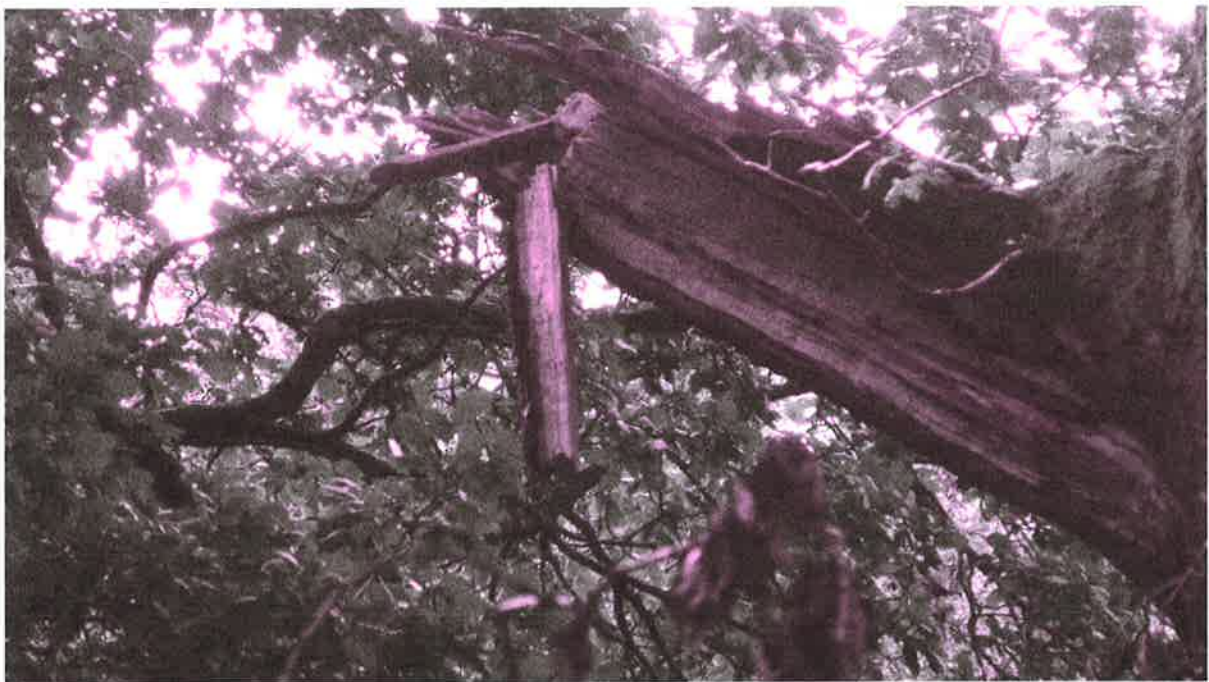
*Figure 4: Tree 2 – Example of Shedding*

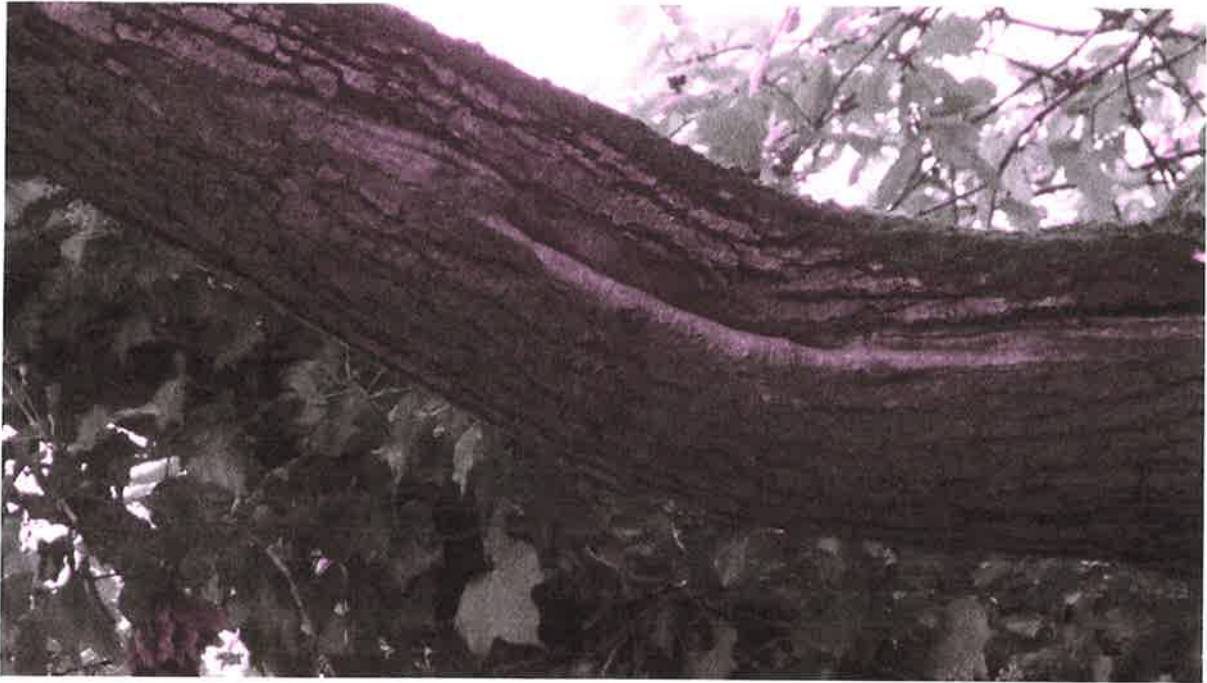
This Sessile Oak is showing some loss of leaves which are pale; it has signs of wind damage (figure 5). It is also very close to the property.

*Figure 5: Tree 5- Wind Damage*

**Recommended Action:** Ideally, due to the risk to property this tree should fell. If not, it requires removal of the damaged limb, removal of all branches overhanging the property boundary along with 30% crown thinning/reduction. Will need continued maintenances and observation to asses future risk to property.

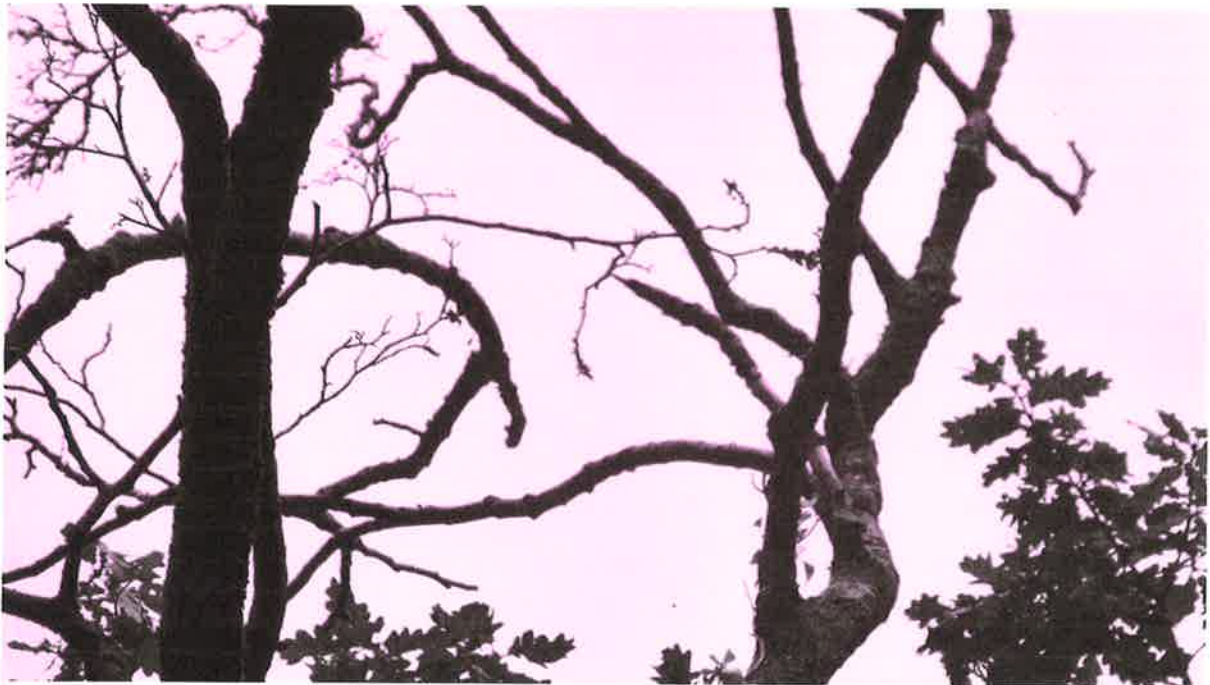
These trees are Alders which have had some work done to them in the recent months (some cuts are a little close to the joints so could be weak). There are two trees in the nearby wood which are showing signs of phitophoria (figure 6)) so these trees could also be at risk. They are close to property boundary.

*Figure 6: Signs of Phitophoria in Nearby Wood*

**Recommended Action:** Removal of all branches overhanging the property boundary.
