**Structural Condition Report**  
**on**  
**Existing Retaining Walls**  
**at**  
**Former Clun Primary School**  
**Clyne, Neath**  
**SA11 4BW**

Date : 17th July 2019  
Ref :CM/SM/JS/001

**RE: SITE INSPECTION AND STRUCTURAL CONDITION REPORT ON EXISTING MASONRY RETAINING WALLS AT FORMER CLUN PRIMARY SCHOOL, CLYNE, NEATH, SWANSEA, SA11 4BW**

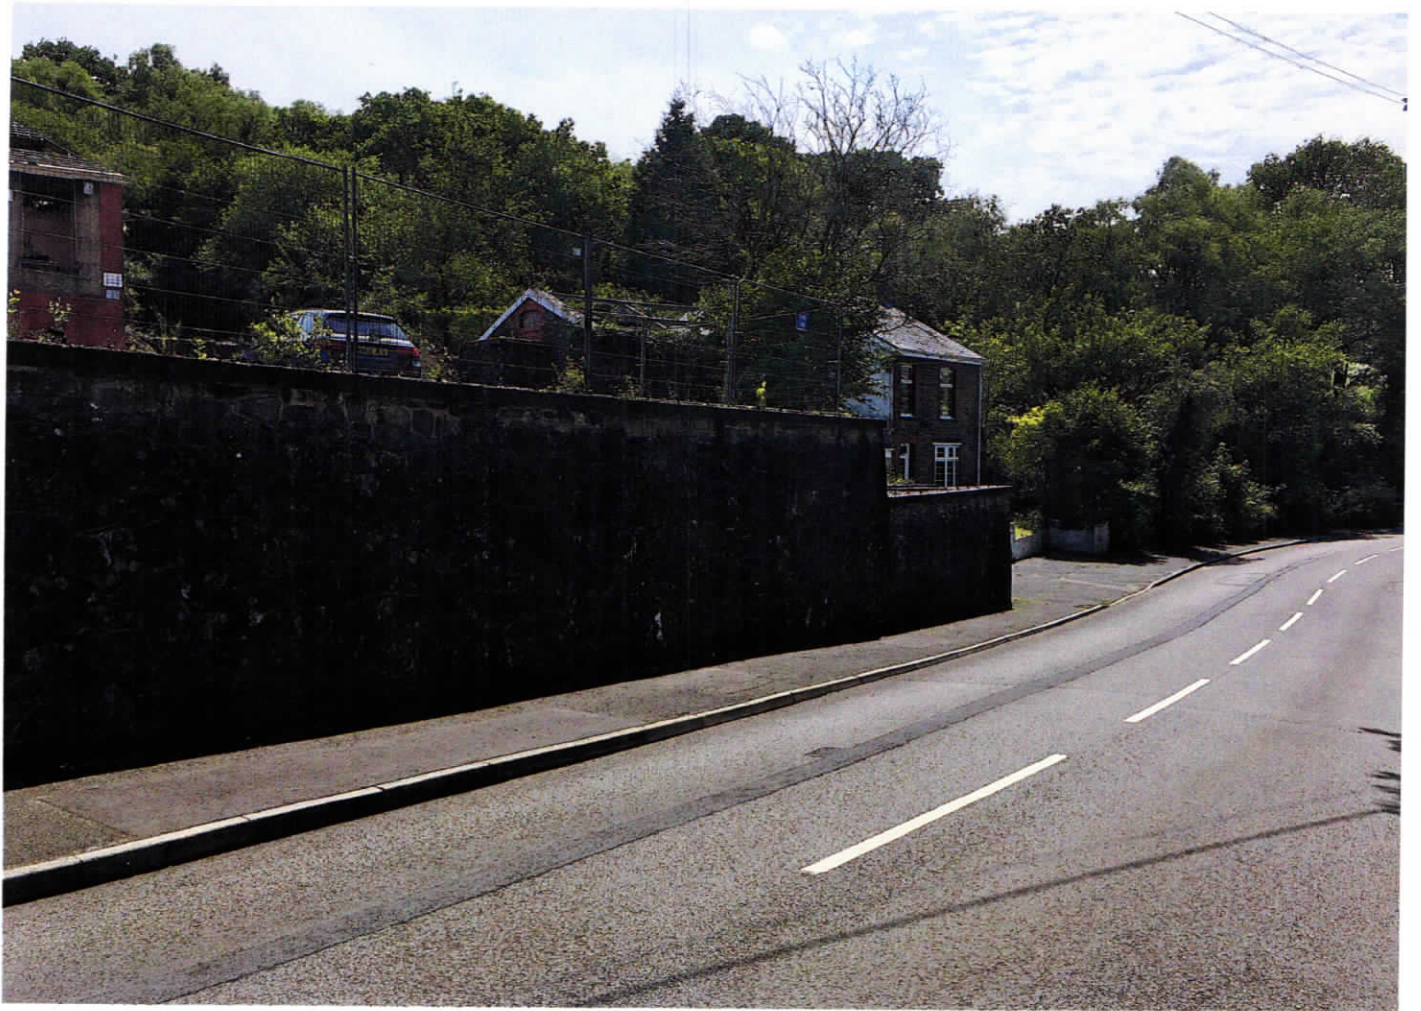
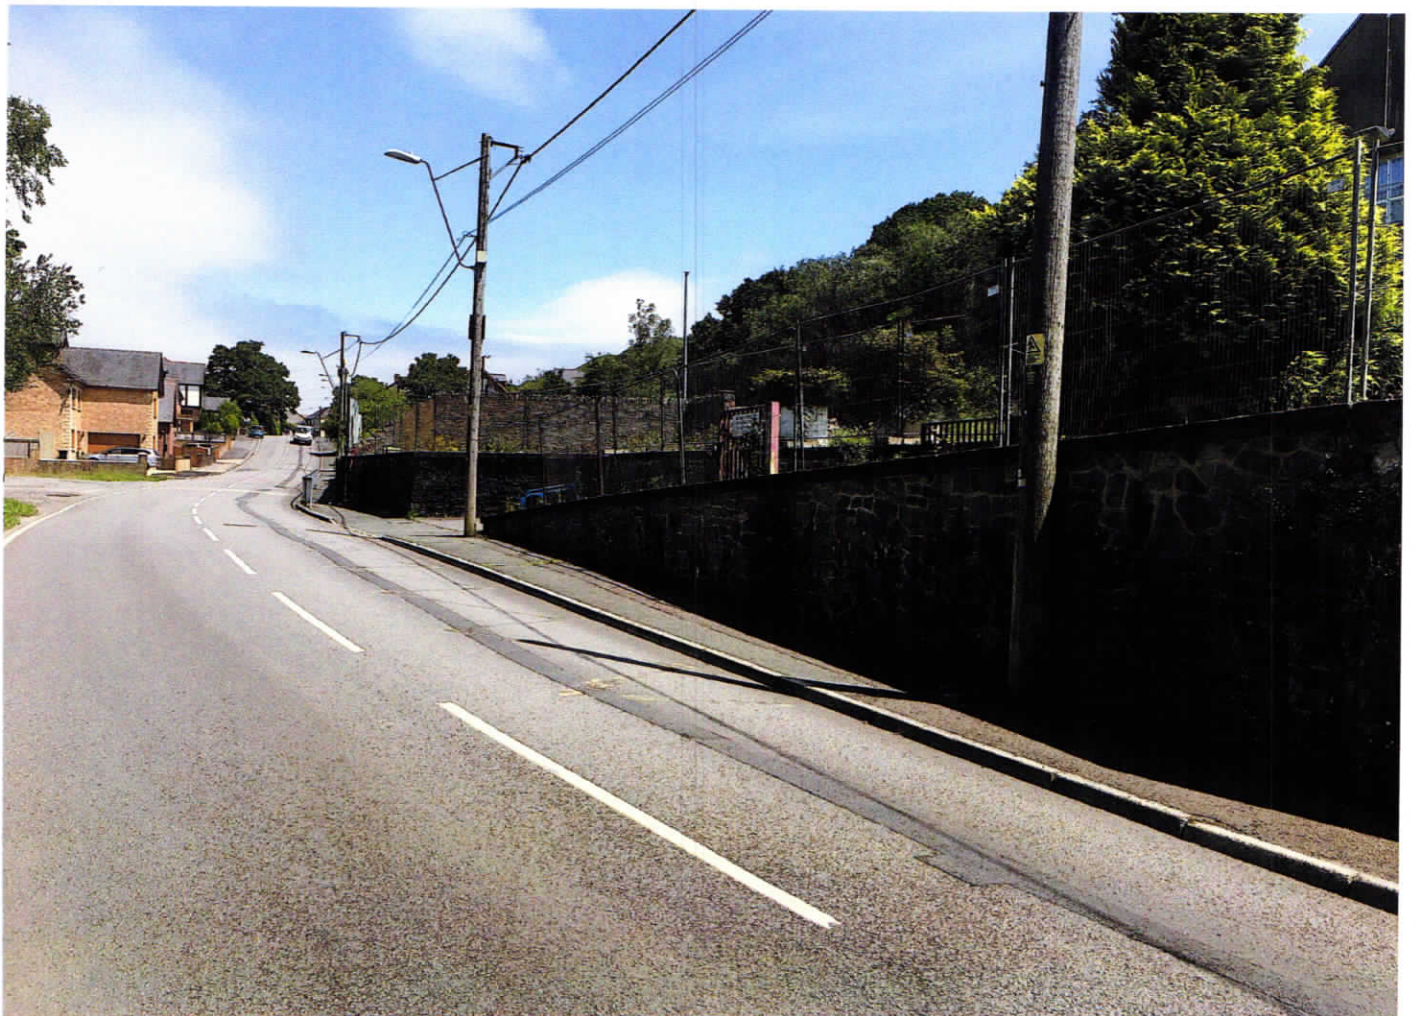
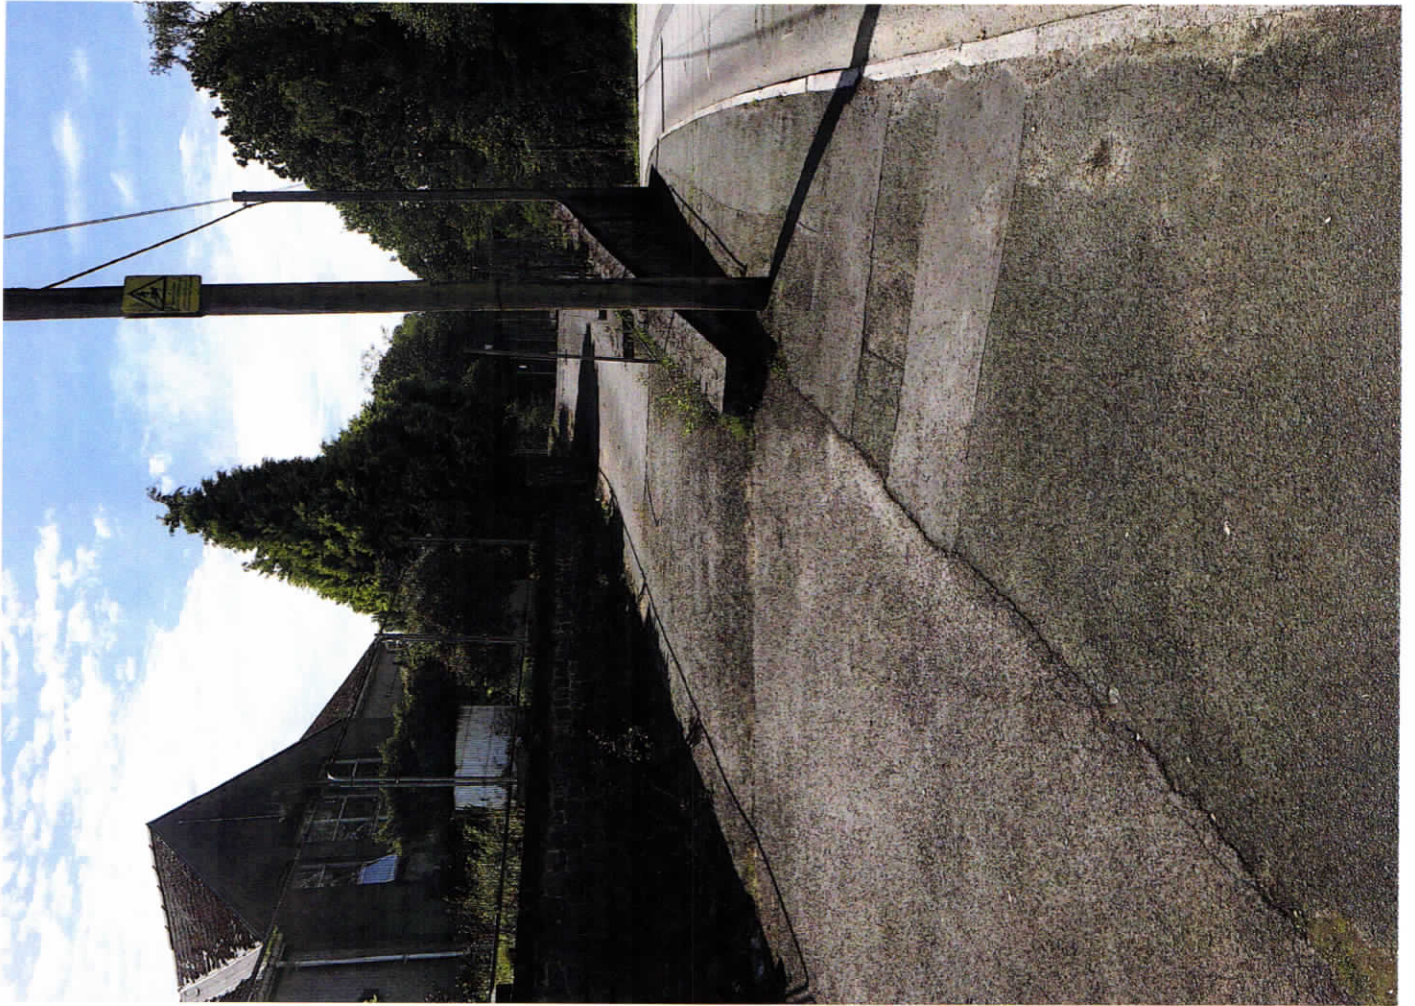
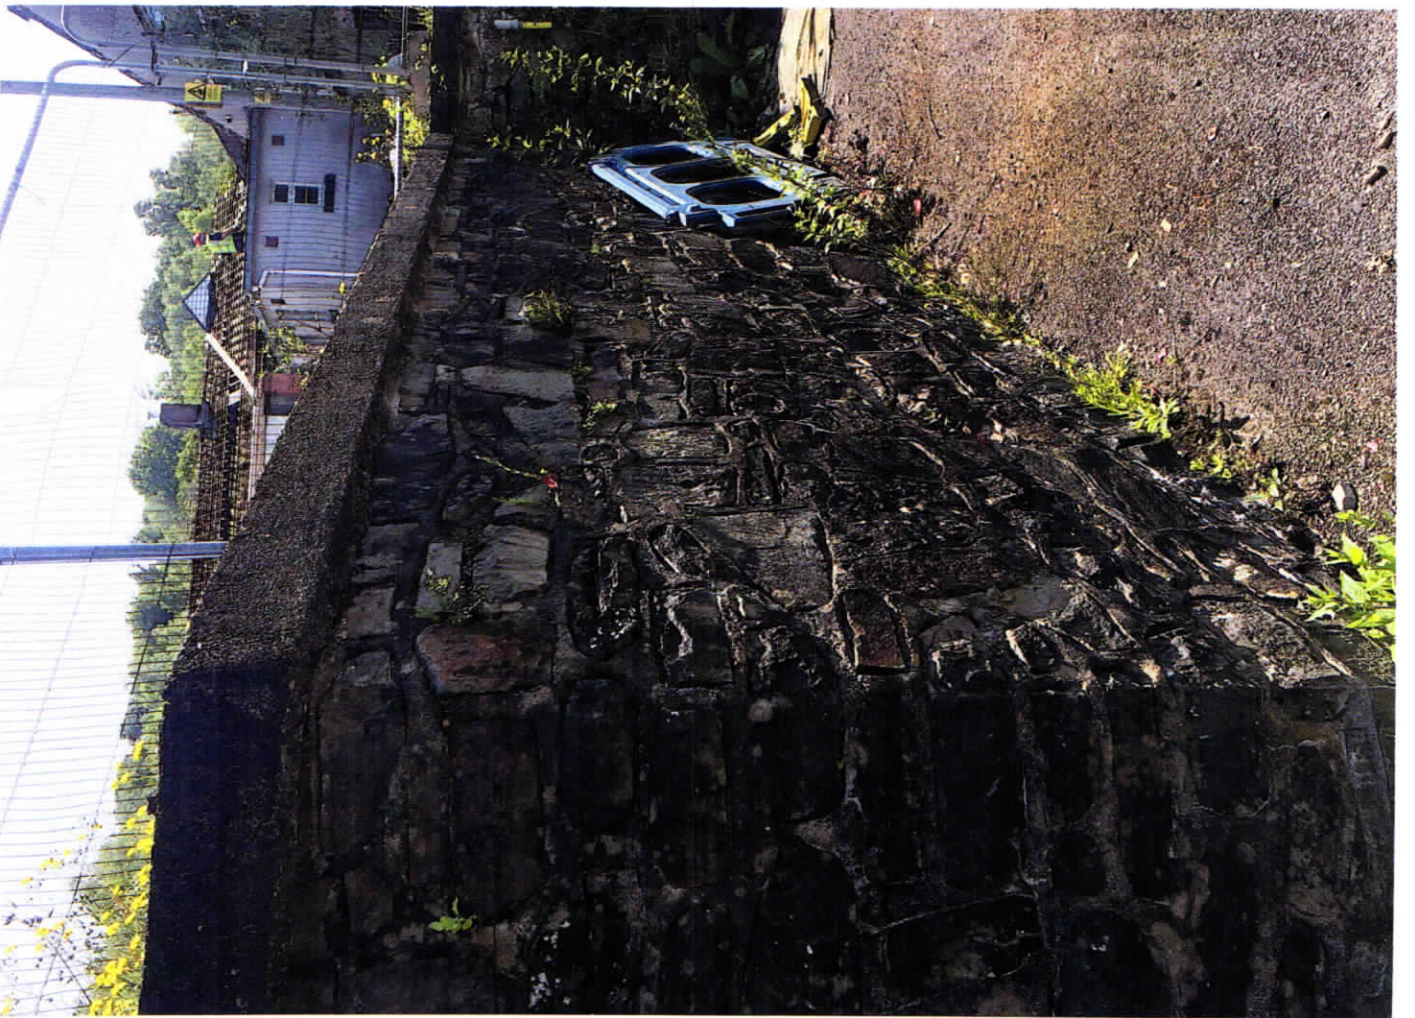
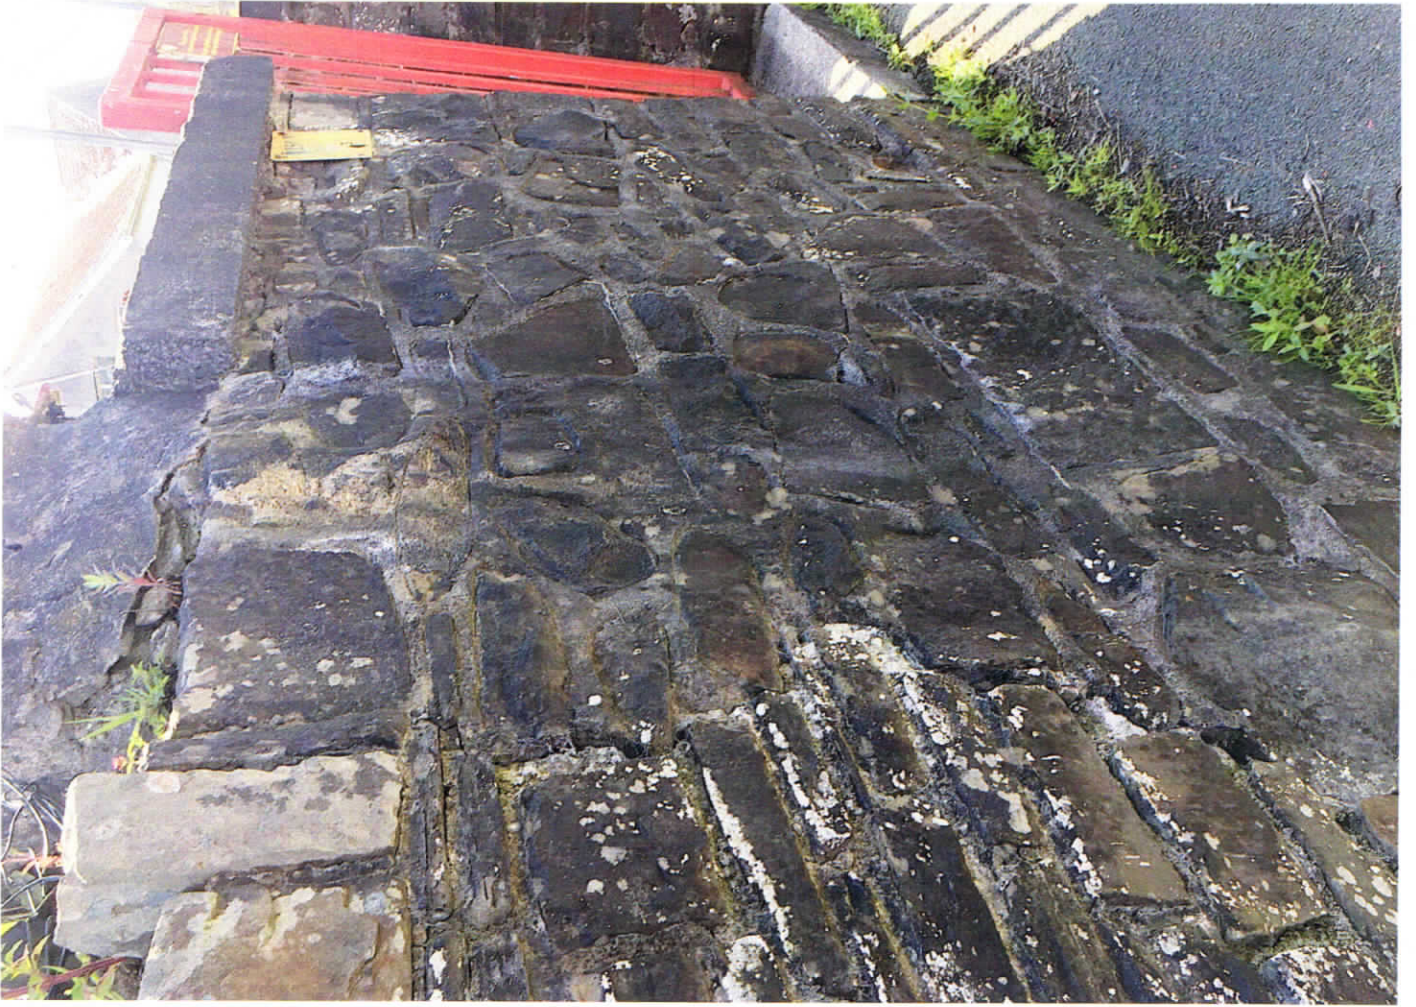
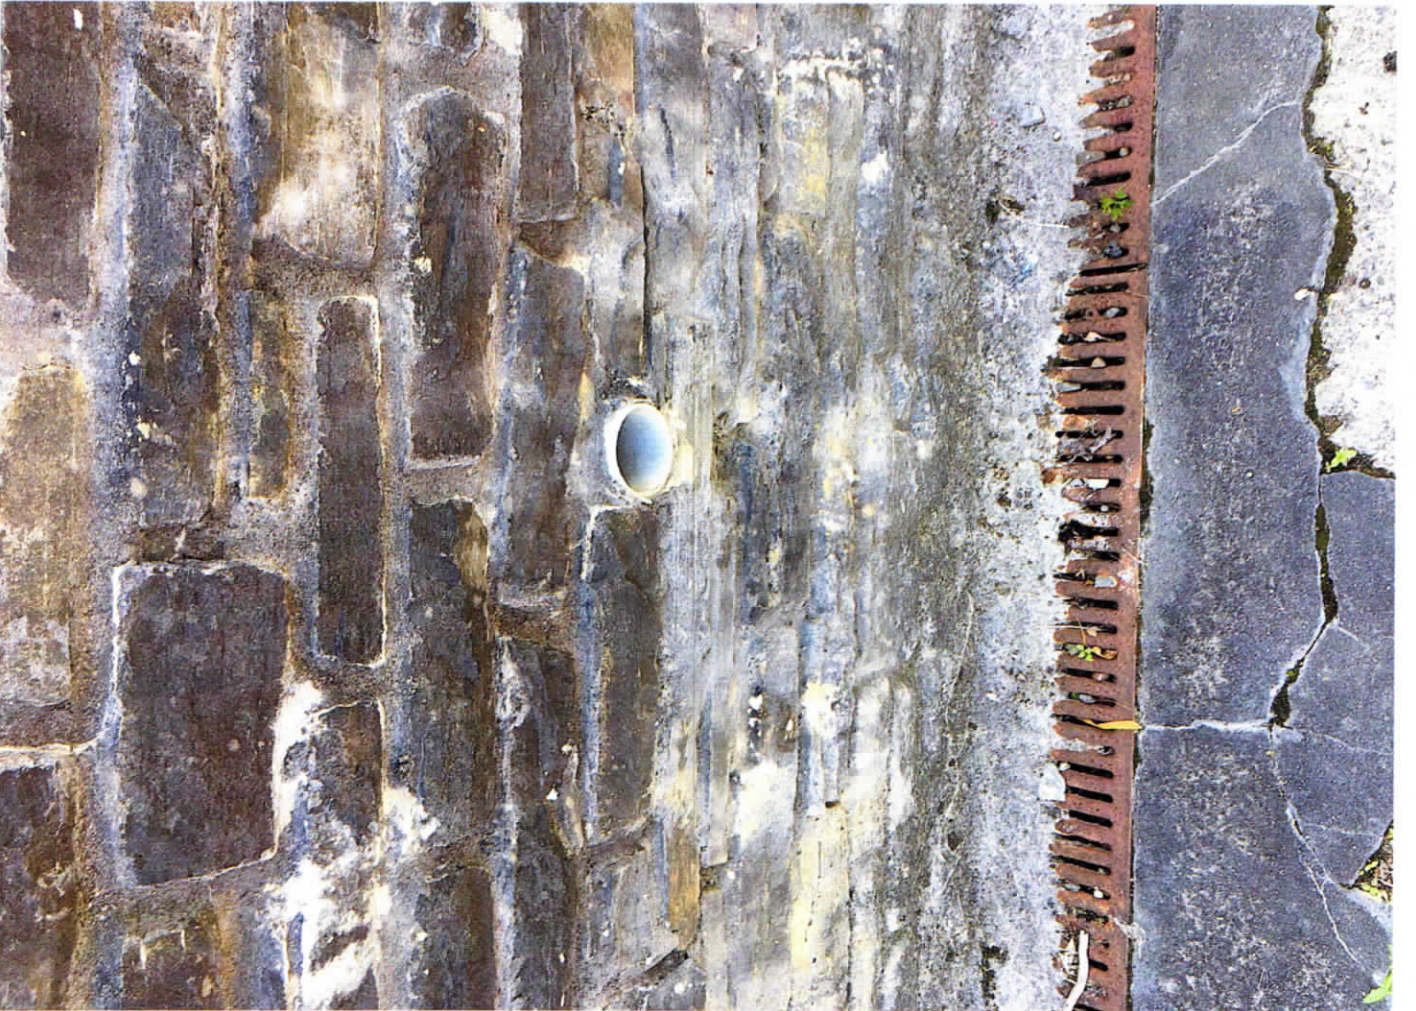
- 2.3 Generally this section of original stone wall, given its age, appears to be in very good condition and apart from some small localized areas where vegetation is growing from the face of the wall (see photo) the wall appears to have been well maintained over the past 100yrs.

- 3.2 The vegetation growing in the older section of wall should be carefully removed and the wall treated with weed killer and then re-pointed. Both sections of wall, and in particular the older section, should be periodically inspected and routine maintenance work carried out, such as cleaning the weep holes, to ensure that long term they still remain in a serviceable condition.
