# Drainage Report

Site  
**CJ Construction**  
**Sonalyt**  
**Baglan**  
**Neat Port Talbot**  
**SA12 7DJ**

**RHB DRAIN SERVICES**

## Sonalyst Baglan CCTV Survey - CCTV Survey Report : 25/02/20

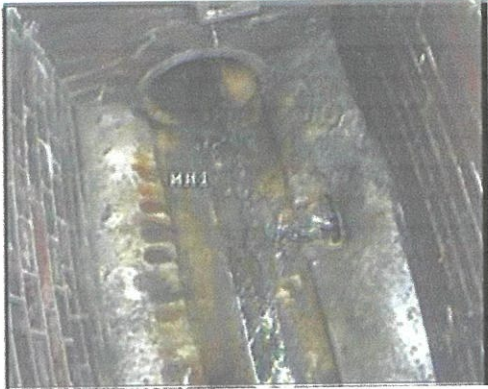
| Pos | Video Ref | Code | Description | Image |
|---|---|---|---|---|
| 00.00m | | MH | Start node type, manhole MH1 | Image Provided - Ref: 0_0<br> |

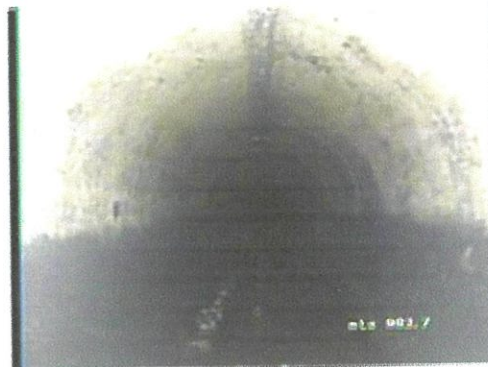
| Pos | Video Ref | Code | Description | Image |
|---|---|---|---|---|
| 03.70m | 0:00:41 | S1 DER | Settled deposits coarse 3.7m - 10.7m: 15% Cross sectional area loss - Severity 3 | Image Provided - Ref: 0_4<br> |

| Pos | Video Ref | Code | Description | Image |
|---|---|---|---|---|
| 10.70m | 0:00:41 | F1 DER | Settled deposits coarse Defect End: 15% Cross sectional area loss - Severity 3 | |

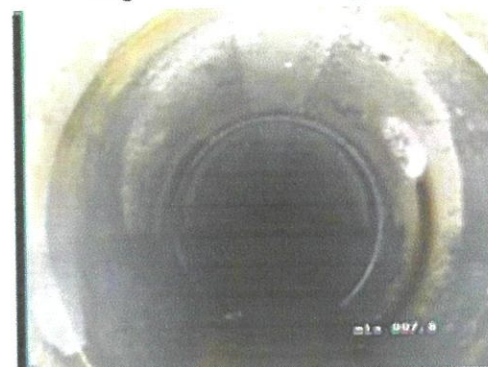
| Pos | Video Ref | Code | Description | Image |
|---|---|---|---|---|
| 07.80m | 0:01:12 | CN | Connection other than junction at 02 o'clock: 100mm Diameter | Image Provided - Ref: 0_5<br> |

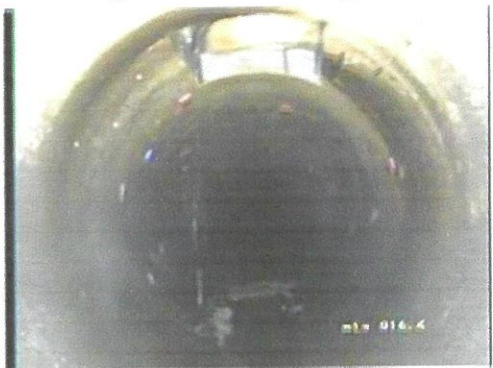
| Pos | Video Ref | Code | Description | Image |
|---|---|---|---|---|
| 16.40m | 0:02:28 | CN | Connection other than junction at 12 o'clock: 150mm Diameter | Image Provided - Ref: 0_6<br> |

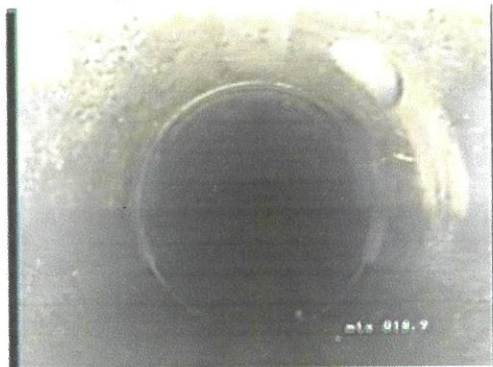
| Pos | Video Ref | Code | Description | Image |
|---|---|---|---|---|
| 18.90m | 0:02:21 | CN | Connection other than junction at 02 o'clock: 100mm Diameter | Image Provided - Ref: 0_7<br> |

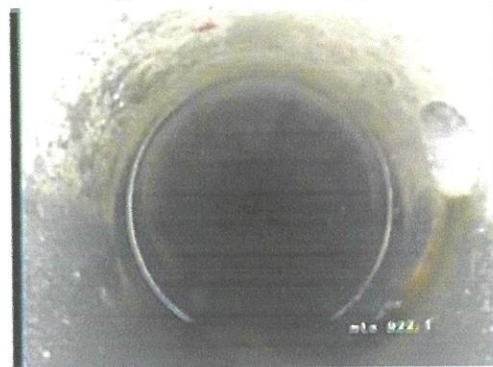
| Pos | Video Ref | Code | Description | Image |
|---|---|---|---|---|
| 22.10m | 0:03:14 | CN | Connection other than junction at 03 o'clock: 100mm Diameter | Image Provided - Ref: 0_8<br> |

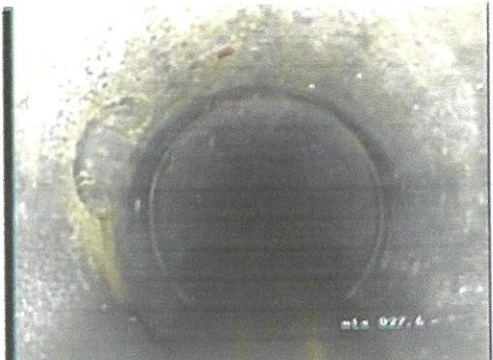
| Pos | Video Ref | Code | Description | Image |
|---|---|---|---|---|
| 27.60m | 0:03:43 | CN | Connection other than junction at 09 o'clock: 150mm Diameter | Image Provided - Ref: 0_11<br> |

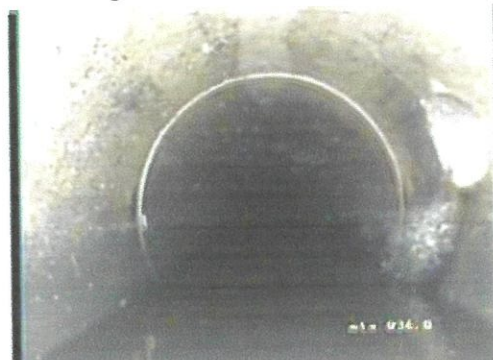
| Pos | Video Ref | Code | Description | Image |
|---|---|---|---|---|
| 36.00m | 0:06:45 | CN | Connection other than junction at 02 o'clock: 100mm Diameter | Image Provided - Ref: 0_14<br> |

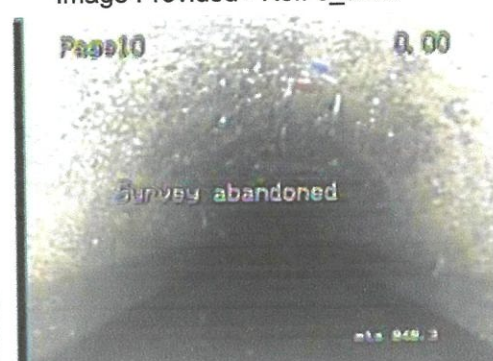
| <p><b>Section: 1</b></p> <p><b>From: MH S1</b><br/><b>To: MH S2</b></p> | <p>Survey between MHS1 to MHS2 was abandoned due to water level in pipe and settled deposits. Water level in MHS2 is 50% height/diameter of pipe, checked downstream manhole (MHS3) which has a 1050mm diameter pipe in and the water level is 60% height/diameter. The pipe connecting from MHS2 is below the water level so we were unable to survey. Water level in MHS5 is 60% height/diameter, unable to survey from MHS4 to MHS5 due to water level in pipe.</p> | <p><b>DRB Grade: B</b><br/><b>Pipe Size: 400</b><br/><b>Material: Vitrified Clay (i.e. all clayware)</b><br/><b>Use: Surface Water</b></p> |

| Pos | Video Ref | Code | Description | Image |
|---|---|---|---|---|
| 40.30m | | SA | Survey abandoned<br>Survey abandoned due to water level and settled deposit in pipe. | Image Provided - Ref: 0_9999<br> |
