# TREE CONDITION REPORT

Land adjacent to 27A Bryn Catwg, Neath

Tree condition survey carried out on behalf of Mr & Mrs L. Greaves, prepared by Christopher  
Matts of Cadno Contracting & Consultancy

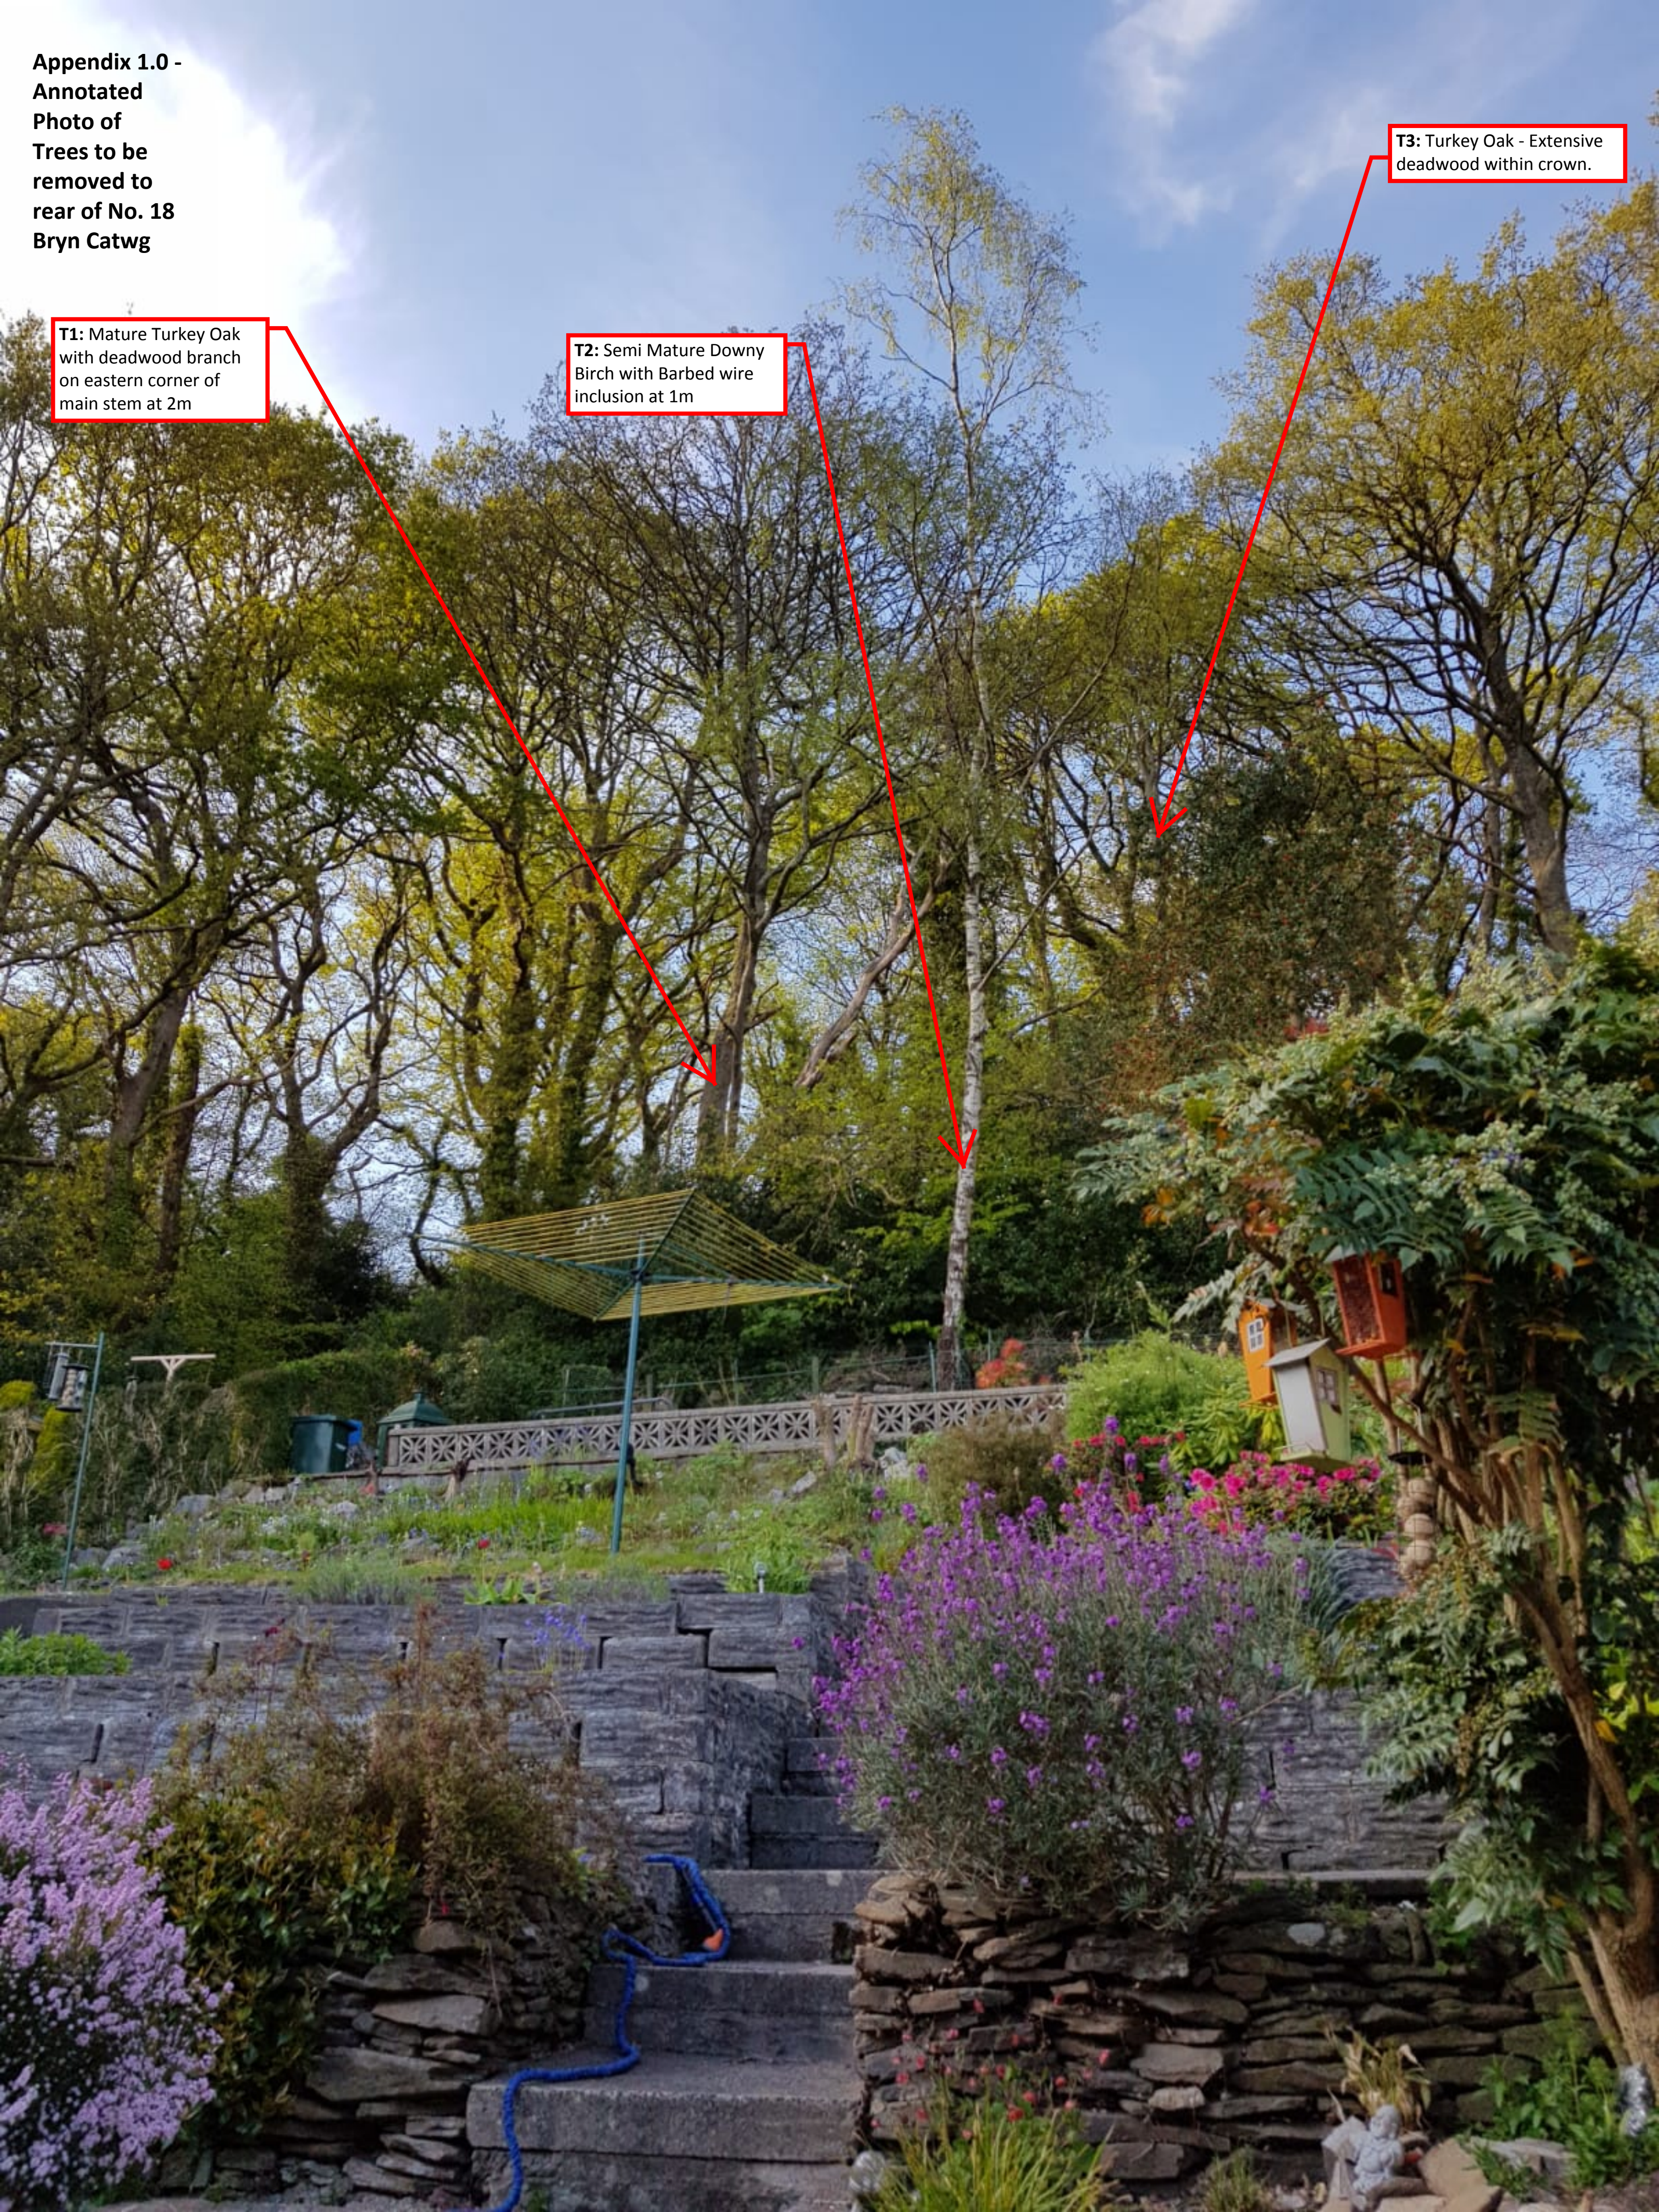
Appendix 1.0 -  
Annotated  
Photo of  
Trees to be  
removed to  
rear of No. 18  
Bryn Catwg

| Tree No. | Species | Height (m) | Dbh | Age Class | N | E | S | W | Condition | Recommendations | Specification | Work Priority | Identification |
|---|---|---|---|---|---|---|---|---|---|---|---|---|---|
| T1. | Turkey Oak<br>(Quercus cerris) | 23 | 2000mm+ | Mature | 4 | 6 | 6 | 5 | Poor - Tree contains approximately 25% deadwood within crown area and major deadwood limb on south eastern corner from fork at 2m which includes extensive decay. Tree's position is within close proximity to former rock hole to on south west corner with base of the tree deformed from previous wounding and/or historical damage. | <b>Due to nature of species recommendation includes a crown reduction: Dismantle the tree to 10 metres/main fork of main stem and retain as standing dead, include veteranising cuts as outlined in section 4.6.2 of 'Ancient and other veteran trees: further guidance on management' ISBN 978-0-904853-09-4 to create coronet feature and allow controlled fracture cutting.</b> | BS 3998 clause 7.7 | 3 | Orange Paint on stem |
| T2 | Downy Birch<br>(betula pubescens) | 18 | 300mm | Mature | 0 | 2 | 3 | 0 | Fair - Tree has strong vitality with good leaf coverage and less than 25% deadwood within crown but has a barned wire inclusion from a former boundary fence at 1m above ground level. Main stem extends over party boundary with lean towards no 18 Bryn Catwg and is alongside other D.Birch which have been removed due to poor condition and safety risk in 2019. Evidence of ground movement can be observed but would require geological surveyer to conclude extent and impact. | <b>Dismantle to ground due to risk of main stem snapping across party boundary in strong winds and physical lean towards neighbouring properties.</b> | BS 3998 clause 12.2 | 3 | Orange Paint on stem |
| T3 | Turkey Oak<br>(Quercus cerris) | 18 | 380mm | Middle Aged | 1 | 2 | 0 | 0 | Very Poor - Semi mature Turkey Oak which has extensive deadwood within crown area and observed 50% leaf coverage loss. Tree is within falling distance of neighbouring property boundaries and Public Right of way on western side of stem. | <b>Dismantle to 10m or fell into woodland behind and stack arisings in windrow not more than 1m high with logs over brash. Care must be used to avoid damage to other trees within the proximity including young Beech tree establishing within target area on south side of main stem. Main stem can be 'veteranised'</b> | BS 3998 clause 12.2 and App. C.4 extreme crown reduction and topping | 2 | Orange Paint on stem |

T1: Mature Turkey Oak  
with deadwood branch  
on eastern corner of  
main stem at 2m

T2: Semi Mature Downy  
Birch with Barbed wire  
inclusion at 1m

T3: Turkey Oak - Extensive  
deadwood within crown.

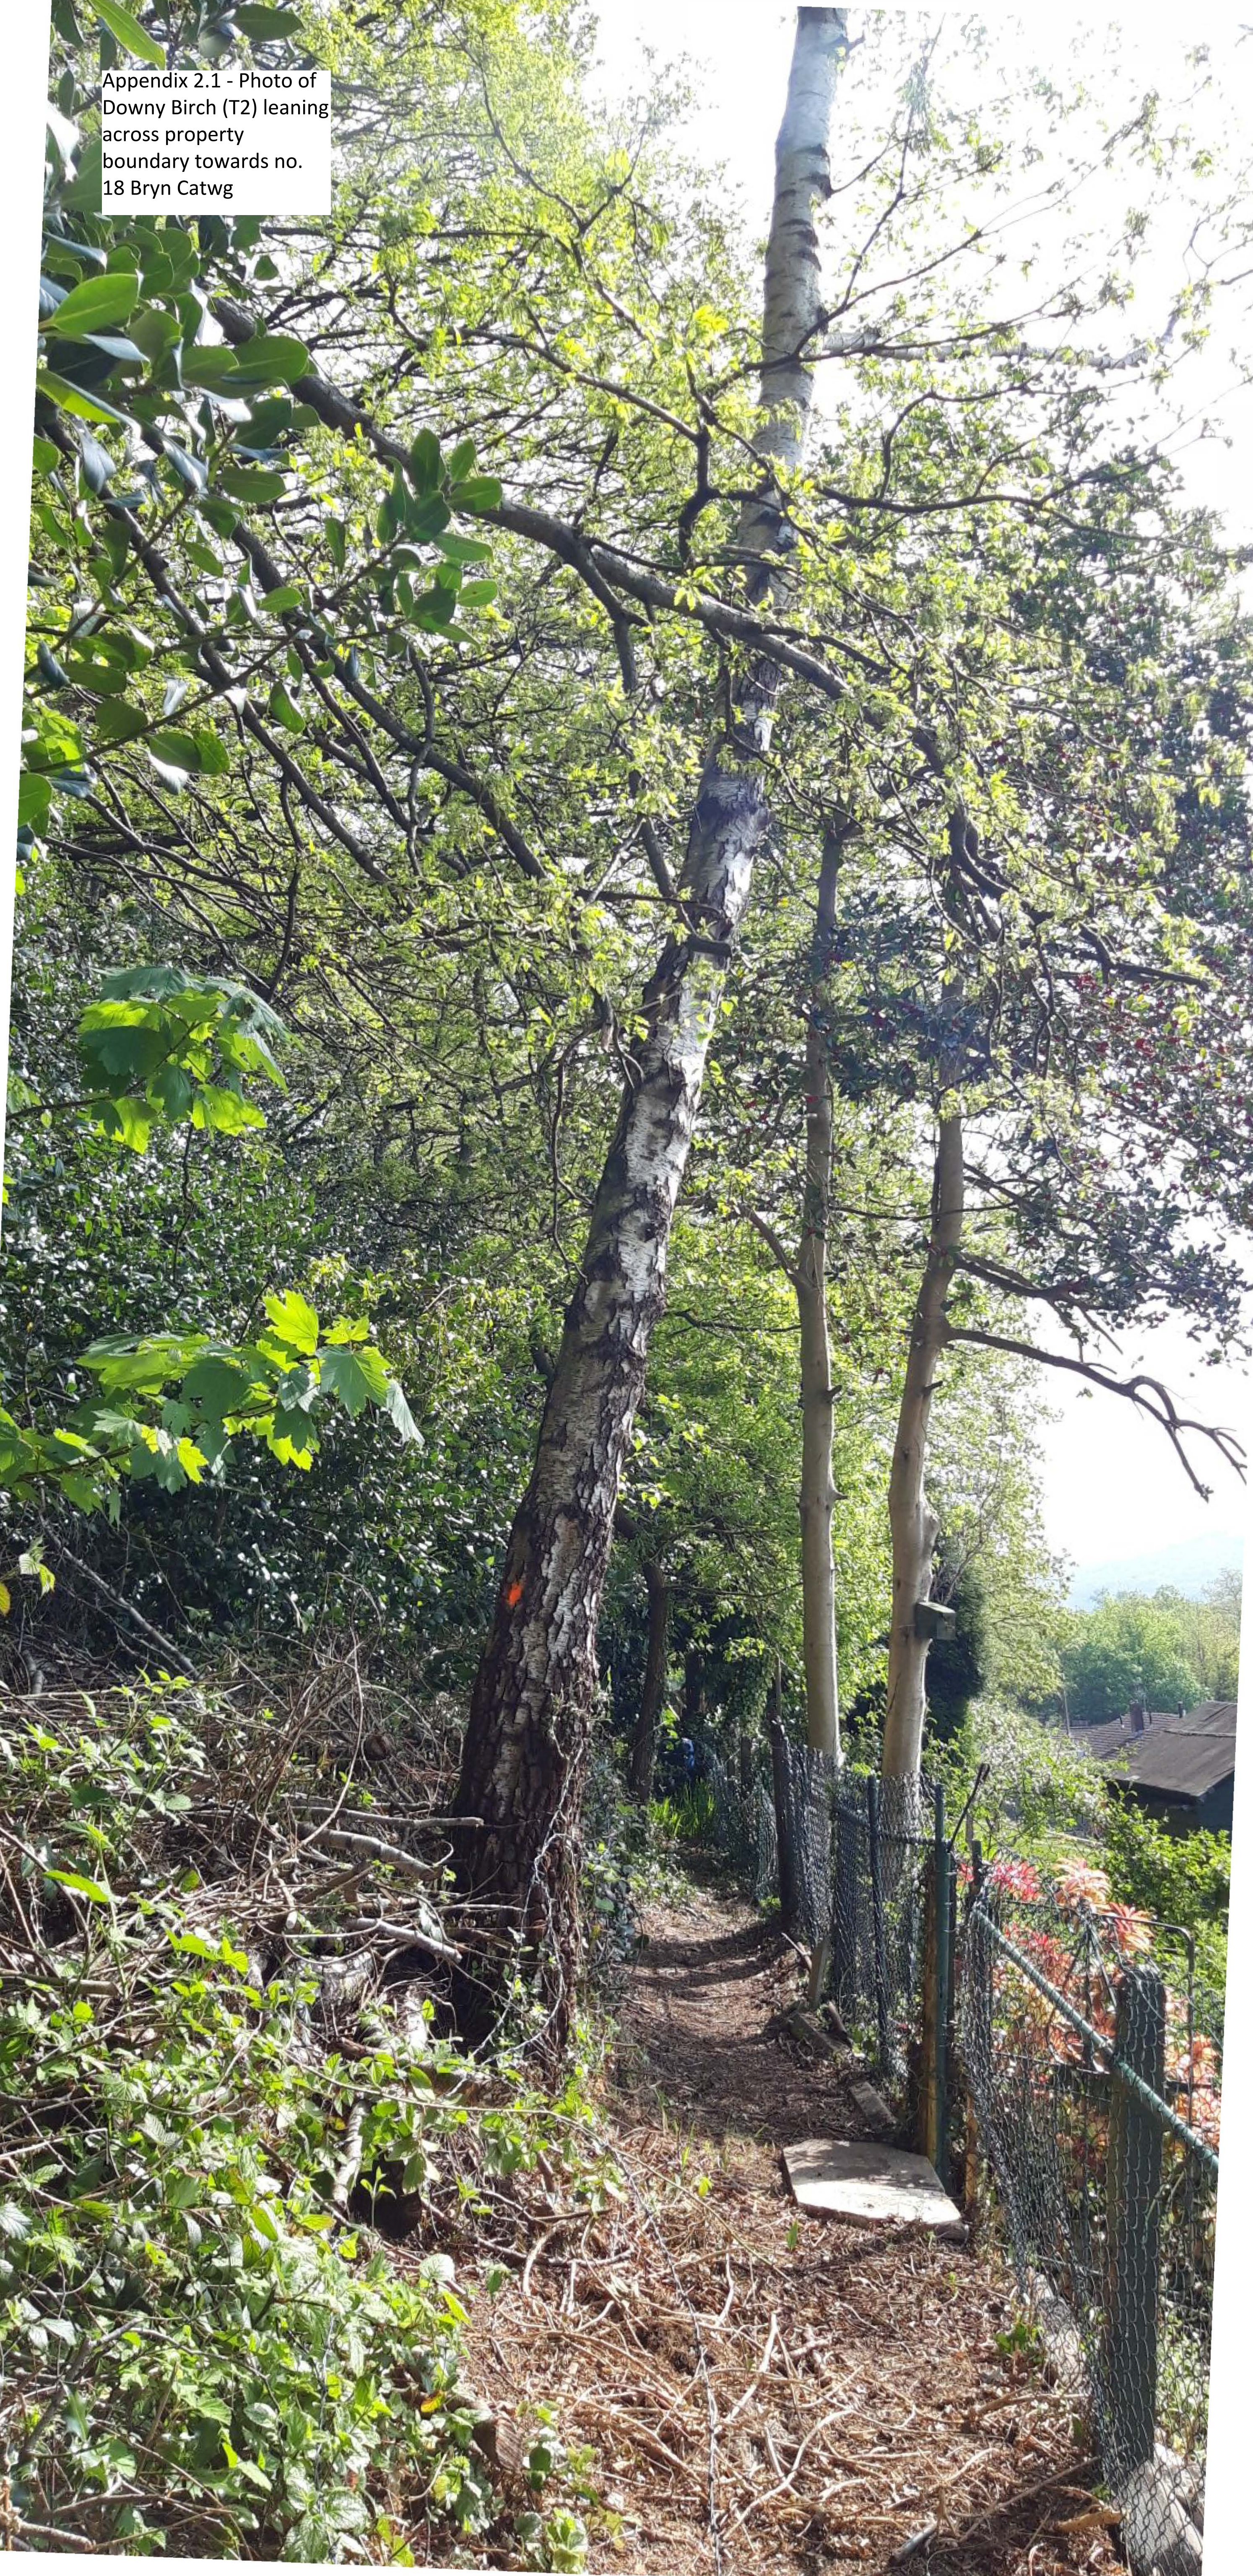
Appendix 2.1 - Photo of  
Downy Birch (T2) leaning  
across property  
boundary towards no.  
18 Bryn Catwg
