Tidal Lagoon (Swansea Bay) Plc

**Tidal Lagoon Swansea – Onshore GI**

**Ground Investigation Interpretive  
Report (Phase 1)**

March 2017

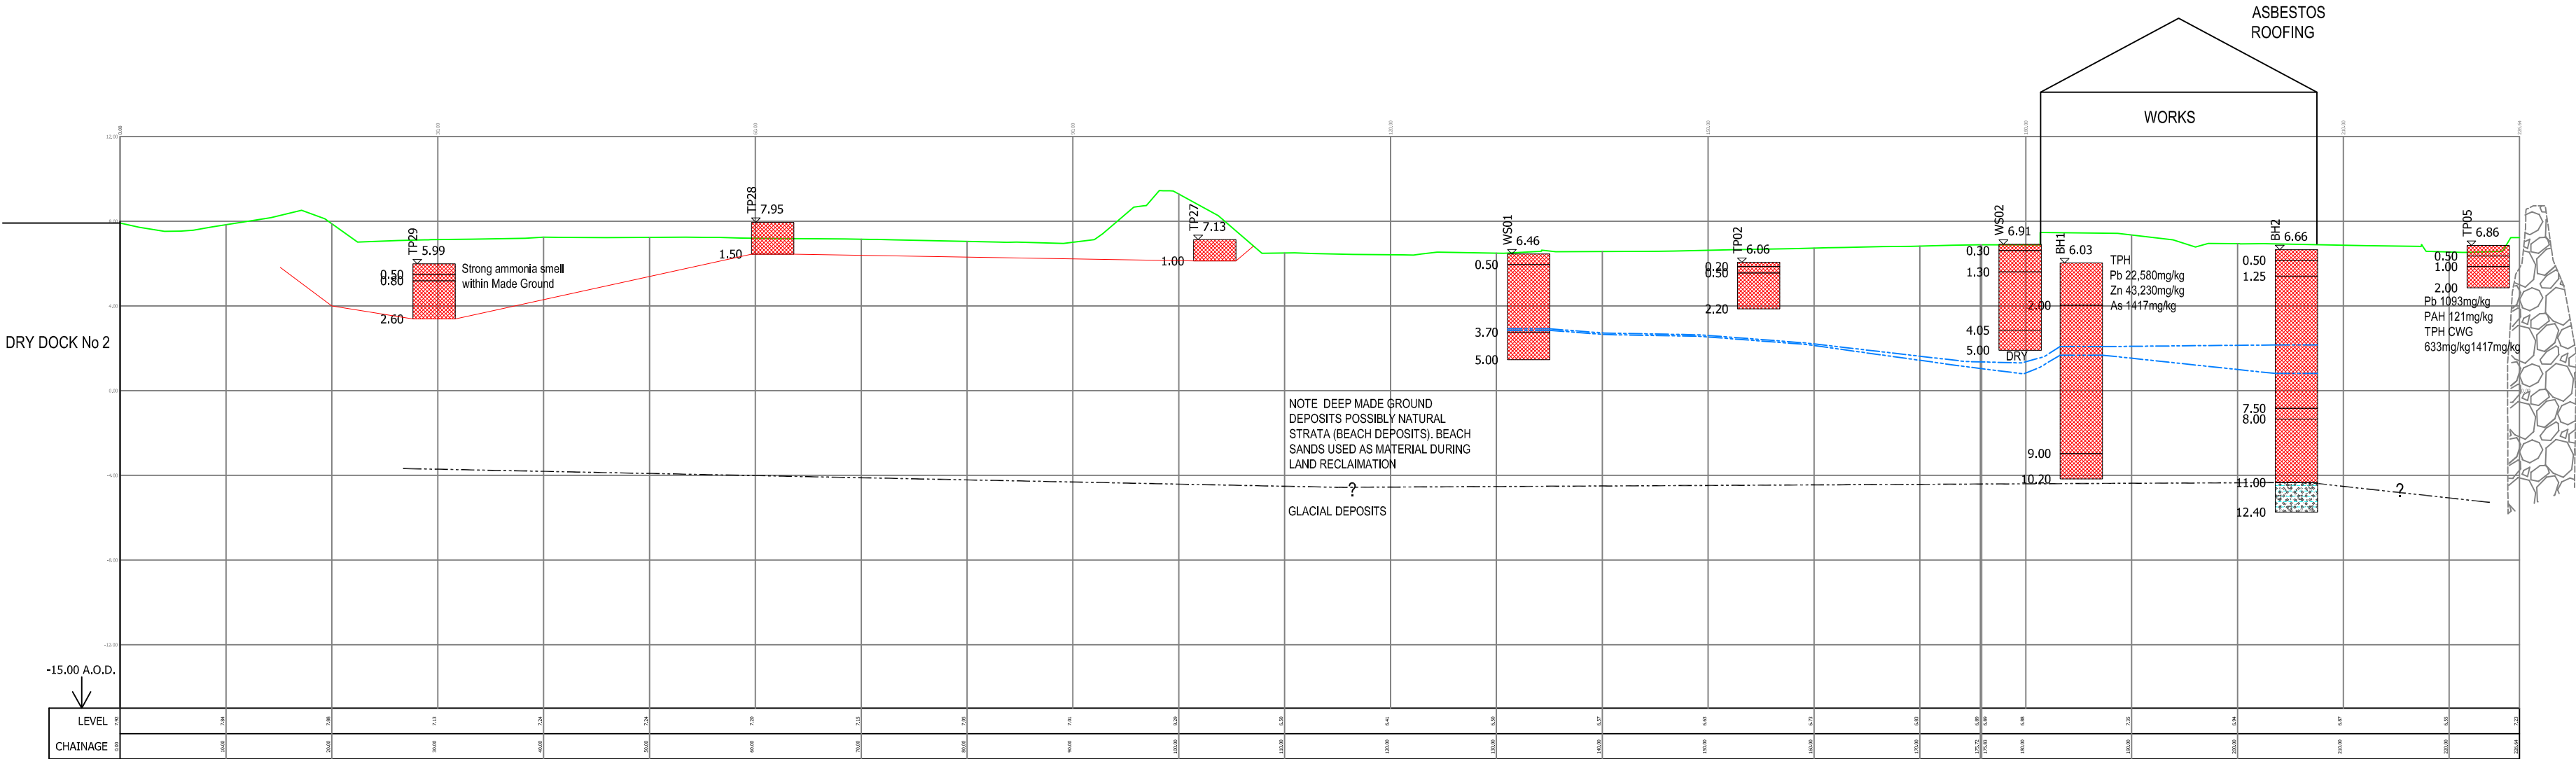
SECTION 1  
WESTERN LANDFALL AREA  
Horiz. 1:200  
Vert. 1:100

Made Ground was encountered within all the exploratory holes across the Western Landfall Area. It was generally found to comprise black becoming brown (with depth) sand with varying amounts of gravel that decreased in content with depth.

Depths and thicknesses for the principal soil types are given in Table 1 with exploratory hole logs presented in Appendix B. Figure 3a provides a cross section of the ground conditions encountered across the Western Landfall Area.

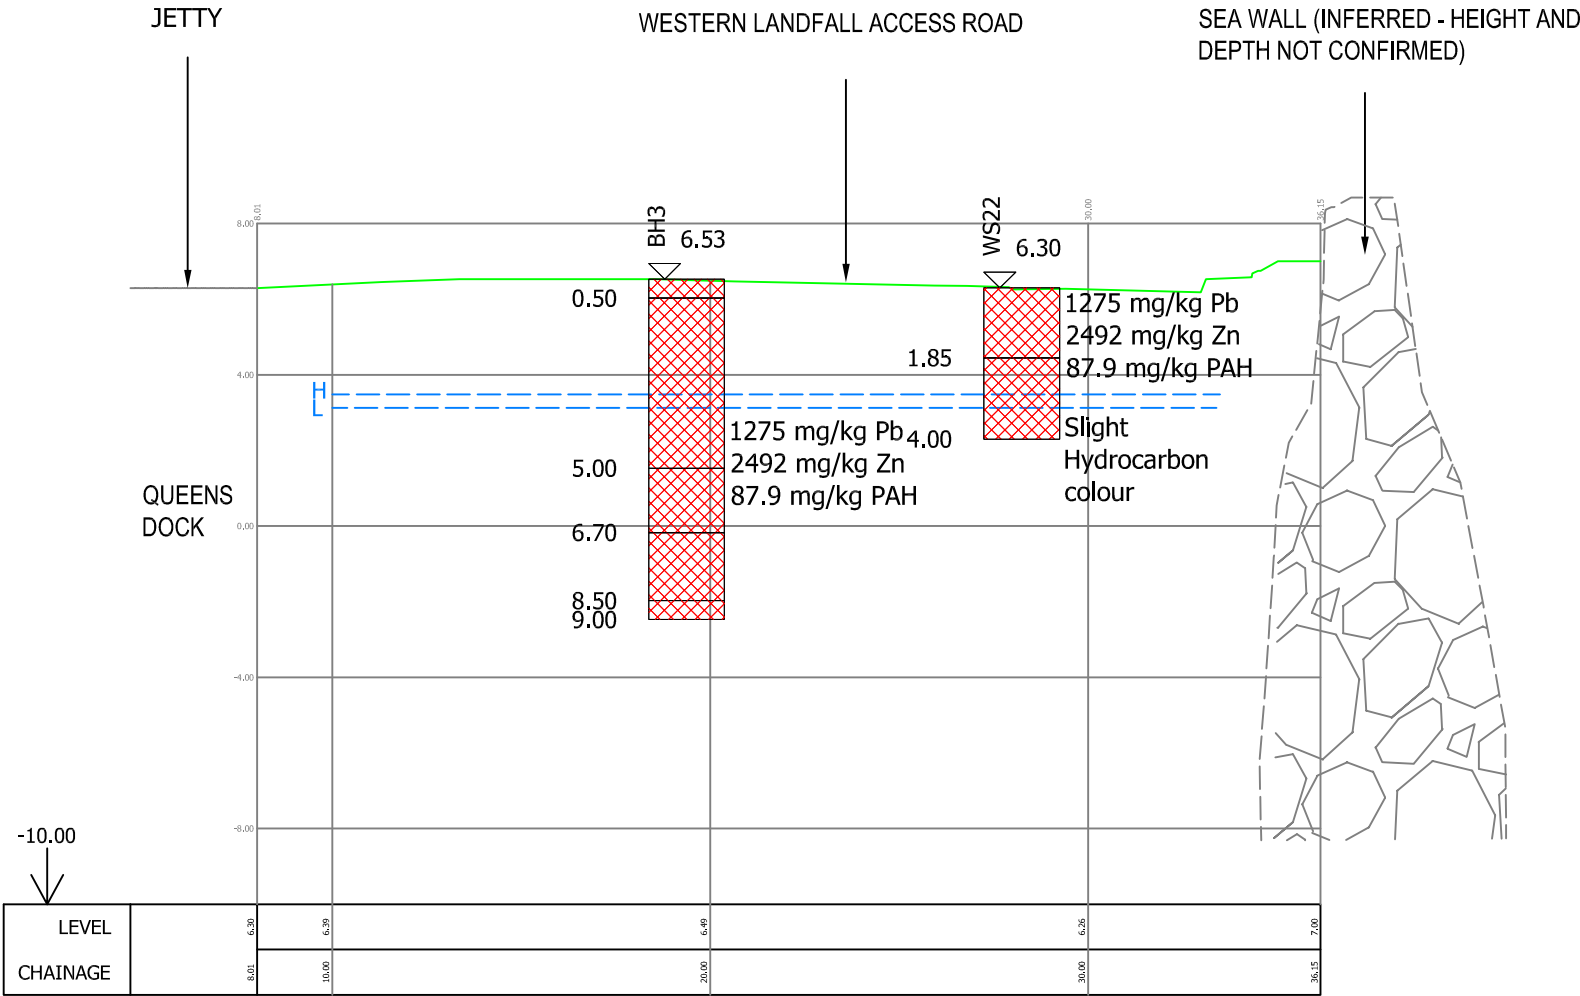
SECTION 2  
WESTERN LANDFALL ACCESS ROAD

Made Ground was encountered within all the exploratory holes across the Western Landfall Access Road. It was generally found to comprise black becoming brown (with depth) sand with varying amounts of gravel

that decreased in content with depth. Visual and olfactory evidence of hydrocarbon contamination was noted from BH3 northwards along the Western Landfall Access Road. Hydrocarbon impacted Made Ground was encountered in BH3 (3.40-3.95m), WS05 (3.60-5.00m), WS06 (3.25-5.00m), WS07 (1.20-5.00m), WS22 (3.00-4.00m), WS24 (3.00-4.00m) and WS25 (0.10-3.90m).

Figures 3b-3e provides a cross section of the ground conditions encountered across the Western Landfall Area.

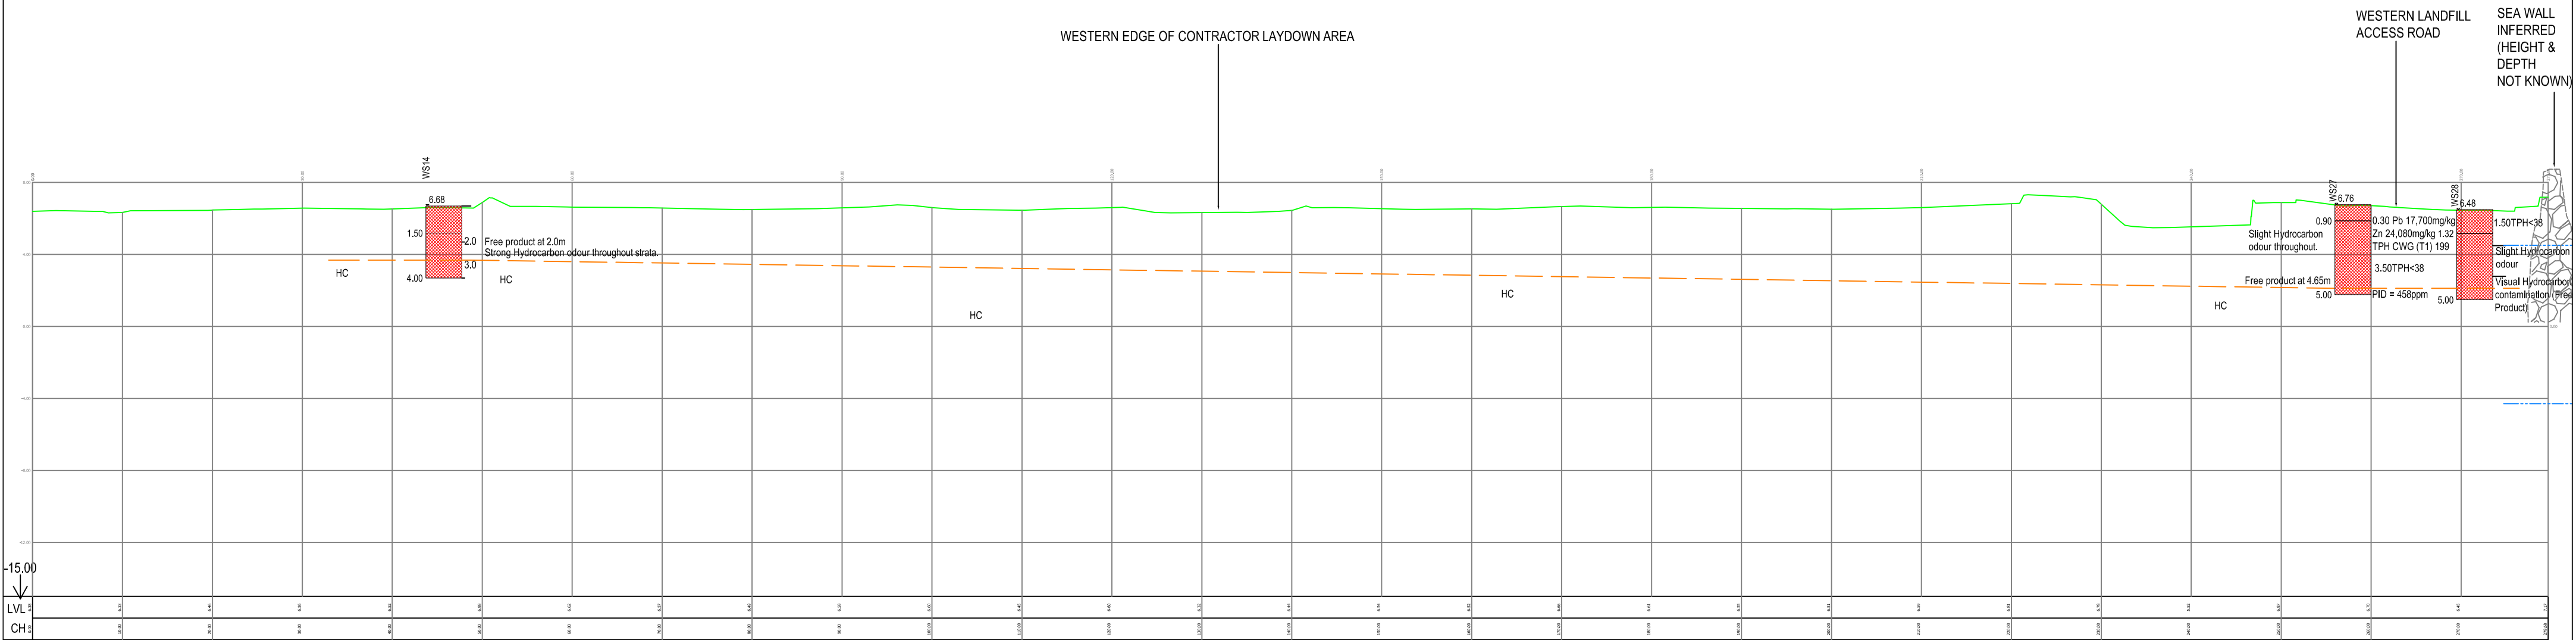
SECTION 6  
CONTRACTOR LAYDOWN AREA  
Horiz. 1:200  
Vert. 1:100

Made Ground was encountered within all the exploratory holes across the Contractor Laydown Area. It was generally found to be coarse grained in nature comprising black to brown sand or gravel with variable cobble contents. Variable amounts of metal waste, iron slag, concrete, brick and wood were encountered within the Made Ground. Visual and olfactory evidence of hydrocarbon contamination was noted in the Contractor Laydown Area – most prominently in BH9 – BH11. Hydrocarbon impacted Made Ground was encountered in BH7 (4.00-5.00m), BH9 (1.00-9.70m), BH10 (0.50-6.00m), BH11 (0.50-9.00m), TP18 (2.10m), TP20 (0.20 – 3.20m), WS13 (2.60 – 3.40m), WS14 (1.30-3.00m), WS16 (2.00-3.30m), and WS17 (1.90-4.00m).

Figure 3f-h provides cross sections of the ground conditions and petroleum hydrocarbon contamination encountered across the Contractor Laydown Area.

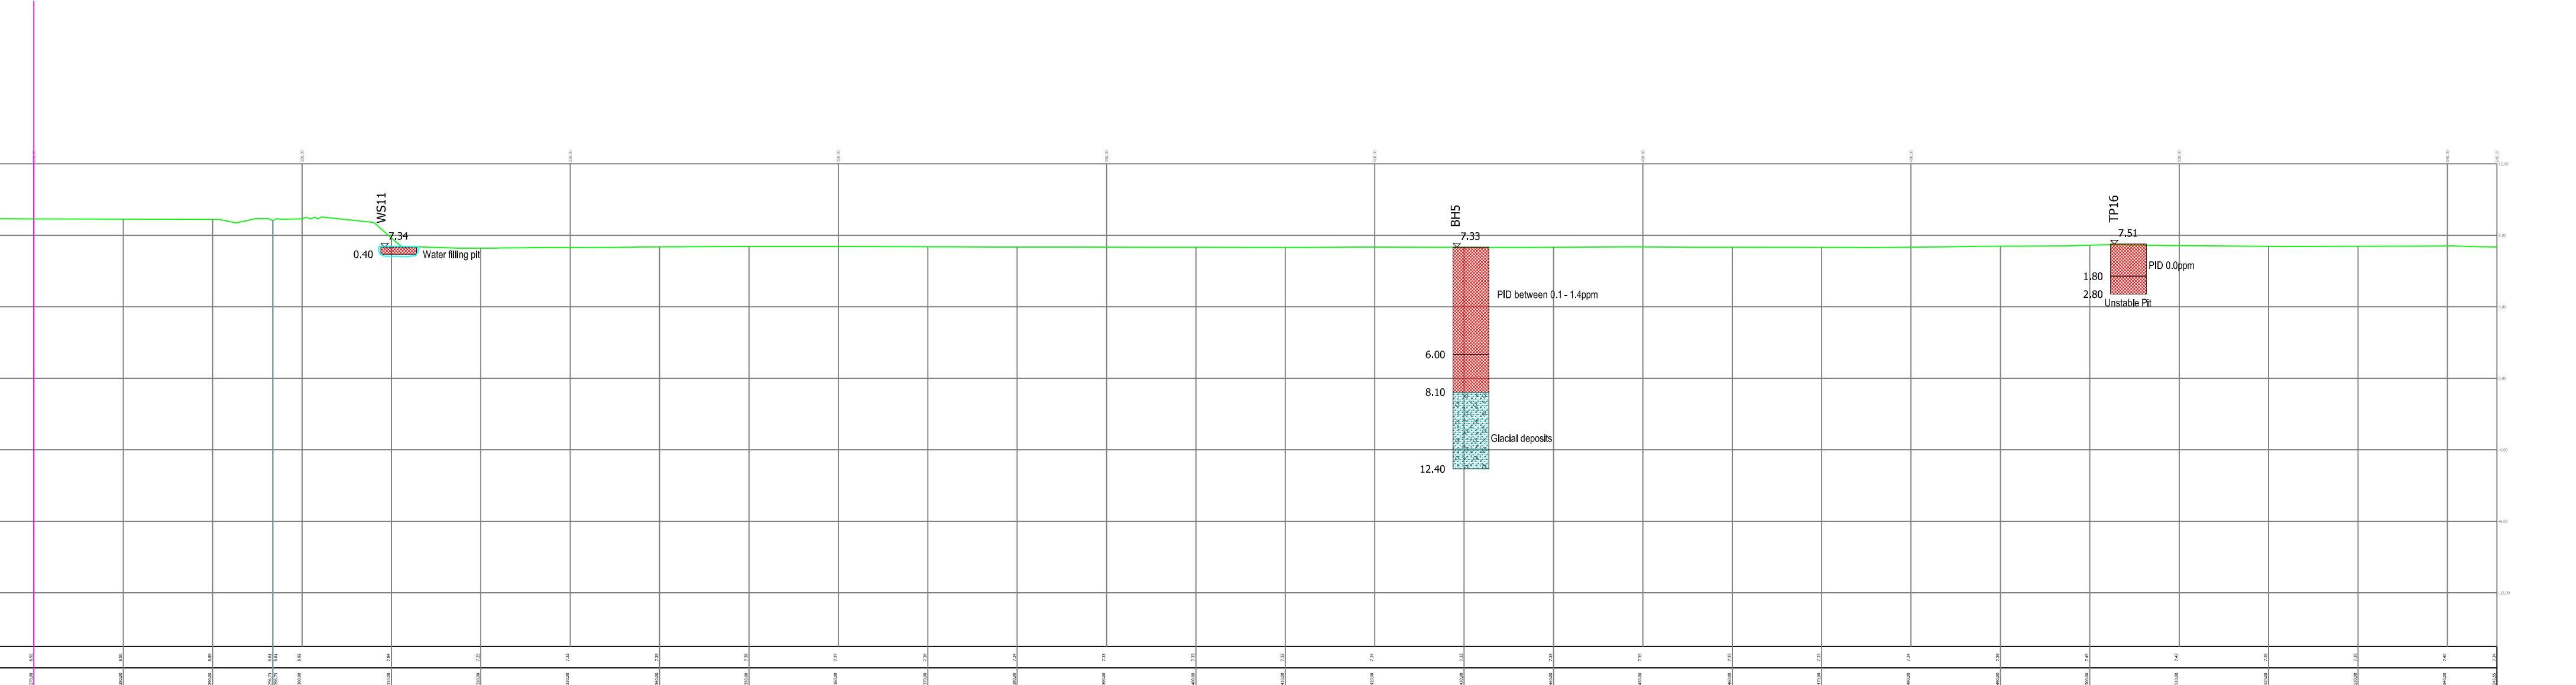
SECTION 9  
MORRISSEY LAND  
Horiz. 1:200  
Vert. 1:100

Made Ground was encountered within all the exploratory holes across the Morrissey Land area of the site. It was generally found to comprise coarse grained sand and gravel deposits ranging from brown sandy cobbly Gravels of sandstone, brick and iron slag and grey to black gravelly coarse SAND. Significant visual or olfactory evidence of hydrocarbon contamination was not noted within this area of the site.

Figure 3i provides a cross section of the ground conditions encountered across the Morrissey Land.
