Project  
**Cefn Coed Colliery Museum**  
Renovation of two Grade II\* Listed headgear frames

Sheet  
**Building at base of Headframe 1**  
Current condition and works proposed

| Drawing No. | Sheet No. | Revision |
|---|---|---|
| CD-V-C8458.60 | 105B | R0 |

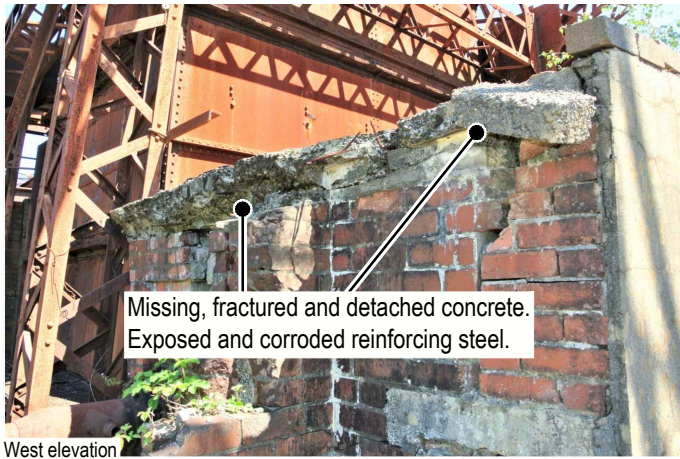
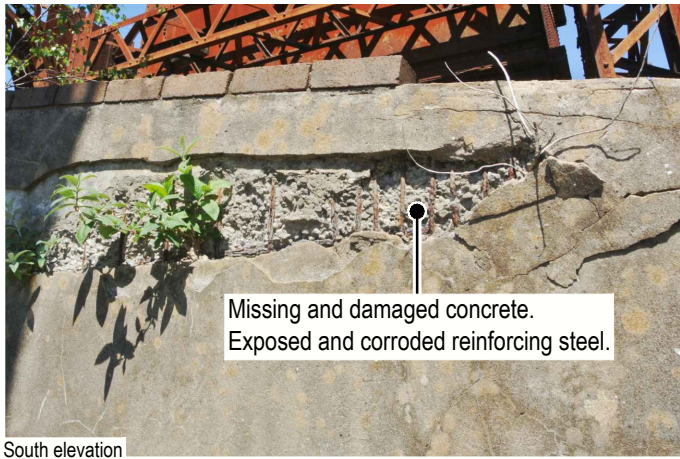
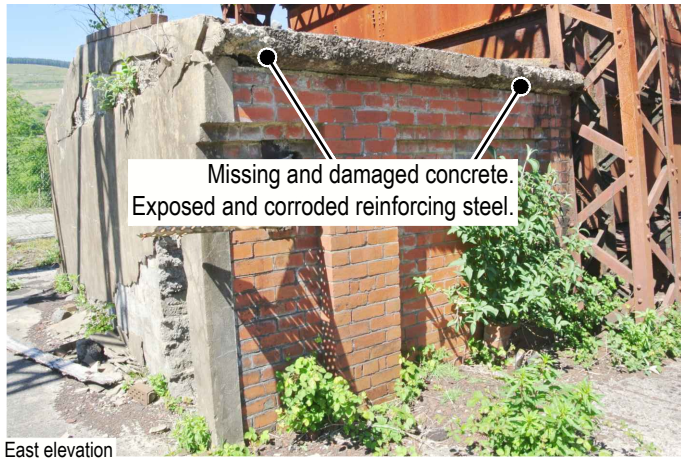
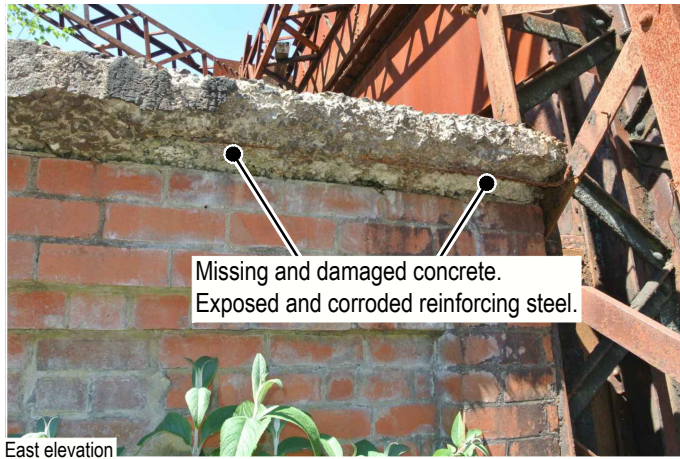
Significant deterioration of the concrete roof has occurred since the survey in April 2018 (and the basis for the Listed Building Consent granted in July 2018): holes have appeared through the slab; widespread loss of concrete across the underside of the slab and beam faces, exposing corroded reinforcing steel. Consequently, it is no longer feasible to repair the roof nor ensure it can safely remain in place whilst adjacent repairs are undertaken.

The concrete roof is of limited architectural or historic significance. It is proposed to remove the concrete roof entirely (it will not be replaced). The adjoining steel canopy will remain and be refurbished. This follows the profile of the roof and, together with the wall remains (see text opposite), will retain sufficient evidence of the form of the building.

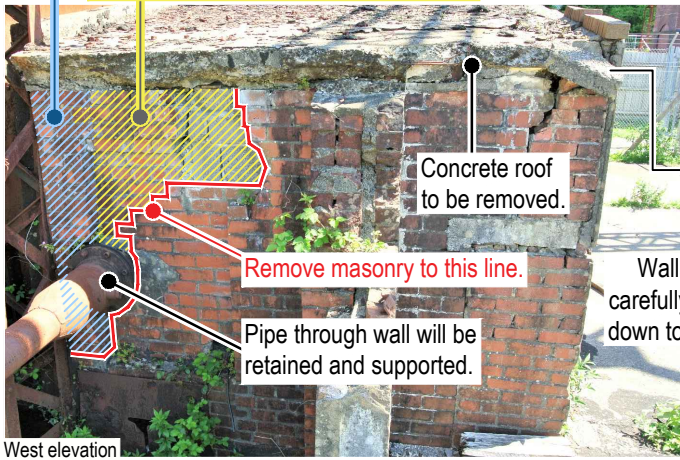
This masonry likely to become unstable.

Remove this masonry to improve access for repairs and maintenance.

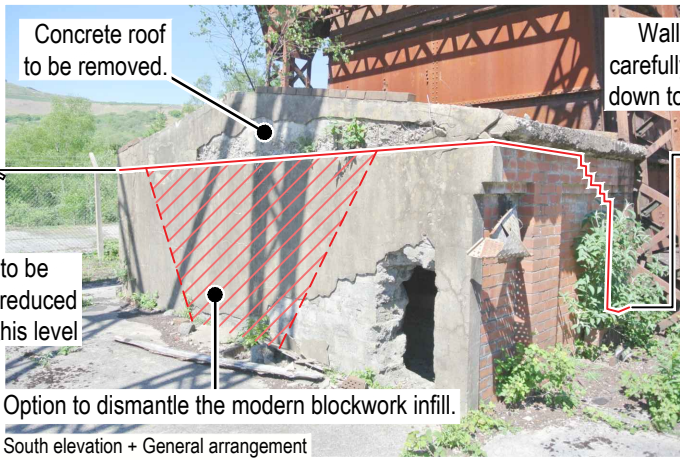
This masonry likely to become unstable.

Remove this masonry to improve access for repairs and maintenance.

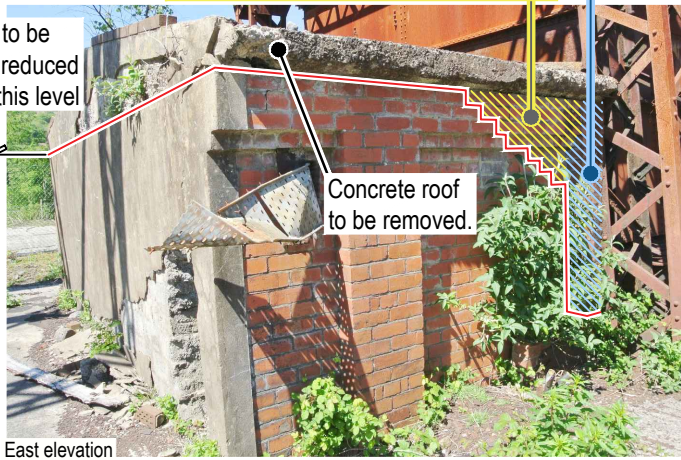
This masonry likely to become unstable.

Remove this masonry to improve access for repairs and maintenance.
