**BUILDING INSPECTION**  
**OF**  
**16 OLD ROAD, SKEWEN, NEATH**

| <b>Site Address</b> | Cross Keys Hotel, 16 Old Road, Skewen, Neath, SA10 6AR |
| <b>Report type</b> | Building Inspection |
| <b>Project number</b> | 001GENU100 |

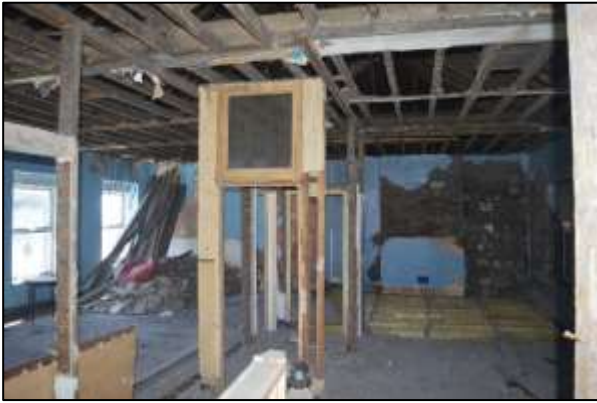
**Photograph 1** – First floor of the building, taken from the northern end looking south.

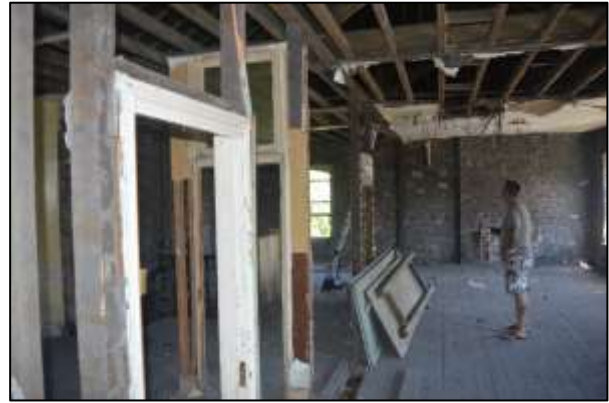
**Photograph 2** – First floor of the building, taken from the southern end looking north.

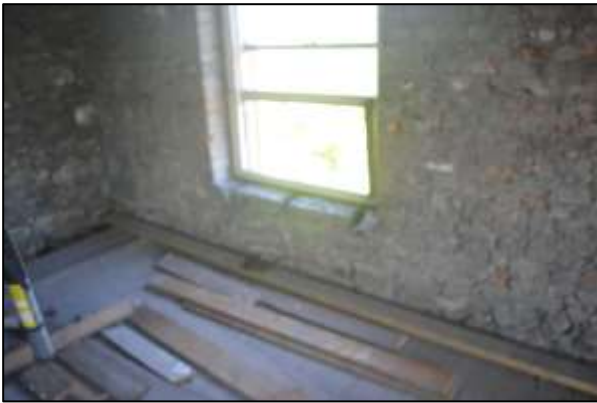
**Photograph 3** – First floor window on northern elevation, access point to the inside of the building as it has been left open.

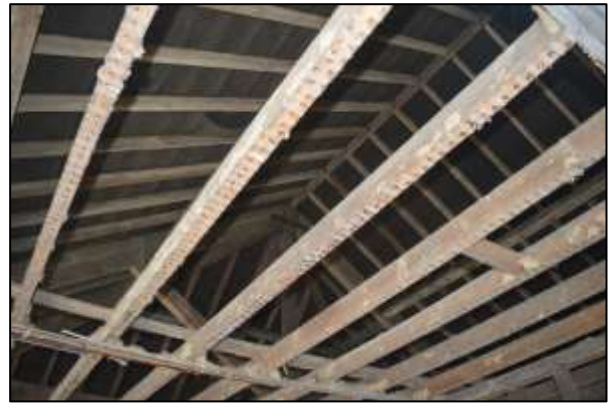
- 3.3.1 No birds or evidence of nesting birds were found during the building inspection.
- 3.3.2 The interior of the building has the potential to support nesting birds in the roof spaces among the beams where the ceiling is missing. Access to the interior is in the form of open windows.

**Photograph 4** – interior view of the roof, with ceiling missing, taken from the first floor.

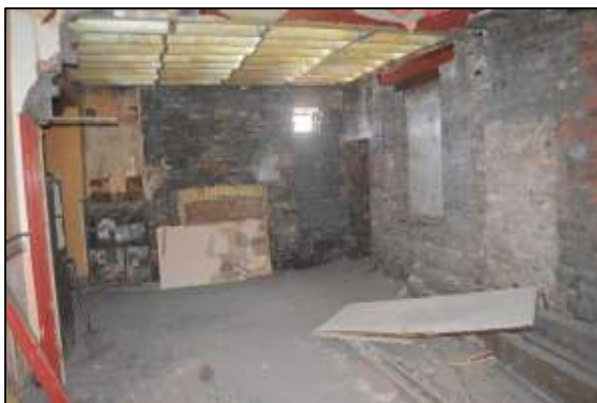
**Photograph 5** – ground floor room in the single storey extension on the western side of the building. Showing access point to the interior of the building.

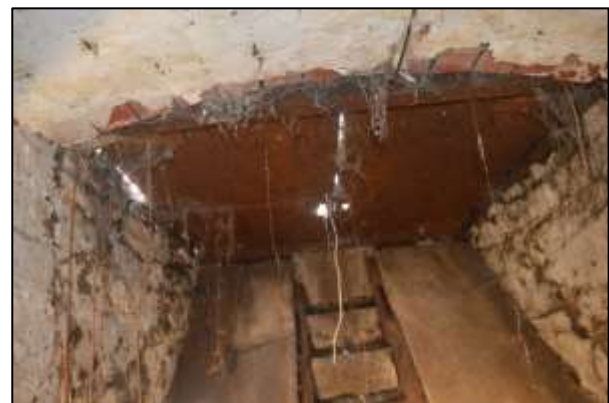
- 3.1.6 There is a metal cellar hatch directly outside the building on the eastern side. It is mostly covered by debris and vegetation. Some gaps are present around its edges, leading into the cellar.

- 4.1.3 Narrow gaps (3cm or less) were present in and around the metal cellar hatch, however those were completely covered/blocked by either vegetation and/or debris on the outside or cobwebs on the inside.

**Photograph 6** – Cellar hatch, taken from inside the cellar. Showing access points to cellar in the form of gaps around the hatch.

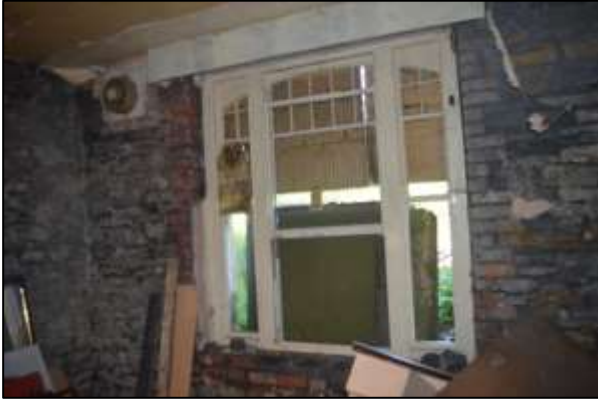
**Photograph 7** – Ground floor window on northern side of the building. Access point to the interior as it has missing panes.

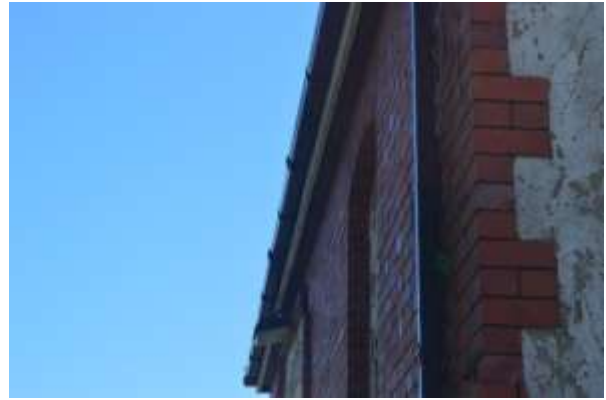
- 4.1.1 All bat species are protected by UK and EU legislation (see Appendix A).
- 4.1.2 No bats or evidence of bats was identified during the building inspection. The main roof is in good state of repair with tight fitting tiles throughout however, gaps were present between the walls and soffit boards on the eastern, western and northern elevations, potentially leading to spaces/crevices within the roof.

**Photograph 8** – Soffit boarding on the northern elevation, with gaps present beneath.

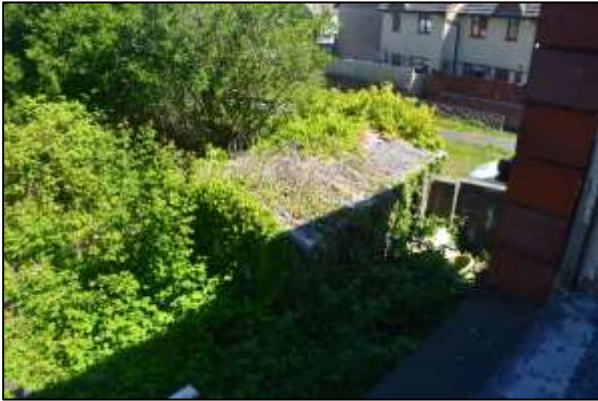
**Photograph 9** – Overgrown garden area and shed to the north of the building, taken from first floor window.

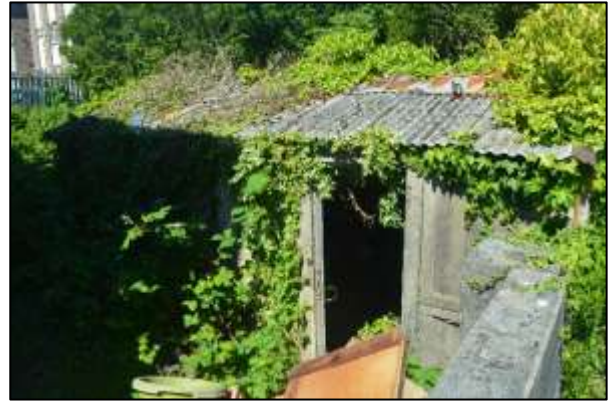
- 3.1.7 The garden shed was inspected remotely from the garden wall. The walls and roof are constructed from asbestos type material and corrugated metal. The doorway is permanently open with no door attached.

- 4.1.7 The shed in the garden is considered to be unsuitable for bats due to lack of suitable bat roosting features and the light interior.

**Photograph 10** – Small garden shed constructed of asbestos type material and corrugated metal, taken from garden wall.
