Report to support discharging of planning condition  
No 3 of planning approval P/2019/19/5442  
at  
Ynyswen Farm Ynyswen Terrace  
Crynant SA10 8PT

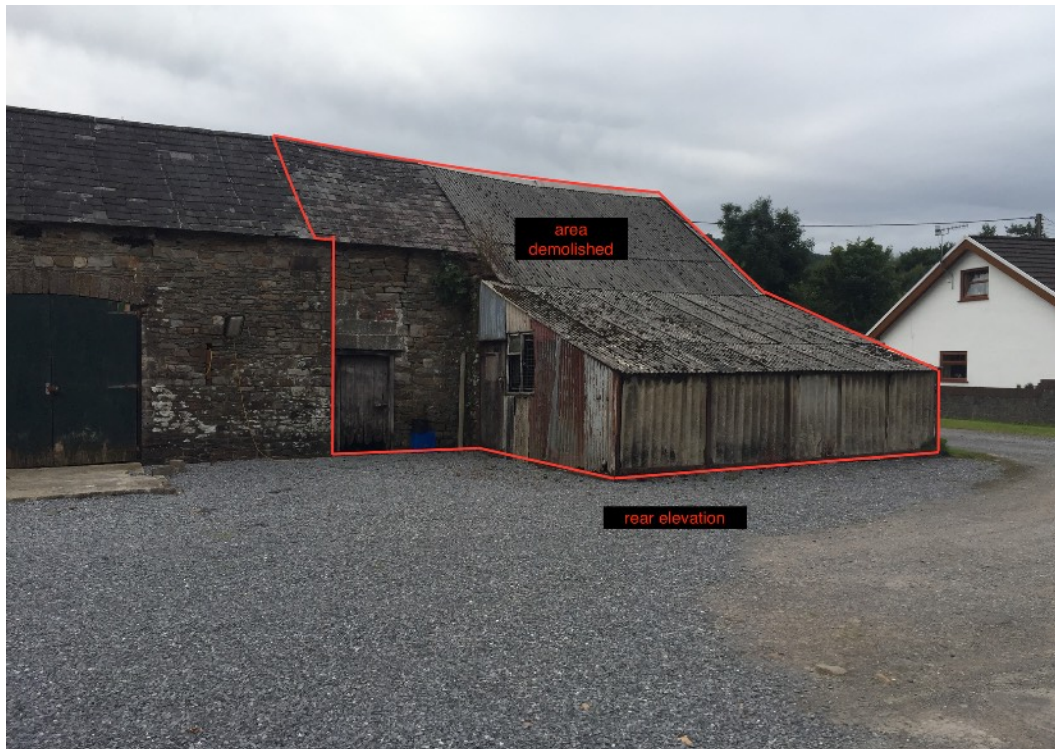
**PHOTOGRAPH 1**

It can be seen clearly from both the photographs 1 & 2 together with drawing No 003 that the area to be demolished is a later addition to the original barn. This addition has not been bonded to the original barn and has straight construction joints to the front and rear and is of a poor construction compared to the original barn that is being converted.

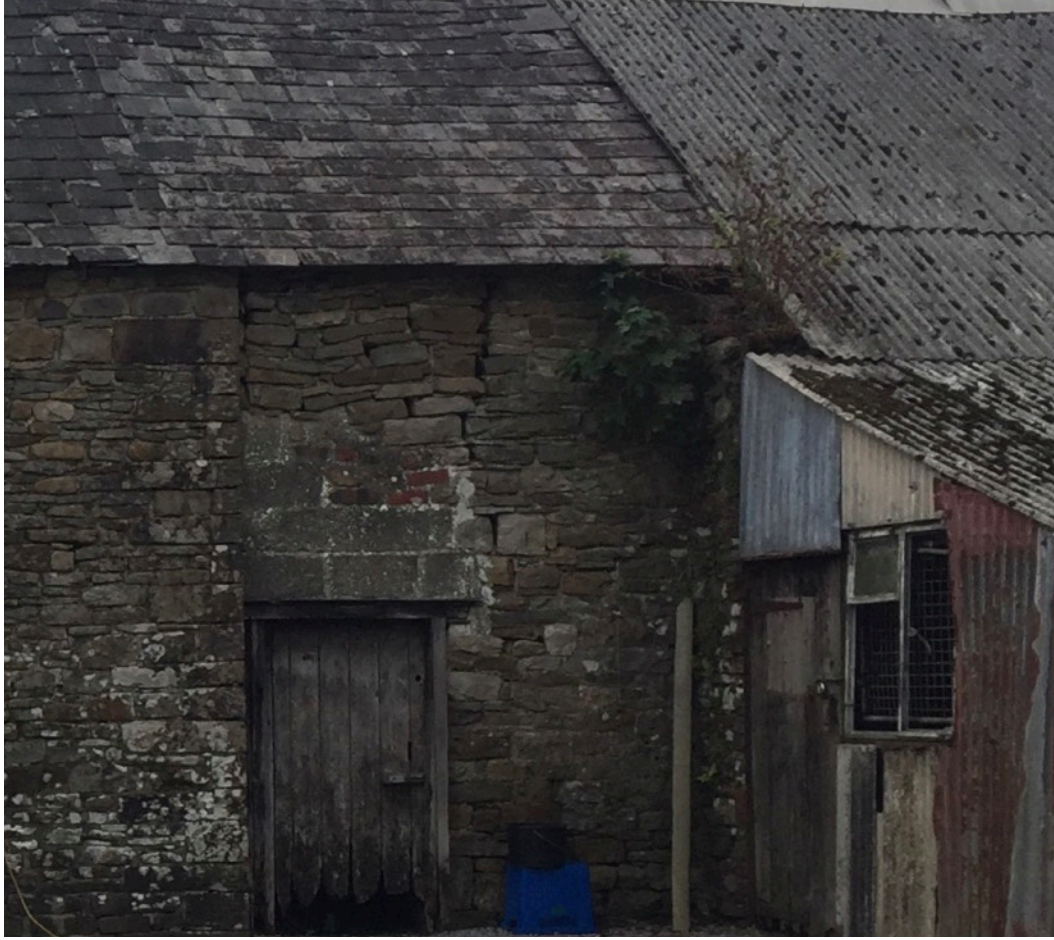
**PHOTOGRAPH 3**

The planning condition refers in part to locations and details of cracking and solutions to remediate of the cracking. All of the known cracking to the stone walls are restricted to the portion of the barn that is to be demolished, this is particularly evident in photograph 3 which was identified in the earlier report.

The original barn that is subject to conversion has no identifiable structural cracking and is in very good condition and does not require structural remediation work. However should any arise during the process of the conversion and construction as suitably qualified construction professional will be engage to provide solutions. Any cracking will stitched by recognised methods and techniques such as Helibond and by appropriately experienced contractors.

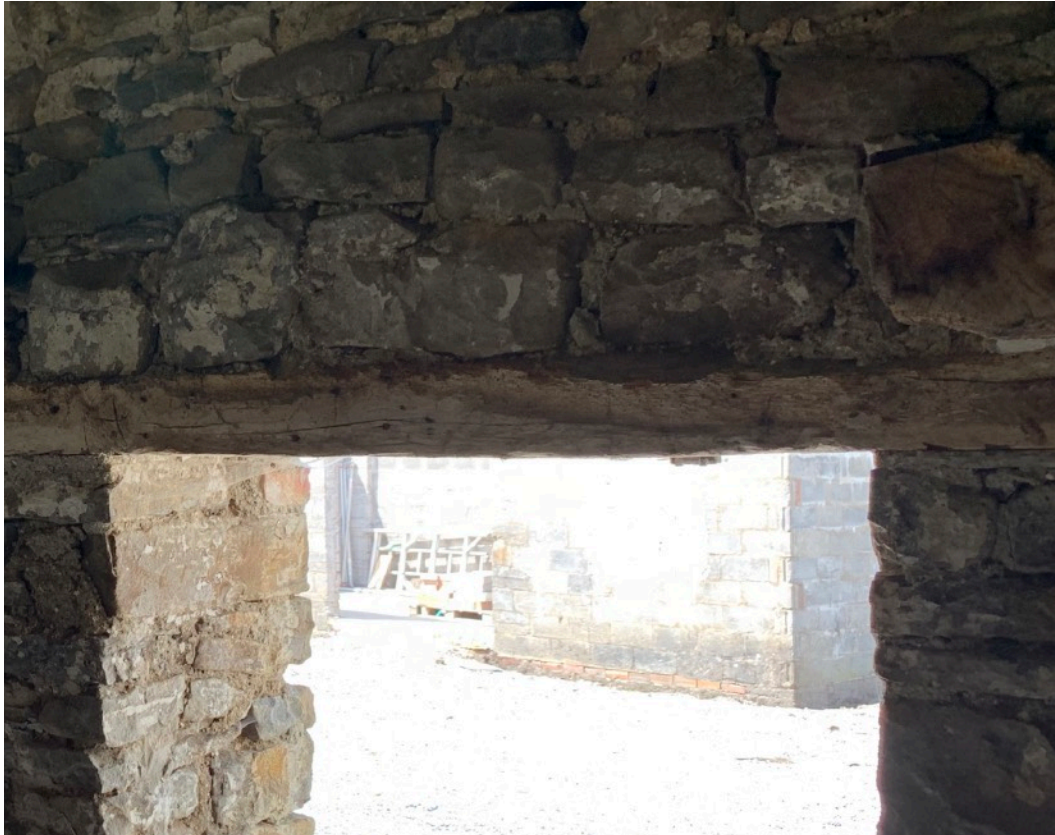
**PHOTOGRAPH 4 TYPICAL EXISTING TIMBER LINTEL**

Any existing timber lintels (Photograph 4) relating to the blocked up openings will be removed and the pockets in the existing stonework treated for any residual decay by a specialist dam-proofing and timber treatment specialist. The proposed infills will be tied into the existing building by either cutting indentations into the original work or by using a recognised proprietary fixing system eg Firfix or similar.

Openings D2, D4 & D5 are all to be increased in height to allow a standard door and frame to be fitted to the opening allowing access to proposed bedrooms/toilets etc. This being the case the existing timber lintels will be removed as above, with the exposed stone work pockets treated and new pre stressed concrete lintels of sufficient number, size and length fitted to form the structural opening and support the stonework above. Any gaps above will be filled in with masonry. The appointed contractor will provide any necessary support to the existing masonry above while this process is being carried out.

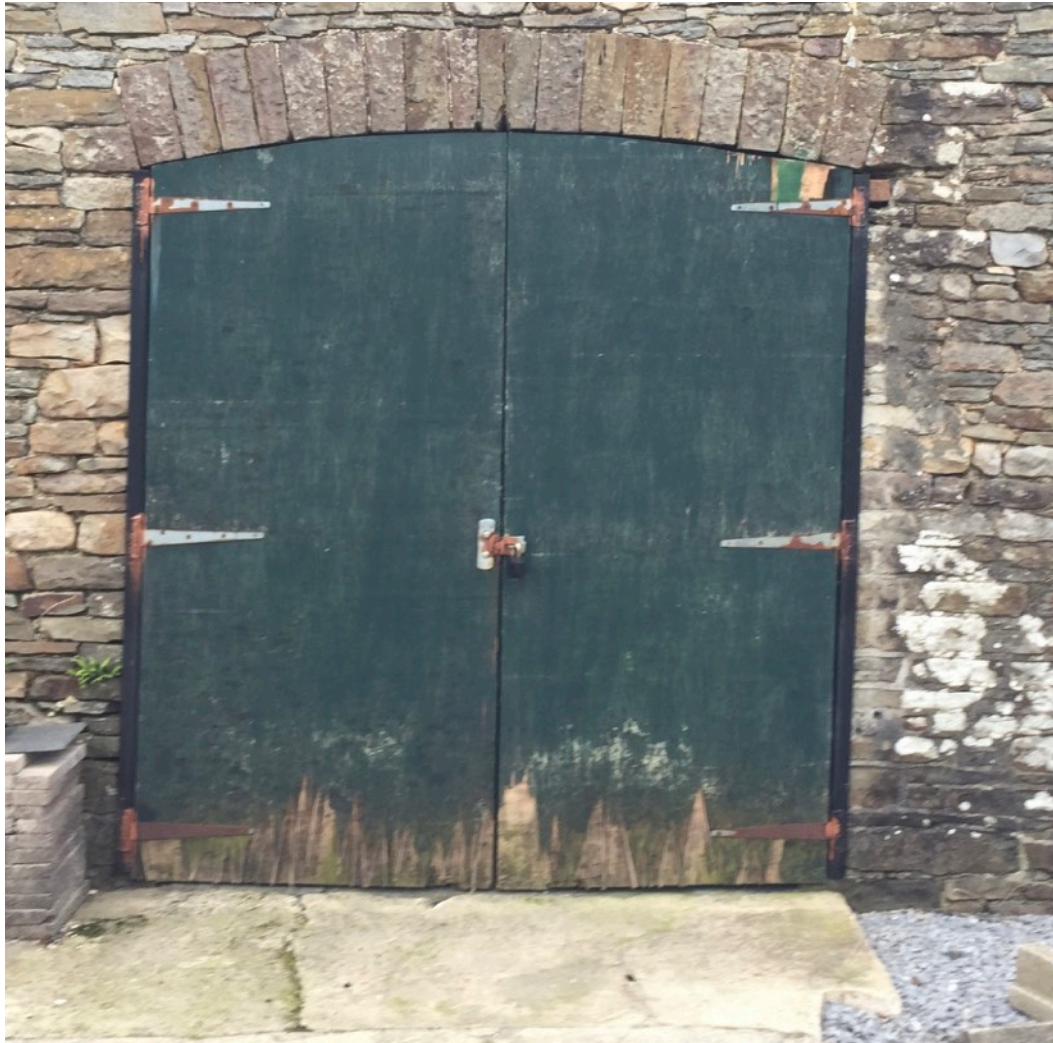
**PHOTOGRAPH 5**

All timber lintels to the remaining openings of the barn not mentioned above will be removed and replaced with suitable pre stressed concrete lintels as detailed above, except for openings D1 and D8 as the openings have been formed from supporting stonework arches internally and externally see ( Photograph 5 & 6) . the existing arches are in good condition and show no signs of stress, however both arches will be repointed any minor movement identified rectified. The existing opening sizes will be retained as part of planning application.
