**Cefn Coed Colliery Museum**  
Renovation of two Grade II\* Listed headgear frames

**Building at base of Headframe 1**  
Current condition and works proposed

| Drawing No. | Sheet No. | Revision |
|---|---|---|
| | 105B | R0 |

For Listed Building Consent CD-V-C8458.60

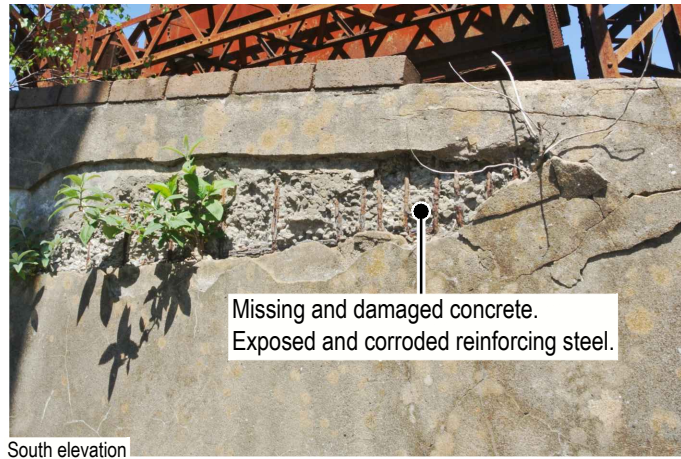
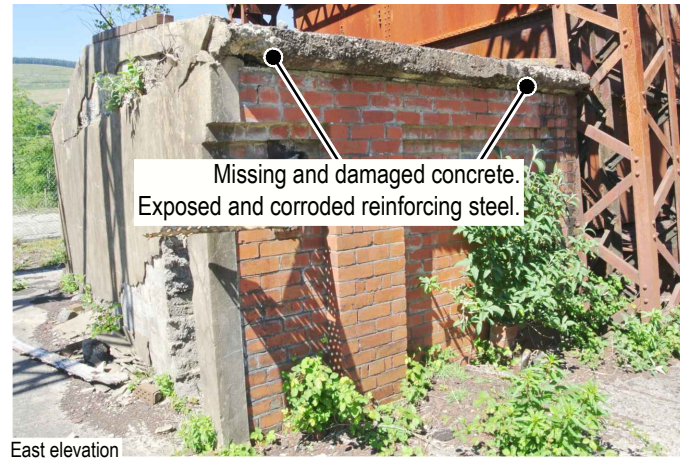
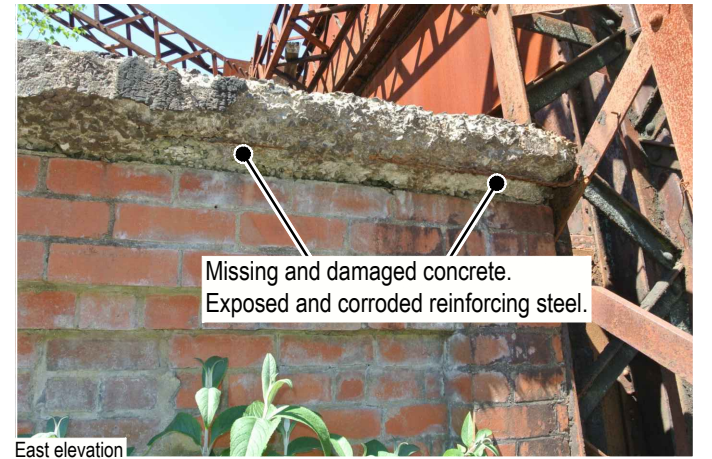
Significant deterioration of the concrete roof has occurred since the survey in April 2018 (and the basis for the Listed Building Consent granted in July 2018): holes have appeared through the slab; widespread loss of concrete across the underside of the slab and beam faces, exposing corroded reinforcing steel. Consequently, it is no longer feasible to repair the roof nor ensure it can safely remain in place whilst adjacent repairs are undertaken.

The concrete roof is of limited architectural or historic significance. It is proposed to remove the concrete roof entirely (it will not be replaced). The adjoining steel canopy will remain and be refurbished. This follows the profile of the roof and, together with the wall remains (see text opposite), will retain sufficient evidence of the form of the building.

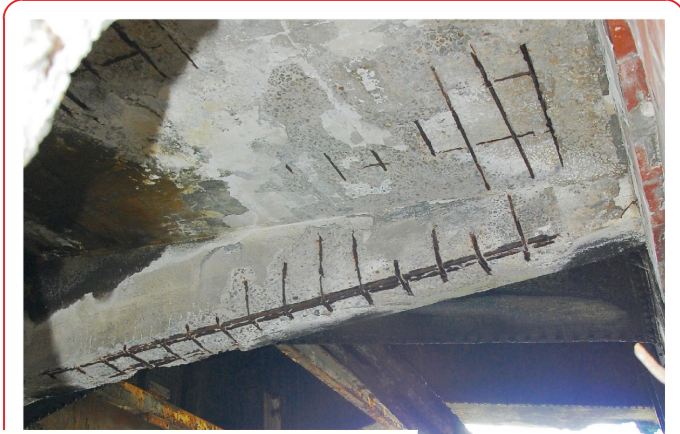
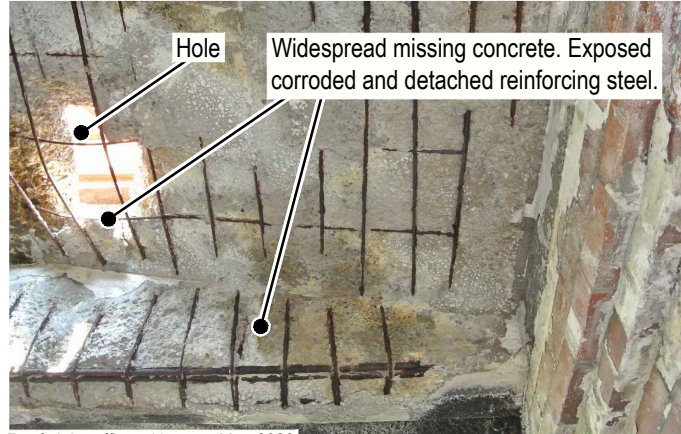
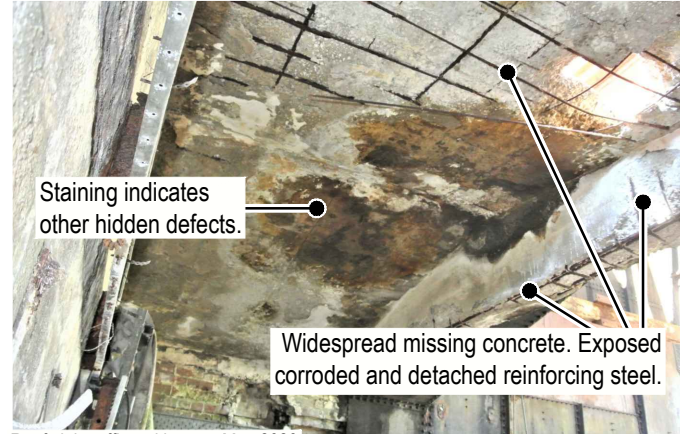
This masonry likely to become unstable.

As the roof is now to be removed, the modification to the wall can be adjusted to improve the access further: the extents of this is shown on the annotated photographs above (hatched light blue). Consequently, small areas of wall (hatched yellow) have the potential to become unstable, primarily due to the corbel detail or apertures formed crudely in the wall: it is proposed to dismantle these areas to safeguard the stability of the majority of the walls. The pipe which passes through the wall will be retained and supported in-situ.

Remove this masonry to improve access for repairs and maintenance.

The current proposals (granted LBC in July 2018) permits some dismantling and modification of the masonry adjacent to the steel lattice girder columns in order to reduce the risk of corrosion and improve access for repairs and future maintenance (i.e. prevent trapping of moisture and debris and permit future applications of protective paint). The masonry was to be reconstructed (albeit modified) because the concrete roof relied upon support from the walls.

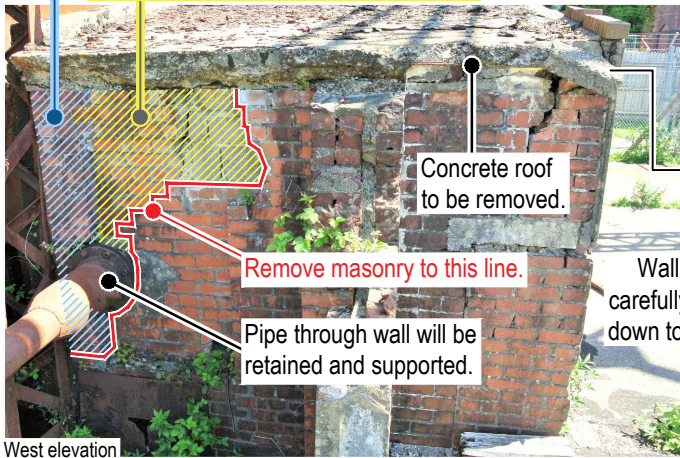
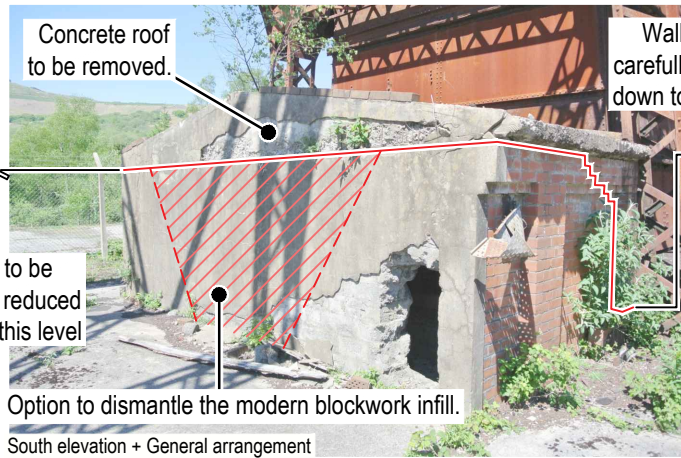
This masonry likely to become unstable.

Remove this masonry to improve access for repairs and maintenance.
