# MW Consult Ltd

**Project:**            **Structural Appraisal of 5 Heol Y Felin,  
Seven Sisters, Neath, SA10 9BG**

**Project Ref:** 20/143                      **Revision:**    –

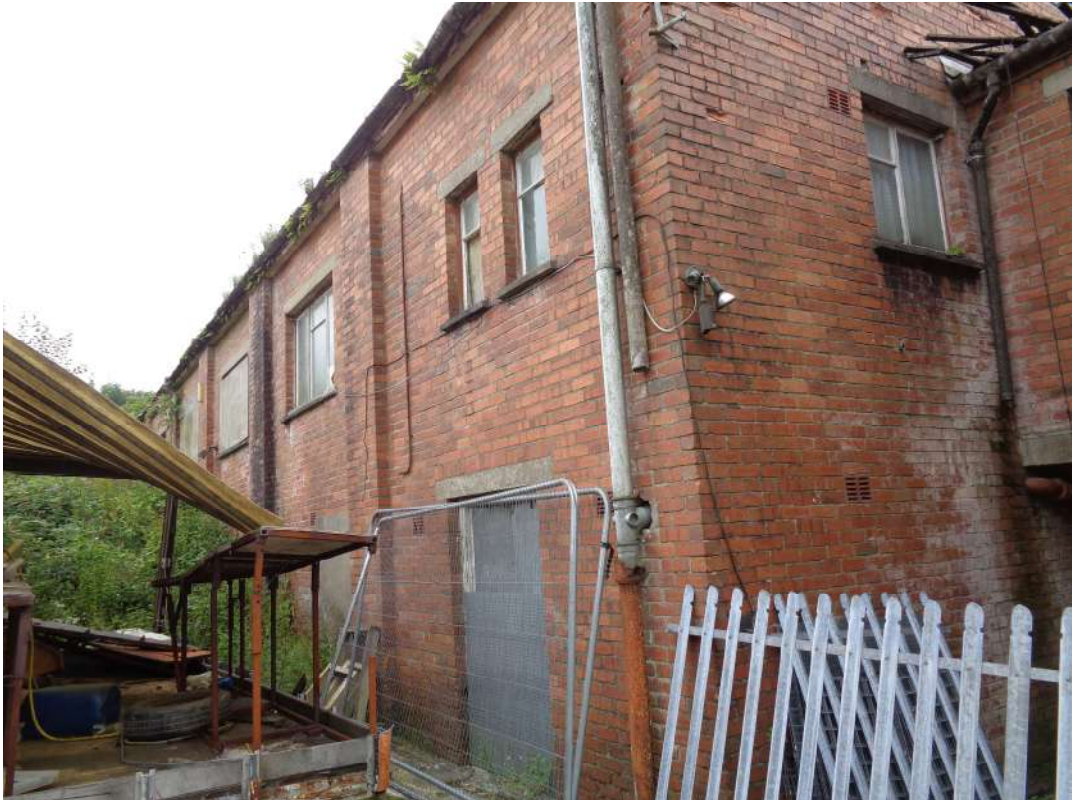
Photograph 1 – North wall of workshop.

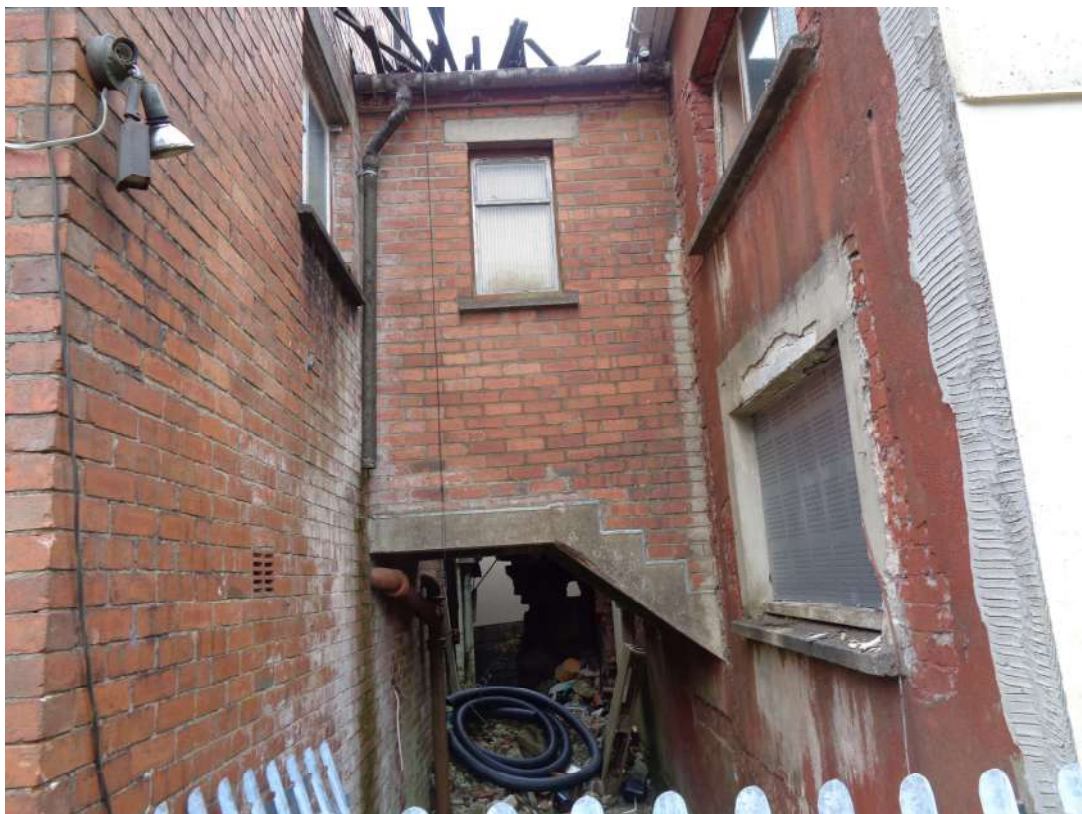
Photograph 2 – North wall of the link structure.

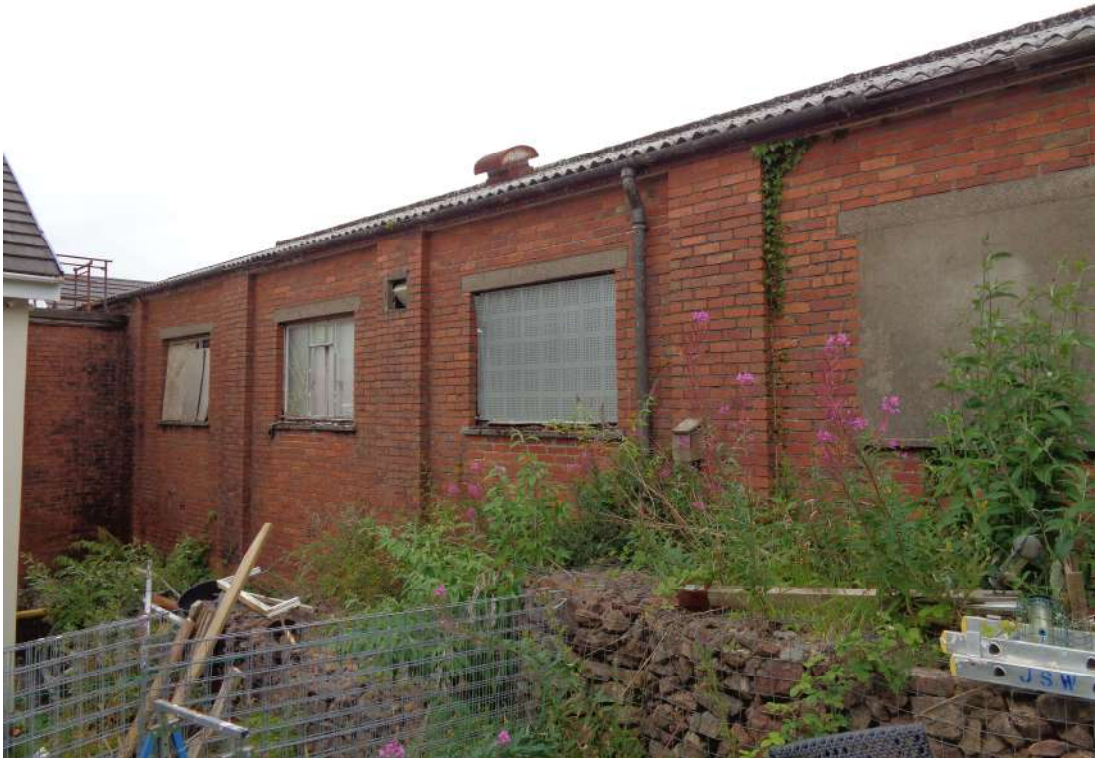
Photograph 3 – South wall of the workshop.

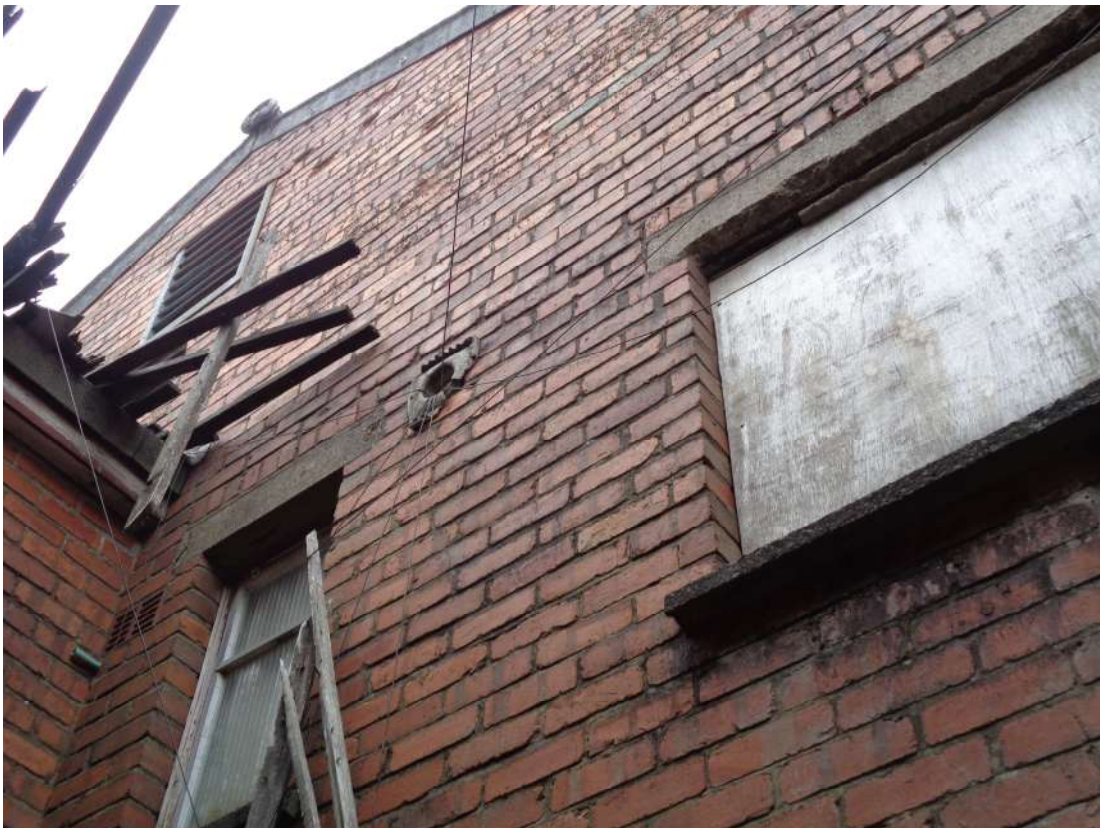
Photograph 4 – Front wall of the workshop.

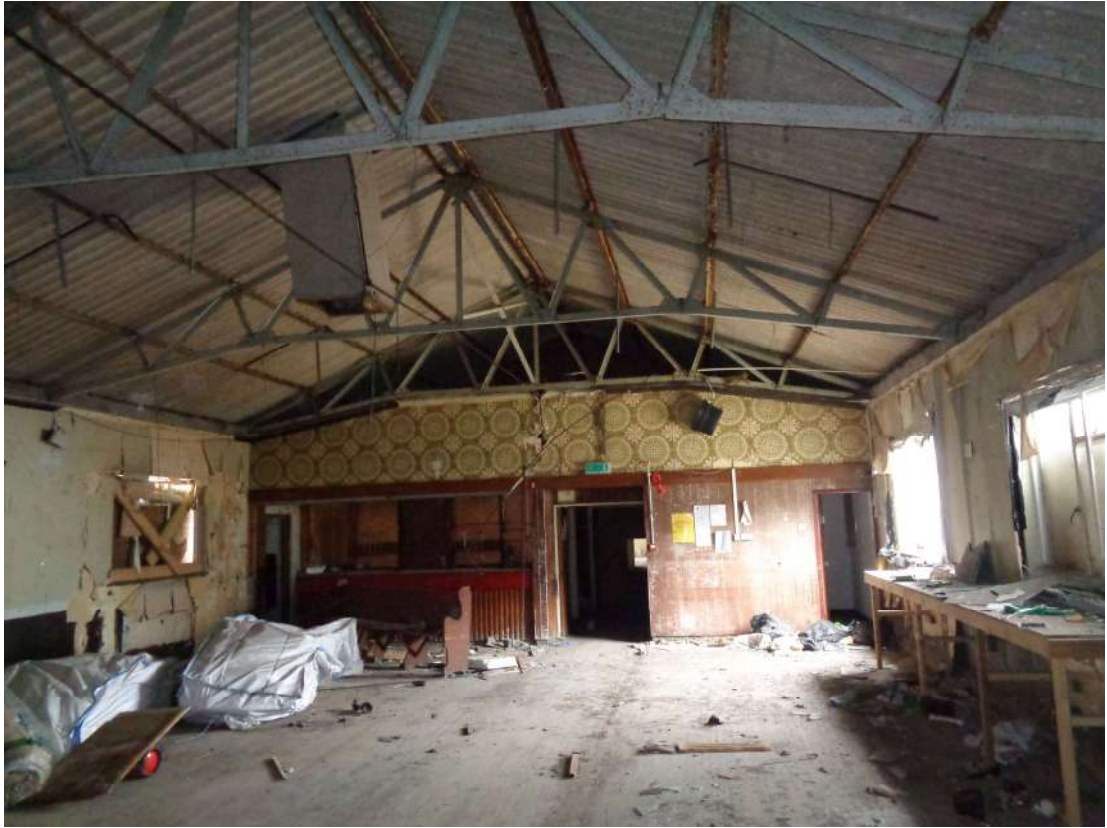
Photograph 5 – Internal view of workshop first floor level (facing front of workshop).

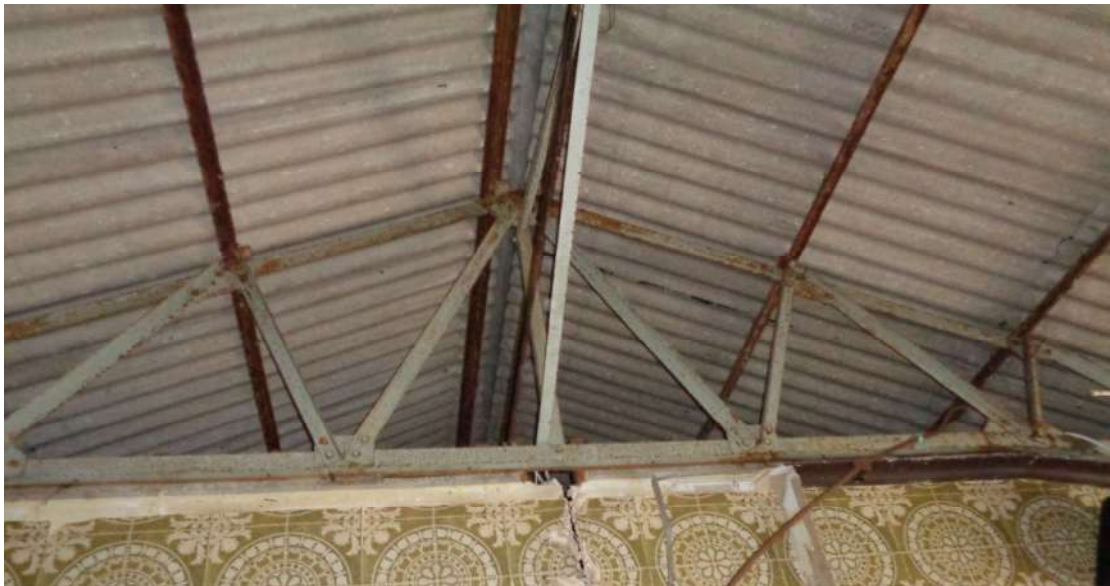
Photograph 6 – Roof truss on the line of the extent of the proposed conversion.

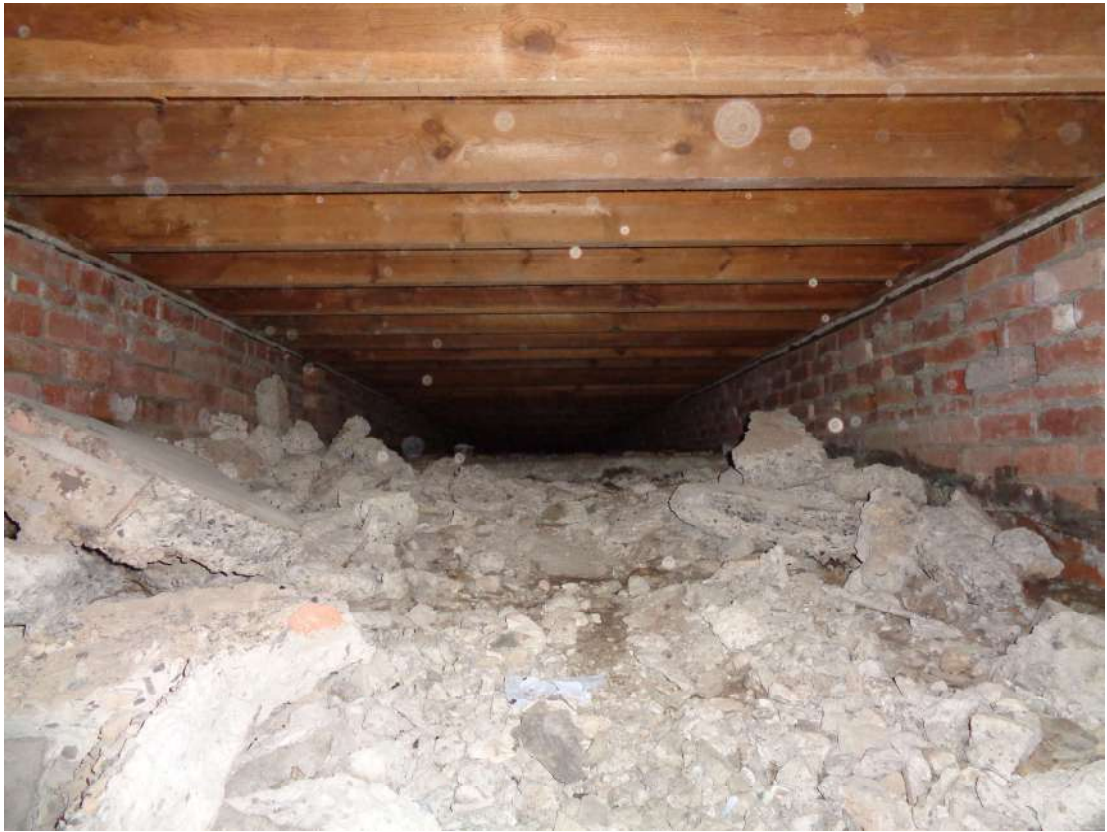
Photograph 7 – Sub-floor void beneath the majority of the workshop.

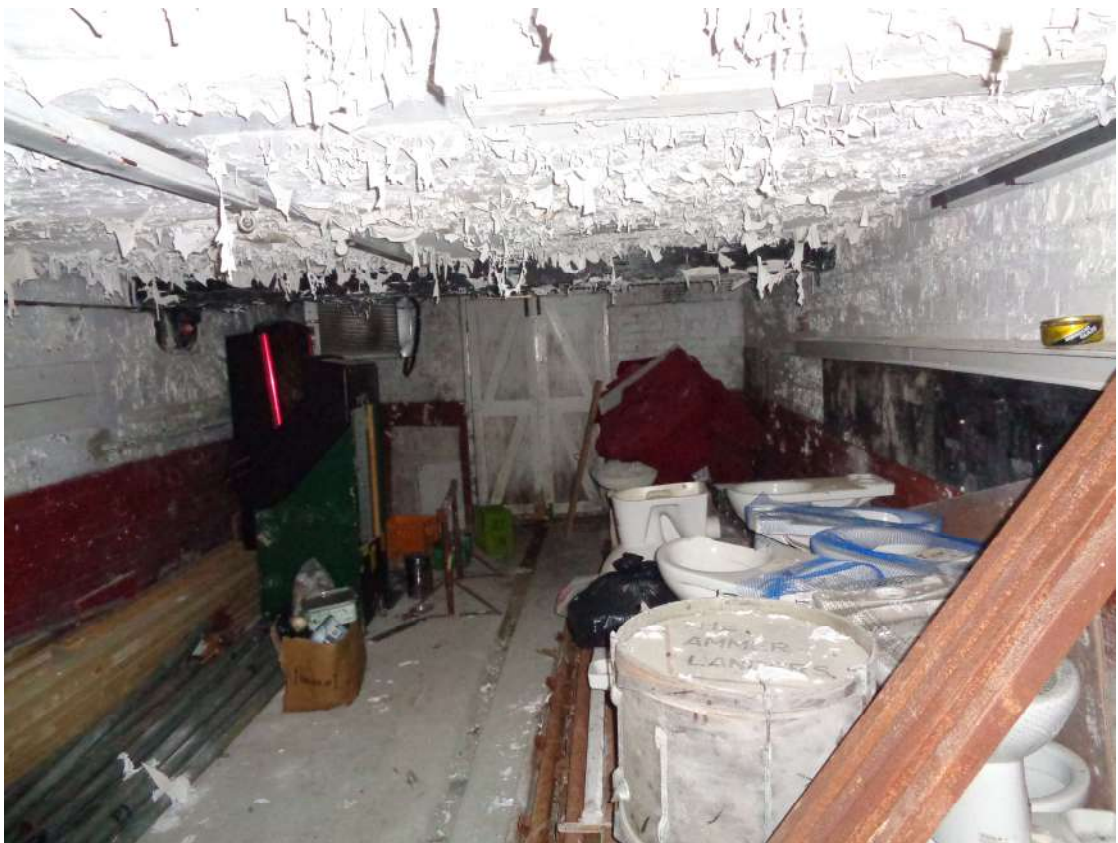
Photograph 8 – Main storage space beneath the area which is to be converted.
