| <b>Notes:</b><br>Drawings are based on survey data and may not accurately represent what is physically present.<br><br>Do not scale from this drawing. All dimensions are to be verified on site before proceeding with the work.<br><br>All dimensions are in millimeters unless noted otherwise.<br><br>Volute Architects shall be notified in writing of any discrepancies. | | | | | | <b>CLIENT</b> THE RECTORIAL BENEFICE OF ABERAVON | <b>DRAWING TITLE</b> EXTERNAL REPAIRS<br>EAST ELEVATION<br>CHANCEL AND VESTRY | <b>JOB NUMBER</b> 18-1001 |
| | First Issue 20.04.2018 AN AN Development of repair schedules for preparation of schedule of works and preliminaries | | | | | <b>PROJECT</b> ST MARYS CHURCH, ABERAVON<br>PHASE 1: EXTERNAL REPAIRS | <b>SIZE &amp; SCALE</b> A3<br>NOT TO SCALE | <b>DRAWING NO.</b> 403 <b>REVISION</b> - |

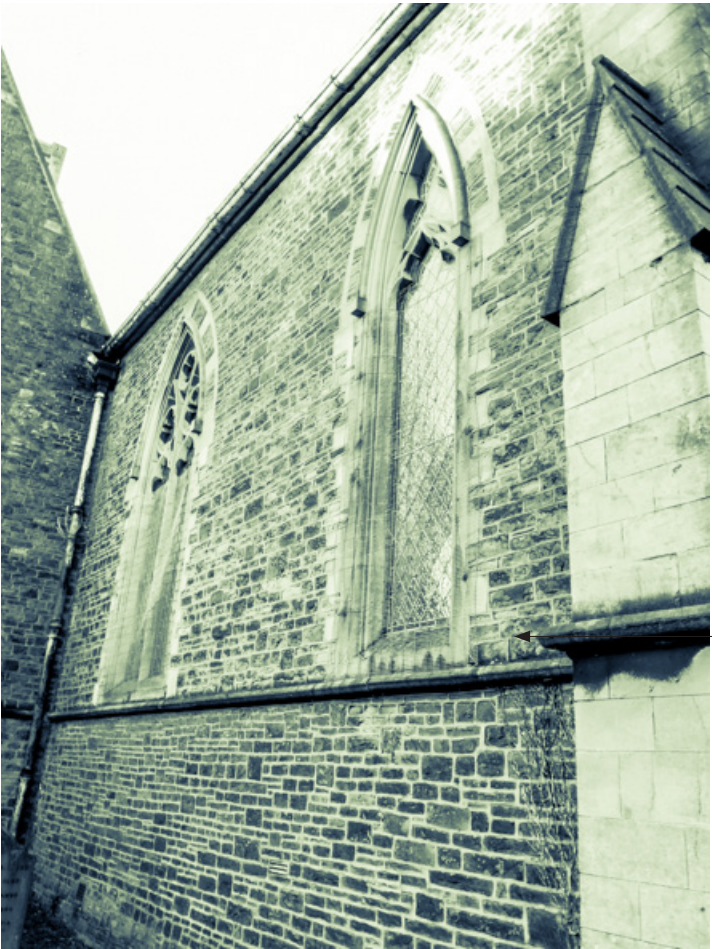
Image 403-04: South return to the Chancel

The rainwater goods (pipes and gutters) that can be seen in image 403-04, appear to be metals that contain ACM's. These are to be disposed of in an orderly fashion and as per the H&S legislation requirements. Rainwater goods are to be obtained from J&JW Longbottom Ltd as noted on drawing 401.

#### Rainwater goods to the Chancel south elevation (RWG05)

Allowances are to be made for the following:

- 9.2m of 150mm dia gutter with stop ends
- 7.3m 100x150mm (6x4") rectangular rainwater pipe
- 1 no rectangular 18" hopper head (no 59)
- 1 no shoe

Requirements of rainwater pipes are to be confirmed on site once access is provided. Tender price is to allow for connections between pipe lengths with standard ears fixings. All fixings are to be made within the mortar joints. Supply and install new straight bar cast iron grid (assume 8x8") to 2 no gully.

All rainwater goods are to be decorated as per M60/200, with all new items decorated in full.

#### Repointing to Coursed Masonry and Buttresses

Allow for carrying out repointing works to coursed sandstone found on east elevation of the Chancel and Vestry - assumed quantity of 16m². Area includes the buttress that is located to the east of the wall.

Preparation works and removal of existing cementious mortar is to be carried out as per clause C41/340. With all new mortar to pointing works applied as per clause C41/345. Mortar as per clause C41/215.
