# Jersey Marine Access Road

## BS5837:2012 Survey 3<sup>rd</sup> June 2020

| Site Location: Land to north of The Towers Hotel | Report Reference: 06/20/LJM/V7 |

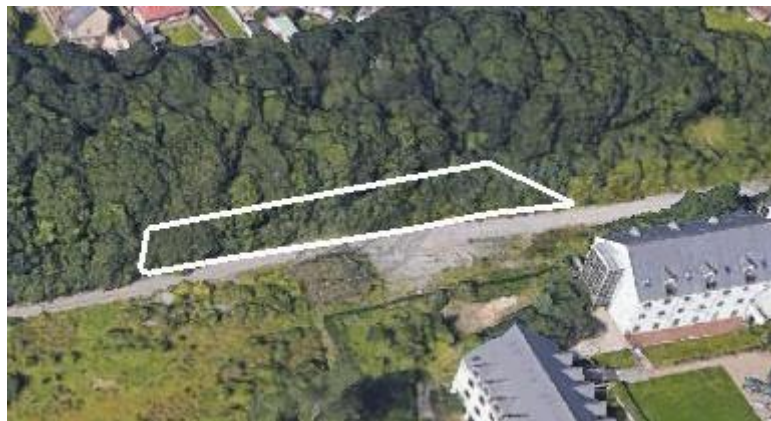
3.2 Survey Area 1 is the area to the north of the electricity pylon as shown below. This area runs for approximately 40m to the east and west of the pylon.

3.3 The area between the access road and the small plateau halfway up the embankment is densely covered with small young and semi-mature goat willow (*Salix caprea*), common hawthorn (*Crataegus monogyna*), bramble (*Rubus fruticosus*) and buddleia (*Buddleia davidii*).

3.4 The plateau has a line of semi-mature trees, predominantly sycamore (*Acer pseudoplatanus*) growing along the southern edge closest to the road. The plateau itself is mostly clear of trees but very overgrown with brambles and ferns. The woodland area then continues up the remaining area of the embankment to the north.

5.2.1 Survey Area 1: Approximately eleven trees with stem diameters between 250mm and 480mm will be removed and a small area of scrub goat willow and hawthorn. There will be a minimal effect on the RPAs of the retained trees. The removal of these trees will not have an adverse effect on the amenity value of the area or on the remaining woodland area. The woodland area bounded by the Tennant Canal; the footbridges and Ashleigh Terrace comprises an area of almost six hectares, therefore, the loss of the small area of trees in Survey Area 1 will not have a detrimental effect.

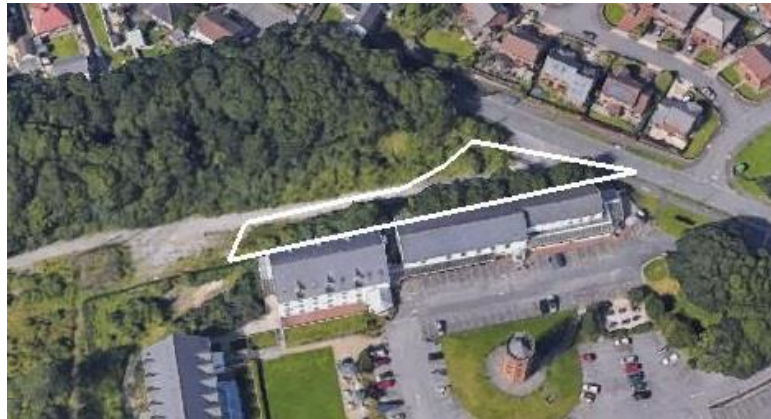
4.1 Survey Area 2 is the area of vegetation immediately inside the access gate and outlined in the photo below.

4.2 The area to the north of the entrance gate contains young self-set buddleia and goat willow; all have been categorised as C.

4.3 The bank to the south of the entrance gate is on the boundary with The Towers Hotel to the south and all trees growing on this bank are encroaching onto and over the roof of the hotel.

4.4 Nine trees were recorded in this area; the eastern end of the bank is inaccessible due to undergrowth and the trees here have been recorded as a group. All trees are semi-mature native species, goat willow, sessile oak, or silver birch (*Betula pendula*).

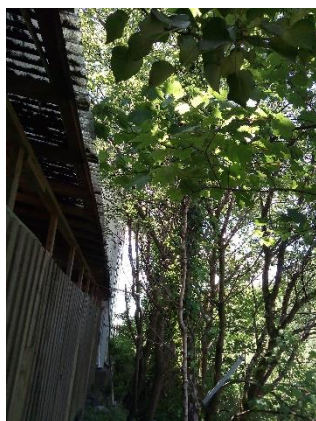
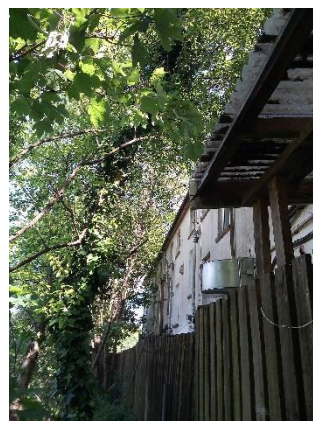
5.2.2 Survey Area 2: The trees in this area are semi-mature C category trees. All trees are growing over the roof of The Towers Hotel and are alongside a high voltage overhead powerline. Notwithstanding this potential development, these trees would need to be removed to prevent either damage to the building or a conflict with the powerline.

Trees growing over roof of The Towers Hotel.
