**Intrusive Coal Mining Risk Assessment**  
Proposed Residential Development at Leiros  
Park, Rhydding, Neath

**October 2017**

**Job No: 14156-1**

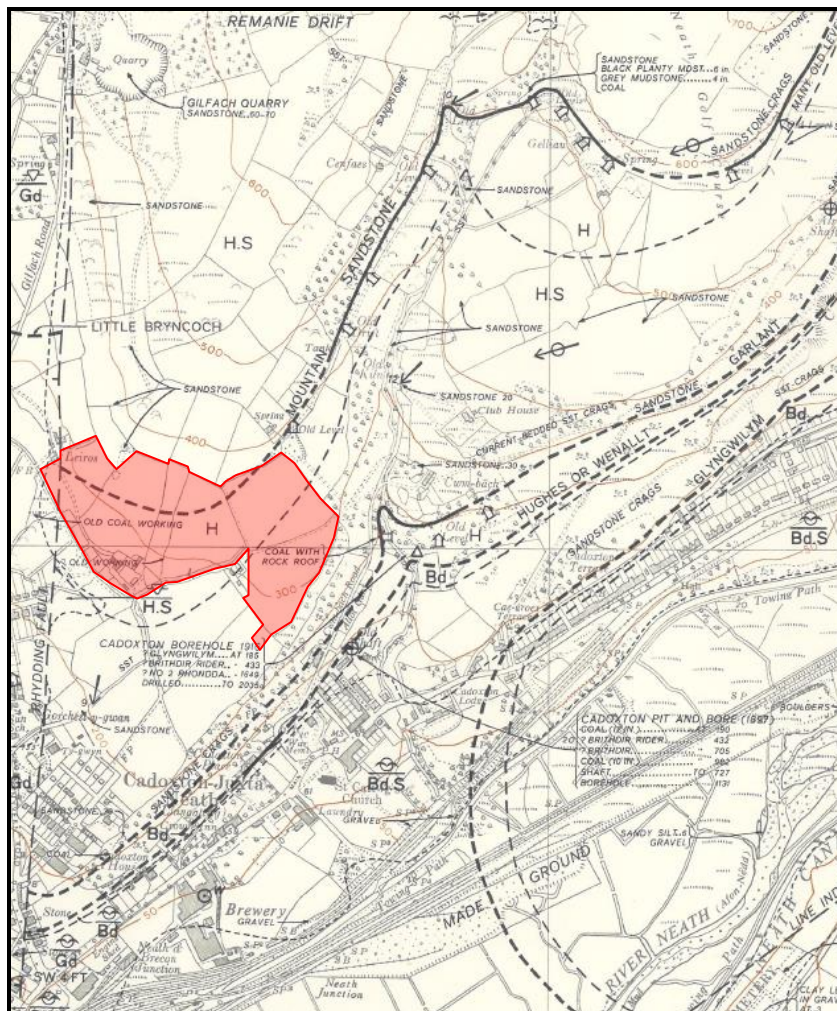
**Figure 2.2: Extract from Geology Map (Sheet SS 79 NE)**

The site is underlain by the Hughes Member of the Upper Coal Measures Formation. These sedimentary rocks were formed in the Carboniferous Period. The north and southeast of the site are underlain by sandstone, and the central area of the site is underlain by bands of mudstones, siltstones and sandstones.

The bedrock in this area is recorded as dipping to the north and west at between 9° and 12°.

The conjectural outcrop of the Mountain coal seam is shown crossing the middle of the site. The seam will therefore underlie the northern area of the site at shallow depth. A number of adits working the seam are shown in the area; the closest of which is located approximately 50m northeast of the site.

The Generalised Vertical Section shows a thin coal seam that lies approximately 12.5m beneath the Mountain coal seam and therefore it too may underlie the northern area of the site at shallow depth.

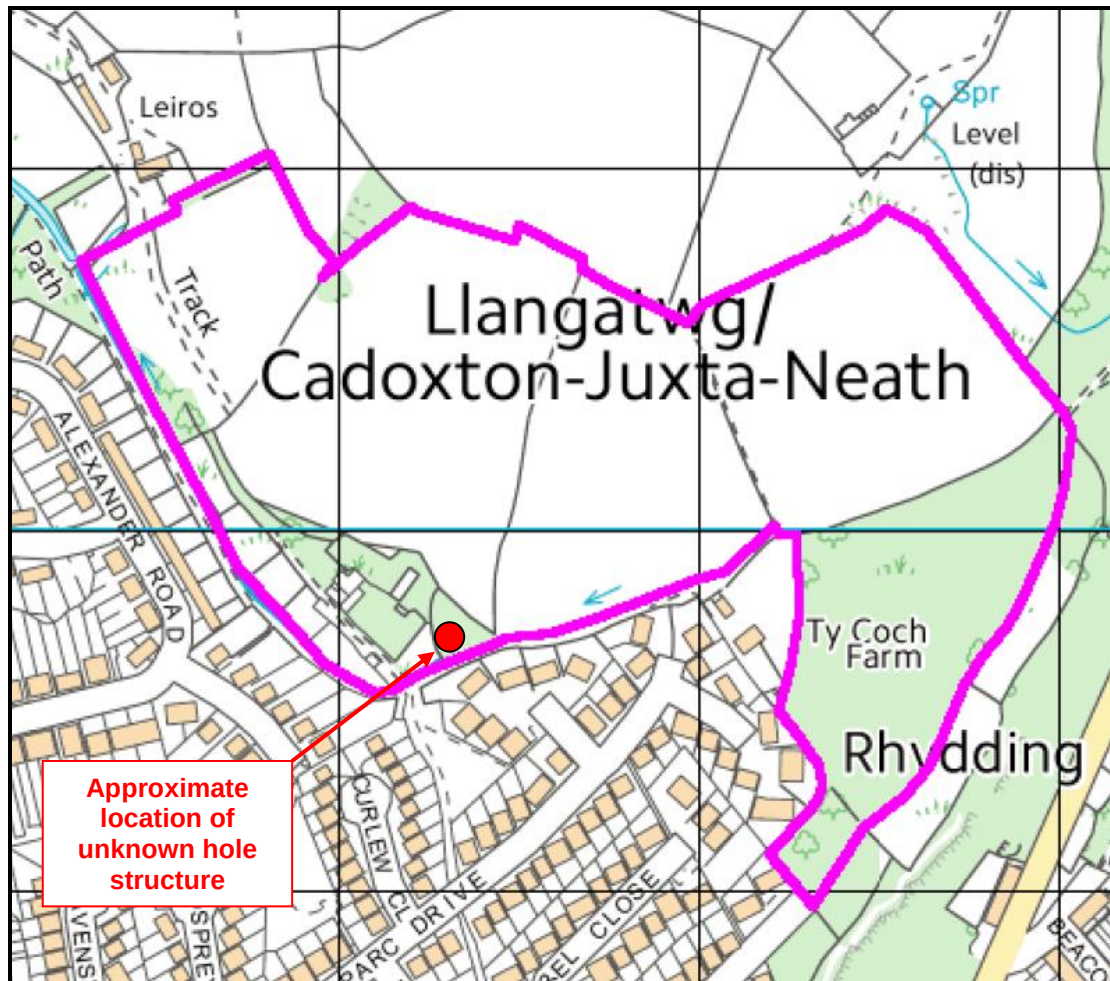
Figure 2.3: Approximate position of unknown hole structure

During the site walkover, a local resident who rents a small parcel of the site for agricultural/recreational use stated that an unknown hole was located within close proximity to old agricultural buildings; as described in Section 2.1. A tractor wheel had been placed over the hole to stop children or animals from falling into it.

Beneath the wheel was a water-filled void with wooden and metal beams spanning across it. The water level was recorded at around 1.0m depth below ground level. The shape, depth or diameter of the structure could not be established.

Whilst the Coal Authority do not hold records of a shaft in this area of the site, the possibility of this structure being a shaft cannot be discounted.

The approximate location of the unknown structure is presented on **Figure 2.3**.

It is also recommended that the possible shaft at the south of the site should be investigated prior to any development in that area. Due to time and budgetary constraints, and the possibility of making the existing area unsafe by destabilising the hole, it was not investigated by exploratory means.
