| <b>R V WILLIAMS ASSOCIATES</b><br>Ashby House, Middleton Street<br>Llandrindod Wells, Powys LD1 5ET<br>Tel: 01597 825788 Fax: 01597 824388 | Project. | MARGAM CASTLE : RENOVATION to WEST ELEVATION | | |
| | Title. | FINIALS F43 & F44 STABILISATION | | |
| Date. | Nov'20 | Scale. | 1:20 | Drawing no.<br>6155/01 A |

| Title. | RENOVATION to EAST WALL OF SHOP | | |

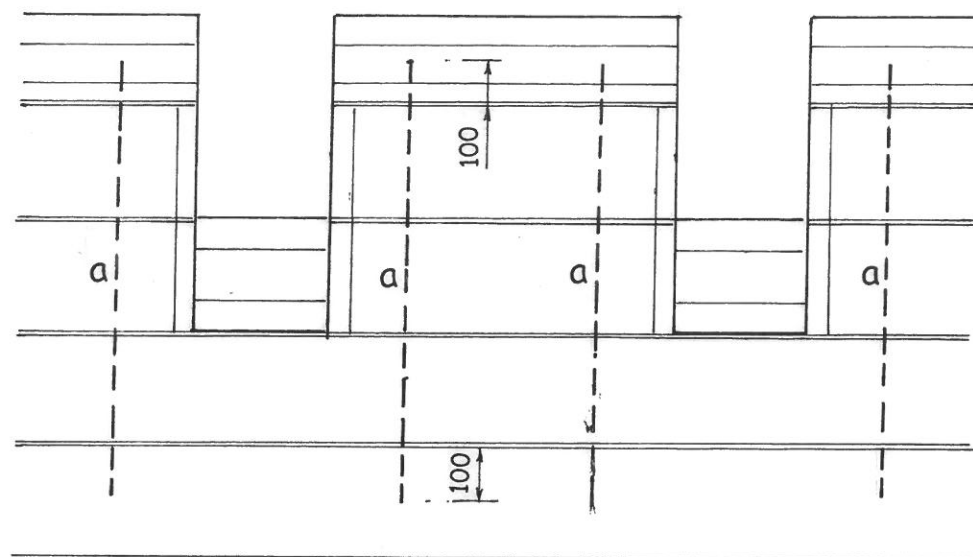
ELEVATION ON CRENELATIONS  
(OPTION A)

- 5.0 The detail on this drawing has been established from a general inspection along the west elevation and appears to occur along its full length with the dismantling of the copings and upper stones by hand only. It is likely that stabilisation will be required along the south face.

- 1.0 The most cost effective option for stabilising the parapets are to be adopted.
- 2.0 Option A indicates 12 mm diameter stainless steel threaded dowels in 20 mm diameter holes cored through the three courses of stone into the fourth course from the top and filled with a free flowing resin such as Zeroset Anchor Grout by Rotafix Ltd or similar approved. All gaps caused by previous movement and displacement are to be pointed with lime mortar. The coping is to be removed and replaced with the rod dowelled into the underside of the coping.

- a - 12 mm diameter stainless steel threaded rod in 20 mm diameter cored hole located centrally on width of stone and filled with a free flowing resin such as Zeroset Anchor Grout by Rotafix Ltd or similar approved.
- b - 10 mm diameter x 200 mm long stainless steel dowel at staggered centres.

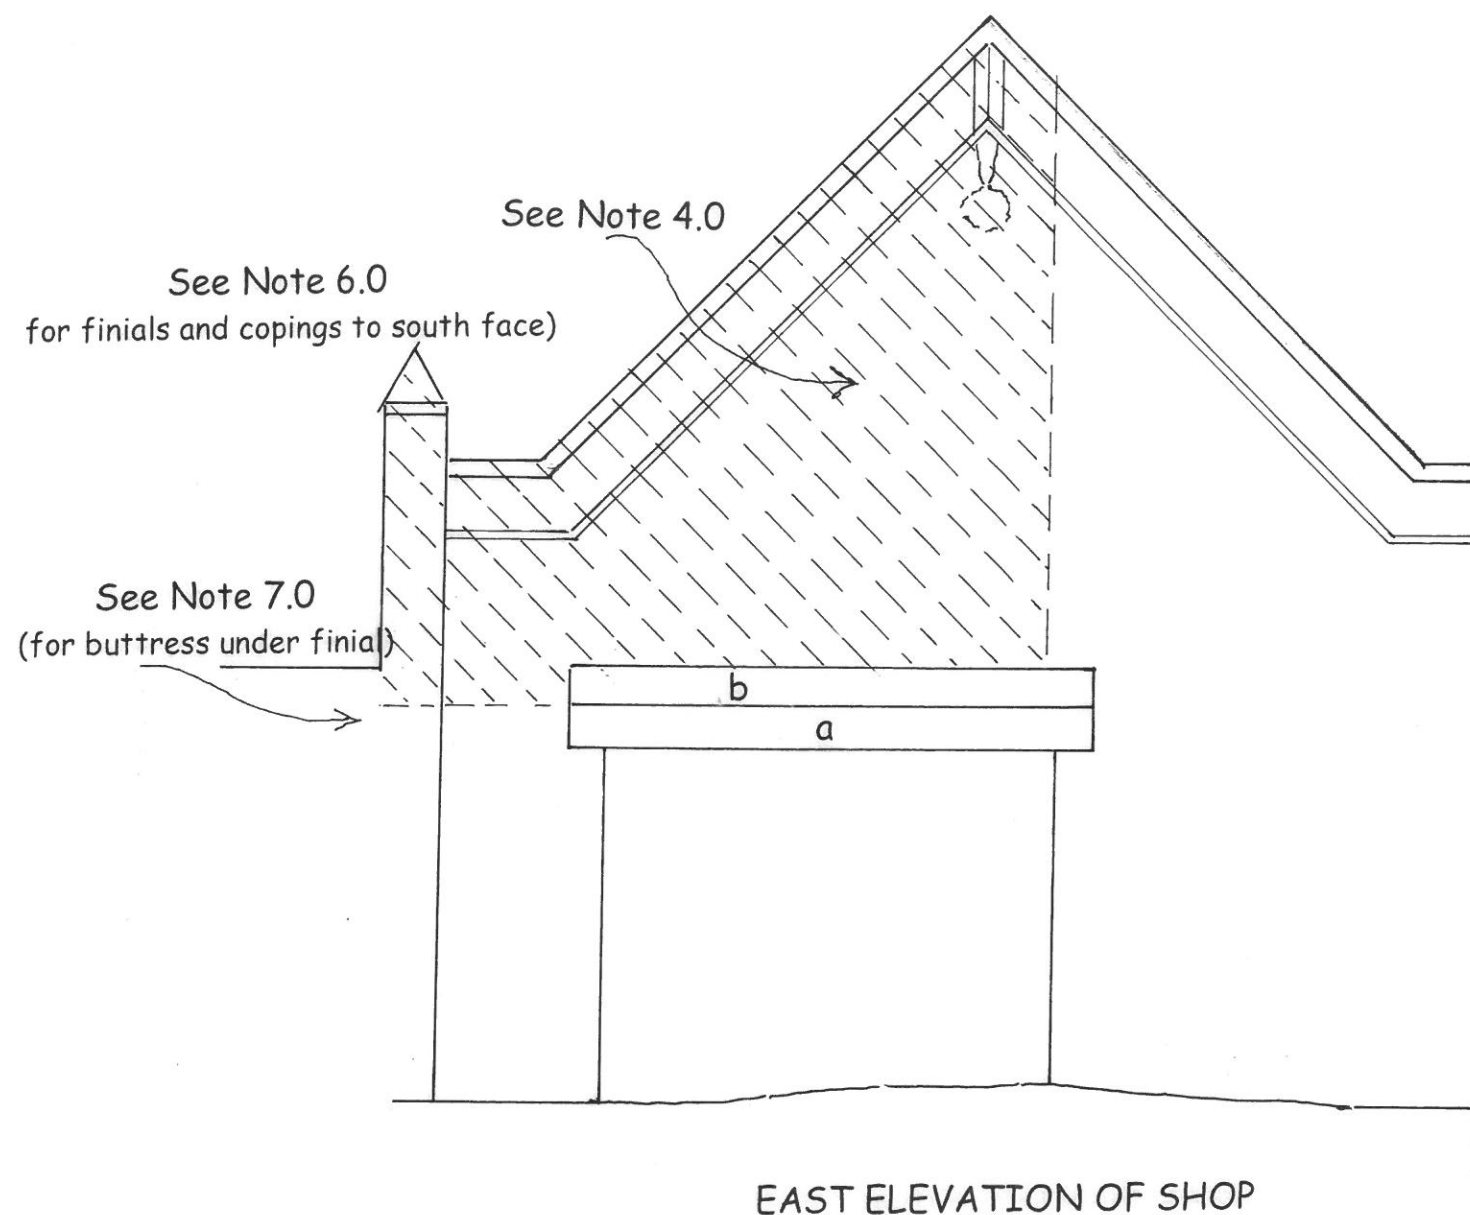
- 1.0 There are two beams above the shop entrance with the upper beam of corroded and laminated steel which are to be replaced with reinforced concrete as detailed on Neath Port Talbot drawing no R13130/S301/01.

- 4.0 Due to expansion of the corroded steel beams the ashlar masonry has been displaced and loosened. The outer ashlar masonry shown hatched together with the finial are to be carefully taken down and rebuilt.

- 6.0 An inspection of the 8 finials together with the parapet copings along the south face of the shop indicated that all finials and copings were loose and could be moved by hand pressure. All are to be stabilised by re-bedding and dowelling.

- 7.0 Below the finial there is a buttress on the south elevation which has displaced stonework caused by the ivy roots and tendrils. All the ivy growth is to be removed and the displaced stonework re-aligned.

- a - Existing beam to be retained (construction not known)  
b - Existing steel beams (3 no) are to be replaced with reinforced concrete as detailed on Neath Port Talbot drawings.

- 2.0 Prior to the removal of the beams the inner roof purlins taking support off the gable are to be propped and the wall above needled and propped.
- 3.0 The wall construction is of ashlar masonry externally and random stonework internally.

- 5.0 Prior to the removal of any masonry the areas are to be photographed before and after construction. All key stones are to be numbered and rebuilt in their original location in accordance with the standard requirements of Cadw.
