## Intrusive Mining Risk Assessment Report

Site: Crynallt Road, Cimla

Job No: 16447

**REPORT TITLE** : **Intrusive Mining Risk Assessment Report**  
Proposed Residential Development,  
Crynallt Road, Cimla, SA11 3RN

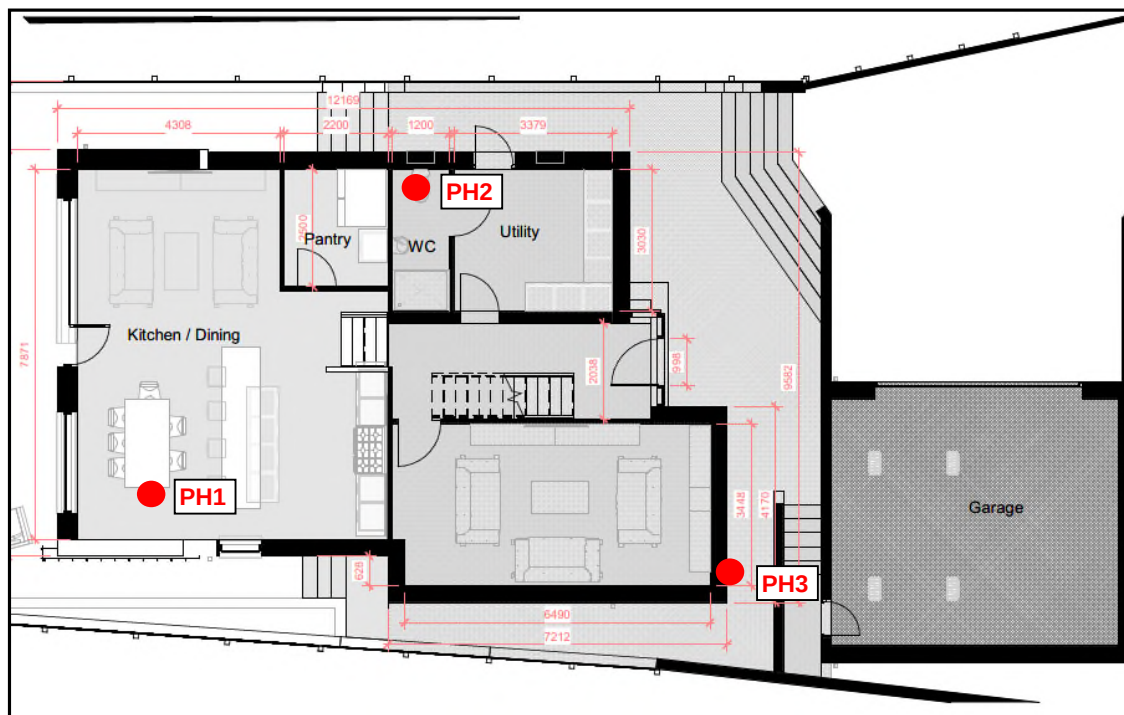
**Figure 3.1: Probehole Locations**

Terra Firma (Wales) Limited performed an intrusive investigation of the site on January 18<sup>th</sup> 2021 comprising 3 rotary open hole probeholes (PH1 – PH3) to determine whether any unrecorded coal workings were present beneath the site.

Coal was not encountered in PH2. This may suggest a steep inclining dip of the seam, or could indicate the presence of a fault across the site.

The probeholes did not record any mining related features such as voids or backfilled workings.

As no risk from ground instability has been identified no special precautionary measures or foundation design are required with respect to past mining.
