## **Tree Condition Inspection and Management Work Recommendations**

2 Ffawydden, Cwmavon, Port Talbot, SA129BJ

Project Reference – ArbTS\_1099.1\_2 Ffawydden

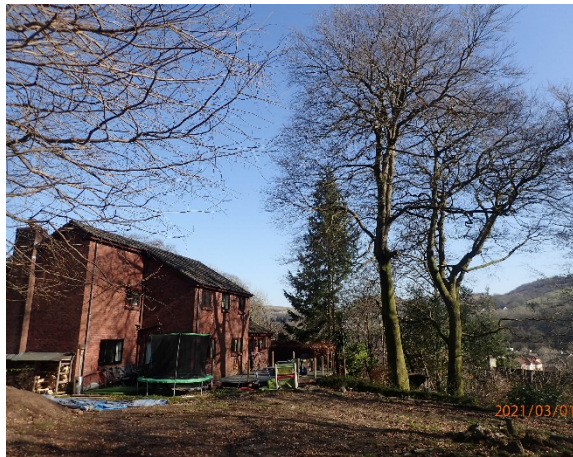
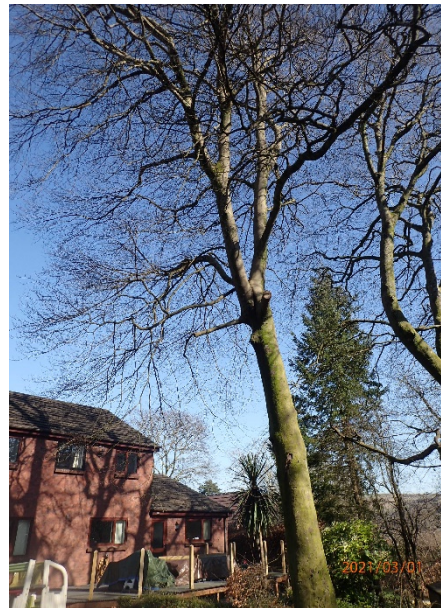
**Surrounding area** – T263 is a large tree located within the rear garden of the property and is close to an adjacent south eastern beech tree (T1) of a similar size. Further beyond this a large south eastern Sycamore tree has been recently felled. T263 is additionally surrounded by medium to larger trees further to the east, south and west. T263 is located some 10 metres south from the dwelling and mainly surrounded by open ground with some recent landscaping of surface soil noted to the west.

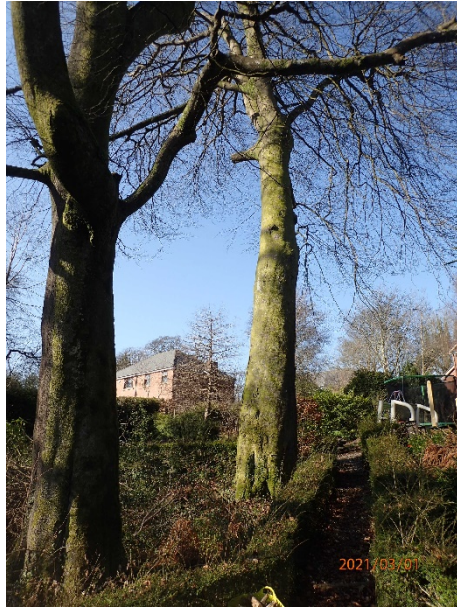
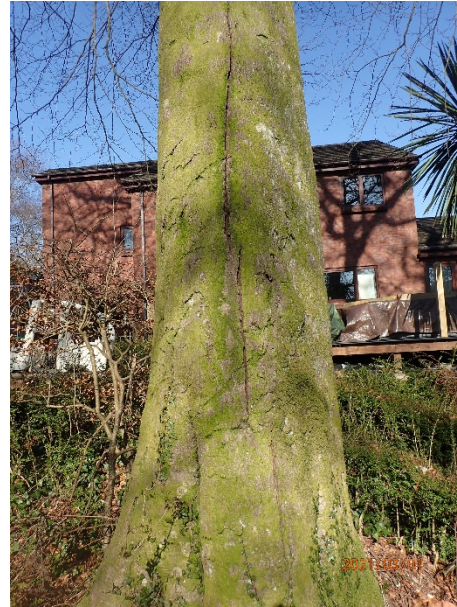
**Buttress and Lower Trunk** – Normal buttress formation. Small area of western surface bark damaged noted on trunk at 3.5 metres above ground level. Occluded vertical rib noted (right photograph below) on southern side of trunk from 0.5 metres to 3 metres above ground level, possibly due to a historic internal crack formed within the trunk. Rib formation closed and appears stable in form.

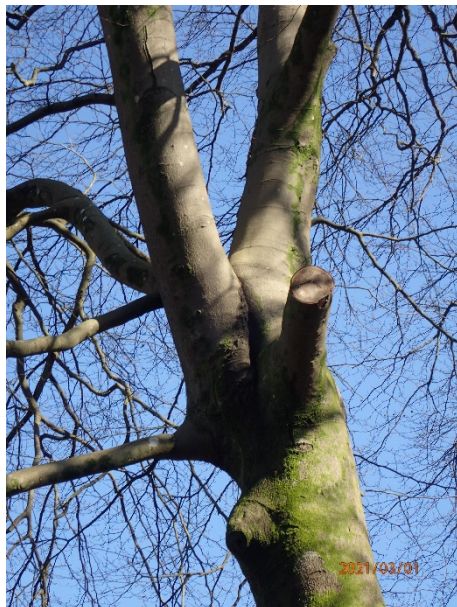
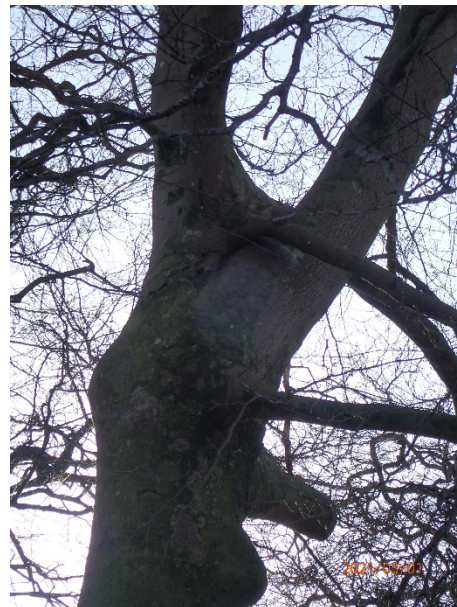
**Trunk/Stem** – Large upright trunk that divides into two main leader stems at approximately 7 metres above ground level. Stem union appears to be bark included between the two stems on the southern side (left picture below) with no significant reactive surrounding growth evident. Northern side of union has side branch growing from union area (right picture below).

- 4.1 **T263 Beech – Sectional fell and replant in 6 months from date of the tree survey.** This recommendation is due to the structural form of the union (bark included) between the main stems, the tree species, size, age, and proximity of the tree in relation to the dwelling. Beech tree species have a history of losing bark included stems and T263 is mature in age with a more limited future compared to other longer lived tree species. Coupled with the fact T263 is near the dwelling then the safe future retention of this tree is limited.
- 4.2 **T1 Beech - Reduce only overextended lateral branches by no greater than 3 to 4 metres in branch length to suitable pruning points** . This recommendation is due to the removal of T263 where T1 will be left out of crown balance with an increased risk of overextended branch failure from intensified exposure.

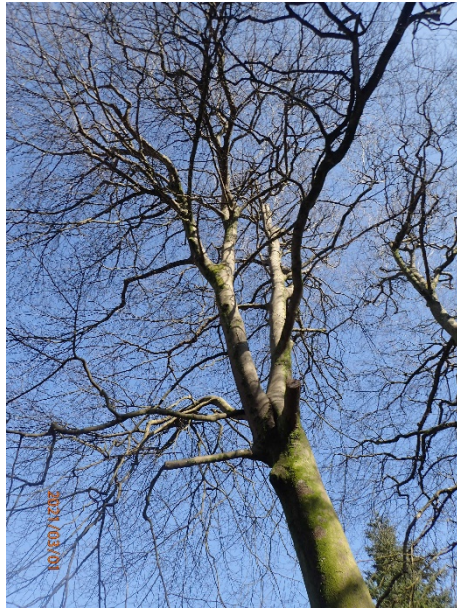
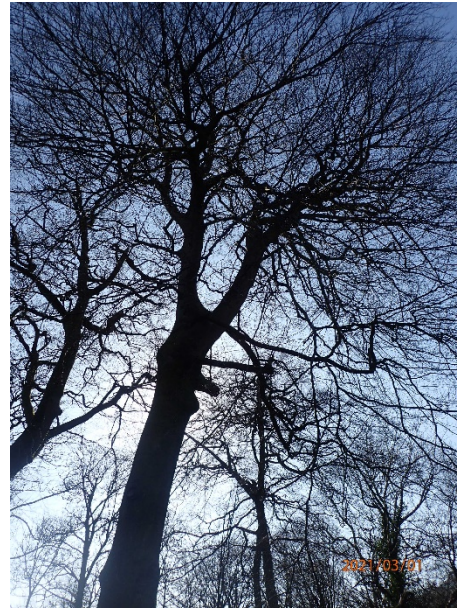
**Primary/Secondary Branches** – The crown is of fair to good form with no evident crossing, rubbing or grafted branches between the two stems.
