**Project Information**

| Project Name | Project Number | Project Date |
|---|---|---|
| Cwm Planning And Design 216 Graig Road | | 03/03/2021 |

## Section Inspection - 03/03/2021 - S1X

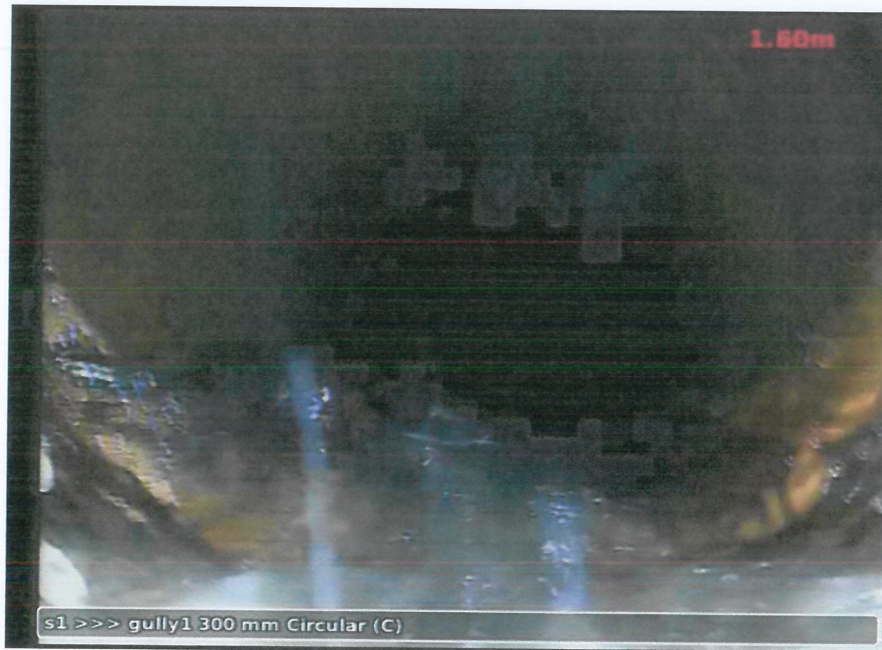
| 1.71 | RFJ | Roots, fine at joint | 00:00:32 | S1X_b5cb<br>d597-4bfd-<br>46ef-b02a- | 2 |

S1X\_b5cbd597-4bfd-46ef-b02a-72fad86109fb\_20210303\_083646\_549.jpg, 00:00:32, 1.71 m  
Roots, fine at joint

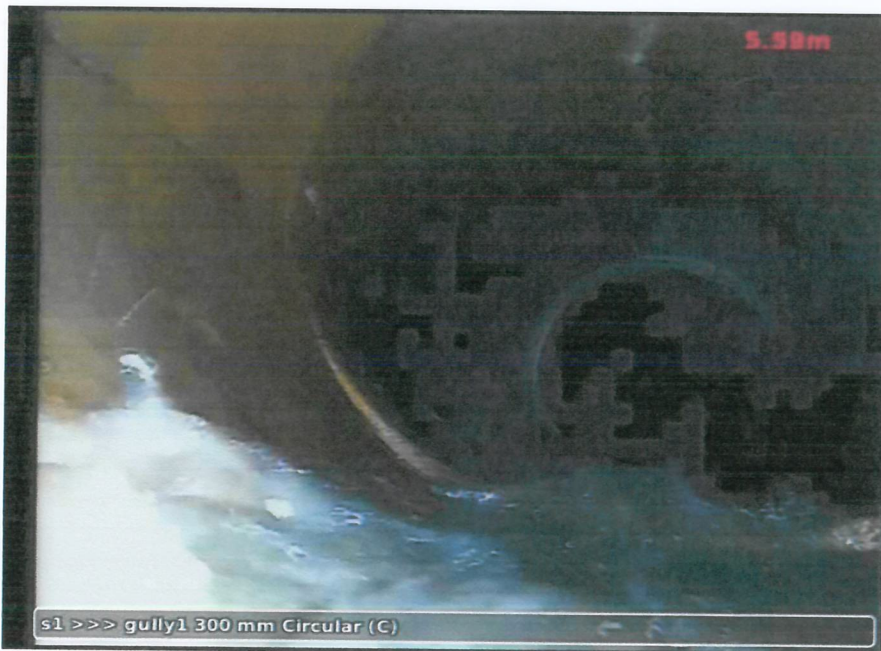
| 5.59 | FC | Fracture, circumferential from 9 o'clock to 12 o'clock | 00:00:46 | S1X_5285<br>4503-d1ea<br>-4d91-817 | 3 / 2 |

S1X\_52854503-d1ea-4d91-8177-e7befb19290b\_20210303\_083723\_541.jpg, 00:00:46, 5.59 m  
Fracture, circumferential from 9 o'clock to 12 o'clock

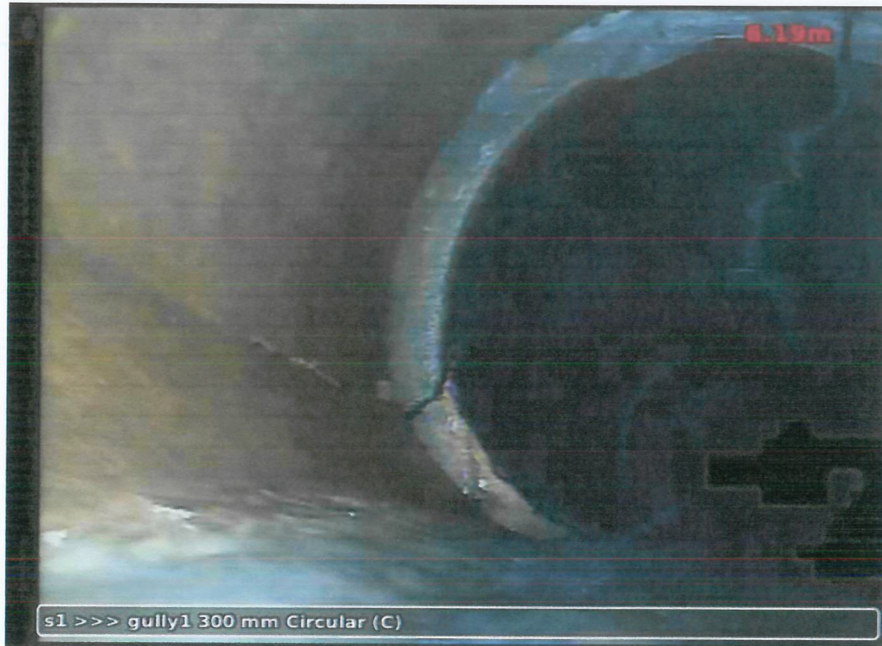
| 6.27 | FM | Fractures, multiple from 9 o'clock to 3 o'clock | 00:00:49 | S1X_f612<br>0a4c-e547<br>-4d8c-bc7 | 4 / 2 |

S1X\_f6120a4c-e547-4d8c-bc76-be326122d481\_20210303\_083810\_540.jpg, 00:00:49, 6.27 m  
Fractures, multiple from 9 o'clock to 3 o'clock

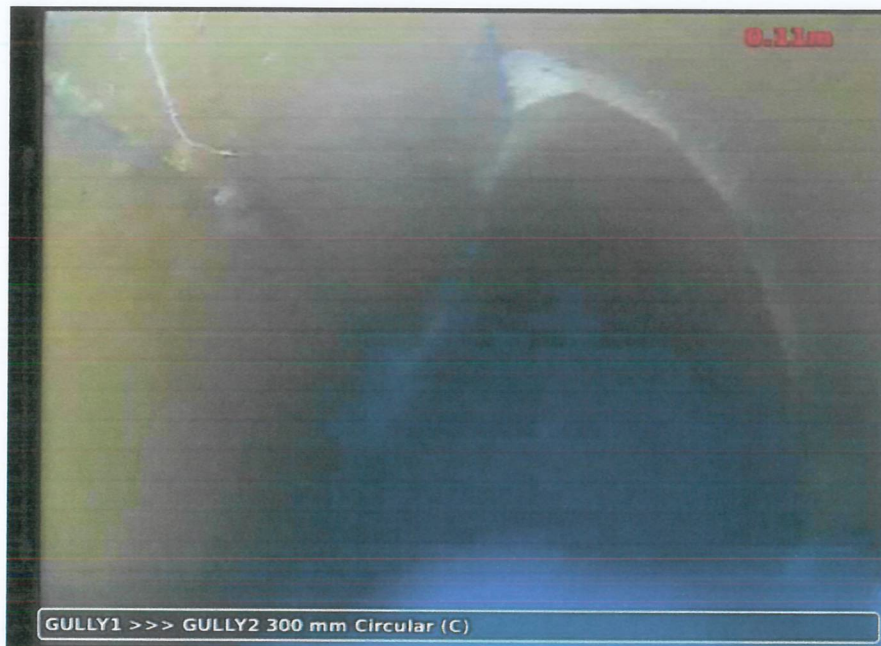
Gully1 X\_714aaae4-d6c2-4859-9964-65d09e363b57\_20210303\_090032\_809.jpg, 00:00:17,  
0.08 m

| 0.08 | S01 FM | Fractures, multiple from 12 o'clock to 12 o'clock, start | 00:00:17 | Gully1<br>X_714aaa<br>e4-d6c2-4 | |
| 2.80 | F01 FM | Fractures, multiple from 12 o'clock to 12 o'clock, finish | 00:00:33 | | 4 / 2 |

Fractures, multiple from 12 o'clock to 12 o'clock, start

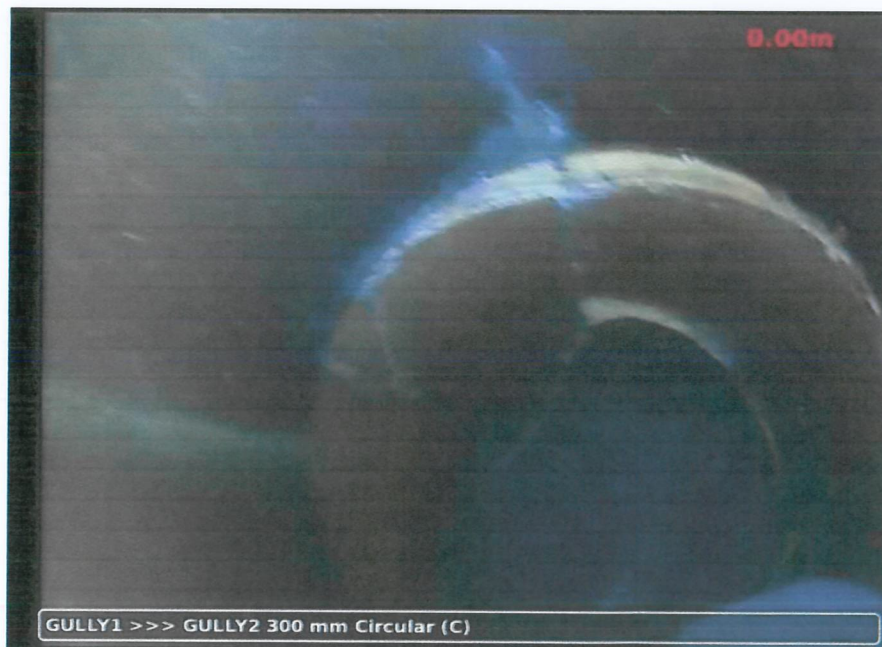
Gully1 X\_75a9dc73-f8e2-433b-9e72-05683c81cf31\_20210303\_090042\_523.jpg, 00:00:17,  
0.08 m

Fractures, multiple from 12 o'clock to 12 o'clock, start
