Cefndon Farm,  
Neath Road, Tonna,  
Neath Port Talbot

## Road Safety Audit - Stage 1

Barratt Homes /  
David Wilson Homes

December  
2016

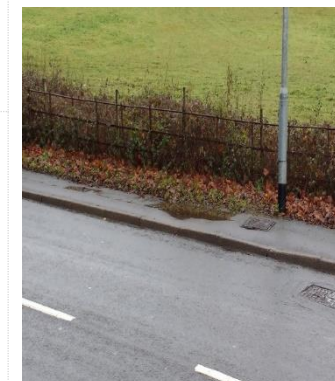
2.1.1 **Problem** Surface water ponding on existing footway

**Location** Western side of carriageway adjacent to proposed development boundary

The Audit Team noted from the site visit areas of surface water ponding on the footway along the eastern edge of the B4434 Neath Road. The Audit Team is concerned that during cold weather the water may freeze and present a slip/trip hazard to pedestrians.

#### **Recommendation**

The Audit Team recommends that the appropriate cross-falls across the footway are provided to prevent excess surface water.

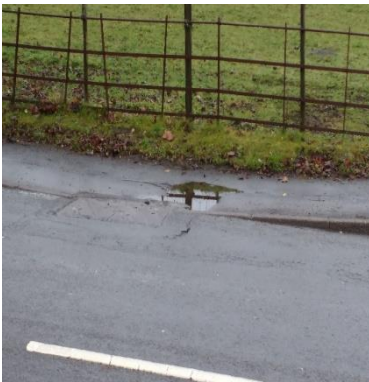
| 2.1.2 | <div><div>Problem</div><div>Surface water ponding on existing footway</div></div> <div><div>Location</div><div>Eastern side of B4434 Neath Road, fronting the proposed development</div></div> | |
| | <p>The Audit Team noted from the site visit areas of surface water ponding on the footway along the eastern edge of the B4434 Neath Road. The Audit Team is concerned that pedestrians could step into the carriageway injudiciously, to avoid the surface water, resulting in pedestrians being hit by oncoming vehicles.</p> <div><div>Recommendation</div><p>The Audit Team recommends that the appropriate cross-falls across the footway are provided to prevent excess surface water.</p></div> | |

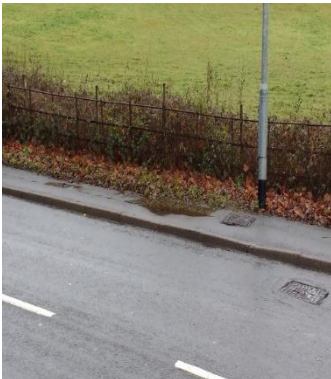
| 2.1.3 | <div><div>Problem</div><div>Existing manhole cover slippery when wet</div></div> <div><div>Location</div><div>Footway along the eastern edge of the B4434 Neath Road</div></div> | |
| | <p>The Audit Team noted from the site visit that there is a manhole cover located within the centre of the footway on the eastern side of the carriageway. The Audit Team is concerned that during wet weather the cover will become a slip/trip hazard for pedestrians, and could lead to pedestrians stepping into the carriageway injudiciously, and being hit by oncoming vehicles.</p> <div><div>Recommendation</div><p>The Audit Team recommends that the cover is treated with appropriate anti-slip surfacing.</p></div> | |

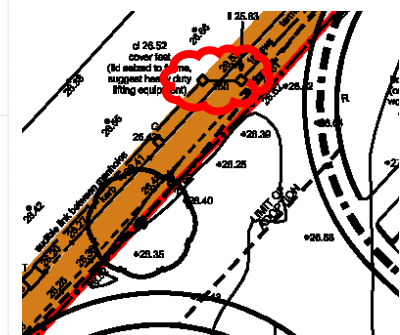
| 2.1.6 | <b>Problem</b> | <b>Manhole covers may become slippery when wet</b> | |
| | <b>Location</b> | <b>Within bell-mouth of proposed site access</b> | |
| <p>The Audit Team note from the Section 278 Agreement Plan (1605/237) that there are a number of manhole covers shown within the junction bell-mouth of the proposed site access. The Audit Team is concerned that during wet weather the covers will become slippery, and could lead to drivers (particularly riders of powered two-wheelers) losing control of their vehicle.</p> | | | |

| <b>Recommendation</b> | | | |
| <p>The Audit Team recommends that the cover is treated with appropriate anti-skid surfacing.</p> | | | |

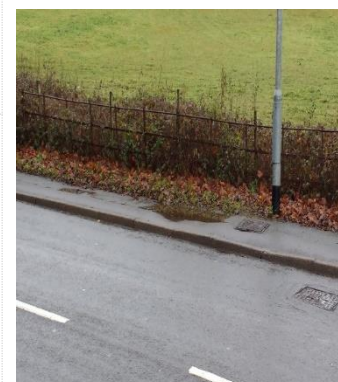
| 2.2.1 | <b>Problem</b> | <b>Surface water ponding on existing footway</b> | |
| | <b>Location</b> | <b>Western side of carriageway adjacent to proposed development boundary</b> | |
| <p>The Audit Team noted from the site visit areas of surface water ponding on the footway along the eastern edge of the B4434 Neath Road. The Audit Team is concerned that during cold weather the water may freeze and present a slip/trip hazard to pedestrians.</p> | | | |

| <b>Recommendation</b> | | | |
| <p>The Audit Team recommends that the appropriate cross-falls across the footway are provided to prevent excess surface water.</p> | | | |

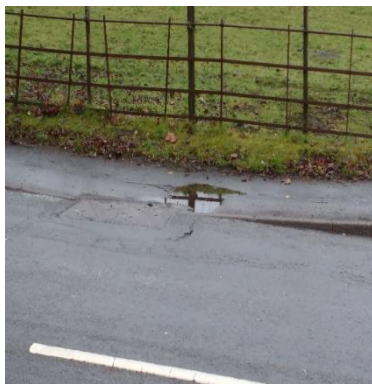
| 2.2.2 | <b>Problem</b> Surface water ponding on existing footway | |
| | <b>Location</b> Eastern side of B4434 Neath Road, fronting the proposed development | |
| <p>The Audit Team noted from the site visit areas of surface water ponding on the footway along the eastern edge of the B4434 Neath Road. The Audit Team is concerned that pedestrians could step into the carriageway injudiciously, to avoid the surface water, resulting in pedestrians being hit by oncoming vehicles.</p> <p><b>Recommendation</b></p> <p>The Audit Team recommends that the appropriate cross-falls across the footway are provided to prevent excess surface water.</p> | | |

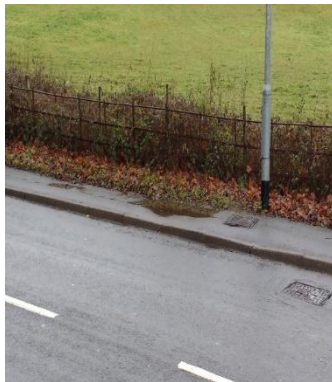
| 2.2.3 | <b>Problem</b> Existing manhole cover slippery when wet | |
| | <b>Location</b> Footway along the eastern edge of the B4434 Neath Road | |
| <p>The Audit Team noted from the site visit that there is a manhole cover located within the centre of the footway on the eastern side of the carriageway. The Audit Team is concerned that during wet weather the cover will become a slip/trip hazard for pedestrians, and could lead to pedestrians stepping into the carriageway injudiciously, and being hit by oncoming vehicles.</p> <p><b>Recommendation</b></p> <p>The Audit Team recommends that the cover is treated with appropriate anti-slip surfacing.</p> | | |

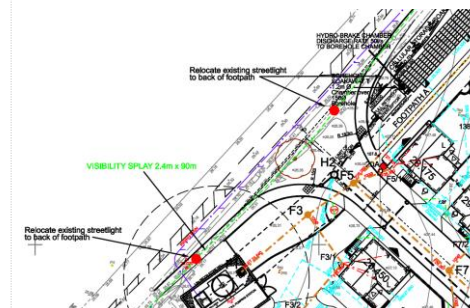
| 2.2.4 | <b>Problem</b> Large vehicles may overrun pedestrian facilities | |
| | <b>Location</b> Proposed site access junction | |
| <p>The Audit Team note from the Engineering Layout (1605/201K) that the tactile paving, located at the proposed site access, is situated along the radius of the kerb-line. In the absence of any swept-path analysis, the Audit Team is concerned that large</p> | | |

vehicles turning into the proposed access may overrun the tactile paving, potentially leading to conflict with pedestrians, resulting in vehicles striking pedestrians.

The Audit Team recommends that the tactile paving is set back along the proposed access approximately one metre beyond the radius of the kerb, as per guidance set out in the Department of the Environment, Transport and the Regions' 'Guidance on the use of Tactile Paving Surfaces' and the Department for Transport's Local Transport Note 2/95 'The Design of Pedestrian Crossings'.

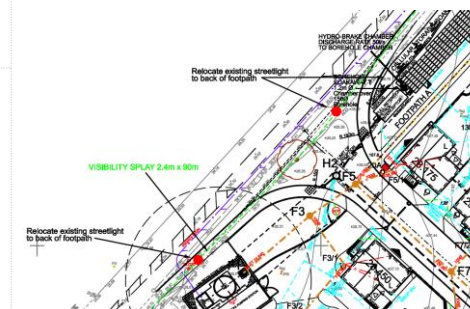
2.2.5 **Problem** Tactile paving situated on kerb-line radius

**Location** Proposed site access junction

The Audit Team note from the Engineering Layout (1605/201K) that the tactile paving, located at the proposed site access, is situated along the kerb-line radius of the proposed access. The audit team is concerned that this increases the time it will take pedestrians to cross the side road, thereby increasing the likelihood of pedestrians being hit by a vehicle.

The Audit Team recommends that the tactile paving is set back into the minor road approximately one metre beyond the radius of the kerb, as per guidance set out in the Department of the Environment, Transport and Regions' 'Guidance on the use of Tactile Paving Surfaces' and the Department for Transport's Local Transport Note 2/95 'The Design of Pedestrian Crossings'.

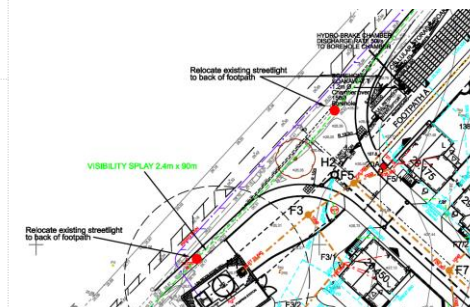
**2.2.6 Problem Pedestrians obscured from view as a result of shadowing**

**Location Proposed site access junction**

The Audit Team note from the plans that it is proposed to relocate the existing lighting columns to accommodate the site access junction. The Audit Team is concerned that relocating the lighting columns will affect the lighting levels throughout the junction, resulting in shadowing, and could obscure from view pedestrians waiting to cross the road. This could lead to pedestrians being hit by oncoming vehicles.

The Audit Team recommends that the lighting levels through the junction are reviewed, and that the appropriate lighting is provided throughout the junction.

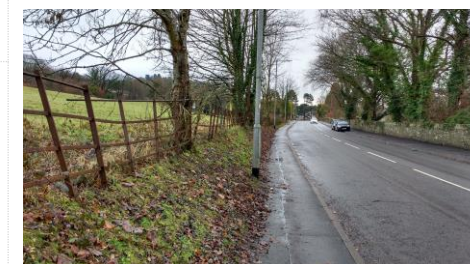
**2.2.7 Problem Lack of pedestrian crossing facilities across the B4434**

**Location B4434 fronting the site**

The Audit Team noted from the site visit that there are no crossing facilities across the B4434 in the vicinity of the site. The Audit Team is concerned that pedestrians, accessing the northbound bus stops, will try to cross the road in the vicinity of the proposed access and step into the road injudiciously, into the path of oncoming vehicles.

The Audit Team recommend that pedestrian crossing facilities across the B4434, such as a pedestrian refuge, are incorporated into the proposed access junction.

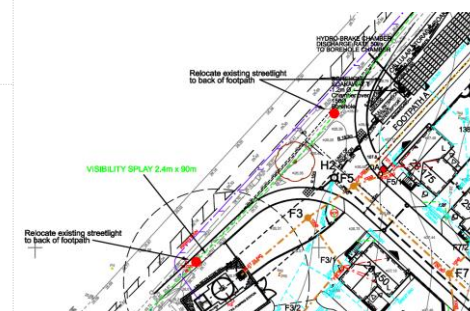
2.3.1 **Problem** Pedestrians obscured from view because of shadowing

**Location** Proposed site access junction

The Audit Team note from the plans that it is proposed to relocate the existing lighting columns to accommodate the site access junction. The Audit Team is concerned that relocating the lighting columns will affect the lighting levels throughout the junction, could lead to shadowing, and could obscure from view pedestrians crossing the side road of the junction.

The Audit Team recommends that the lighting levels through the junction are reviewed, and that the appropriate lighting is provided.
