Cefndon Farm,  
Neath Road, Tonna,  
Neath Port Talbot

## Road Safety Audit - Stage 2

Barratt Homes /  
David Wilson Homes

January  
2017

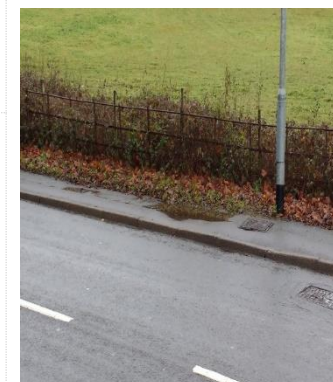
- 3.1.1 **Problem** Existing manhole cover slippery when wet  
**Location** Footway along the eastern edge of the B4434 Neath Road

The Audit Team noted from the site visit that there is a manhole cover located within the centre of the footway on the eastern side of the carriageway that will be within the carriageway when the proposed access is constructed. In the absence of any details, the Audit Team is concerned that the cover/chamber is not designed to support vehicular traffic and could deflect under vehicle loads and create a potential hazard for vehicles, resulting in drivers taking sudden braking manoeuvres or evasive action leading to rear-end shunt type accidents.

##### **Recommendation**

The Audit Team recommends that the cover/chamber is replaced with a suitable cover/chamber that is capable of accommodating vehicle loads.

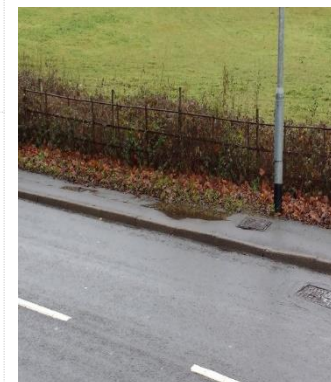
- 3.1.2      **Problem**    **Manhole will become slippery when wet**  
               **Location**   **Footway along the eastern edge of the B4434 Neath Road**

The Audit Team noted from the site visit that there is a manhole cover located within the centre of the footway on the eastern side of the carriageway that will be within the carriageway when the proposed access is constructed. In the absence of any details, the Audit Team is concerned that the cover will become slippery during wet weather, and could lead to drivers (particularly riders of powered two-wheelers) losing control of their vehicles when undertaking turning manoeuvres. This could result in a vehicle hitting an oncoming vehicle or mounting the kerb and striking a pedestrian.

#### **Recommendation**

The Audit Team recommends that the cover is replaced or treated with appropriate anti-skid surfacing.

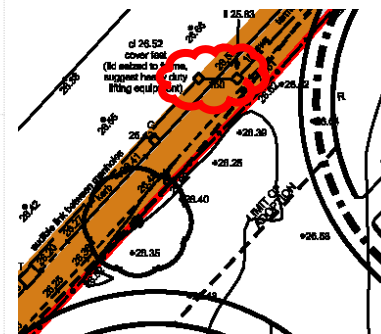
- 3.1.3      **Problem**    **Manhole covers may become slippery when wet**  
               **Location**   **Within bell-mouth of proposed site access**

The Audit Team notes from the Section 278 Agreement Plan (1605/237) that there are a number of manhole covers shown within the junction bell-mouth of the proposed site access. The Audit Team is concerned that during wet weather the covers will become slippery, and could lead to drivers (particularly riders of powered two-wheelers) losing control of their vehicles when undertaking turning manoeuvres. This could result in a vehicle hitting an oncoming vehicle or mounting the kerb and striking a pedestrian.

#### **Recommendation**

The Audit Team recommends that the cover is replaced or treated with appropriate anti-skid surfacing.

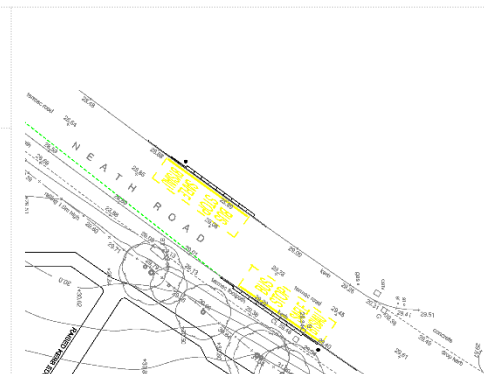
**3.1.4 Problem** Waiting buses will obstruct forward visibility for overtaking vehicles

**Location** Proposed bus stops along the B4434 Neath Road, north of the site access

The Audit Team note from the plans that it is proposed to provide northbound and southbound bus stops to the north of the site access junction, with the northbound stop approximately 30m south of the southbound stop. The Audit Team is concerned that in the event that northbound and southbound buses are waiting at the stop at the same time, the buses will obstruct forward visibility for overtaking vehicles. This could lead to vehicles attempting to pass a waiting bus into the path of an oncoming vehicle, resulting in rear-end shunt type accidents or head-on collisions.

#### Recommendation

The Audit Team recommend that the northbound bus stop is moved north of the southbound bus stop, to prevent both buses obstructing forward visibility for overtaking vehicles.

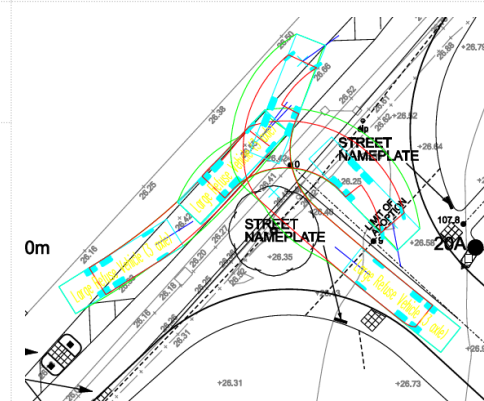
**3.1.5 Problem** Inadequate swept-path analysis has been provided to Audit Team

**Location** Proposed site access

The swept-path analysis provided to the Audit Team does not include all turning movements at the proposed site access (does not include left-in/left-out manoeuvres) and therefore the Audit Team is unable to determine whether large vehicles can access the site without conflicting with other vehicles – resulting in side swipe or rear end shunt type accidents, or pedestrians – resulting in pedestrians being hit by vehicles.

#### Recommendation

The Audit Team recommends that a full swept-path analysis is undertaken to demonstrate that the range of vehicles likely to access the site can do so safely.

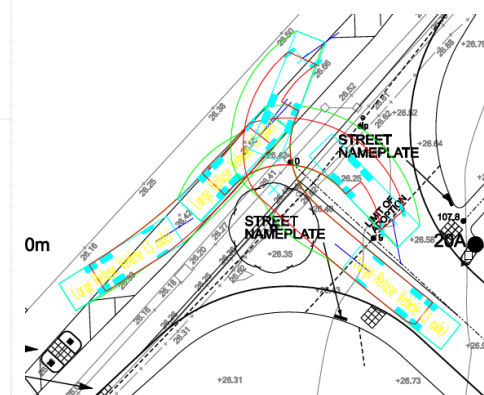
3.1.6      **Problem**    **Rear of large vehicles overhang northbound running carriageway**  
**Location**    **Proposed site access**

The Audit Team note from the plans that the rear of a large refuse vehicle (turning right in to the site) over-sweeps the northbound running lane. The Audit Team is concerned that this could lead to the refuse vehicle striking a vehicle passing along the nearside edge.

#### **Recommendation**

The Audit Team recommends that the swept-path analysis is re-run to determine whether a large refuse vehicle can access the site without the rear of the vehicle over-sweeping the carriageway, and if necessary that the ghost-island right turn lane is widened to avoid potential conflicts.

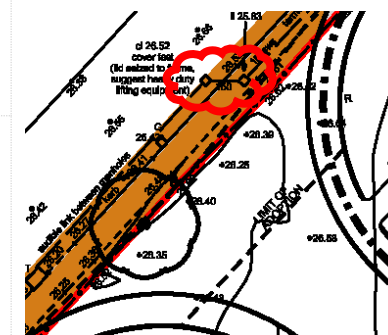
3.1.7      **Problem**    **Manhole covers may become slippery when wet**  
**Location**    **Within bell-mouth of proposed site access**

The Audit Team note from the Section 278 Agreement Plan (1605/237) that there are a number of manhole covers shown within the junction bell-mouth of the proposed site access. The Audit Team is concerned that during wet weather the covers will become slippery, and could lead to drivers (particularly riders of powered two-wheelers) losing control of their vehicles when undertaking turning manoeuvres. This could result in a vehicle hitting an oncoming vehicle or mounting the kerb and striking a pedestrian.

#### **Recommendation**

The Audit Team recommends that the cover is replaced or treated with appropriate anti-skid surfacing.

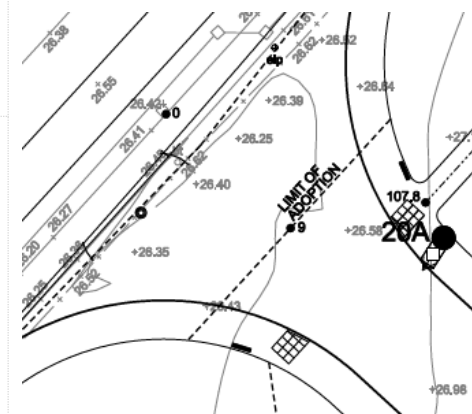
### 3.2.1 Problem Pedestrian crossing situated at the end of the pedestrian ramp

| <b>Location</b> | <b>Adjacent to the proposed site access</b> |

The Audit Team note from the Engineering Layout (1605/201M) that the tactile paving has been relocated further in to the site, at the end of the pedestrian ramp parallel to the B4434. The audit team is concerned that this could increase the potential for pedestrians (and in particular toddlers) entering the carriageway injudiciously into the path of an oncoming vehicle resulting in pedestrians being hit by a vehicle.

## Recommendation

The Audit Team recommends that the pedestrian ramp includes a 'dog-leg', level with the footway, so that the ramp does not lead directly to the tactile paving.

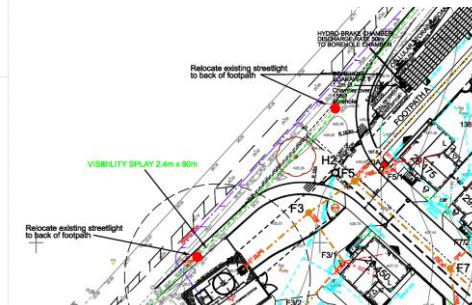
### 3.2.2 Problem Pedestrians obscured from view as a result of shadowing

| Location | Proposed site access junction |

The Audit Team note from the plans that it is proposed to relocate the existing lighting columns to accommodate the site access junction. The Audit Team is concerned that relocating the lighting columns will affect the lighting levels throughout the junction, resulting in shadowing, and could obscure from view pedestrians waiting to cross the road. This could lead to pedestrians being hit by oncoming vehicles.

## Recommendation

The Audit Team recommends that the lighting levels through the junction are reviewed, and that the appropriate lighting is provided throughout the junction.

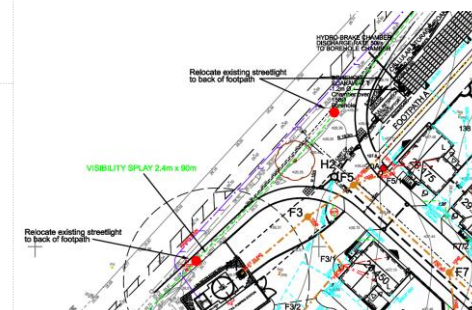
3.3.1 **Problem** Pedestrians obscured from view because of shadowing

**Location** Proposed site access junction

The Audit Team note from the plans that it is proposed to relocate the existing lighting columns to accommodate the site access junction. The Audit Team is concerned that relocating the lighting columns will affect the lighting levels throughout the junction, could lead to shadowing, and could obscure from view pedestrians crossing the side road of the junction.

#### Recommendation

The Audit Team recommends that the lighting levels through the junction are reviewed, and that the appropriate lighting is provided.

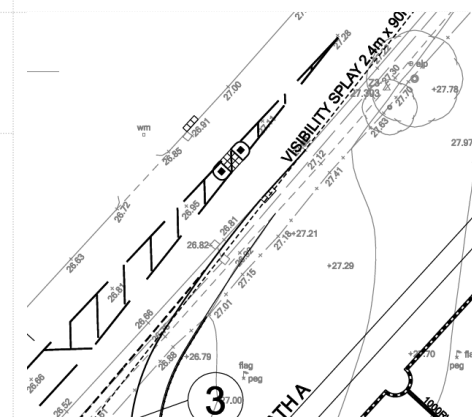
3.3.2 **Problem** Inadequate length of hatched taper

**Location** Pedestrian refuge north of the proposed site access

The Audit Team note from the plans that the length of hatched taper located at the pedestrian refuge, north of the site access, is inadequate. The Audit Team is concerned that a short taper length may not provide enough warning to oncoming vehicles that the carriageway width is narrowing. This could lead to vehicle conflict with the pedestrian refuge.

#### Recommendation

The Audit team recommends that the length of the hatched taper be increased to provide sufficient indication to drivers of carriageway narrowing.

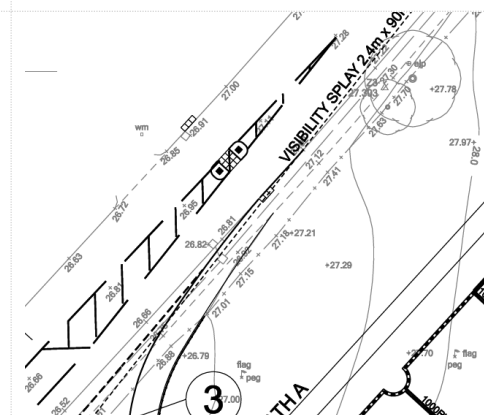
3.3.3 **Problem** Hatched taper markings direct vehicle towards pedestrian refuge

**Location** Pedestrian refuge north of the proposed site access

The Audit Team note from the plans that the hatched taper markings do not run to the edge of the pedestrian refuge, leaving an element of the pedestrian refuge exposed to oncoming vehicles. The Audit Team is concerned that the positioning of the taper markings may be misleading to passing vehicles, encouraging them to drive within proximity, and potentially coming into contact with the pedestrian refuge.

#### Recommendation

The Audit team recommends that the alignment of the taper markings be adjusted, to prevent oncoming vehicles from coming into contact with the pedestrian refuge.
