# **Stage 1/2 Road Safety Audit Report**

**A474 Neath Abbey Road, Neath  
Proposed new Aldi Foodstore  
S 38 Highway works**

**Project Name:** Aldi A474 Neath Abbey Road, Neath S 38 highway works

**Report Title:** Stage 1/2 Road Safety Audit

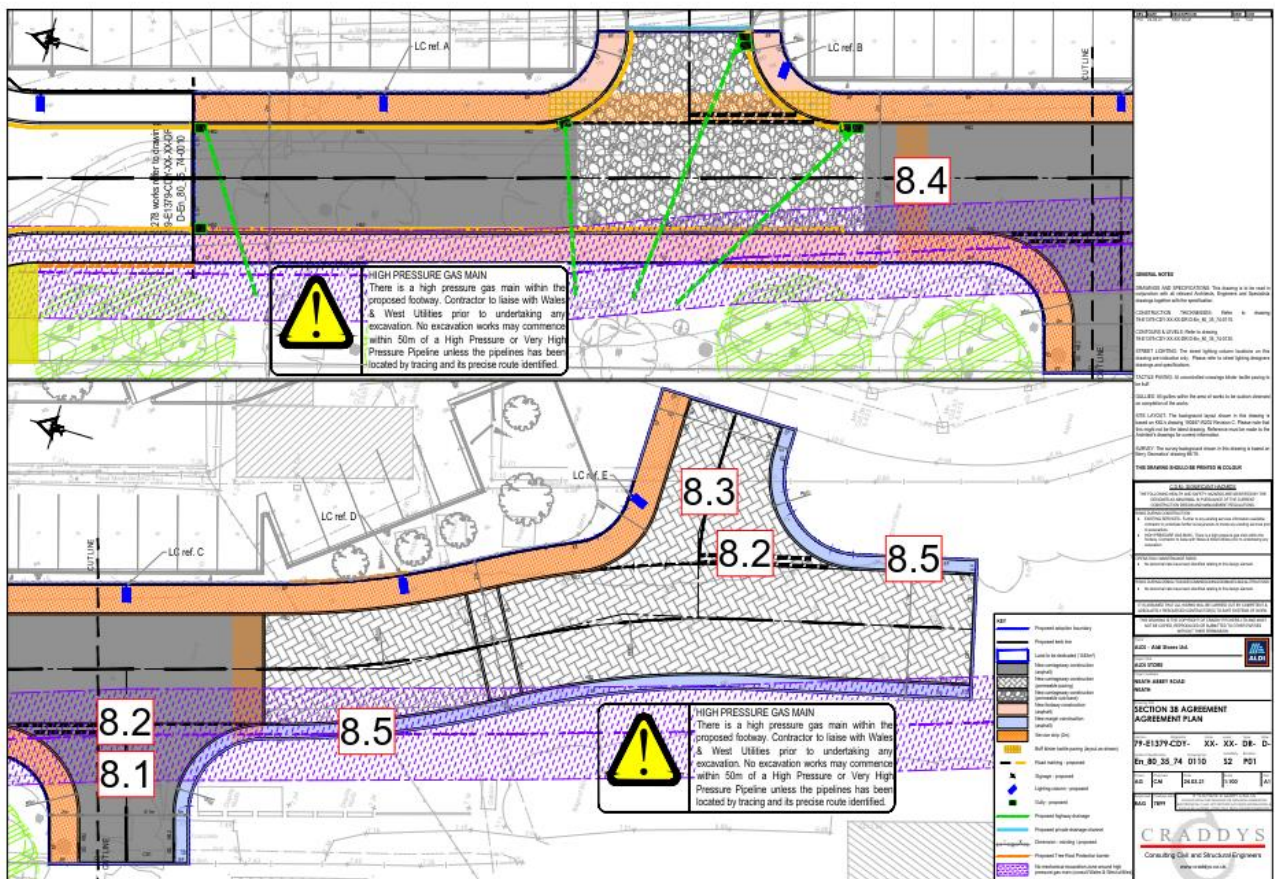
## 13. Appendix B - Identified Road Safety Audit Matters Location Plans

Identified locations of Road Safety Audit Matters are indicated on drawings within **Appendix B** to the rear of this report.

| 8.1 *Problem* (Item B1.2) | |
|---|---|
| <b>Summary:</b> | No carriageway drainage detailed on side road south of Aldi entrance |

| 8.2 *Problem* (Item B3.2) | |
|---|---|
| <b>Summary:</b> | No visibility splays detailed on side roads/accesses |

| 8.3 *Problem* (Item B3.4) | |
|---|---|
| <b>Summary:</b> | Centre line at give way marking appears to be offset on side road |

| 8.4 *Problem* (Item B4.2) | |
|---|---|
| <b>Summary:</b> | No pedestrian crossing point across access road to south of Aldi Store |

| 8.5 *Problem* (Item B4.2) | |
|---|---|
| <b>Summary:</b> | Footways do not extend upto southern end of road to cater for future development |

| 8.1 *Problem* (Item B1.2) | |
|---|---|
| Check levels and provide additional drainage if necessary | |

| 8.2 *Problem* (Item B3.2) | |
|---|---|
| Provide appropriate clear visibility splays on accesses and junctions | |

| 8.3 *Problem* (Item B3.4) | |
|---|---|
| Amend markings on access | |

| 8.4 *Problem* (Item B4.2) | |
|---|---|
| Provide additional pedestrian crossing point | |

| 8.5 *Problem* (Item B4.2) | |
|---|---|
| Provide additional length of footways with pedestrian crossing points if future development is proposed | |
