# **Stage 1/2 Road Safety Audit Report**

**A474 Neath Abbey Road, Neath  
Proposed new Aldi Foodstore  
S278 & 38 Highway works**

**Project Name:** Aldi A474 Neath Abbey Road, Neath S278 & 38 highway works

**Report Title:** Stage 1/2 Road Safety Audit

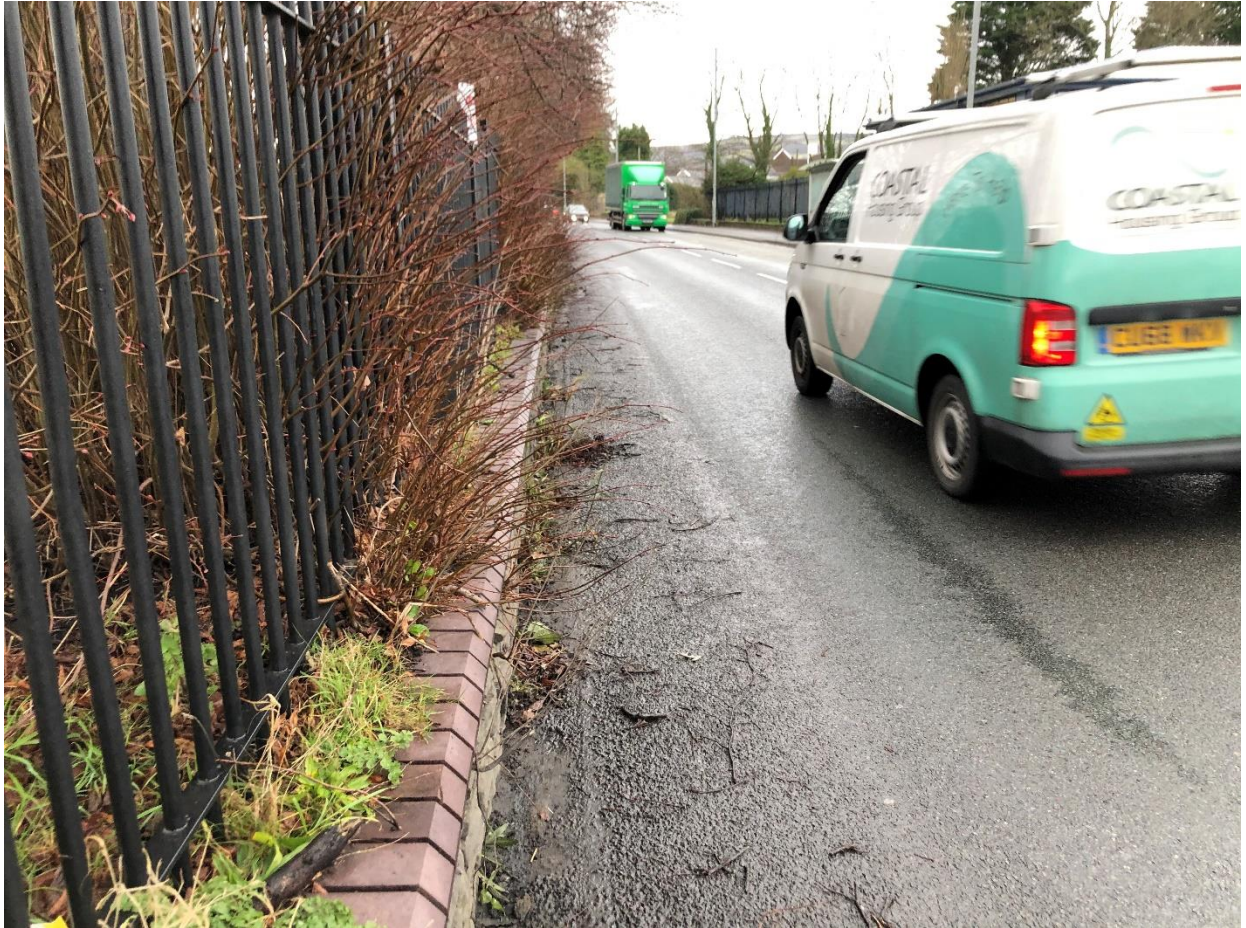
| 8.1 *Problem* (Item B1.4) | |
|---|---|
| Summary: | Vegetation overhanging northern side of carriageway |
| <p>There is vegetation that overhangs the northern side of the carriageway that will cause an obstruction for vehicles travelling along the reduced width traffic lane on the northern side of road. This vegetation needs to be cut back</p> | |
| Vehicle collisions with vegetation | |

| 8.1 *Problem* (Item B1.4) | |
|---|---|
| Cut back vegetation | |

| Stage 1/2 (Road Safety Audit)<br>DESIGNER'S ROAD SAFETY AUDIT RESPONSE<br><b>Scheme Name:</b> Aldi Neath Abbey Road | | |
|---|---|---|
| 8.1 | Vegetation overhanging northern side of carriageway | Agree – All overhanging vegetation to be cut back and identified as an ongoing maintenance requirement, refer to drawing 79-E1379-CDY-XX-XX-DR-D-En_80_35_74-0010 - S278-38 Engineering Layout. |

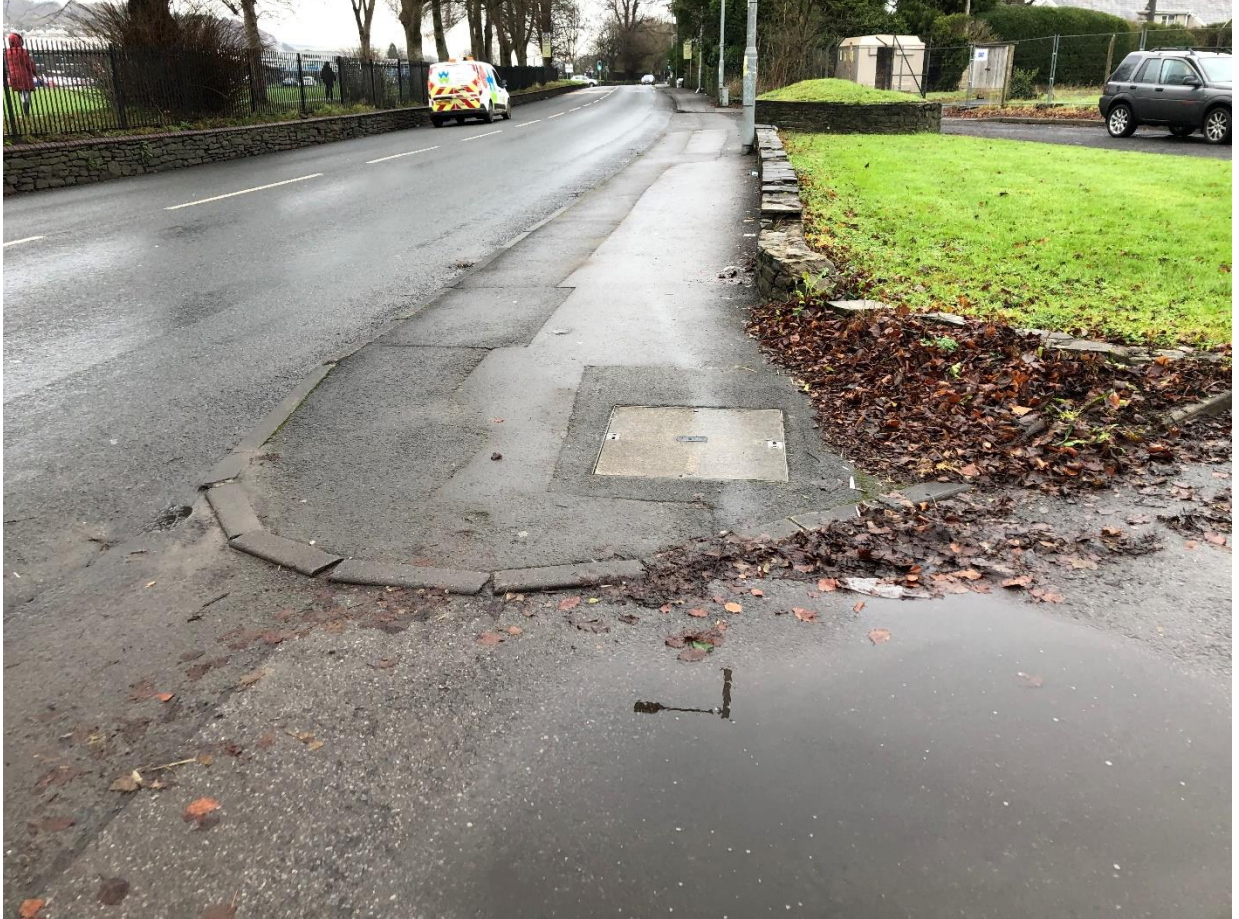
| 8.2 *Problem* (Item B1.5) | |
|---|---|
| <b>Summary:</b> | Existing manhole in middle of new junction inline with turning vehicles |
| <p>There is an existing BT manhole that is detailed to be diverted or lowered that will be in the middle of the new junction carriageway inline with turning vehicles. This will need a non slip cover if its remains within the carriageway as it will cause a stability problem for turning two wheeled vehicles</p> | |
| Turning vehicle loss of control collisions | |

| 8.2 *Problem* (Item B1.5) | |
|---|---|
| Provide non slip manhole cover on manhole if it remains within carriageway | |

| Stage 1/2 (Road Safety Audit)<br>DESIGNER'S ROAD SAFETY AUDIT RESPONSE<br><b>Scheme Name:</b> Aldi Neath Abbey Road | | |
|---|---|---|
| 8.2 | Existing manhole in middle of new junction inline with turning vehicles | Agree – Existing services chamber to receive a non-slip surface treatment or shall be relocated into adjacent footway, refer to drawing 79-E1379-CDY-XX-XX-DR-D-En_80_35_74-0010 - S278-38 Engineering Layout. |

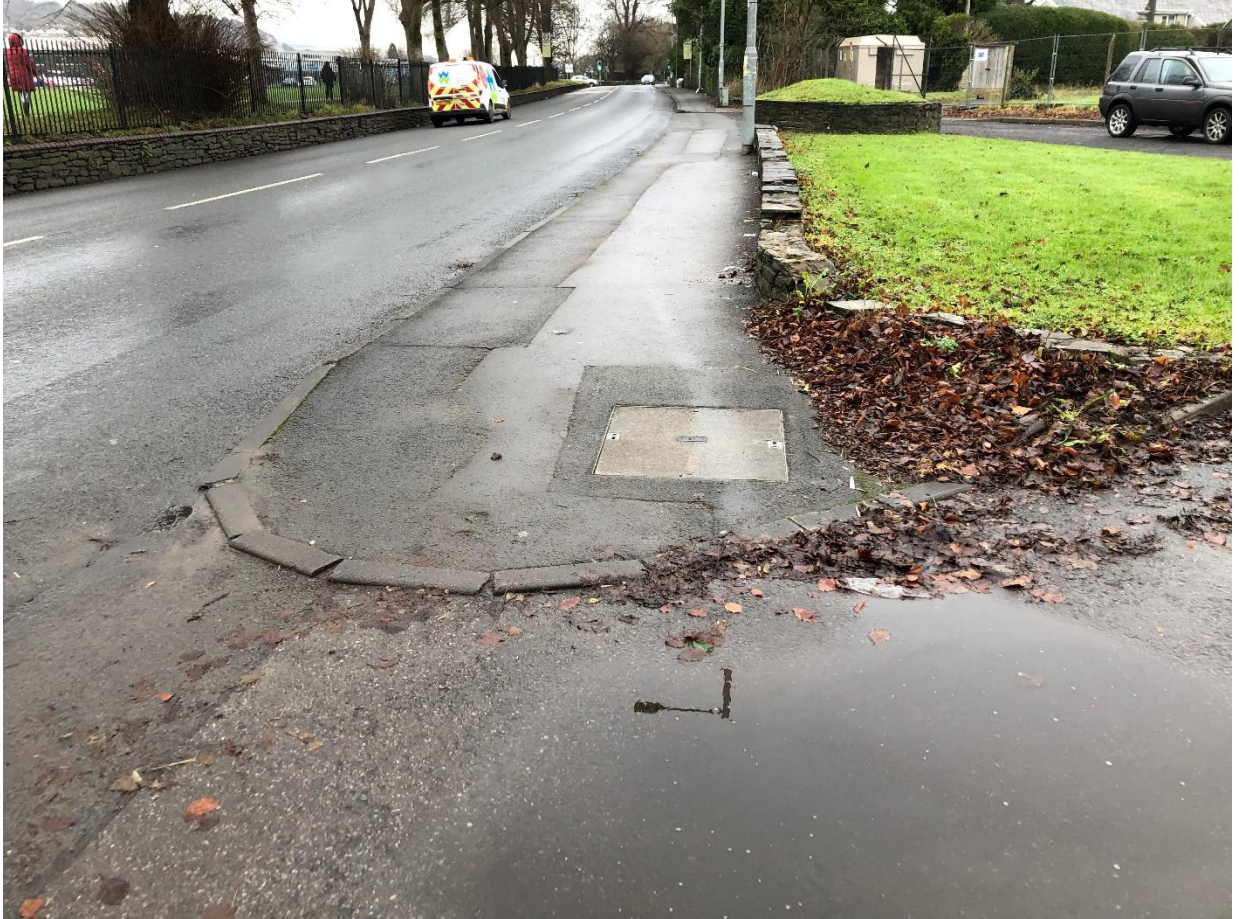
| 8.3 *Problem* (Item B1.5) | |
|---|---|
| <b>Summary:</b> | Existing manhole inline with proposed pedestrian crossing point |
| <p>There is an existing BT manhole that is detailed to be diverted or lowered that will be inline with the proposed pedestrian crossing point. This will cause an obstruction for pedestrians when essential maintenance works are being carried out. Relocate manhole away from line of pedestrian crossing point.</p> | |
| Obstruction in line with pedestrian crossing point when essential maintenance being carried out | |

| 8.3 *Problem* (Item B1.5) | |
|---|---|
| Relocate manhole away from inline with pedestrian crossing point | |

| Stage 1/2 (Road Safety Audit)<br>DESIGNER'S ROAD SAFETY AUDIT RESPONSE<br><b>Scheme Name:</b> Aldi Neath Abbey Road | | |
|---|---|---|
| 8.3 | Existing manhole inline with proposed pedestrian crossing point | Agree – Relocation of the chamber into the new/revised footway is the preference and is currently being progressed by the Developer's team, refer to plan SX/20/NM/833909 Openreach Proposal A. Only if chamber relocation is cost or technically prohibitive will the chamber remain in its current position. |

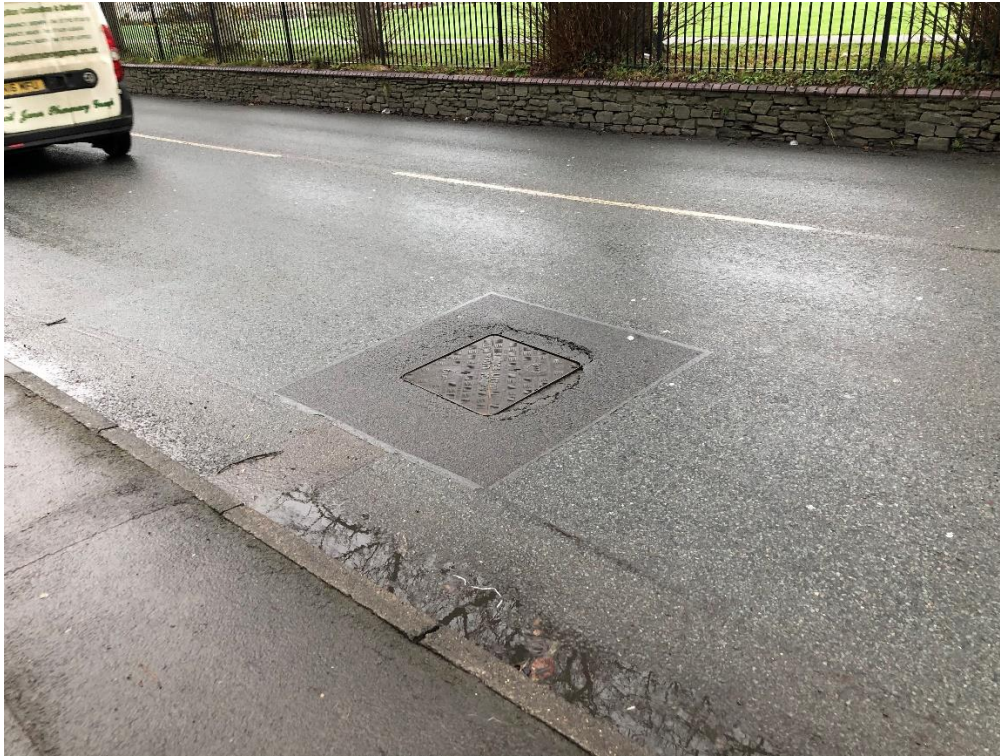
- 9.1 Neath Abbey Road. Existing manhole sunk near new junction. Inform Council for them to rectify
