Civil & Structural Engineering Consultancy

- 1.1 MW Consult Ltd has been instructed by Elin Walters to undertake a structural inspection of the external walls to the storage room at 100 Commercial Road, Rhydyfro, SA8 4SS, and to subsequently prepare a written structural appraisal.

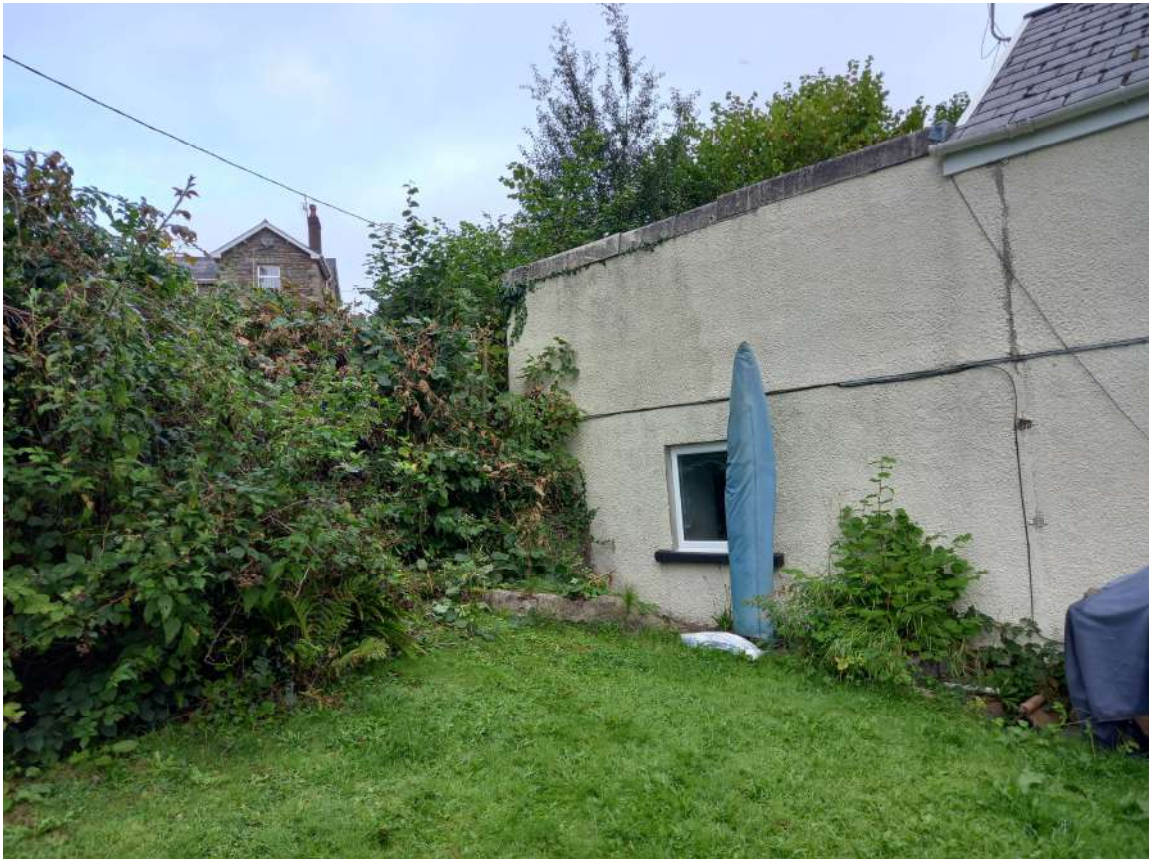
Photograph 1 – Front Elevation (viewed from front garden).

- 2.5 The front wall of the storage room is plumb and in a reasonable condition without any signs of any issues such as crack damage etc. The rear and side walls were more difficult to inspect due to lack of access coupled with the severe vegetation which was present. However, as far as we could see there were no major structural issues with these walls.

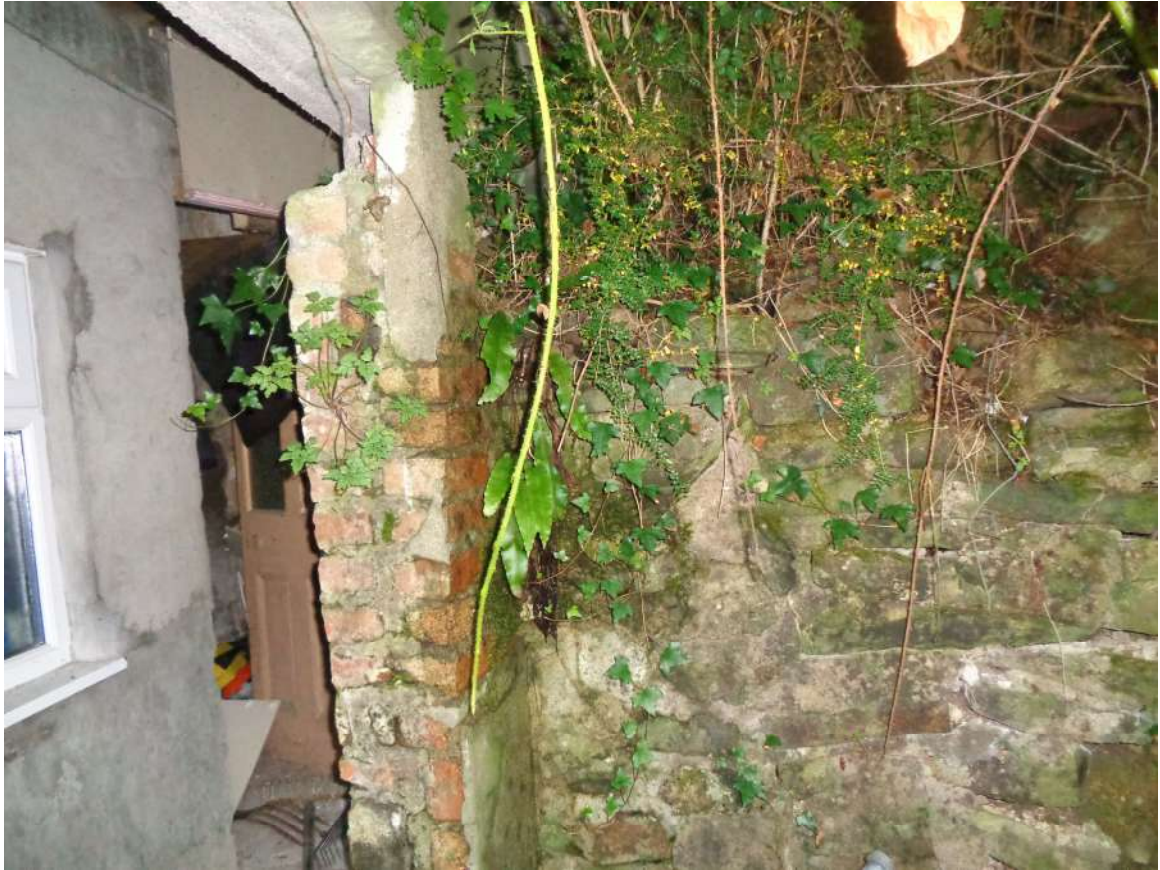
Photograph 3 – Rear elevation facing retaining wall.

- 2.1 It is apparent that the side wall of the storage room is currently acting as a retaining structure. Whilst it was difficult to take exact measurements due to the dense vegetation present to the side and rear of the building, we would estimate that the wall is retaining roughly 1.5m height of ground, although the height of retained earth does appear to vary.

- 2.4 From as far as can be seen, the retaining walls are in reasonably good condition given their age. There are no signs of any significant structural defects and the walls appear to have supported the retained earth pressures without any issues up until the present time.

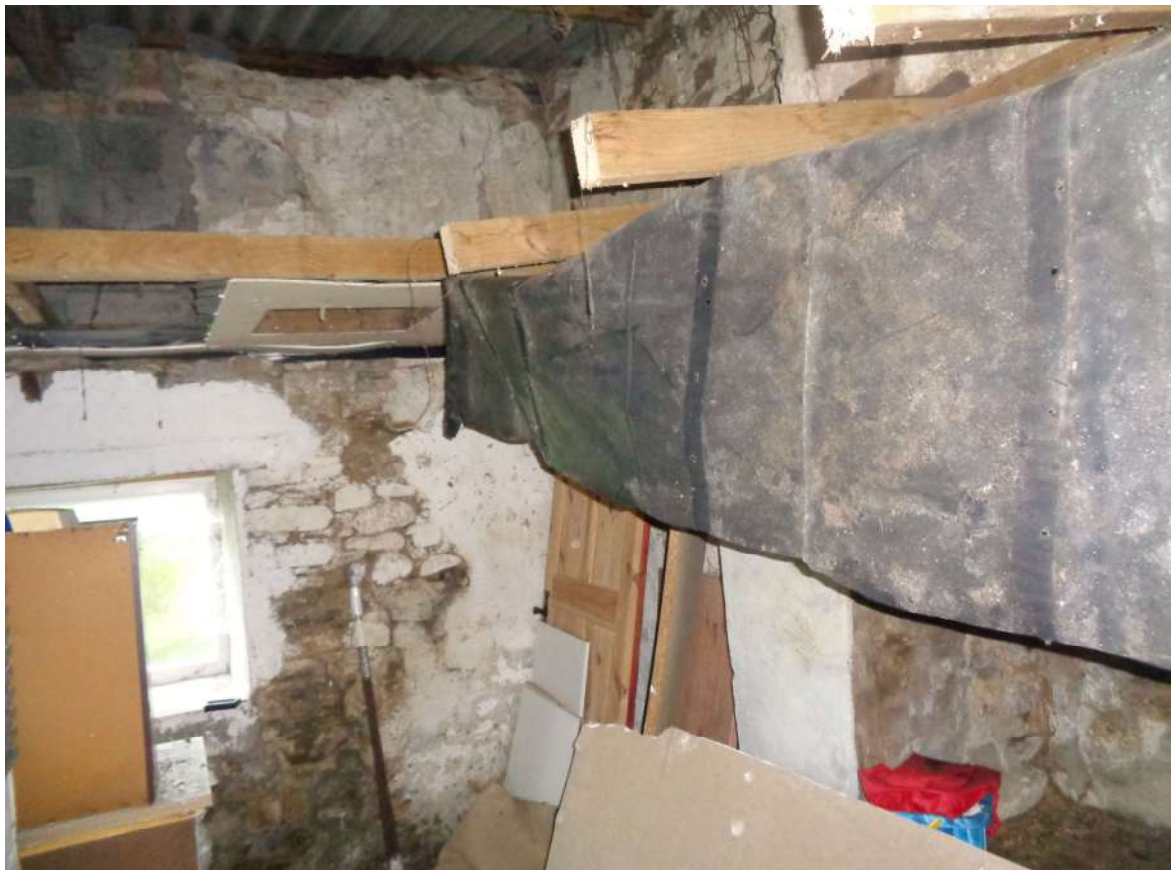
Photograph 4 – Internal view facing side and front wall.

- 3.1 Similarly to when viewed from the outside, the inside faces of the storage rooms walls were found to be plumb and free from any significant defects. The walls are considered to be well built and in good condition, especially for a stone building of this age.
- 3.2 The roof comprises a series of timber joists which span from side-to-side onto the side wall. The joists appear free from defect and support corrugated fibre cement roof sheets.
