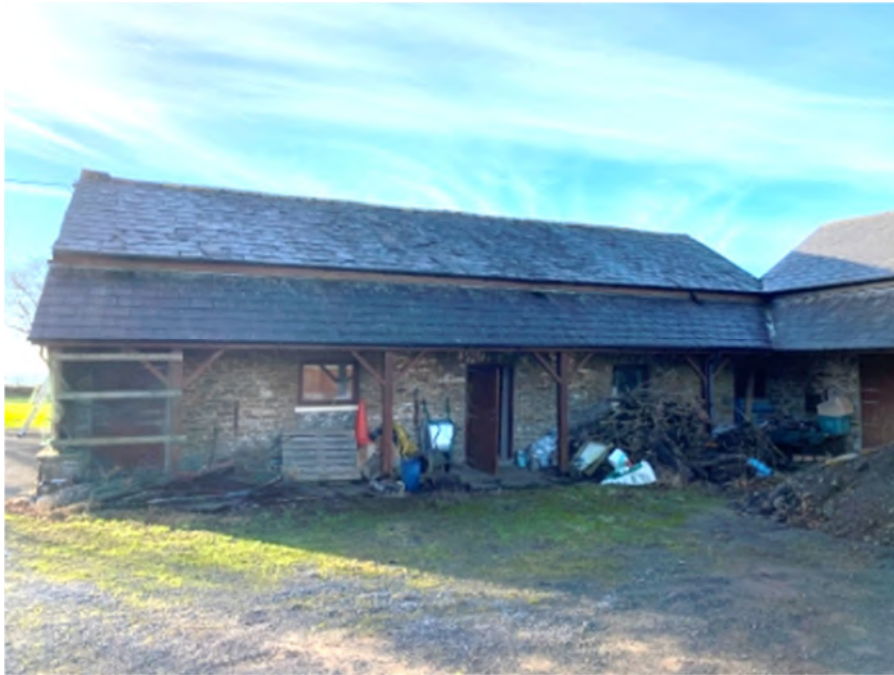
Photograph 1: View of courtyard north elevation of barn at Cilmaengwyn Uchaf Farm with mono-pitch canopy roof structure.

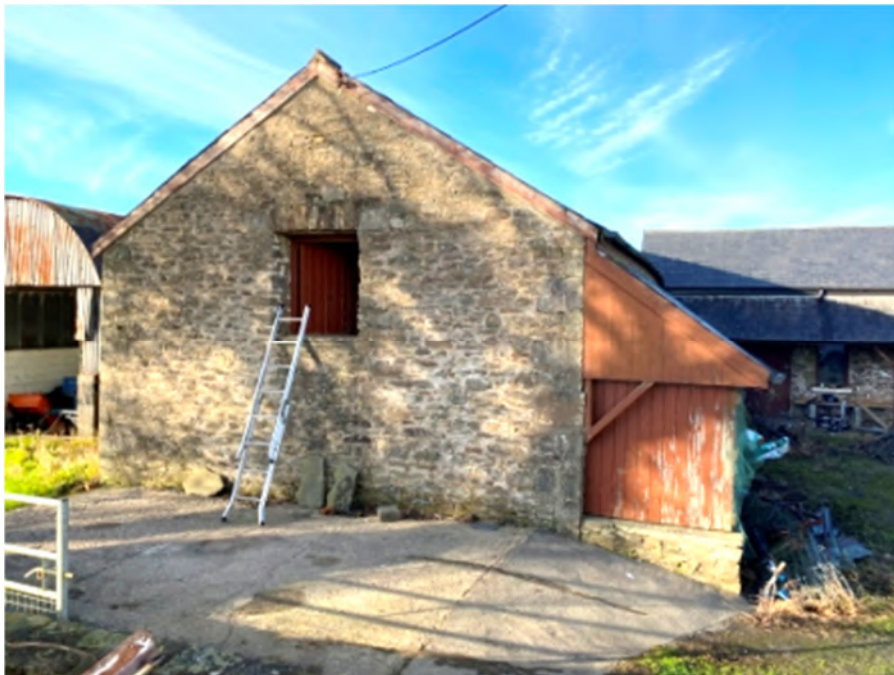
Photograph 2: View of eastern gable elevation of barn building with single opening allowing access to first floor level.

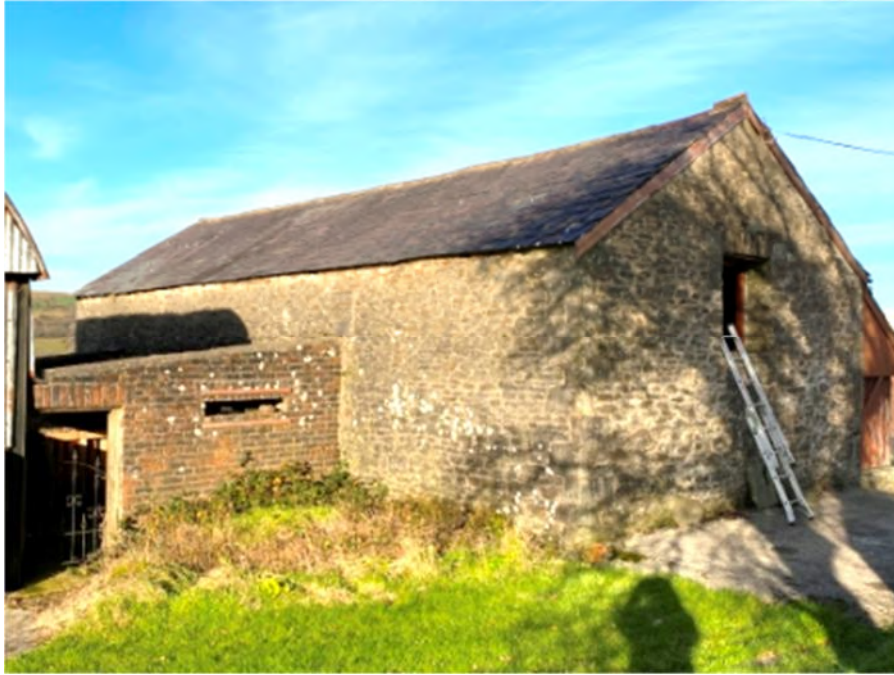
Photograph 3: View of barn south elevation. No openings in this elevation.

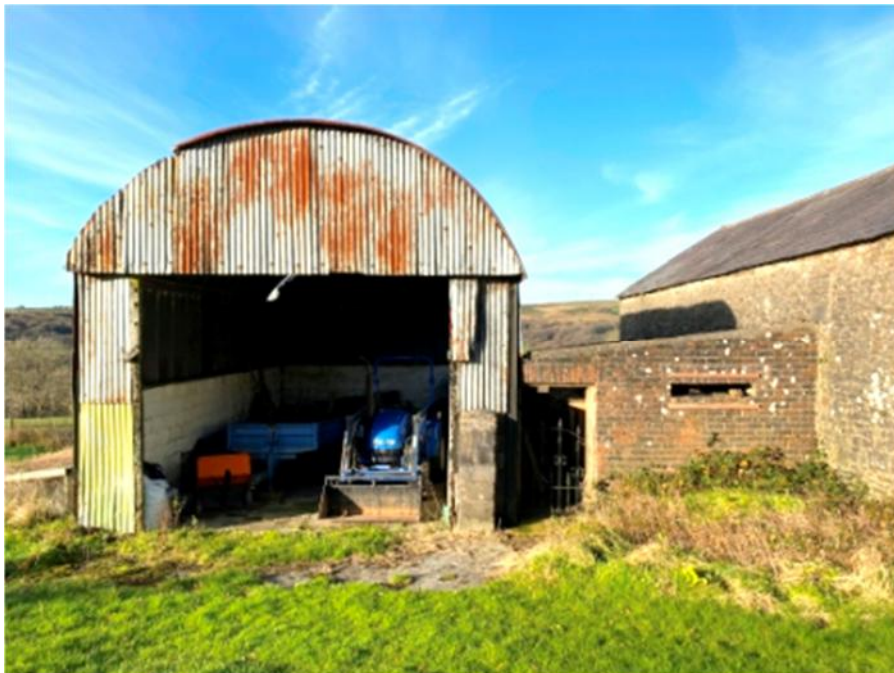
Photograph 4: View of east elevations of Dutch barn and cow shed structure which butts up against the main barn building.

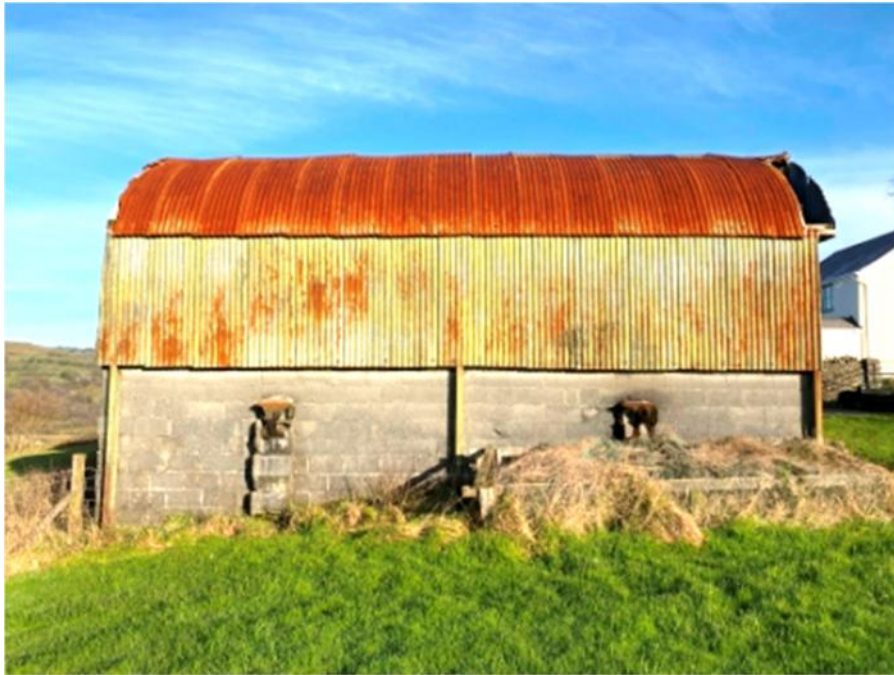
Photograph 5: View of Dutch barn south elevation.

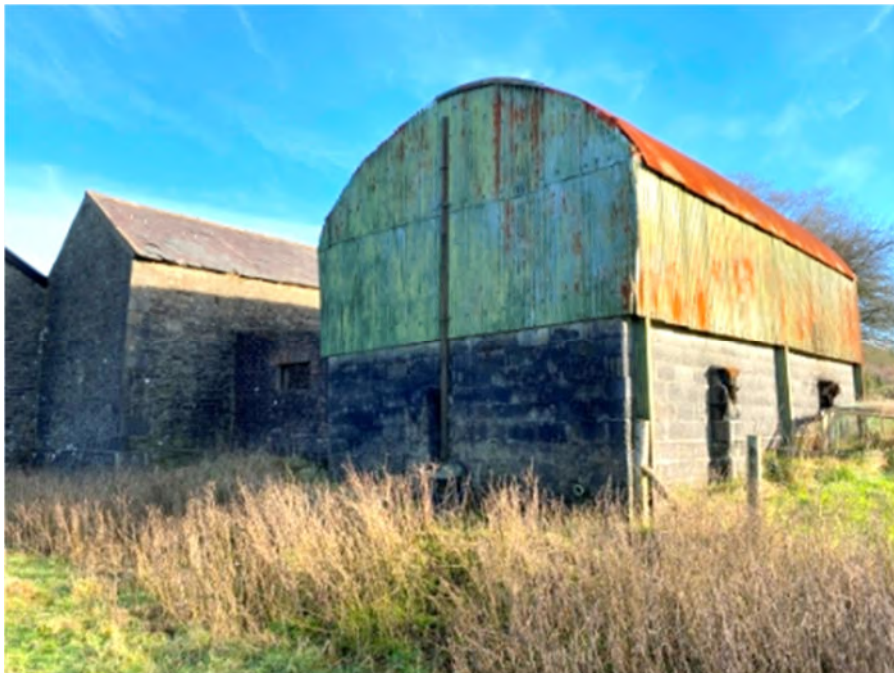
Photograph 6: View from south west corner showing Dutch barn and gable elevation of barn building.

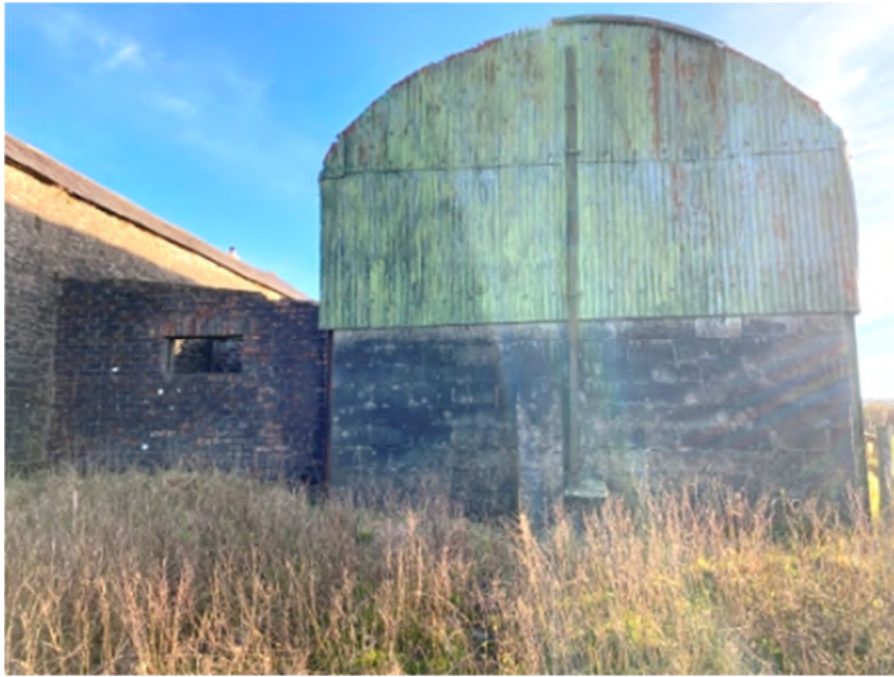
Photograph 7: View of Dutch barn and cow shed west elevation.

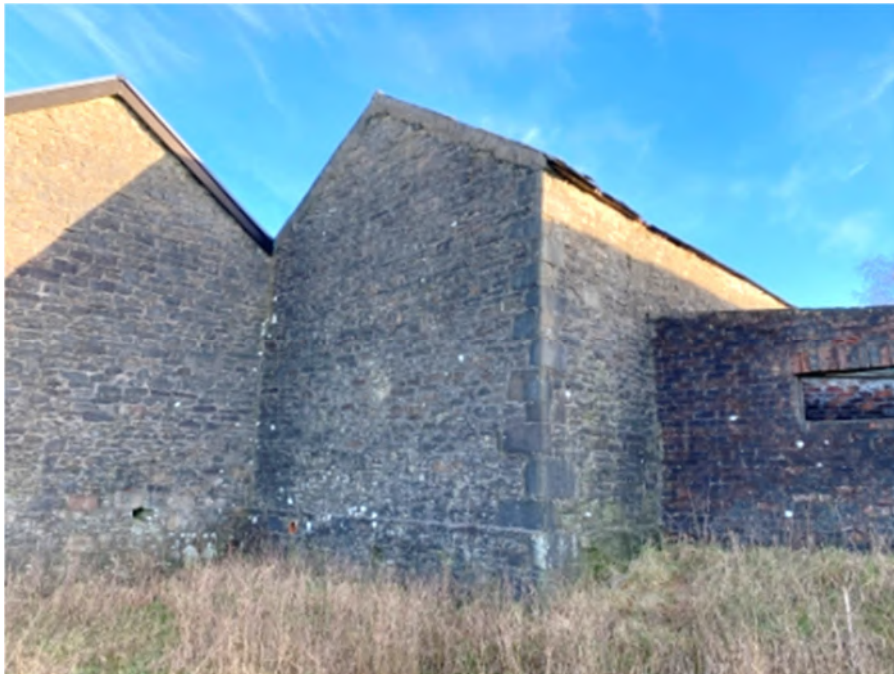
Photograph 8: View of barn west gable elevation and part cow shed elevation.

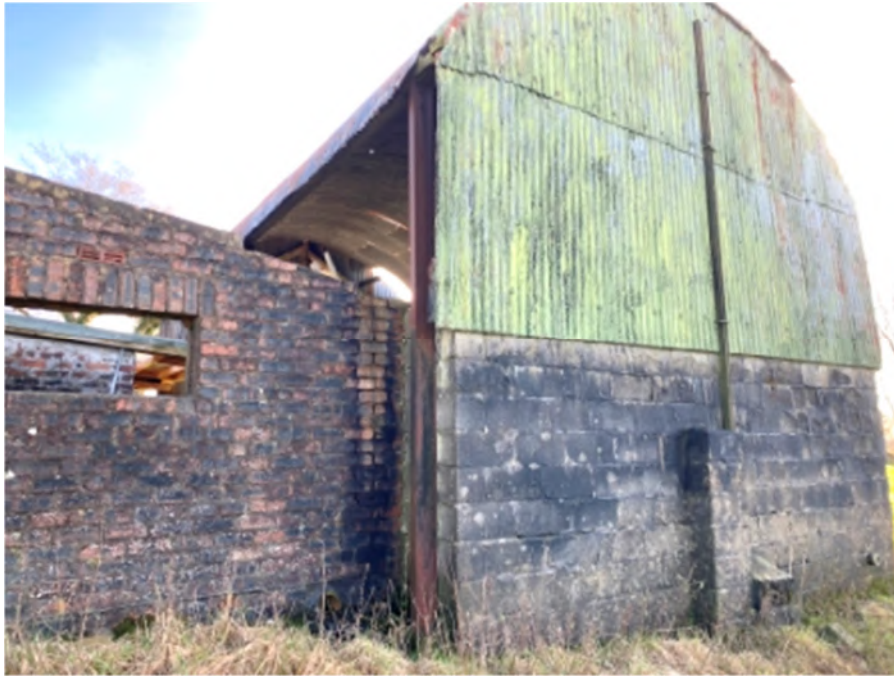
Photograph 9: View at junction of cow shed and Dutch barn on west elevation.

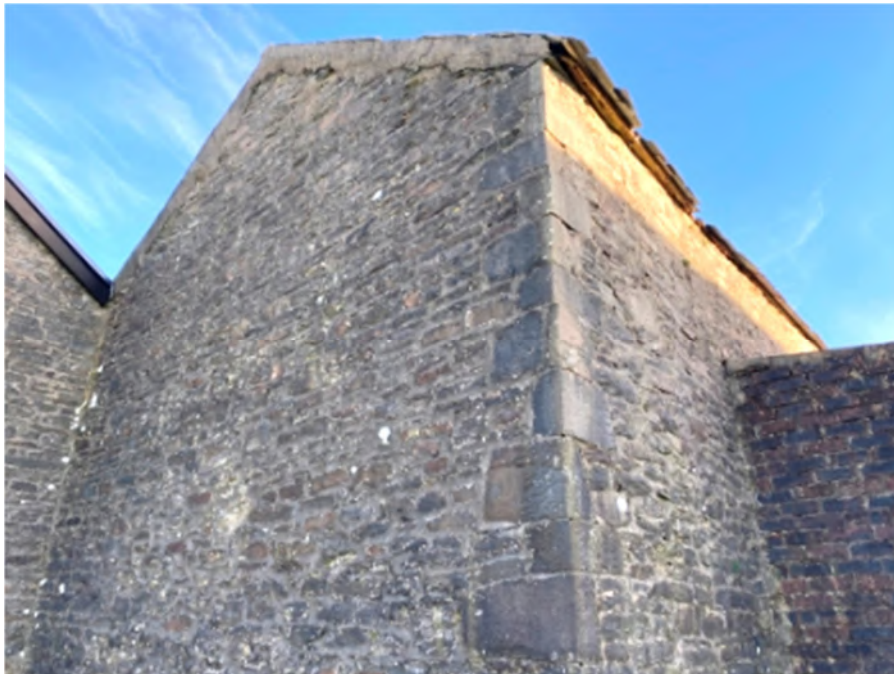
Photograph 10: View at junction of stone barn west gable elevation.

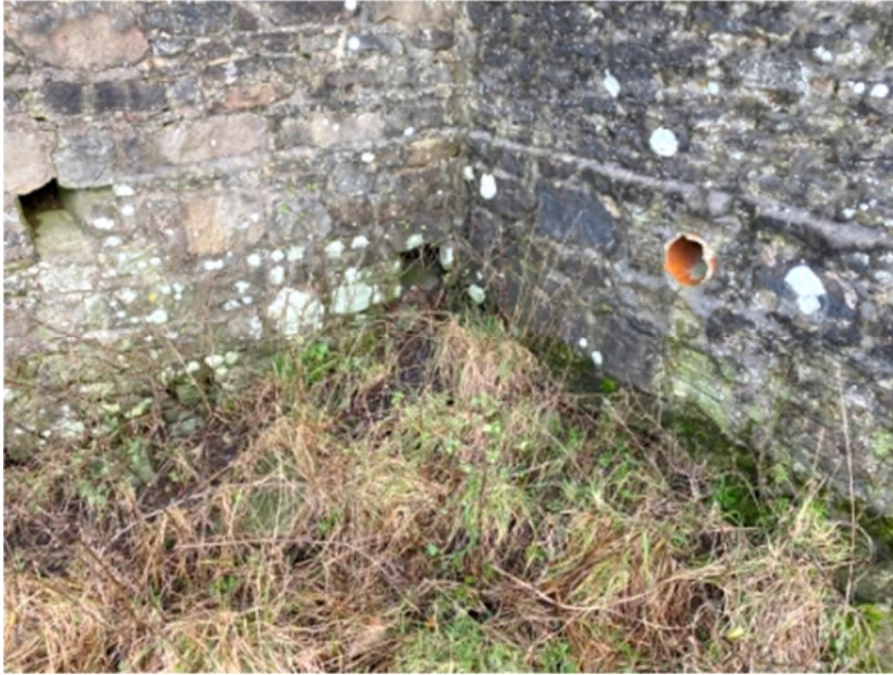
Photograph 11: View of drainage pipes discharging through west gable elevation.

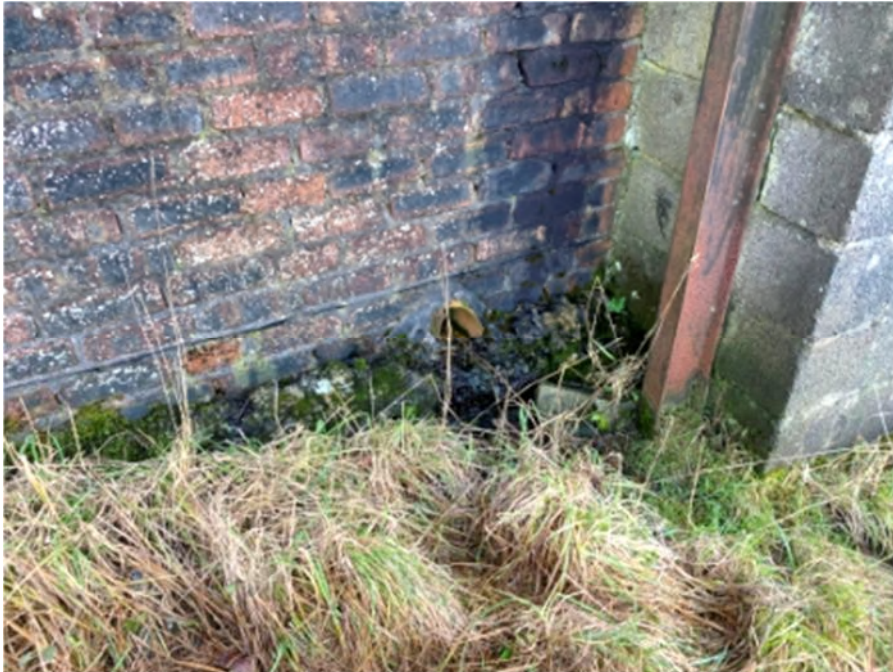
Photograph 12: View of drainage pipe discharging through cow shed west elevation.

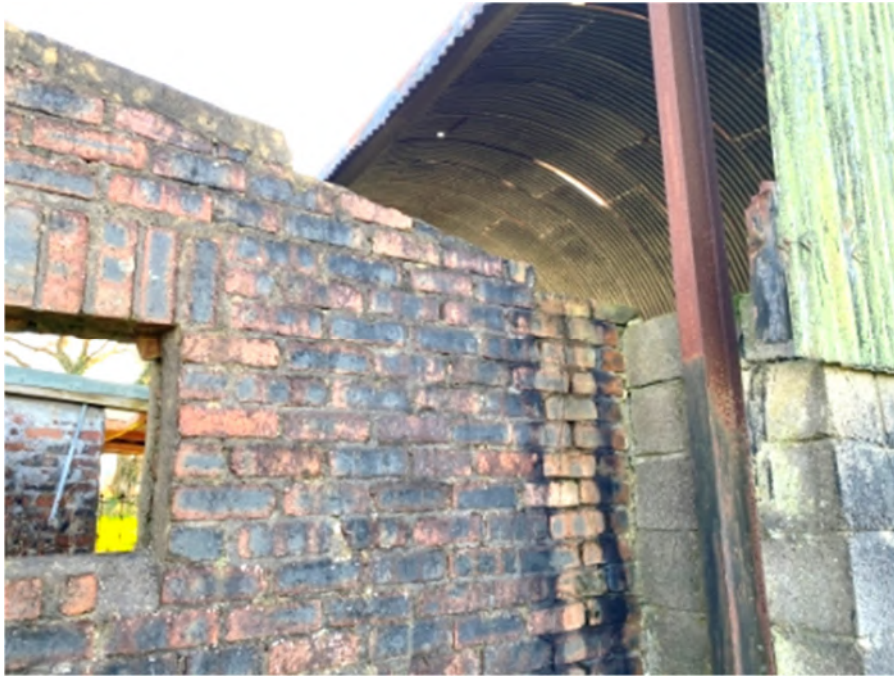
Photograph 13: View of junction between cow shed and Dutch barn on west elevation.

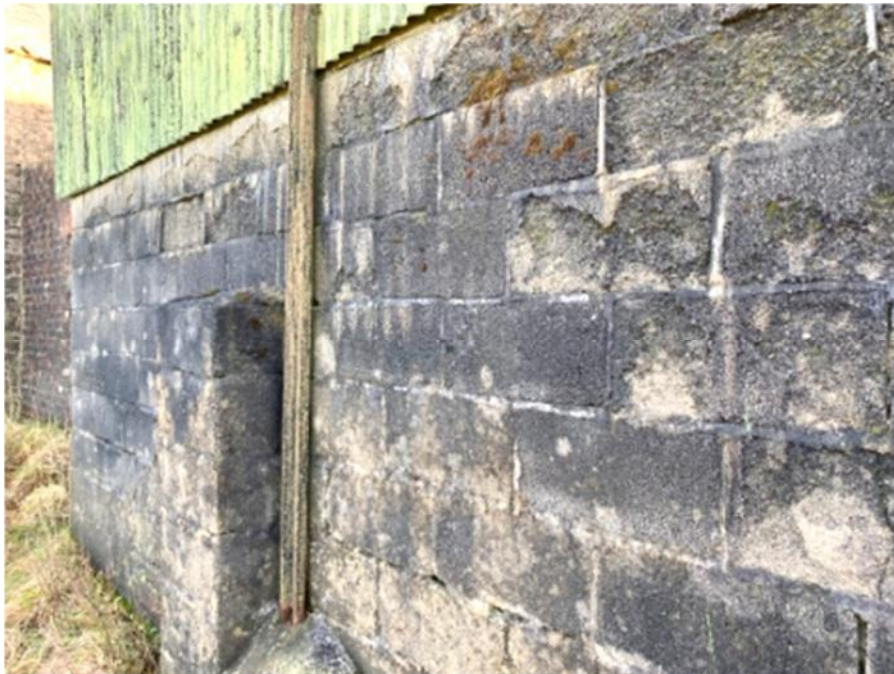
Photograph 14: View of blockwork construction on west gable elevation of Dutch barn.

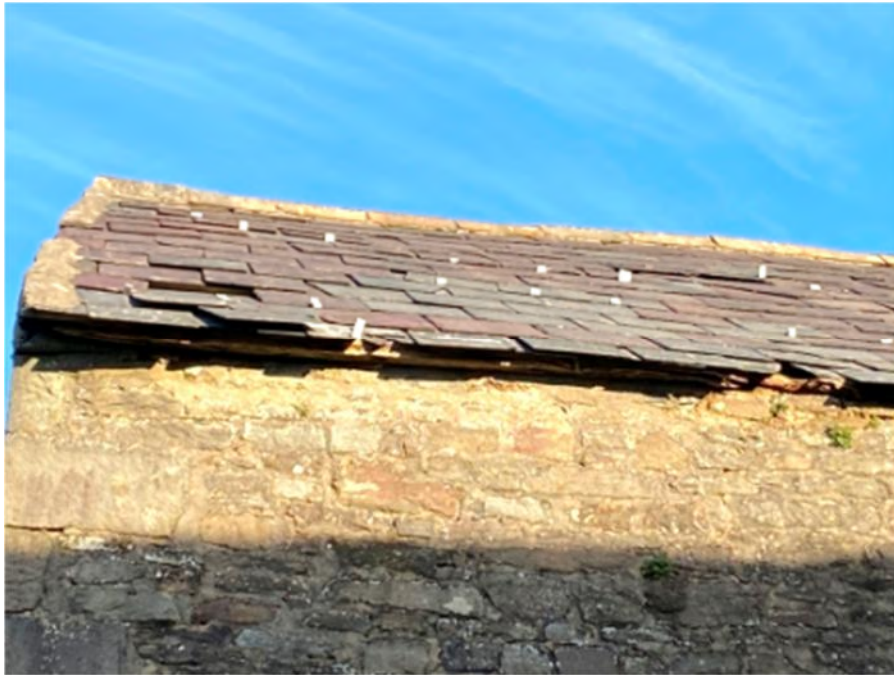
Photograph 15: View of barn roof on southern roof slope. Missing and dislodged slates noted.

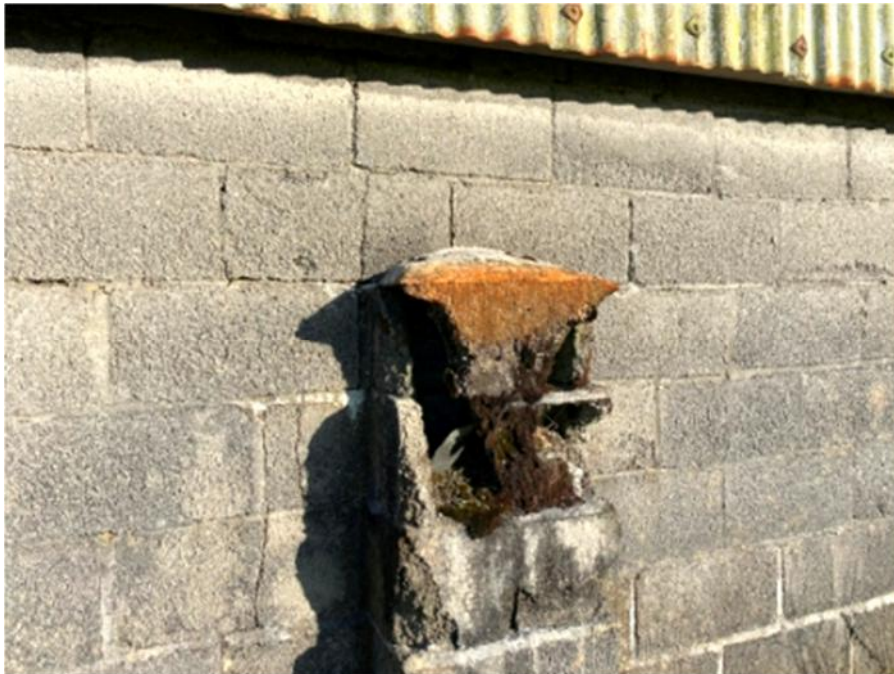
Photograph 16: External blockwork pillars on south elevation of Dutch barn have decayed.

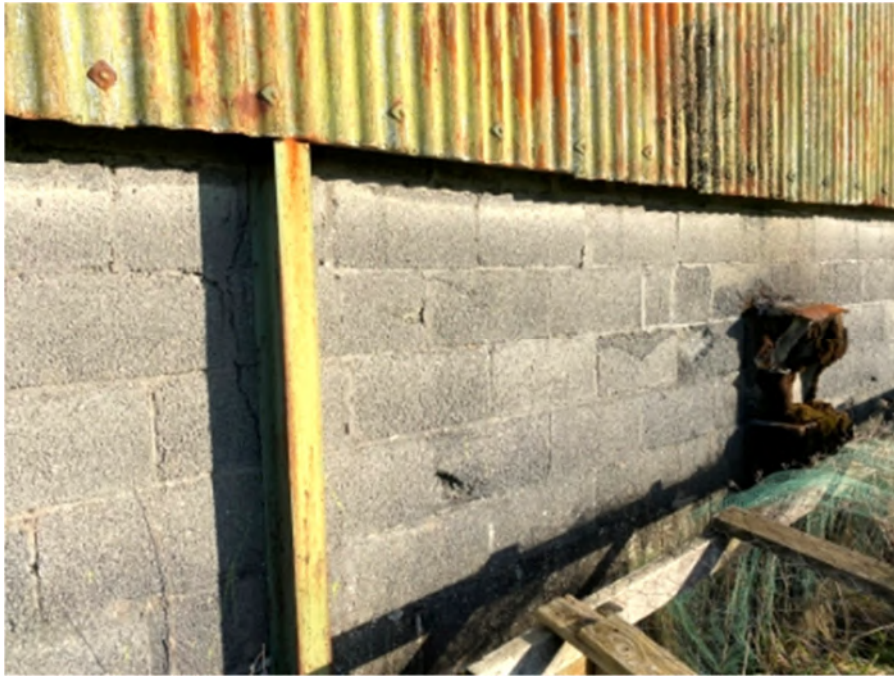
Photograph 17: Dutch barn support steelwork shows evidence of decay due to exposure.

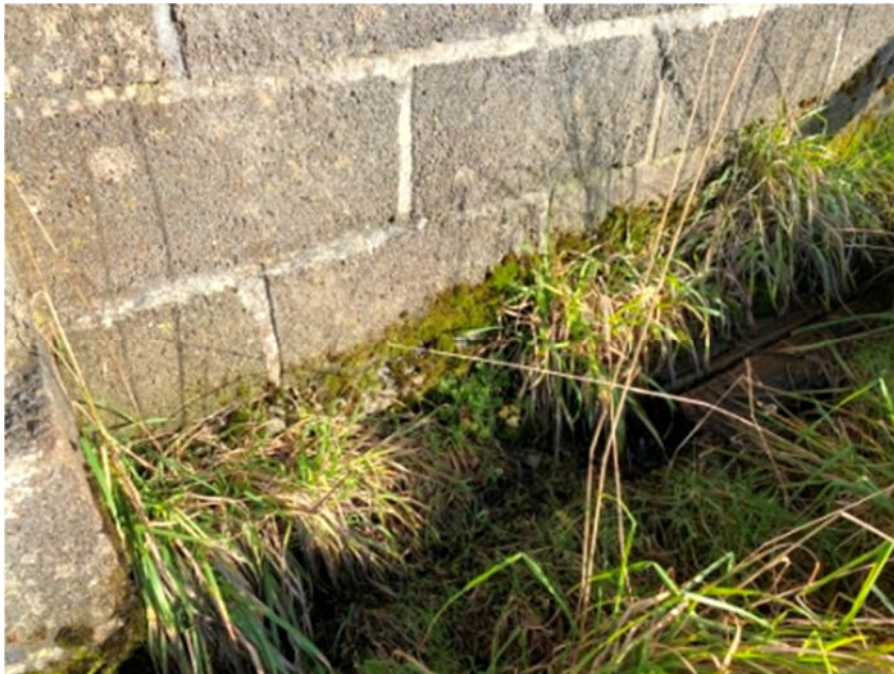
Photograph 18: .Perimeter walls of Dutch barn appear to have been constructed off perimeter of concrete floor slab. Concrete edge is exposed along the southern elevation.

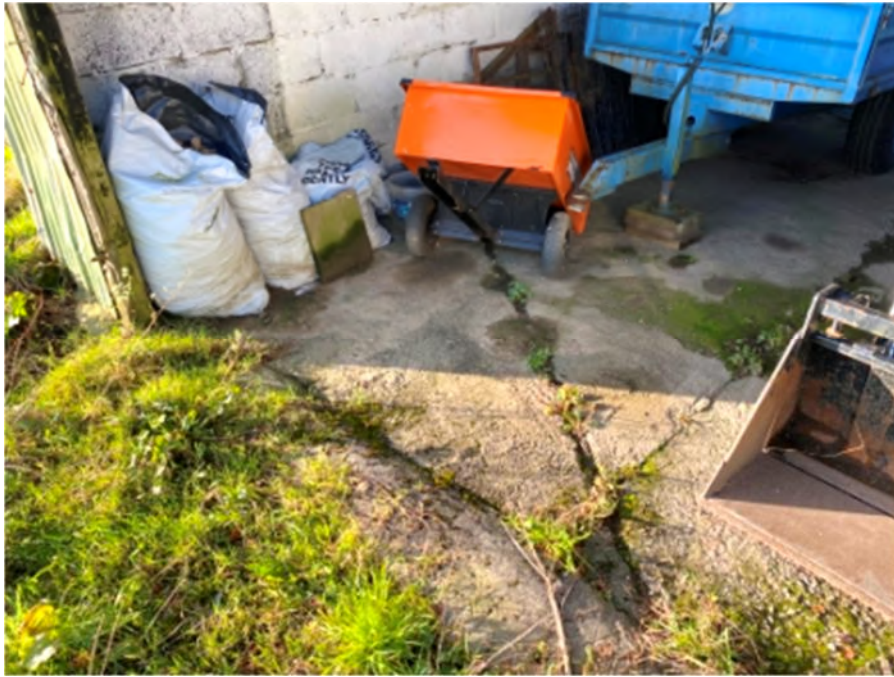
Photograph 19: View of Dutch barn concrete floor slab which has failed at the south east corner.

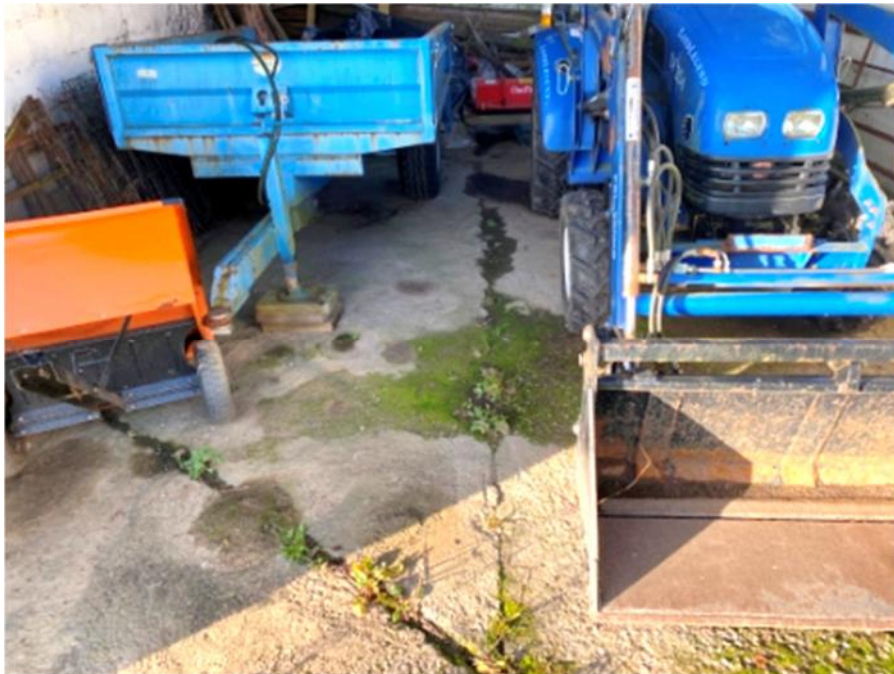
Photograph 20: Crack noted along central joint. Each half of concrete slab has suffered from differential settlement.

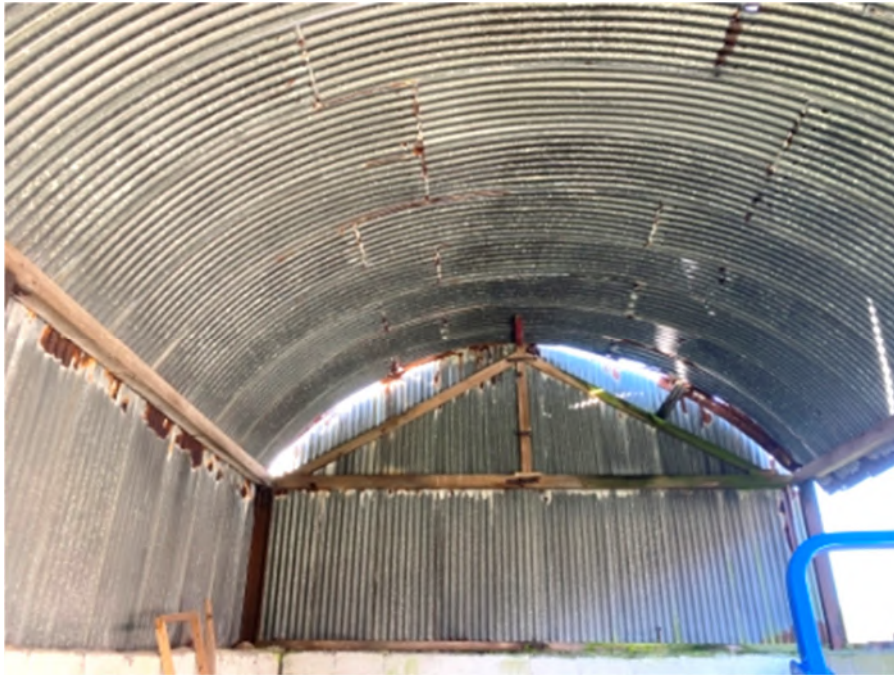
Photograph 21: Internal view of Dutch barn. Timber structure supports corrugated steel sheeting, above blockwork walls. Roof relies on diaphragm action of metal sheeting with no roof support members.

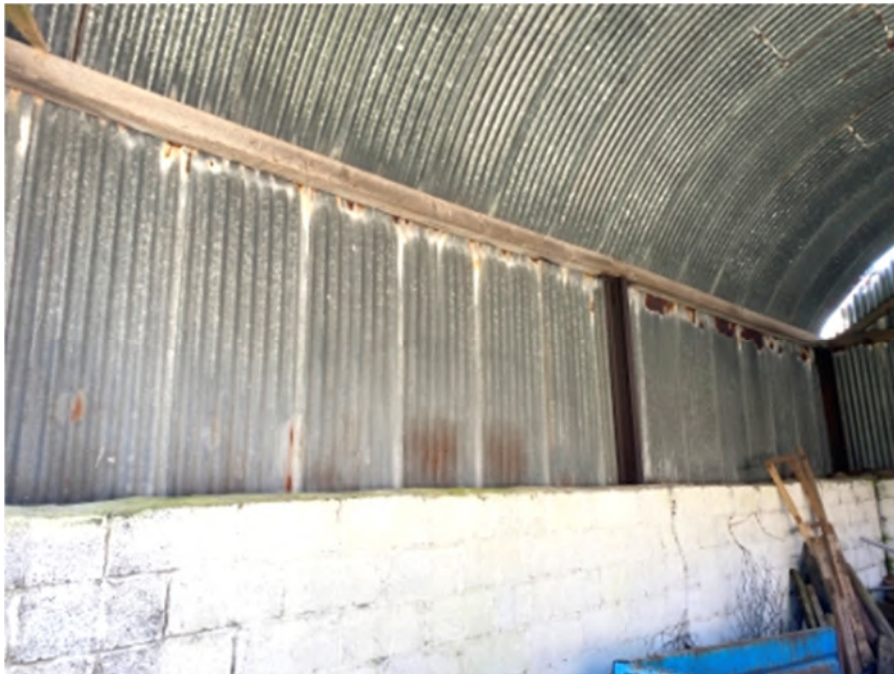
Photograph 22: Internal view of Dutch barn south elevation. No bracing members provided to structure.

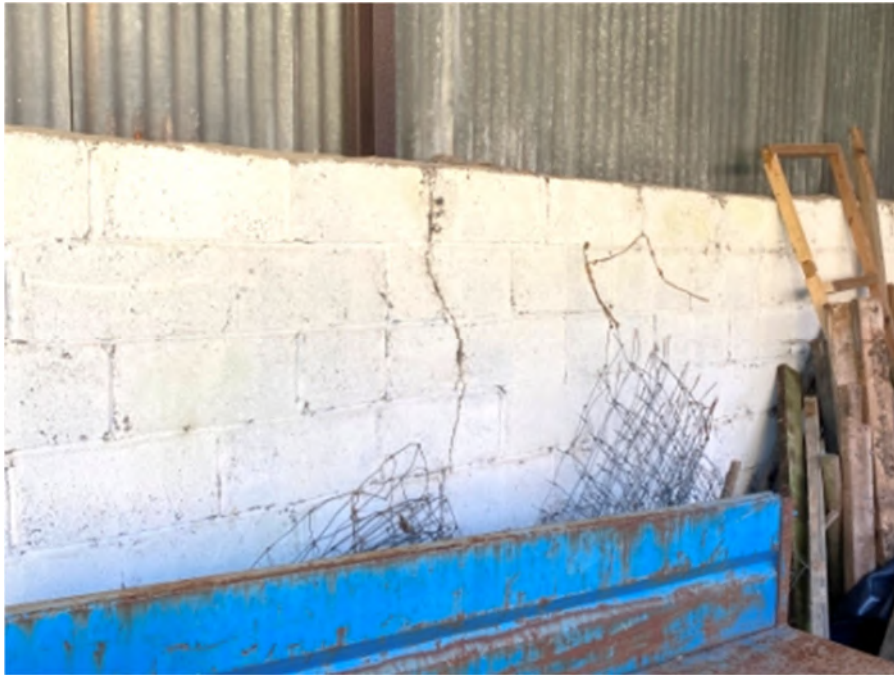
Photograph 23: View of vertical crack, full height of blockwork, on Dutch barn south elevation.

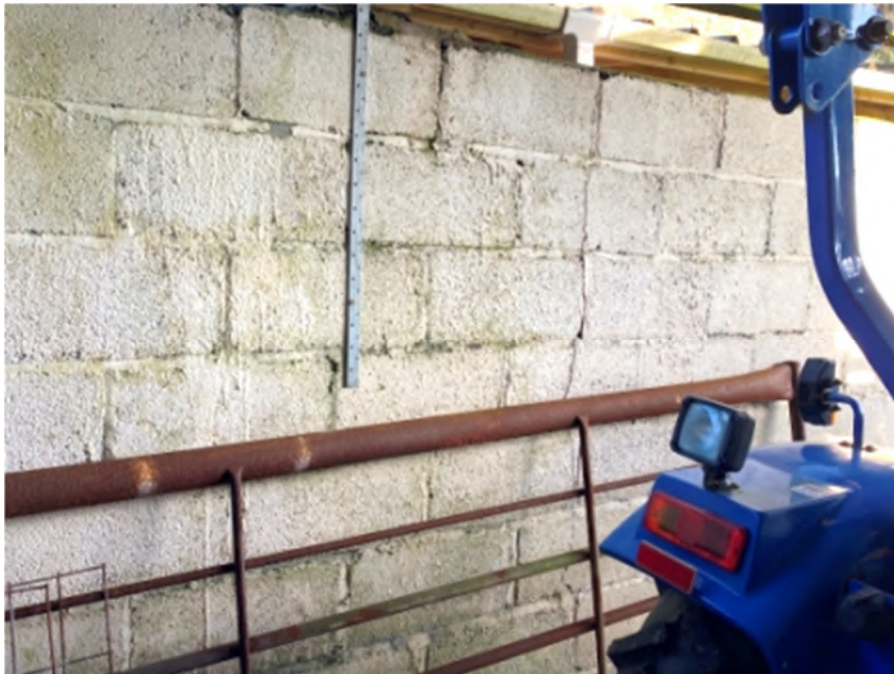
Photograph 24: View of vertical crack, full height of blockwork, on Dutch barn north elevation.

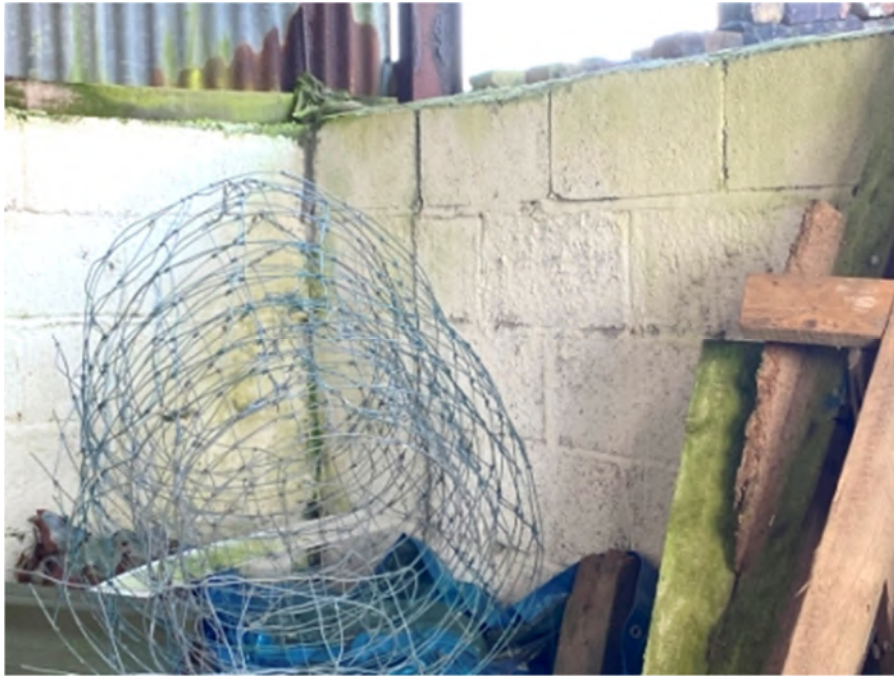
Photograph 25: View of vertical crack, full height of blockwork, on Dutch barn north elevation.

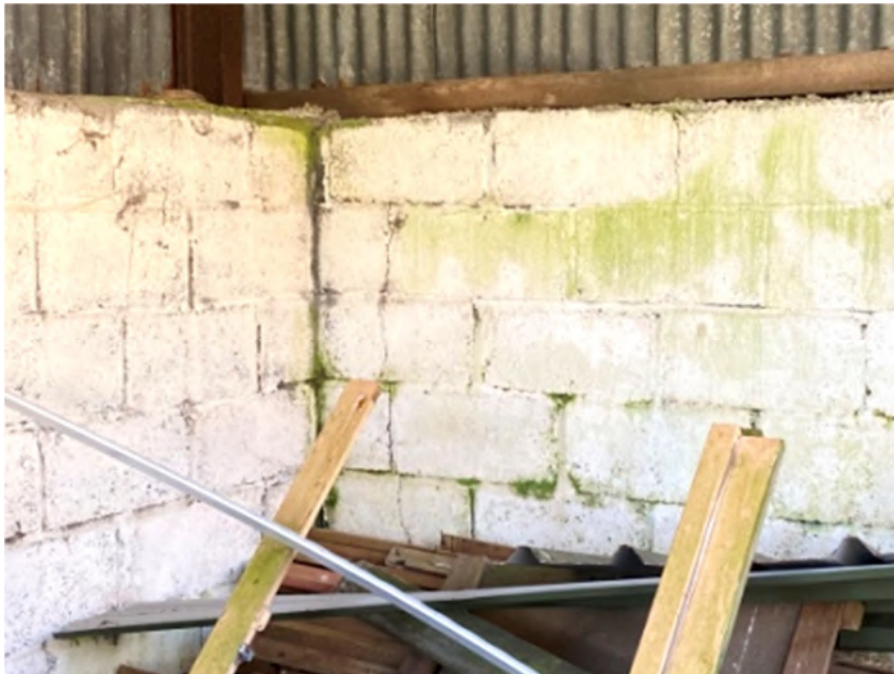
Photograph 26: View of vertical crack within blockwork, on Dutch barn west elevation.

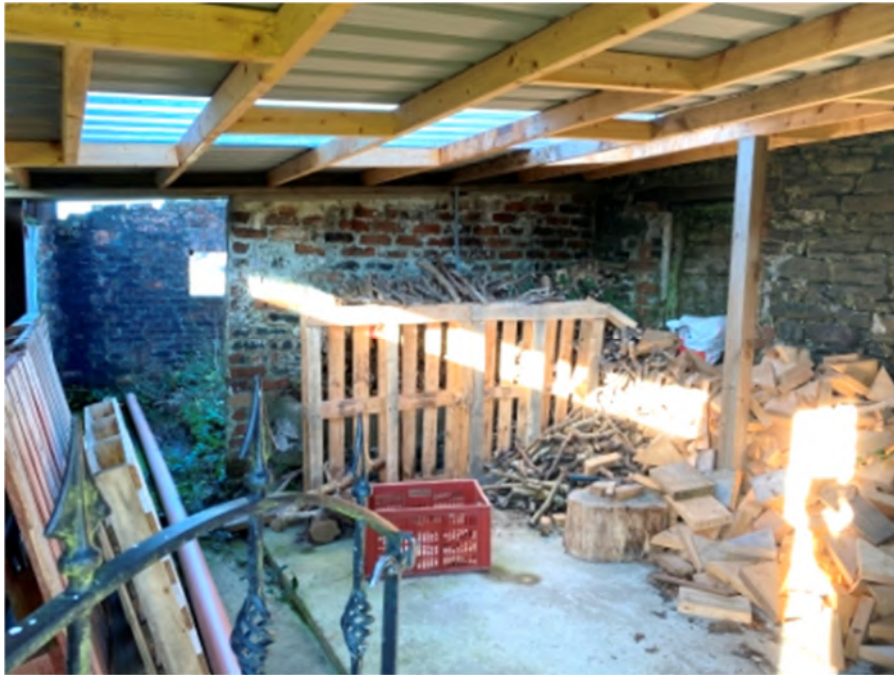
Photograph 27: Internal view of lightweight timber roof structure and profiled metal sheet cladding over cow shed.

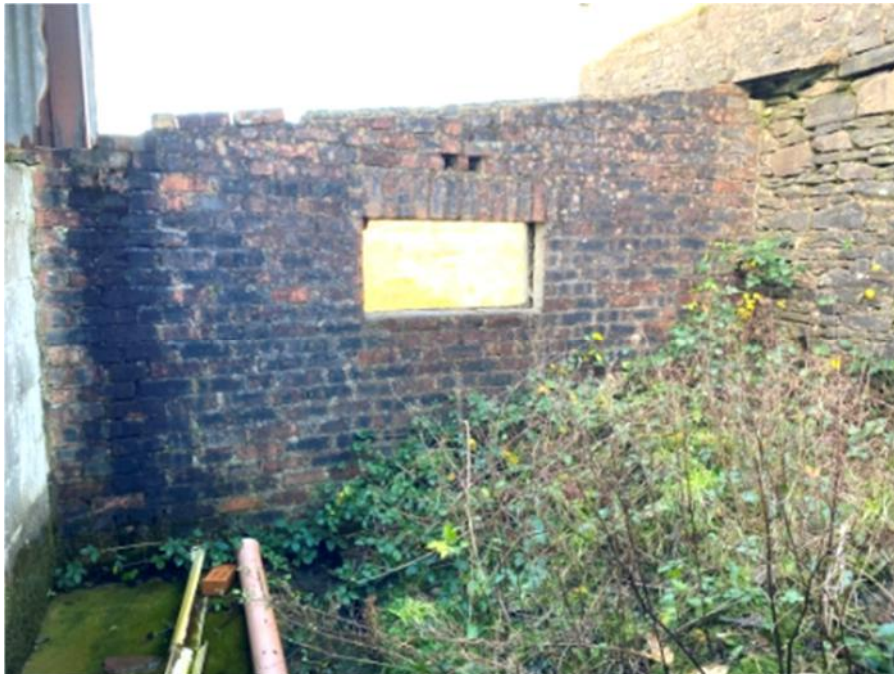
Photograph 28: Internal view of cow shed west elevation brick wall. No window or roof covering.

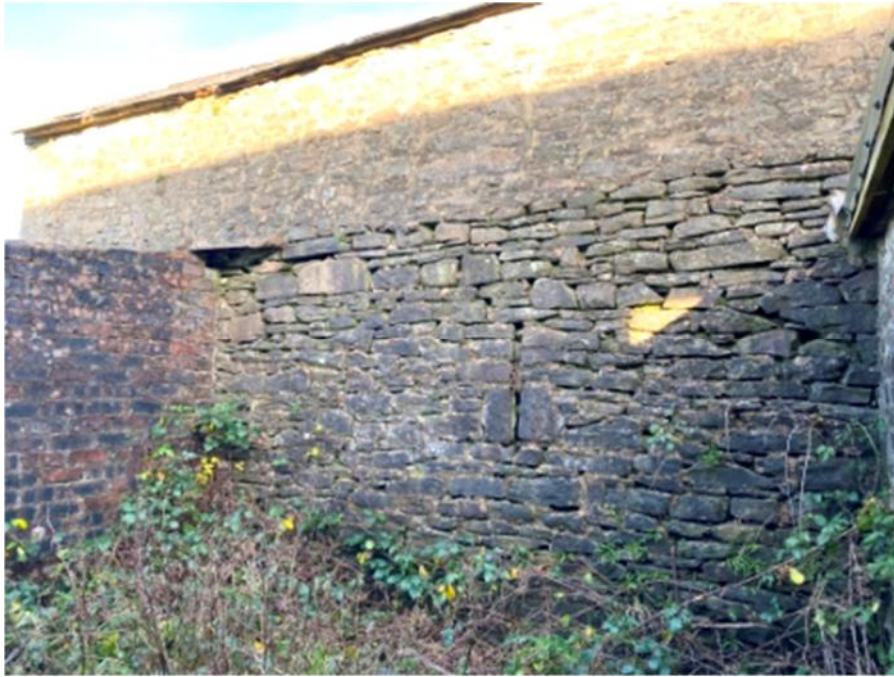
Photograph 29: View of outer face of barn southern elevation from inside cow shed area.

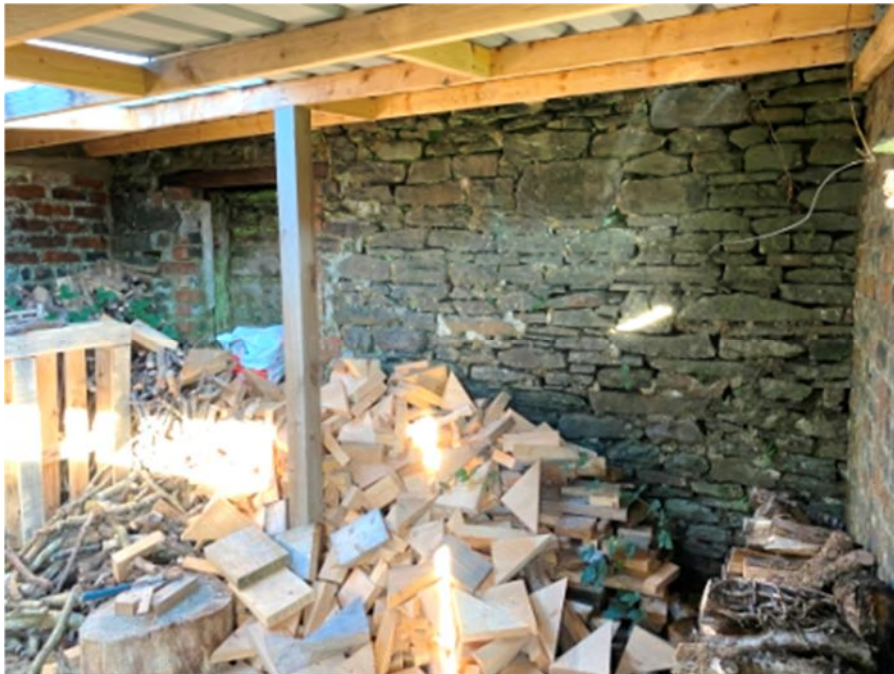
Photograph 30: Second view of barn south elevation from inside cow shed.

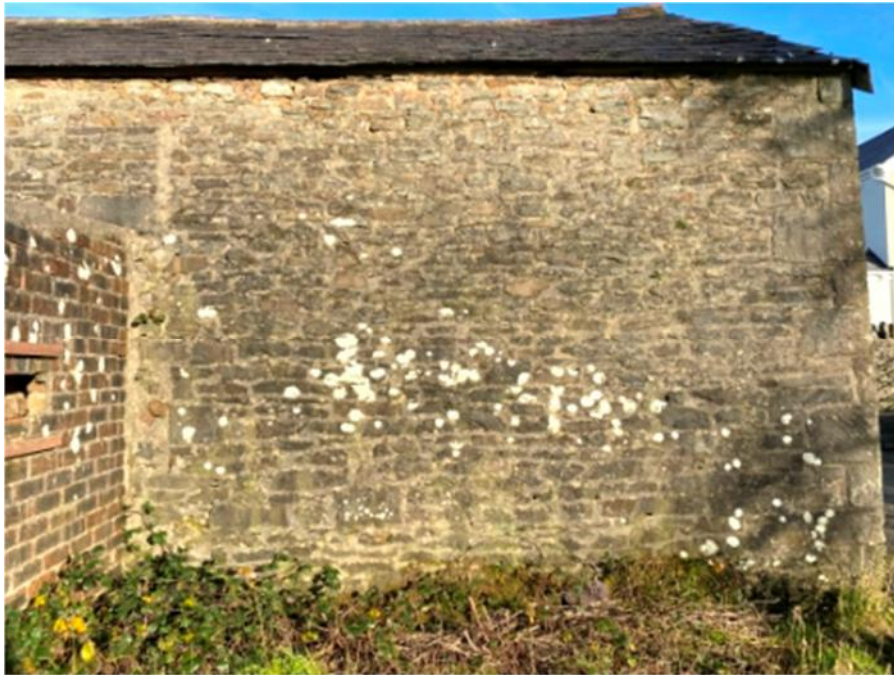
Photograph 31: View of barn south elevation at south east corner. All stonework is in good condition.

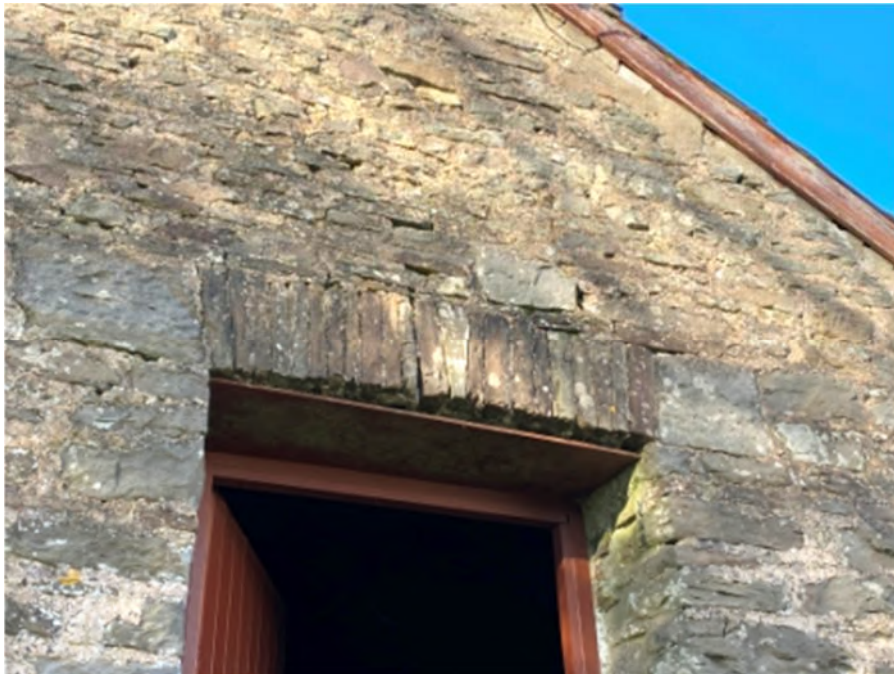
Photograph 32: View of stone soldier course over first floor opening in barn east gable elevation.

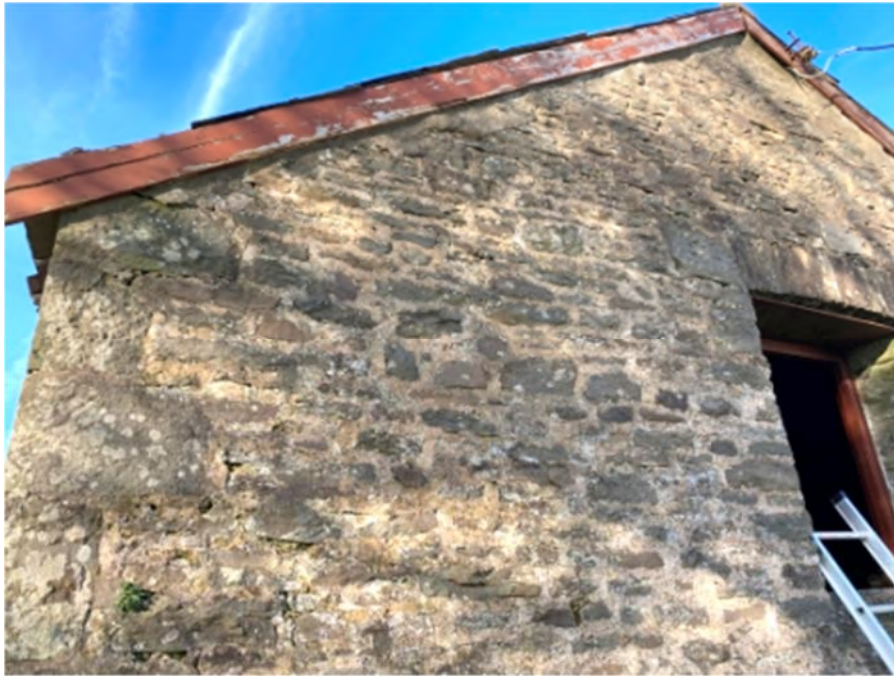
Photograph 33: View of barn east elevation. Stonework is in good condition with no cracking.

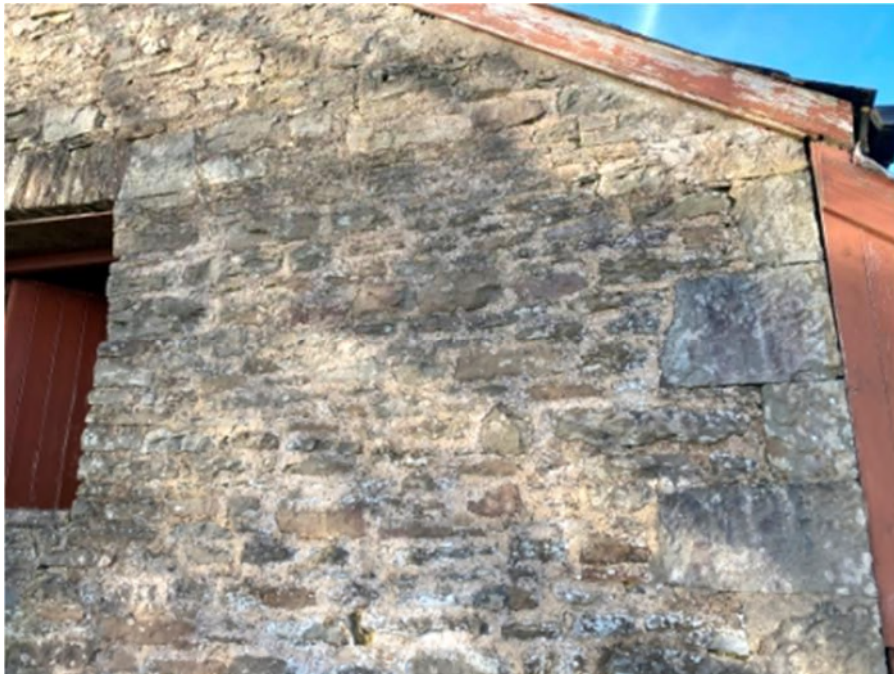
Photograph 34: Second view of barn east elevation. Stonework in good condition.

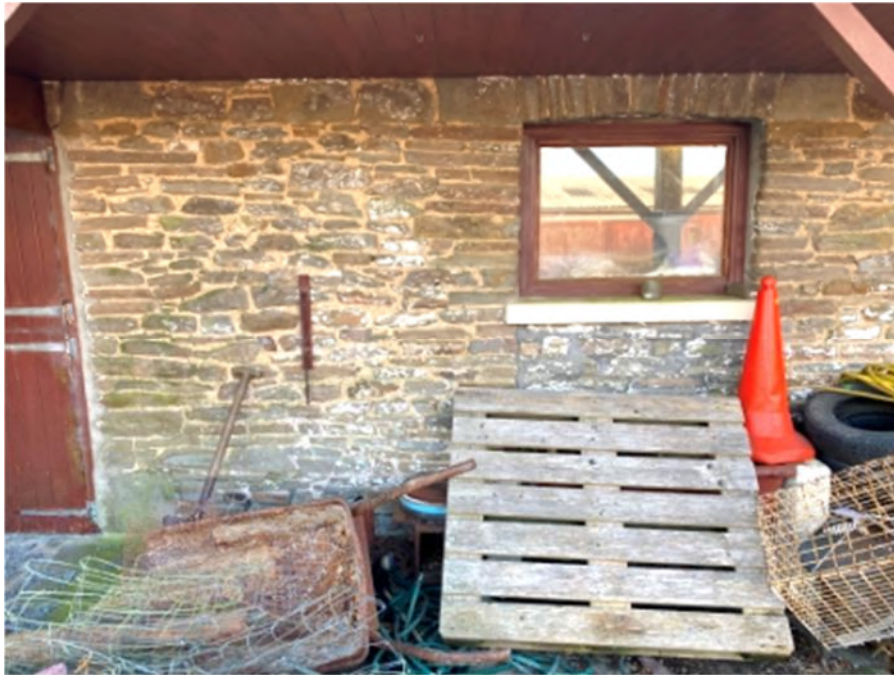
Photograph 35: Part view of barn north elevation (courtyard). No cracking noted externally.

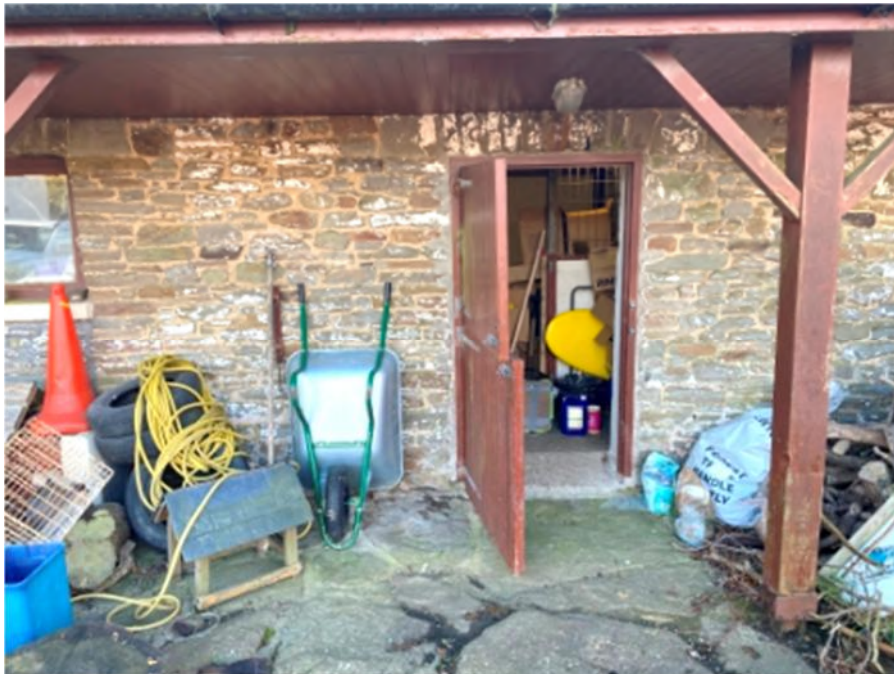
Photograph 36: Part view of barn north elevation (courtyard). No cracking noted.

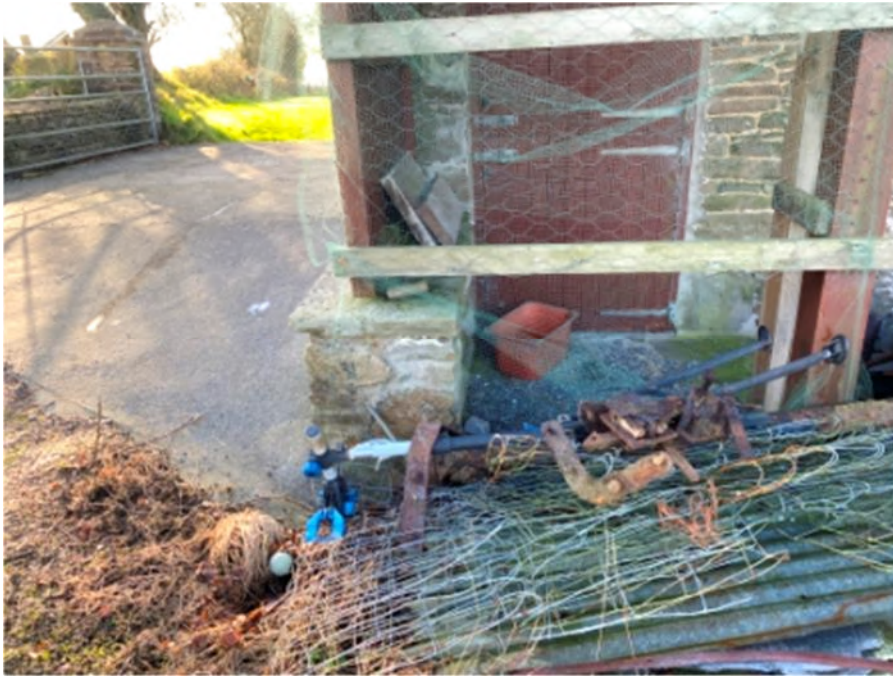
Photograph 37: View showing difference in levels between barn floor and external levels along east gable elevation. External levels are higher along this elevation.
