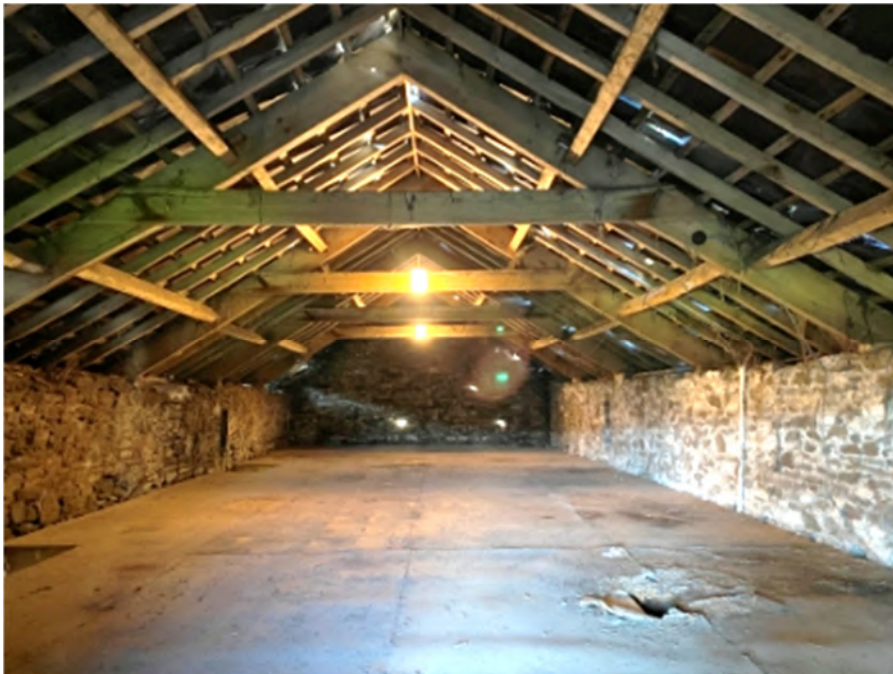
Photograph 38: View of barn roof structure consisting of timber rafters, purlins and A-frame trusses.

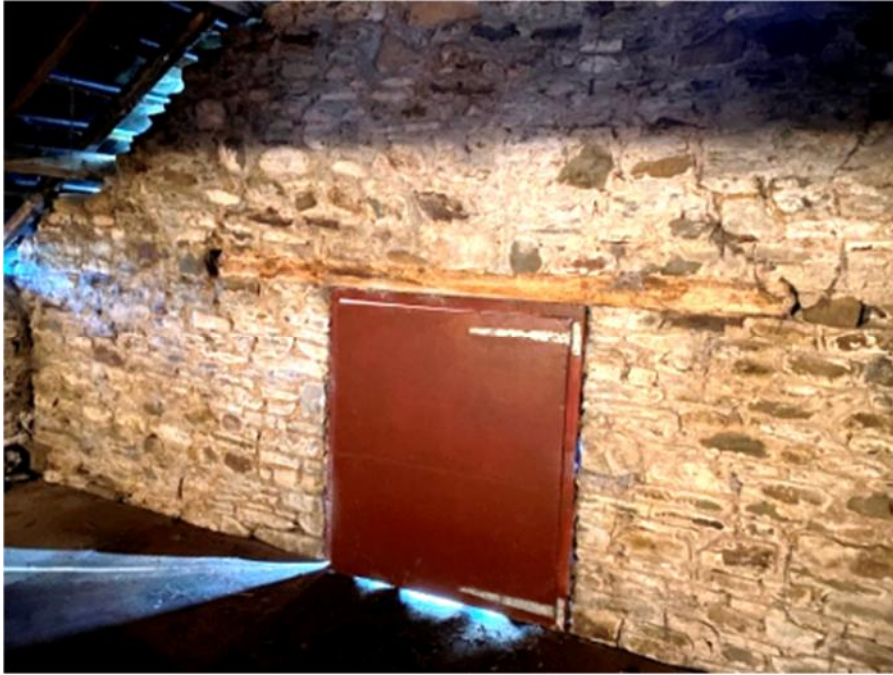
Photograph 39: Internal view of barn east elevation. No cracking or structural movement noted.

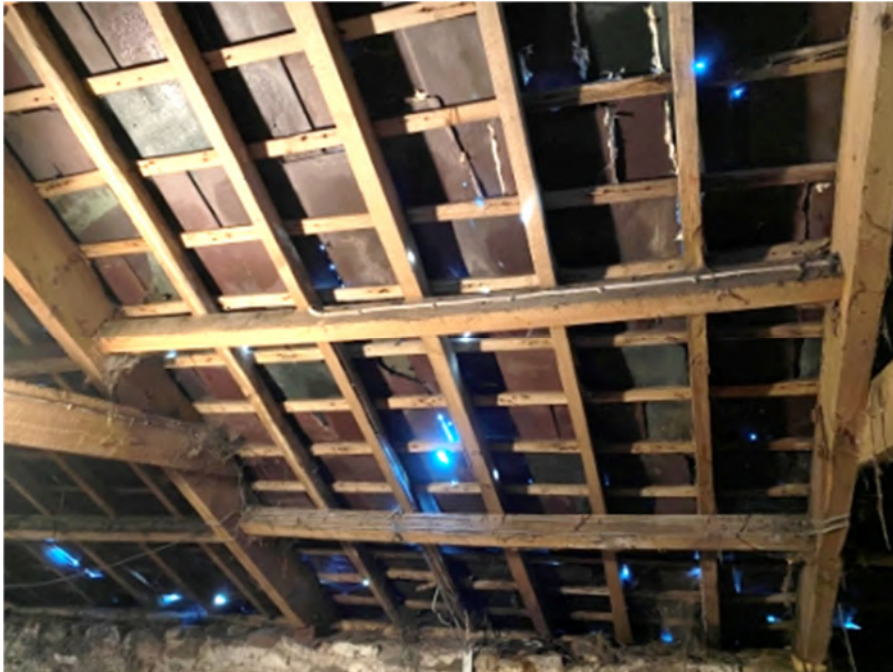
Photograph 40: Daylight can be seen at numerous locations through the slate roof finishes allowing rainwater to penetrate the barn.

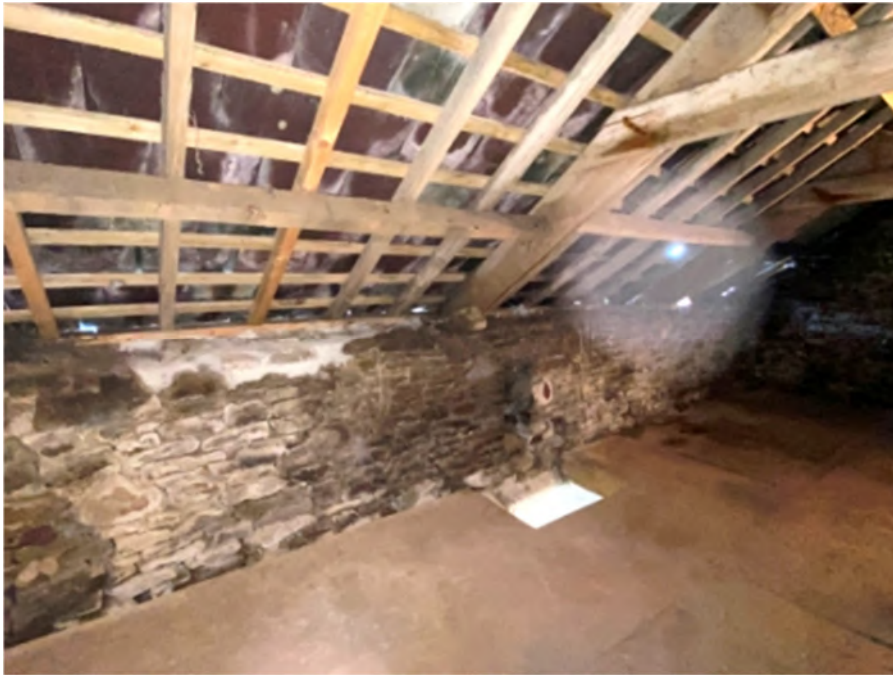
Photograph 41: All stone walls at first floor level appeared stable with no sign of cracking.

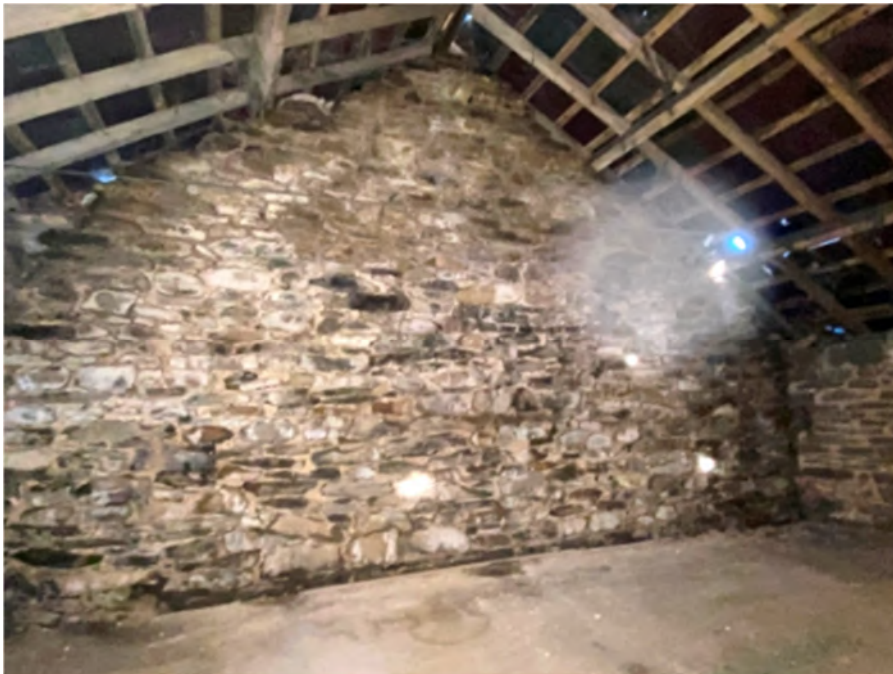
Photograph 42: Internal view of west gable elevation wall. Wall is in a stable condition.

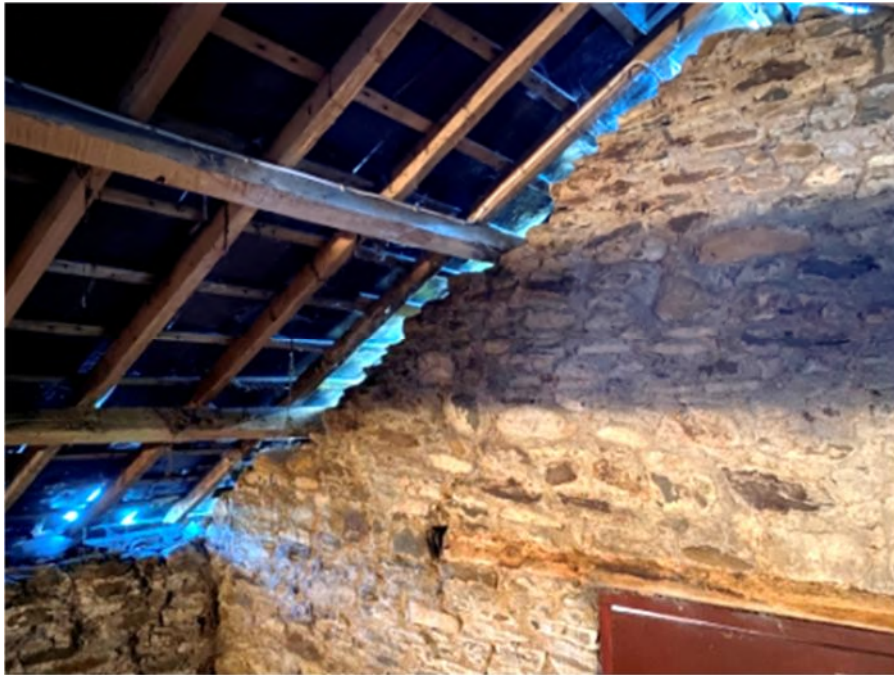
Photograph 43: Timber purlin ends are built over end gable walls and are exposed to the elements.

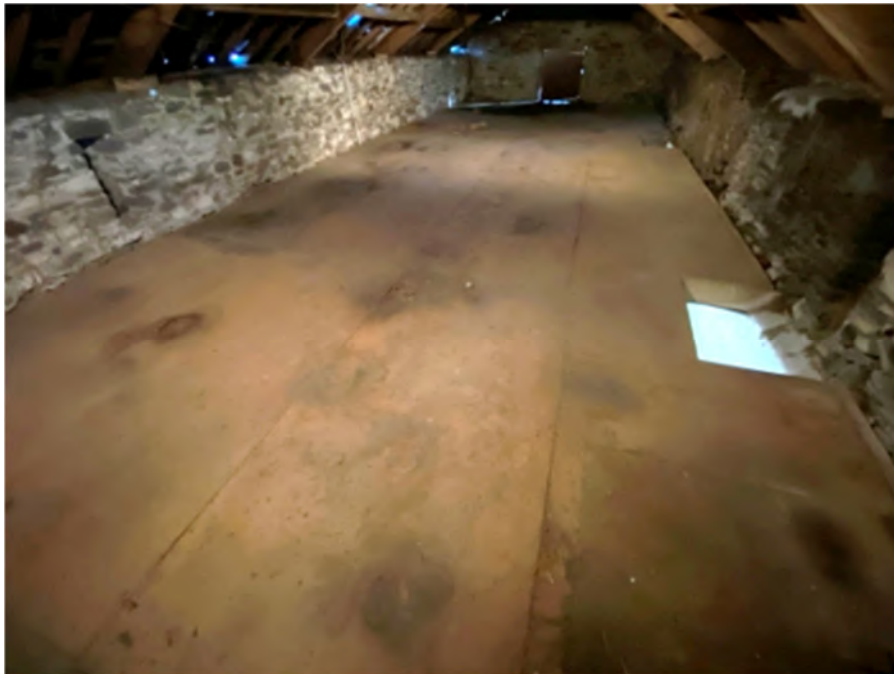
Photograph 44: Areas of first floor timber decking have decayed due to prolonged ingress of rainwater.

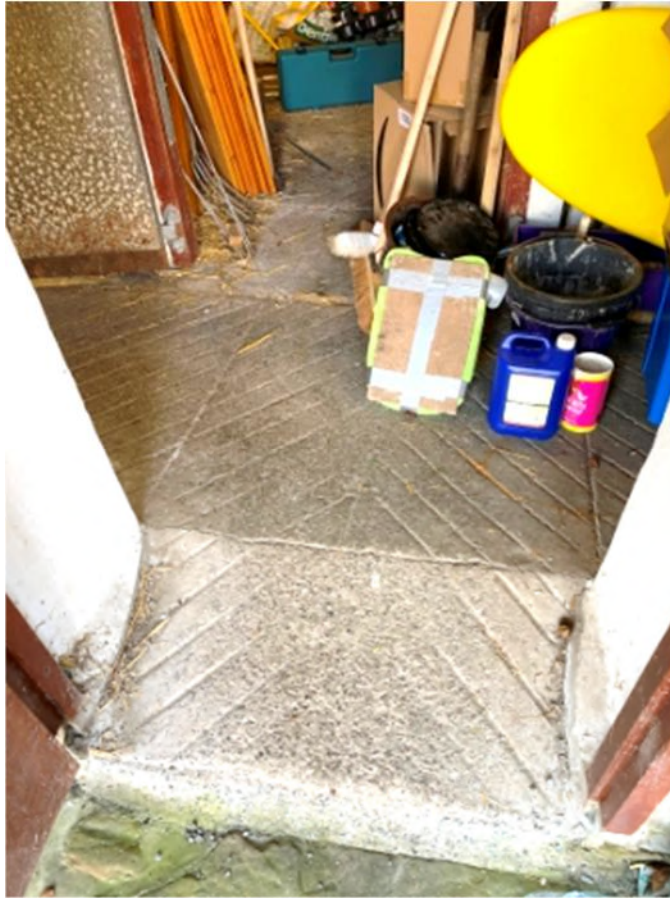
Photograph 45: Barn has a concrete ground bearing slab construction.

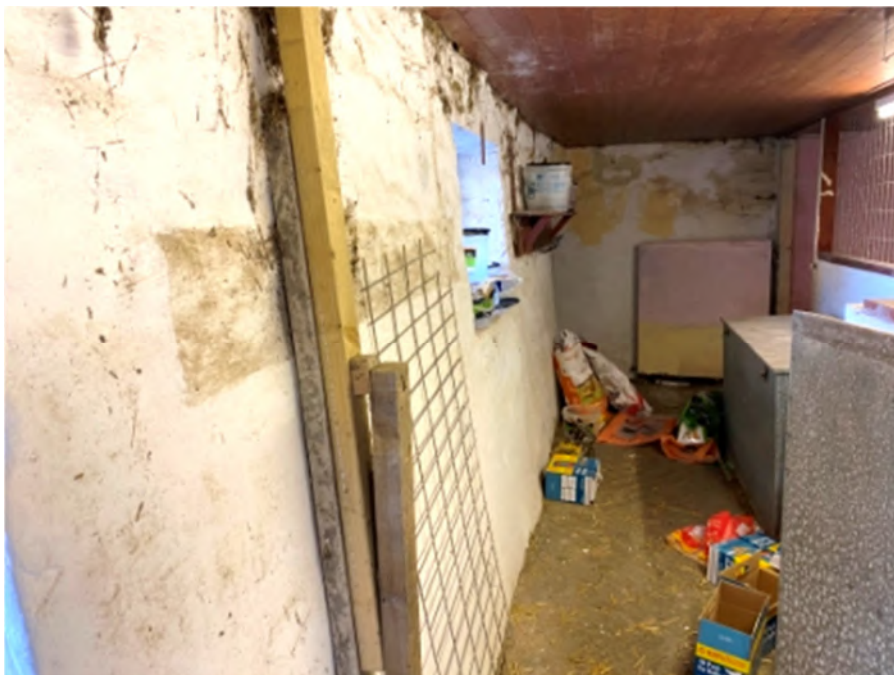
Photograph 46: Internal view of north elevation barn wall shows a significant outwards bow.

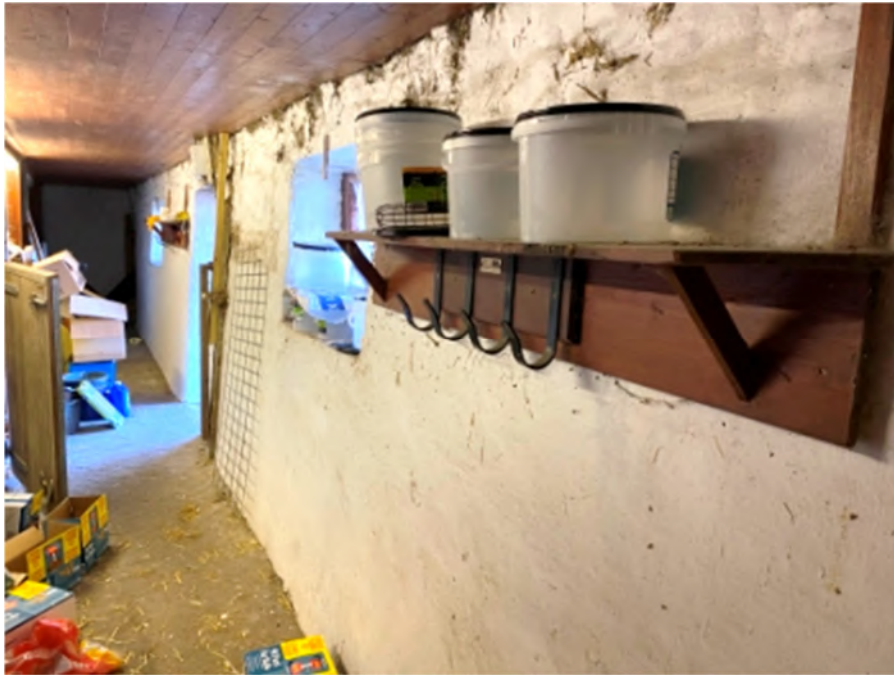
Photograph 47: Second view along the length of the barn north elevation wall with significant outwards lean. No cracking is noted within the wall construction.

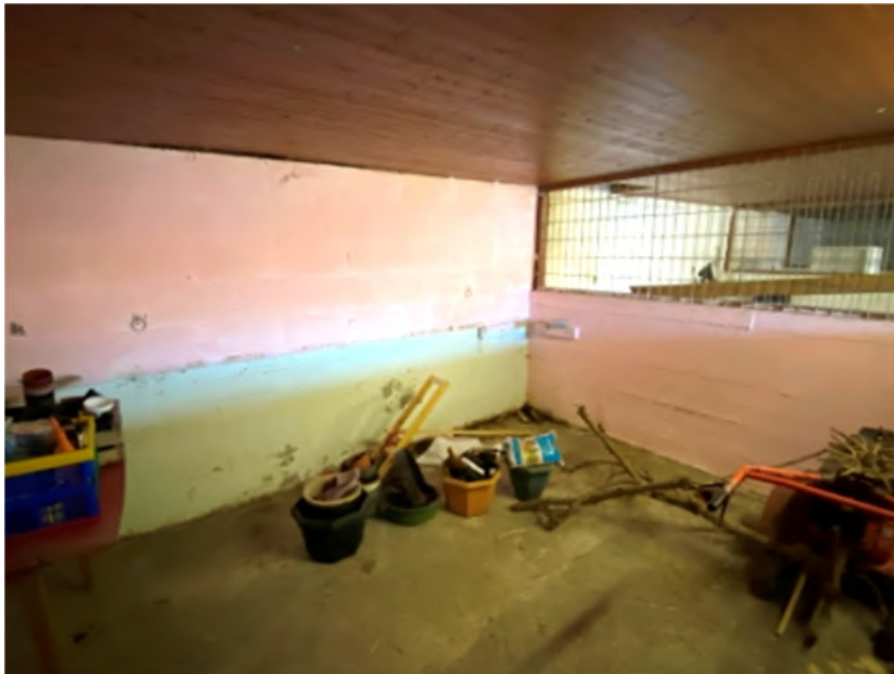
Photograph 48: Internal view of south elevation barn wall shows an inner skin of concrete blockwork. No cracking or structural movement is noted to the blockwork construction.

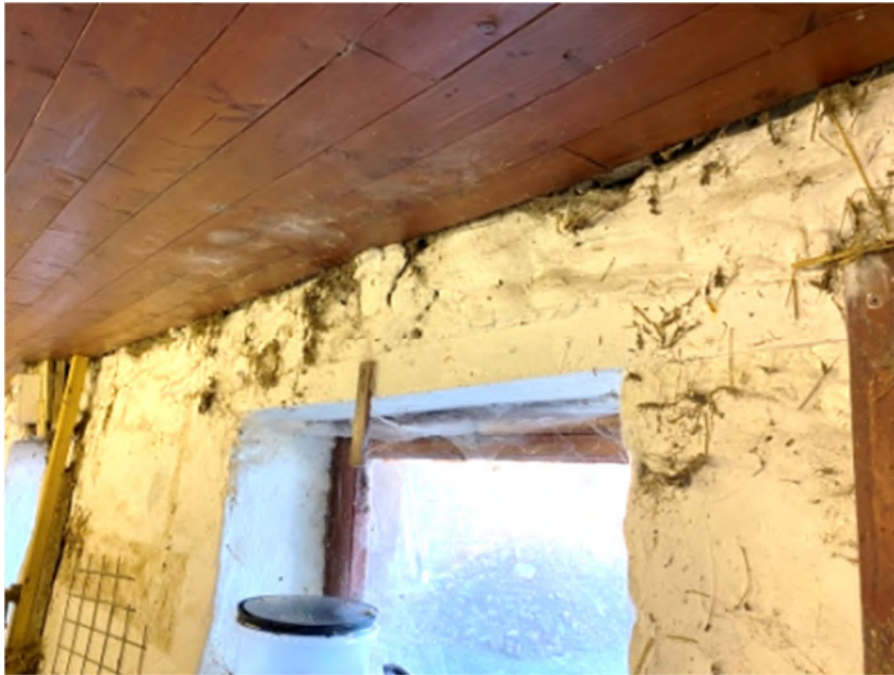
Photograph 49: Inner timber lintels along the north elevation appear in good condition.

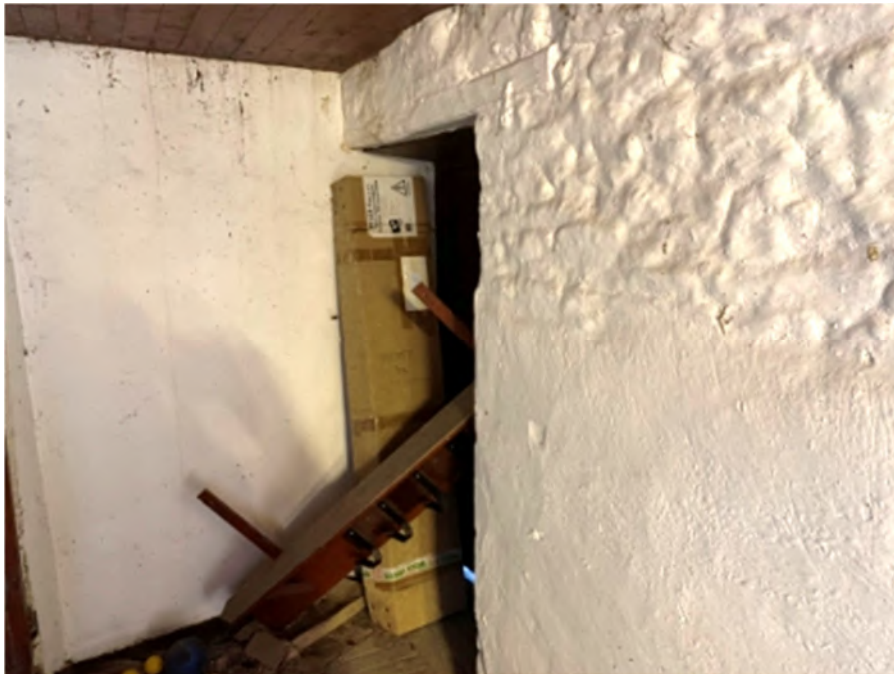
Photograph 50: Single door opening exists in the north west corner, allowing access into the next adjacent barn building.

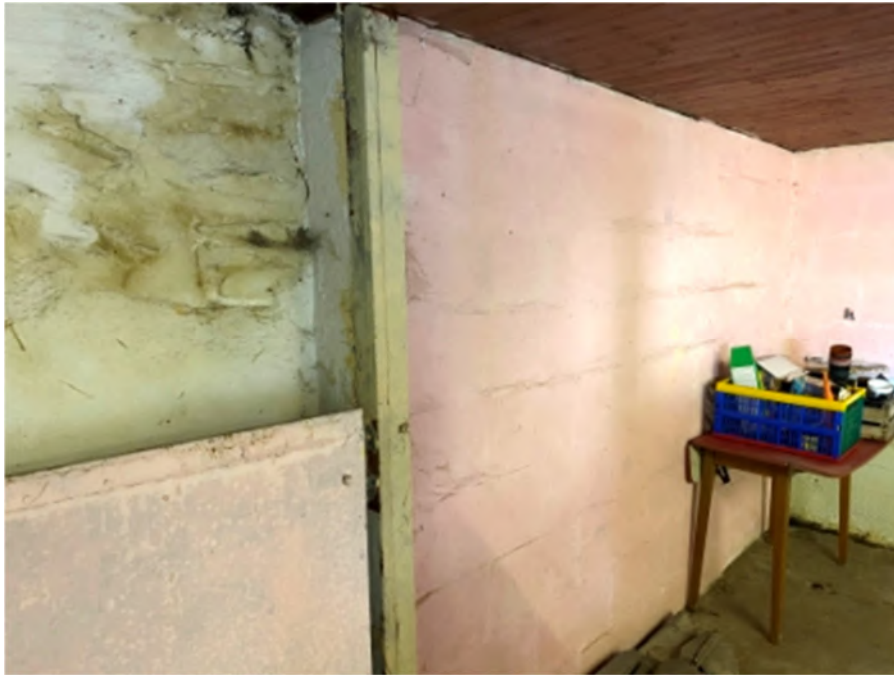
Photograph 51: View of inner block skin which exists along the south, east and west elevations.

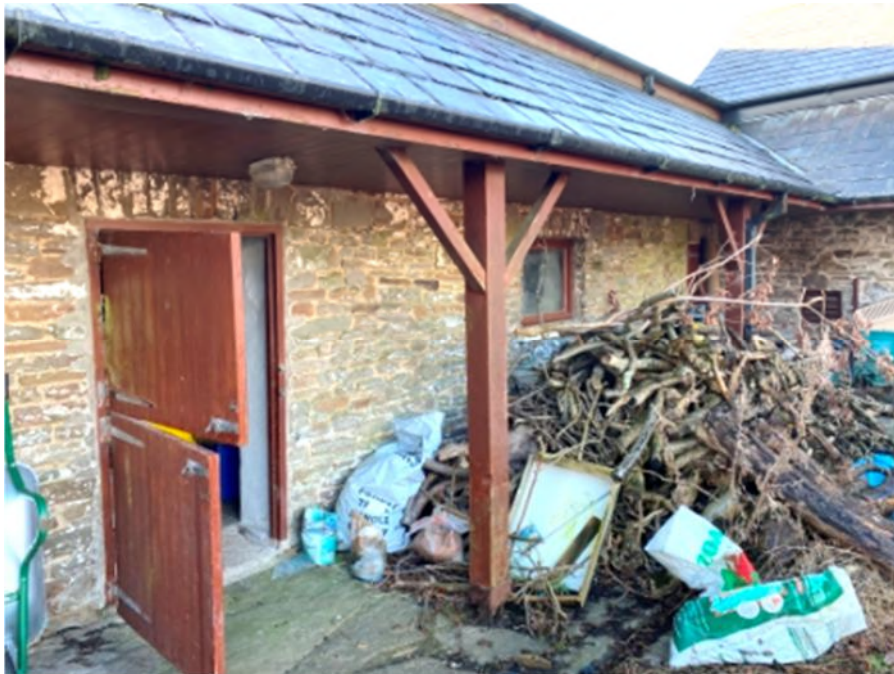
Photograph 52: Timber posts with diagonal bracing support a mono pitch timber canopy structure along the north courtyard elevation.

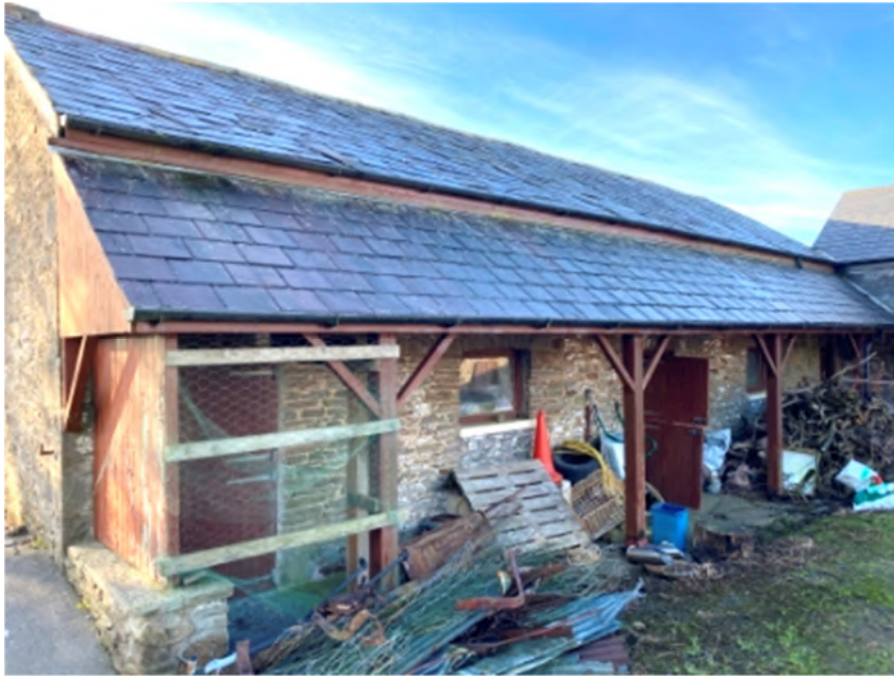
Photograph 53: View of north elevation canopy structure.

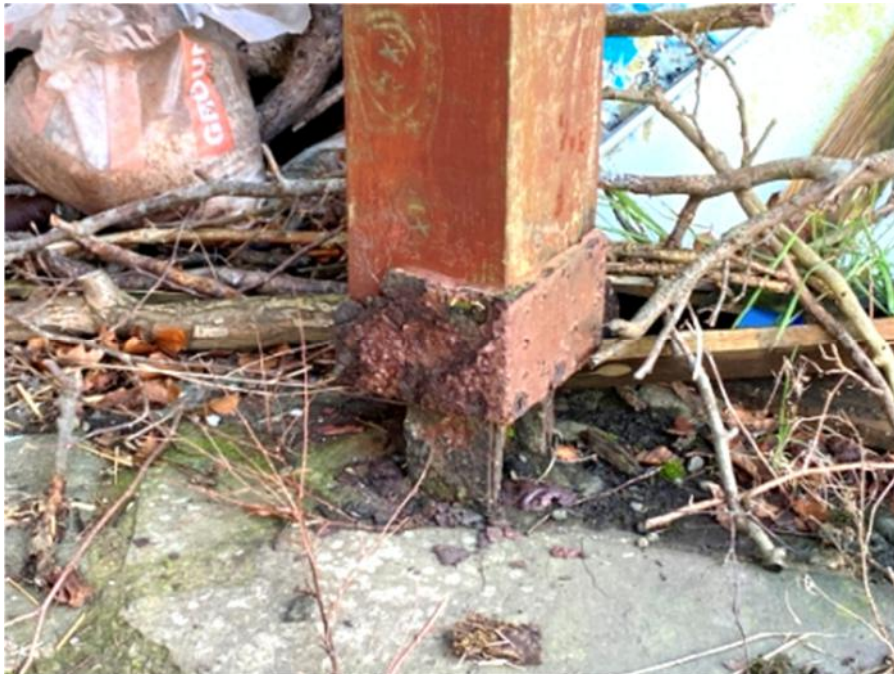
Photograph 54: View of decayed steel post shoe support. Steel shoe shows significant amount of rust.
