**PLANNING CONSENT P2014/0729**

**ENERGYBUILD Ltd.  
(Or the Operating Company)**

**ABERPERGWM COLLIERY  
SCHEME FOR THE REMEDIATION OF THE ROCK TIP LAGOONS AND THEIR ENVIRONS**

**AUGUST 2021**

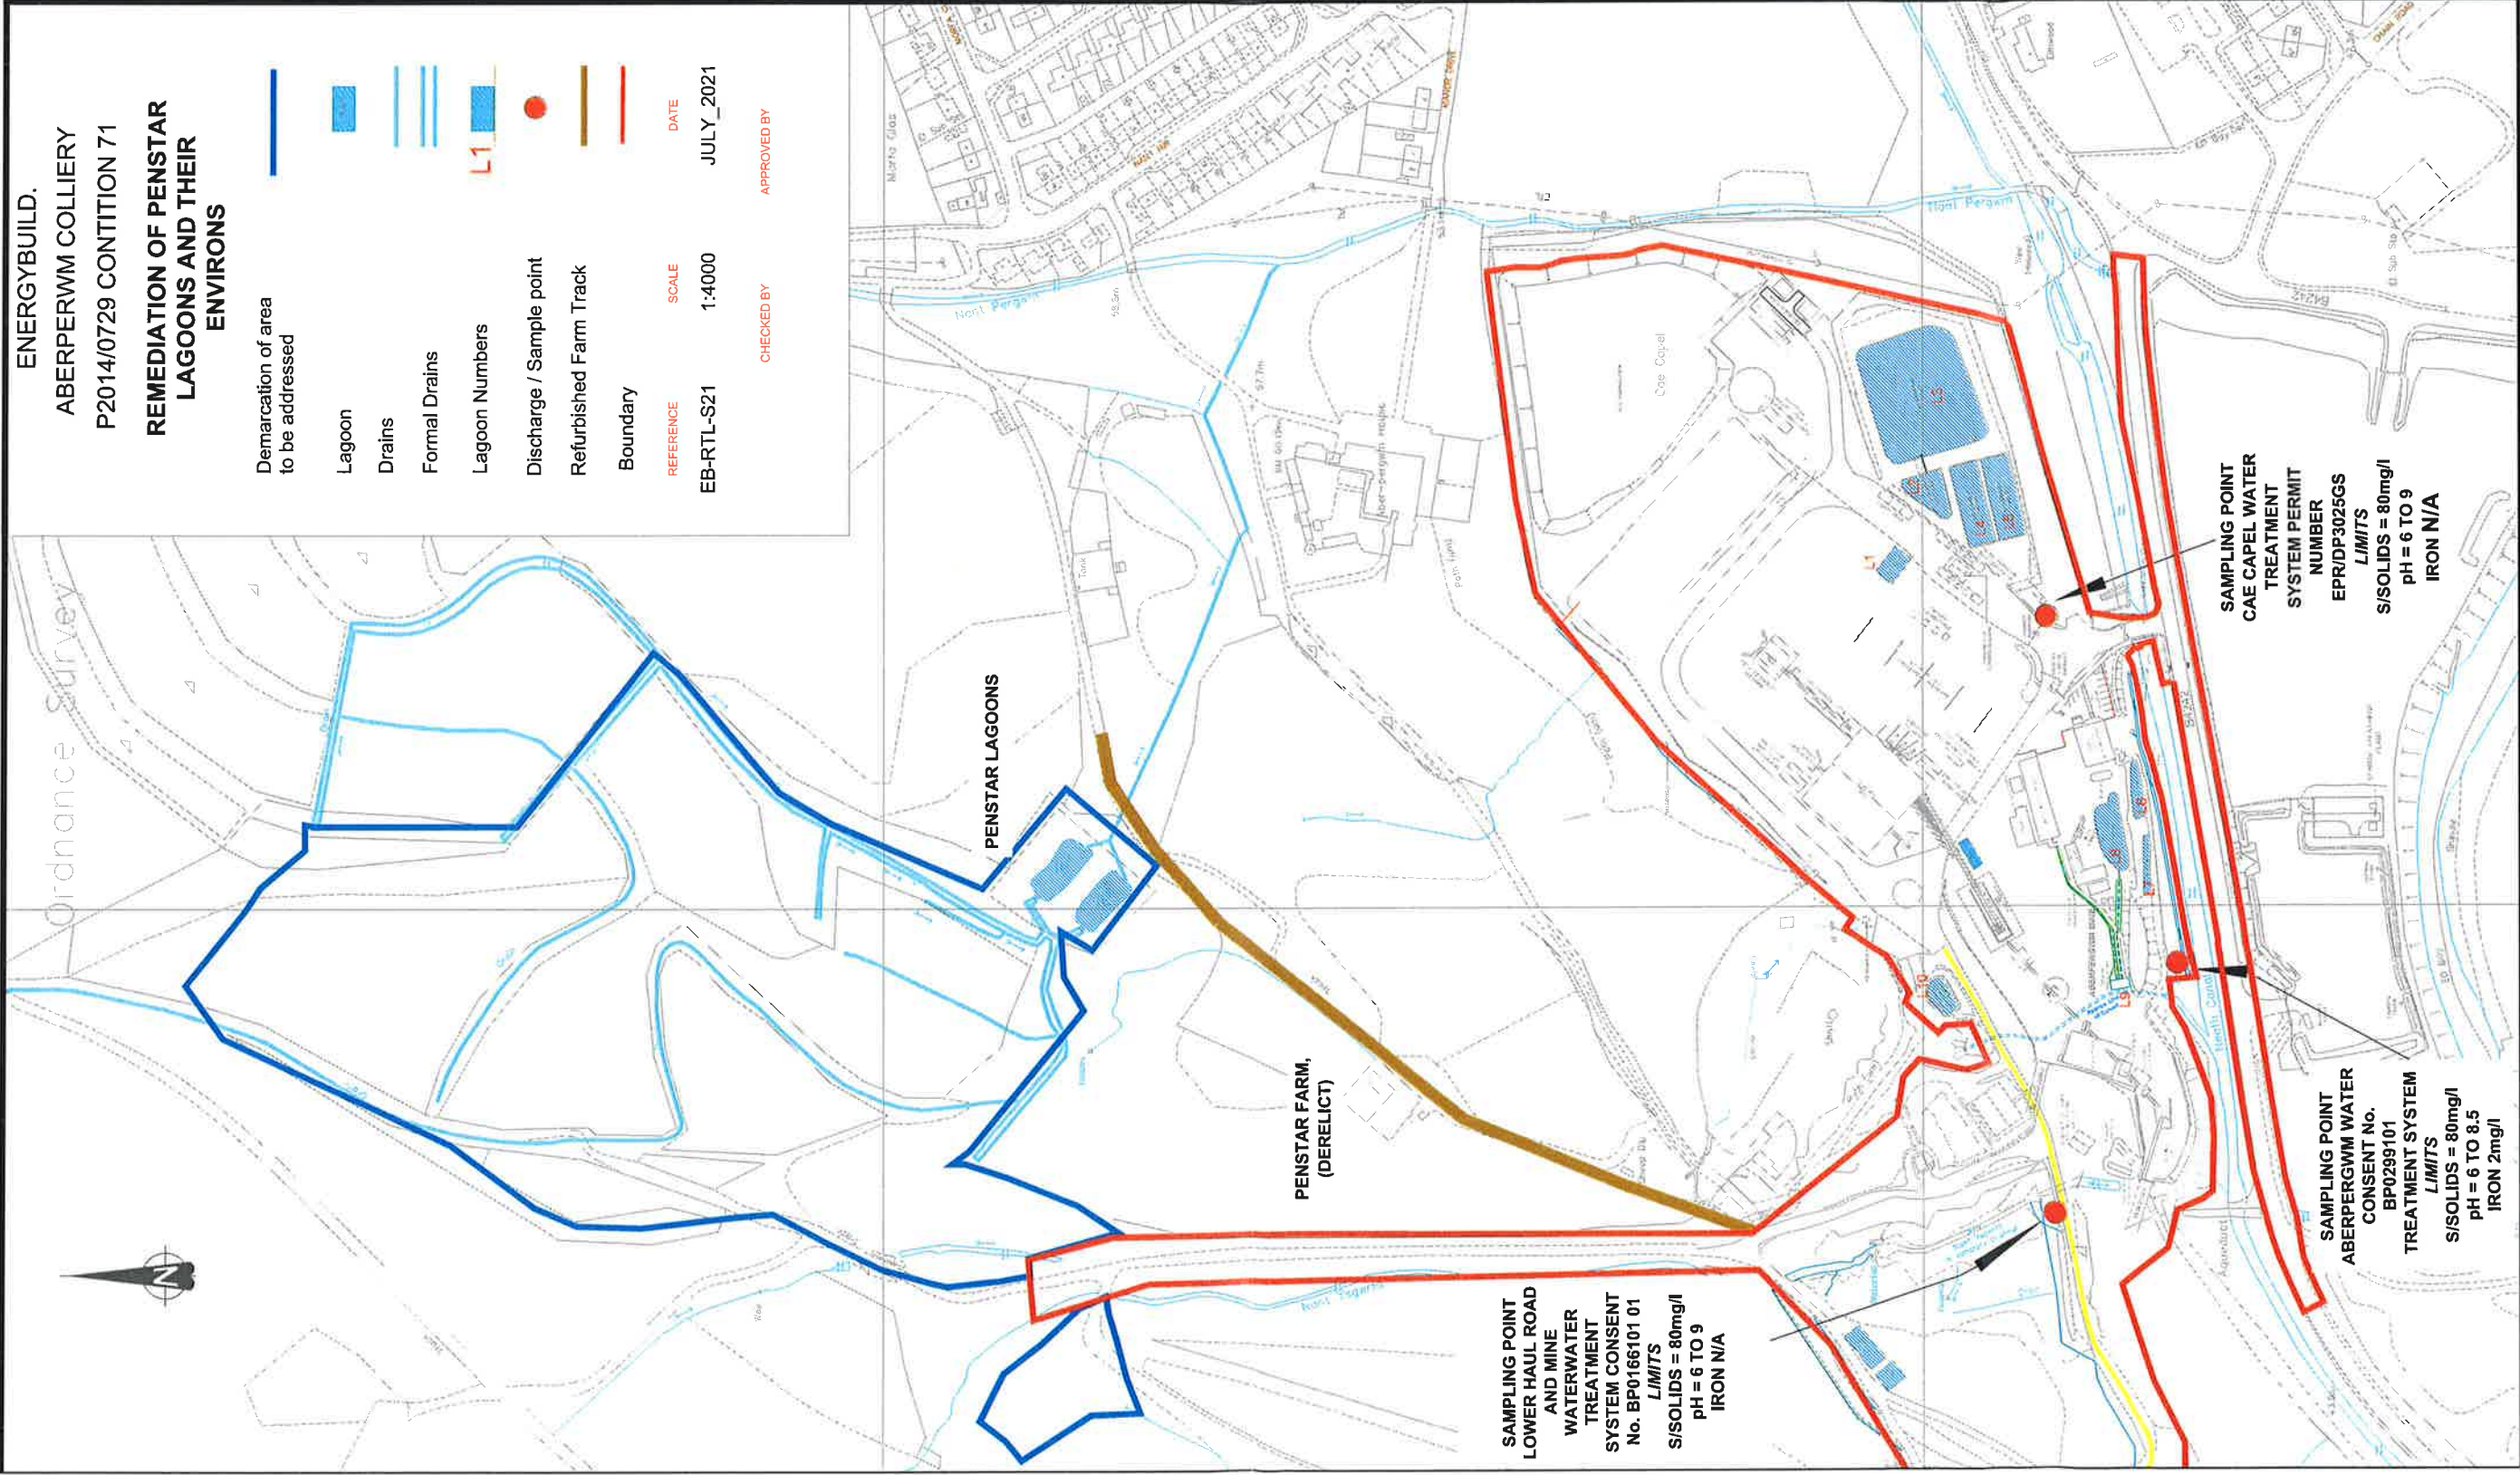
**PLAN 2 –EB-RTL-S21- ROCK LAGOONS AND THEIR ENVIRONS**

The terrain raises steeply from the Rock Lagoon which are sited at the lower southern extremity of the site, the area is interspersed with formal concrete drainage channels and drainage ditches. **Refer to EB-RTL-S21- ROCK LAGOONS AND THEIR ENVIRONS**

The drainage features which intersect the site are heavily silted with many years of accumulated debris. The concrete drainage infrastructure appears to be structurally sound and in good condition apart from the cleaning requirement. The two parallel lagoons themselves are obliterated by a thick blanket of silt thickly overgrown with saplings and brush.

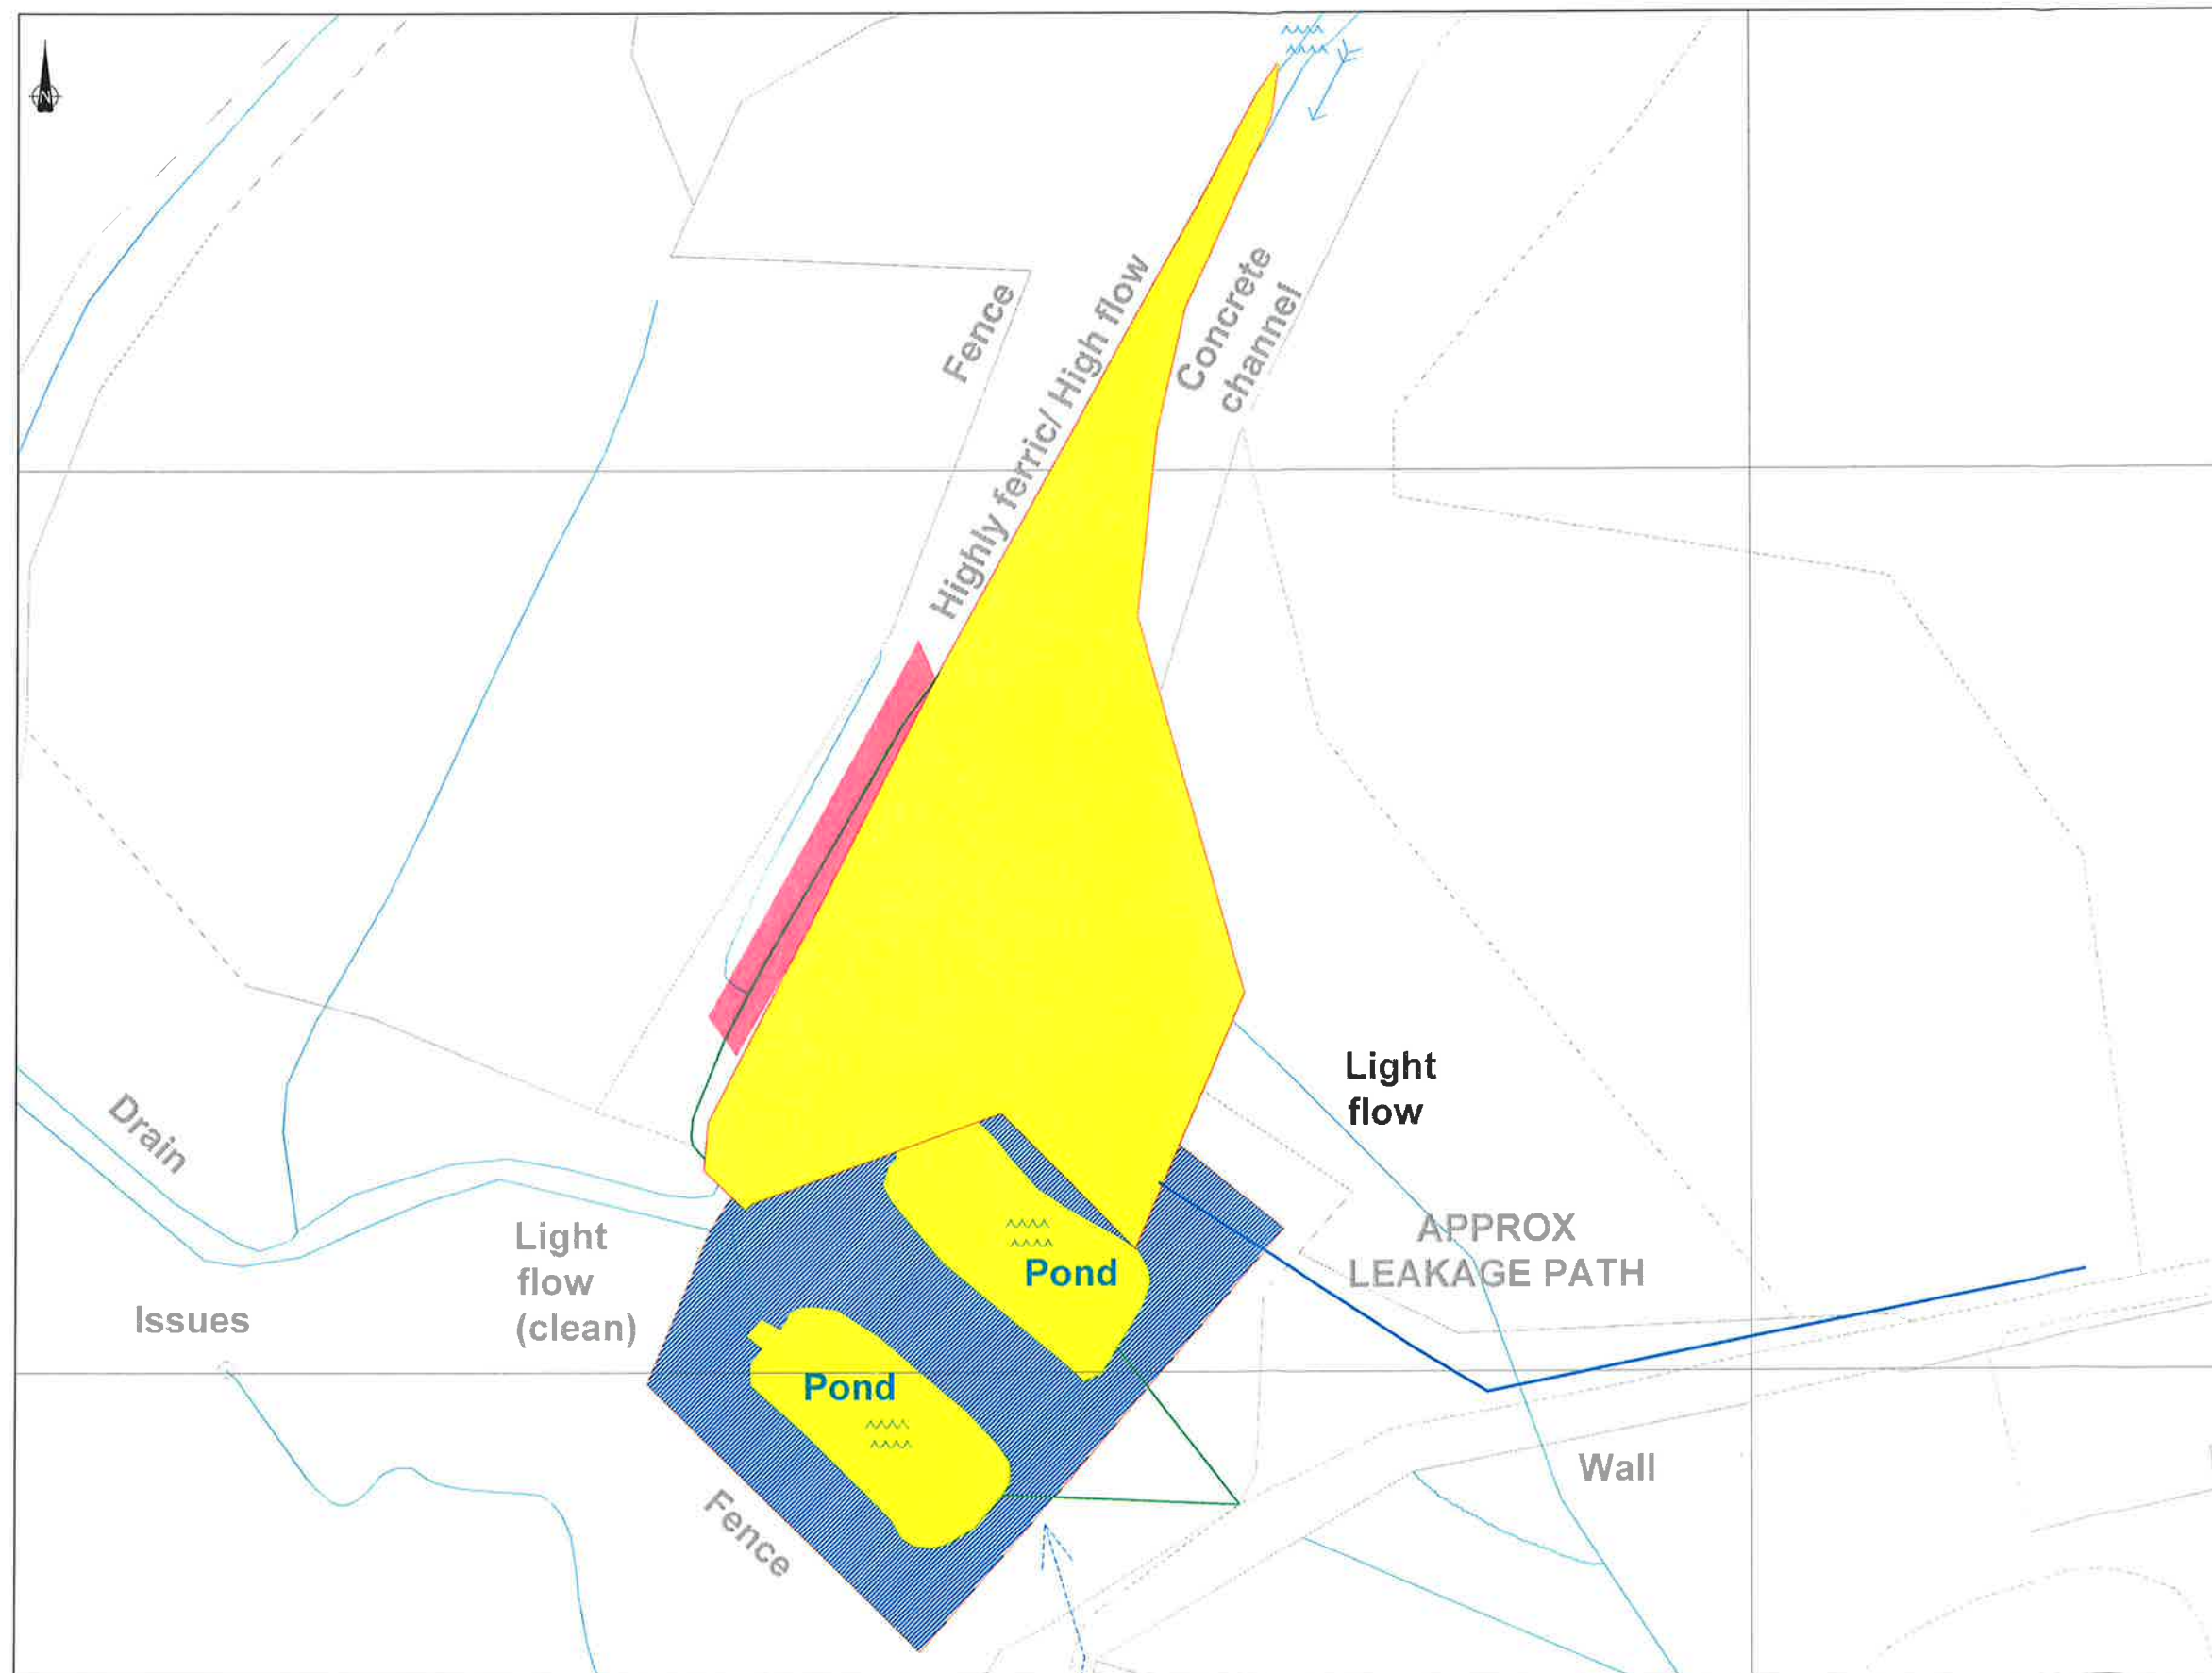
**PLAN 3 – CONDITION ROCK LAGOONS PRIOR TO REMEDIATION.**

The parallel setup lagoons are constructed on an approximately east west orientation. The eastern lagoon accepts drainage water from the eastern extremity of the boundary area and also and substantially beyond in approximately north easterly direction. The concrete drainage channels are heavily silted with a high degree of ochre silt. Above the point at which easterly drainage channel meets the lagoon a minor slip of tip material has broken

away, probably due to short circuited water flow at its base, and has enveloped the drainage channel and the northern end of the lagoons. The infeed water by passes the drainage channel, due to the blockage at a higher point and flows down the eastern periphery of the area and onto a track that runs to the east away from the site.

The western lagoon is again heavily silted to a point where the lagoon structure is not discernible. The lagoon accepts water from the western area within the blue line boundary and from the greater part northern areas above both lagoons. The water from this area is clean and is separate from the eastern input and discharge through its intended discharge point. **Refer to Plan 3– CONDITION OF ROCK LAGOONS PRIOR TO REMEDIATION**

Prior to remediation, although in sound structural condition the drainage features, lagoons, formal drainage channels and gutters were heavily silted and blocked at intervals by fallen trees, branches and other obstructions causing overtopping and leakage from drains and lagoons.

All drainage features have now been cleared of all obstructions and silt and all drained water is taking the correct path and exiting the lagoons at the appropriate discharge point. The system is now refurbished and operating efficiently probable to original design parameters and is well able to cope with the heaviest water flows.
