## Tree Condition Survey and Management Work Recommendations

Date – 2<sup>nd</sup> July 2021

Site – 3 Ffawyddden SA12 9BJ

Project Reference – ArbTS\_1133.1\_3 Ffawyddden SA12 9BJ

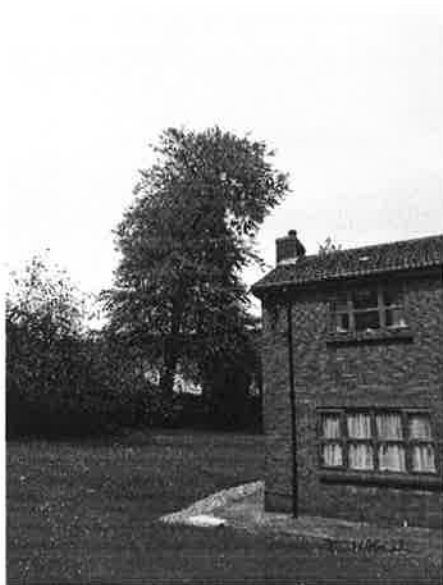
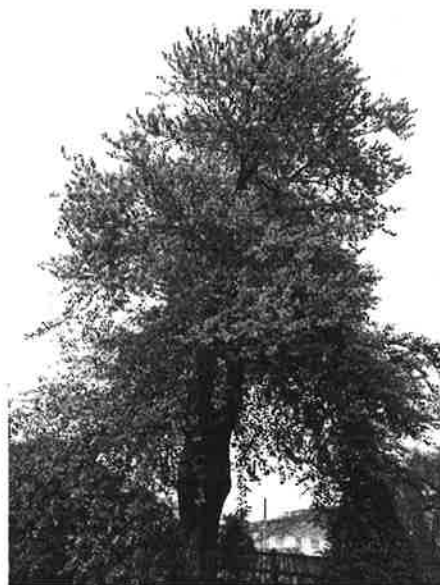
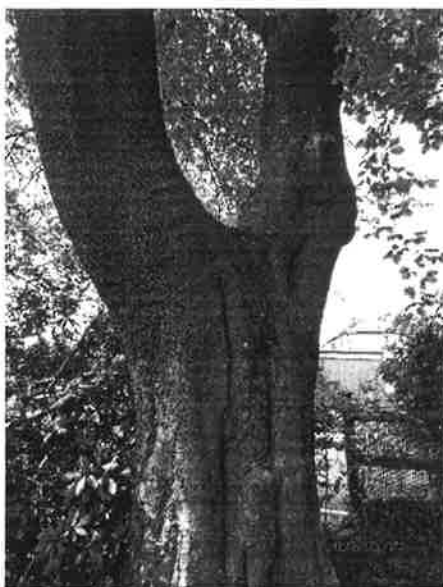
Tree ID#T326

| Tree ID # | Tree Species | Age | Size | Physiological Condition | Structural Condition | Comments | Management Work Recommendations | Target Occupation | Work Type | Work Priority |
|---|---|---|---|---|---|---|---|---|---|---|
| T326 | Fagus sylvatica (Beech) | M | L | G/Fair | G/Fair | <p>large beech tree approx. 17 metres tall, located on boundary of the property, tree located adjacent to driveway and on edge of garden area , large surface roots noted with wide buttress of normal health and form, trunk diameter 1000mm, trunk divides into two stems at 2.5metres above ground level, union appears normal between stems, upper southern stem is fairly upright in form with northern stem and higher northern longer lateral branches noted over the main access and adjacent garden, some old occluded and occluding branch pruning wounds noted, overall crown form is reasonable with some crown suppressed noted on the western side, northern side of crown slightly over extended in form, leaf buds developing and appear normal</p> | | H/Medium | | |

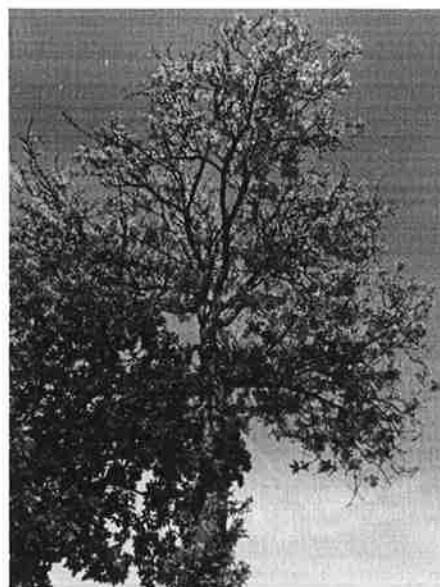
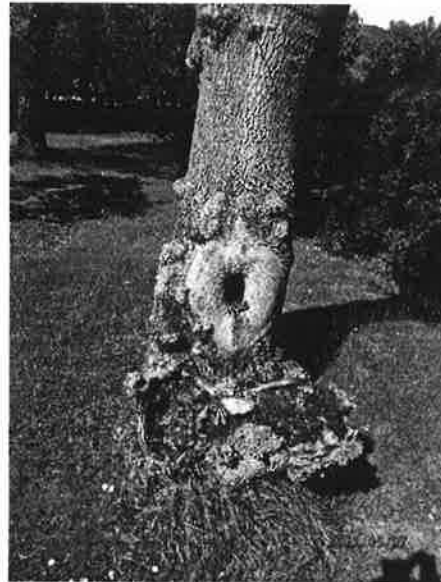
Tree ID#T327

| Tree ID # | Tree Species | Age | Size | Physiological Condition | Structural Condition | Comments | Management Work Recommendations | Target Occupation | Work Type | Work Priority |
|---|---|---|---|---|---|---|---|---|---|---|
| T327 | Fraxinus excelsior (Ash) | M | M | F/Poor | F/Poor | <p>ash located in rear garden, close to dwelling and adjacent property, open cavity at 700mm above ground level on southern side, cavity extends 200mm into trunk and appears isolated within that area, old failed stem remain still connected onto lower trunk, tree of fair structure, significant signs of decline with less than 50 percent canopy leaf cover likely from ash dieback disease</p> | <p>fell to retain 2 metre trunk to maintain cavity wildlife habitat</p> | H/Medium | Hazard | H/Medium |

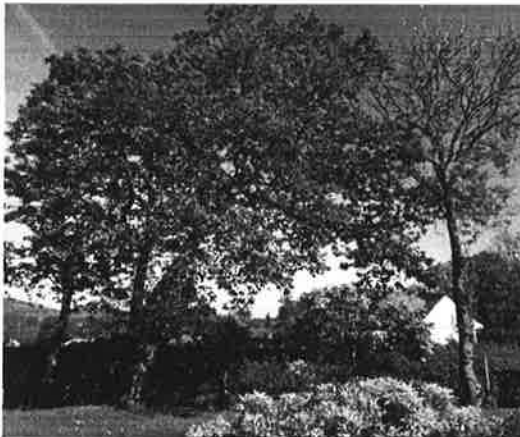
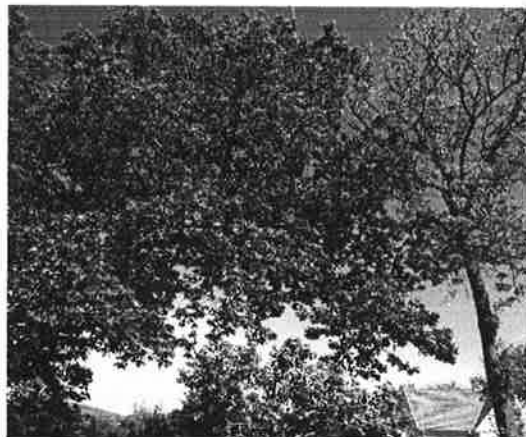
Tree ID#T329 + T327

| Tree ID # | Tree Species | Age | Size | Physiological Condition | Structural Condition | Comments | Management Work Recommendations | Target Occupation | Work Type | Work Priority |
|---|---|---|---|---|---|---|---|---|---|---|
| T329 | Quercus robur (Common Oak) | M | L | G/Fair | Fair | oak located in rear garden area of property with surrounding grass lawn, buttress appears normal with small desiccated fungal fruiting body noted on western side of buttress that appears to be Ganoderma resinaceum (100mm by 100mm dimensions), small area of some isolated soft wood decay noted around fungal fruiting body, main stem contorted in form of 590mm diameter, grown with south easterly lean, reasonably short in height with wide forming southern laterals branches adjacent to declining ash tree and one long easterly lateral branch noted, leaf cover normal | due to form and increase exposure from removal of adjacent ash tree reduce south and eastern side of crown by up to 3.5 metres in branch length to suitable pruning points to form a more compact crown | H/Medium | Hazard | H/Medium |
