| PROJECT <div>COED DARCY</div> | | | |
| DRAWING TITLE <div>COMMERCIAL AREA AS BUILT (FEBRUARY 2009)</div> | | | |

| DRAWING TITLE | COMMERCIAL AREA - ISOPACHYTE<br>BASE OF REMEDIATION EXCAVATION<br>TO FINAL LEVELS - PHASE 3 | | |

# Appendix A

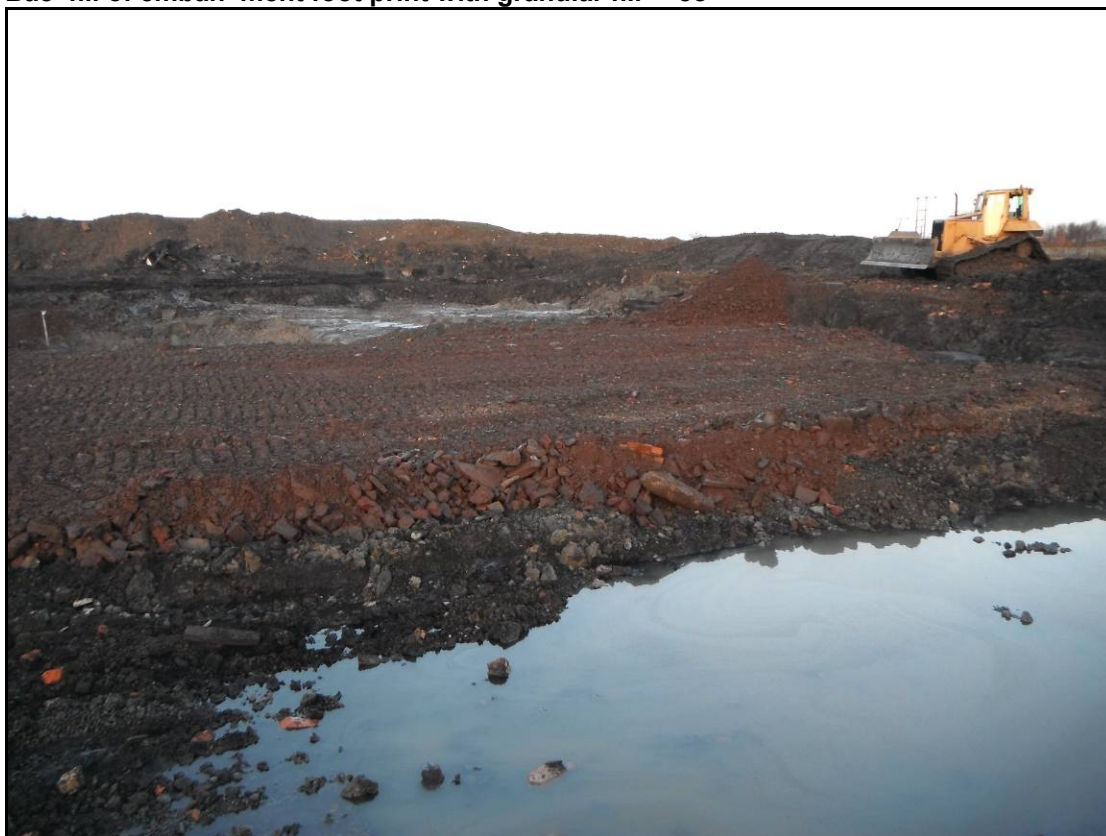
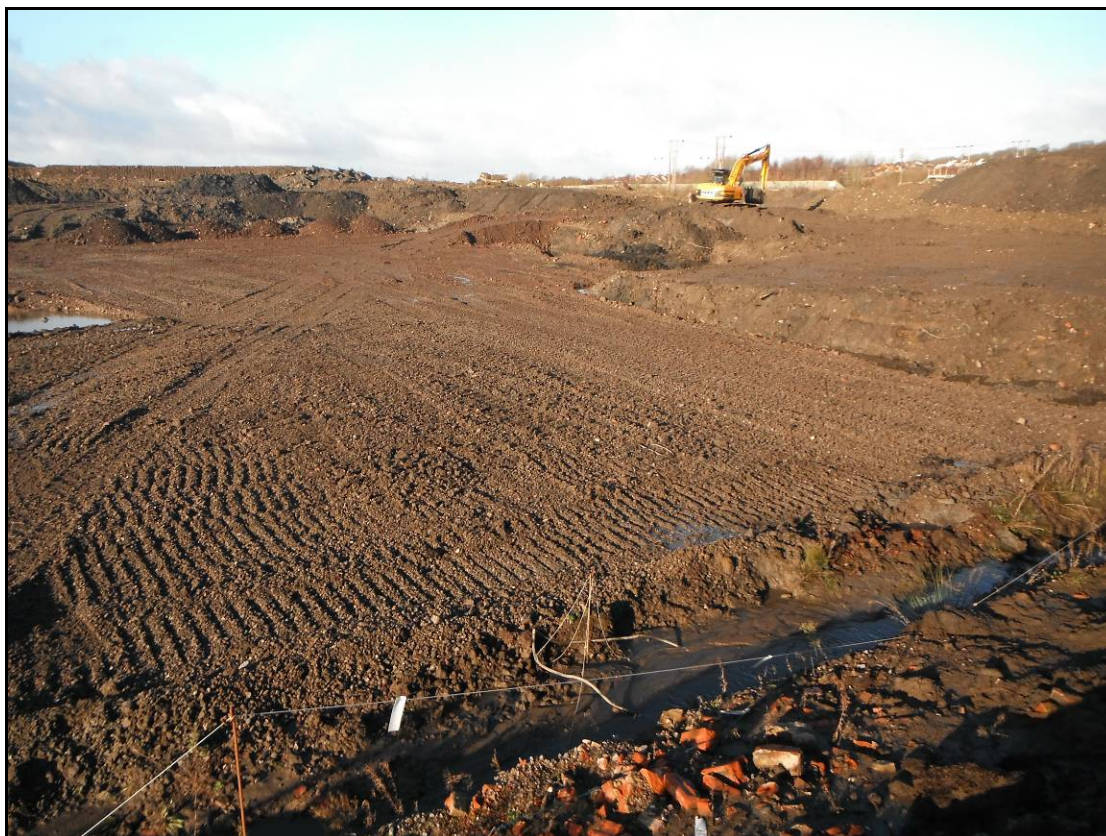
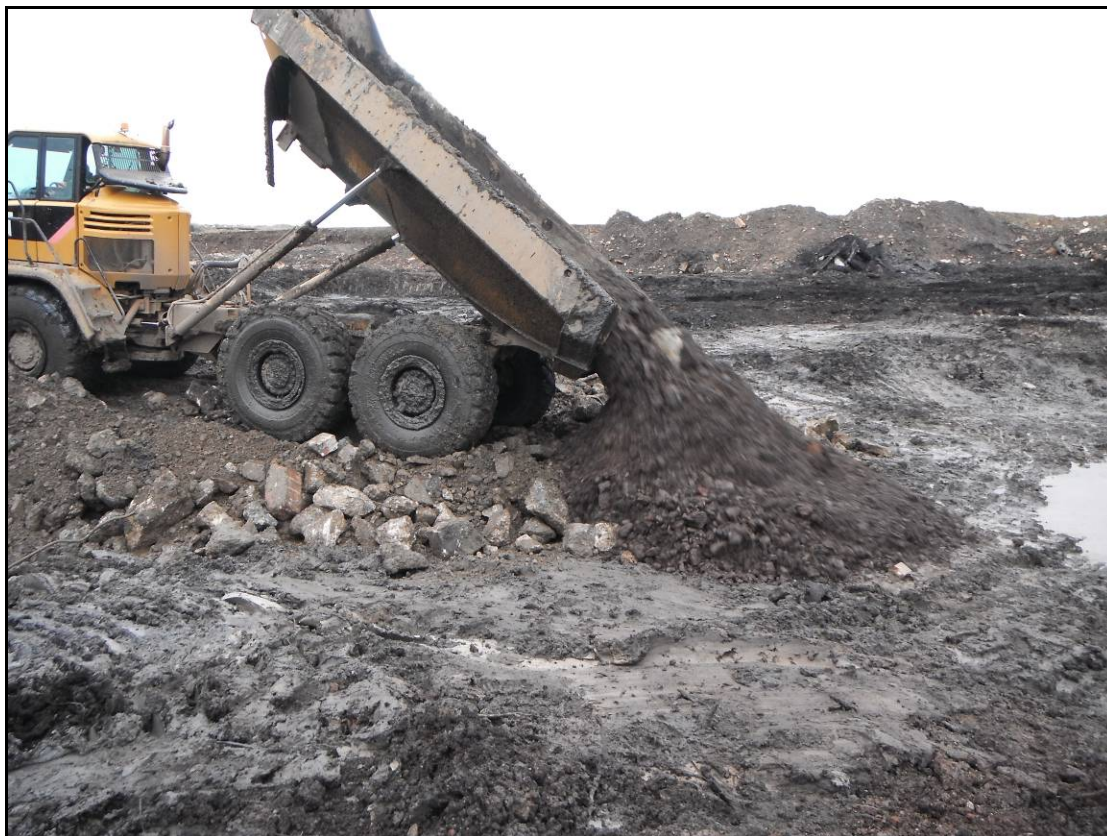
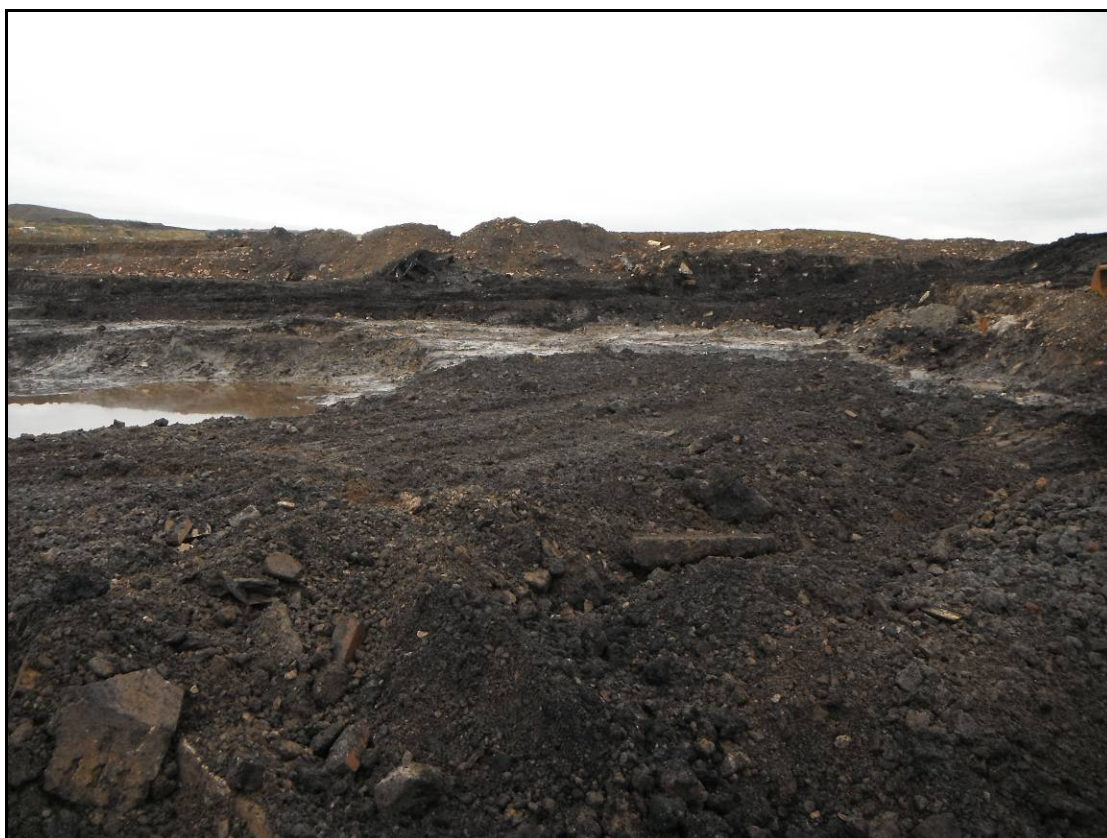
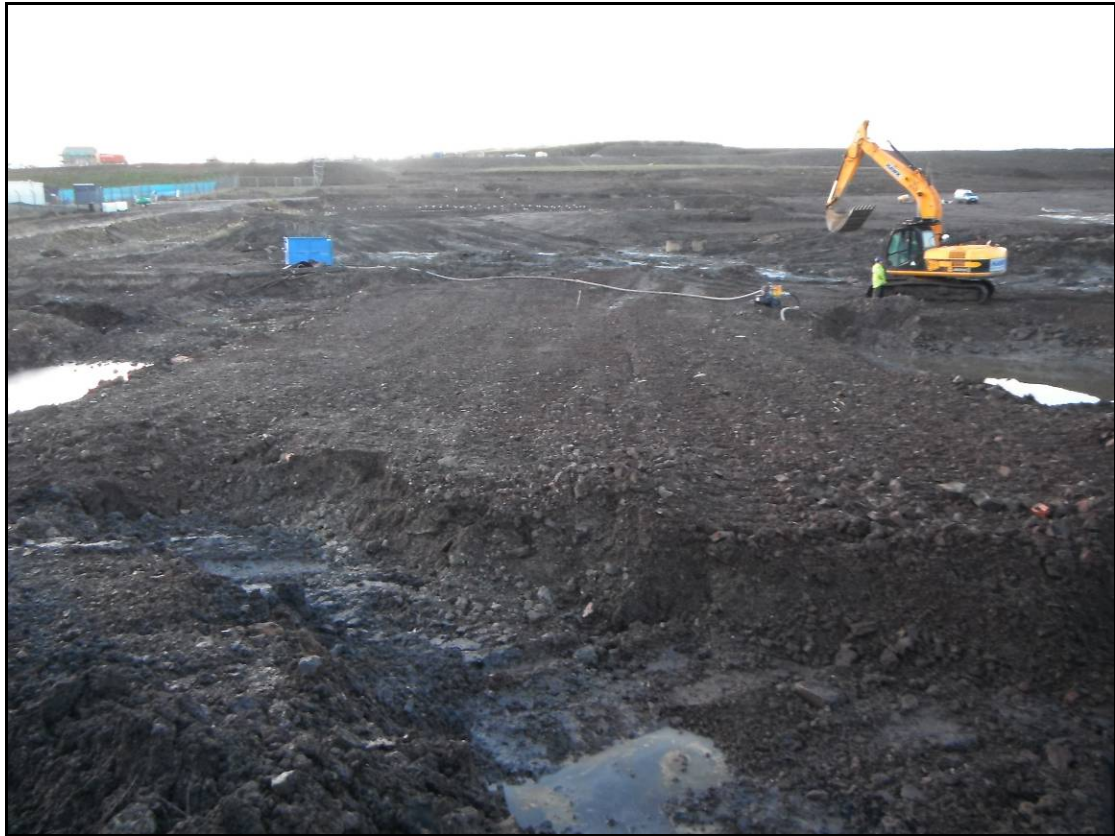
Photographs  
Backfill of embankment foot print with granular fill

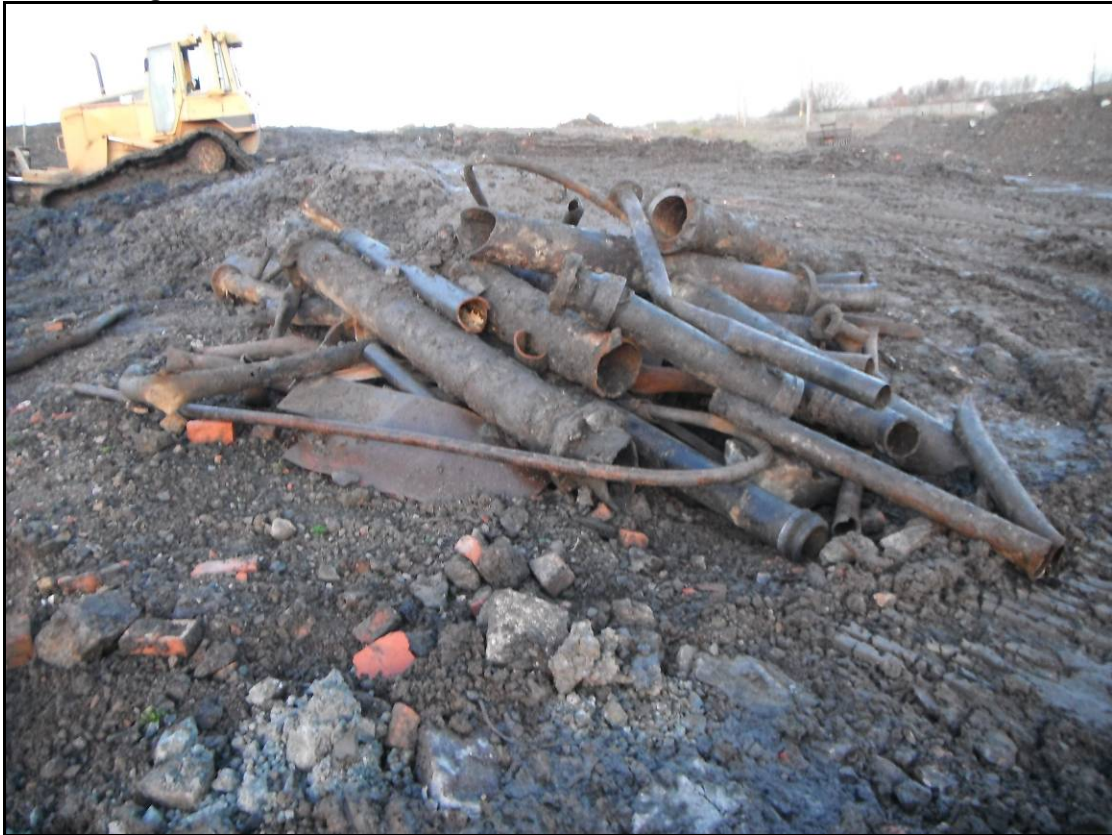
Photograph 6

Examples of pipe work bedded in natural ground clay across the commercial area  
CA pipe work was located at various depths across the CA varying from mm to m below ground level

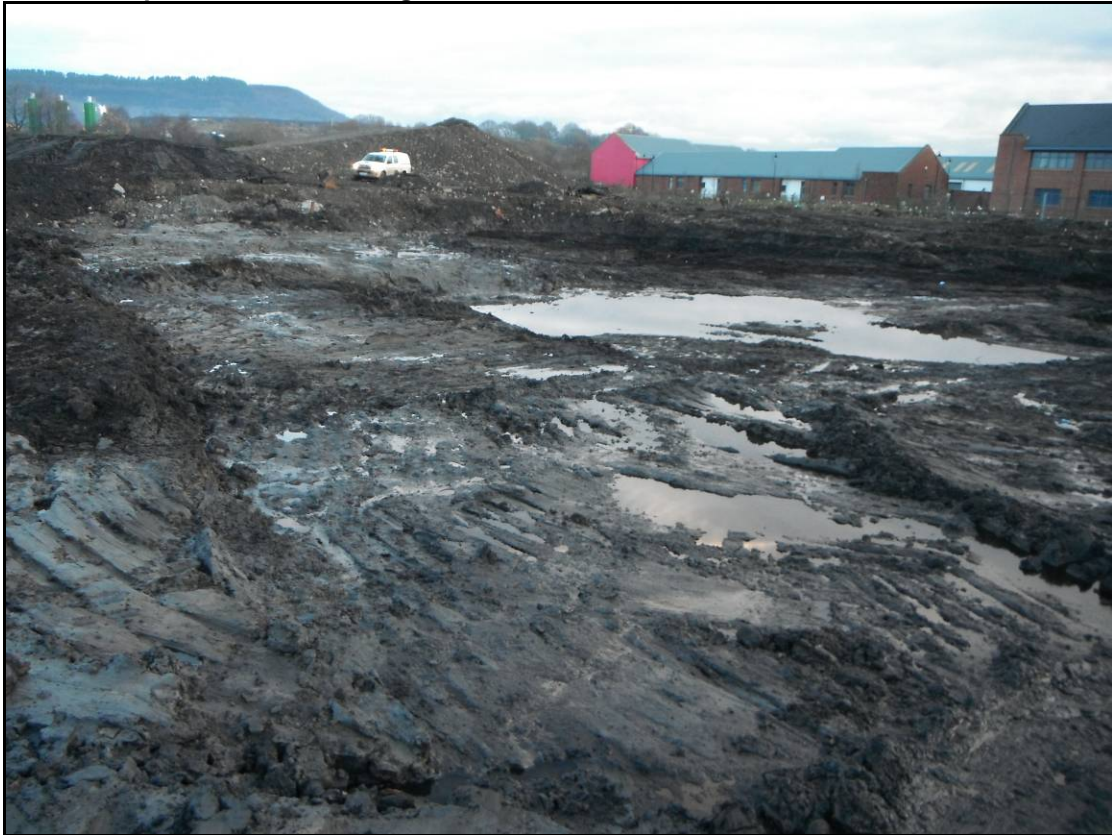
Photograph 8

**Base of excavation across the lower lying levels of phase 1 and beneath existing road embankment**

**Area was upfilled with suitable granular material**

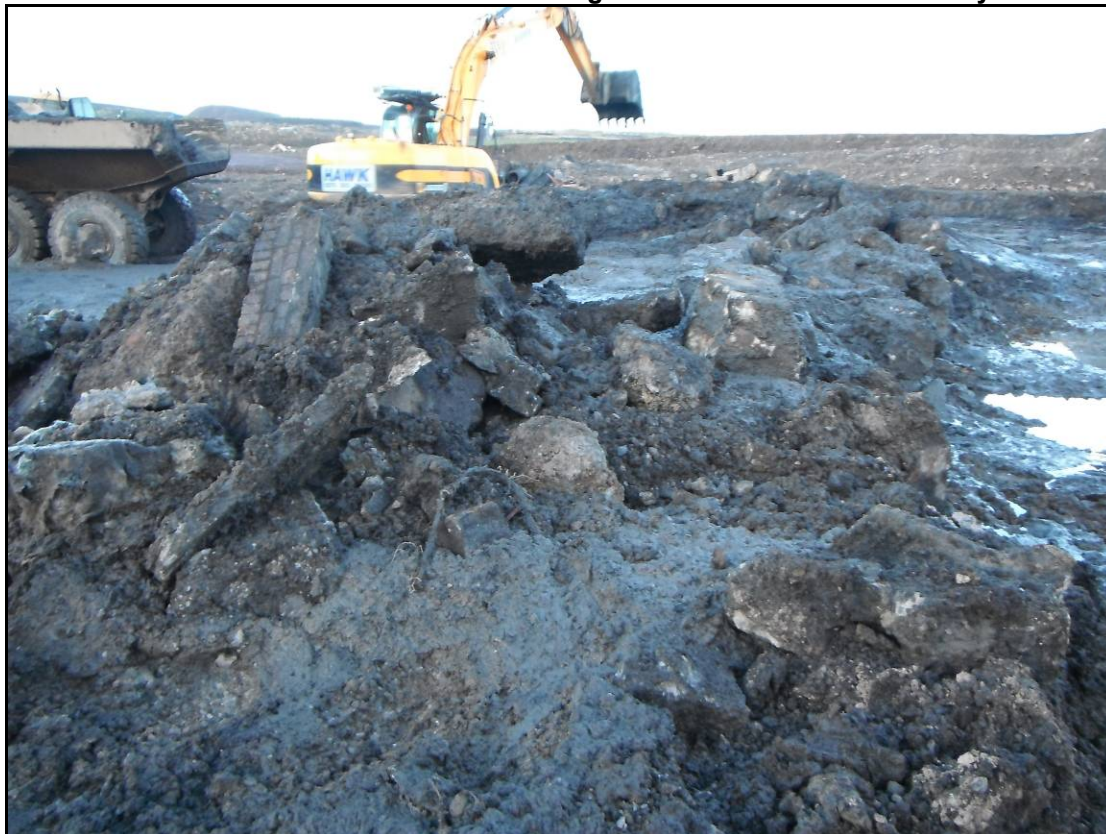
Photograph 9

**Removal of concrete foundations and founding blocks bedded in natural clay**

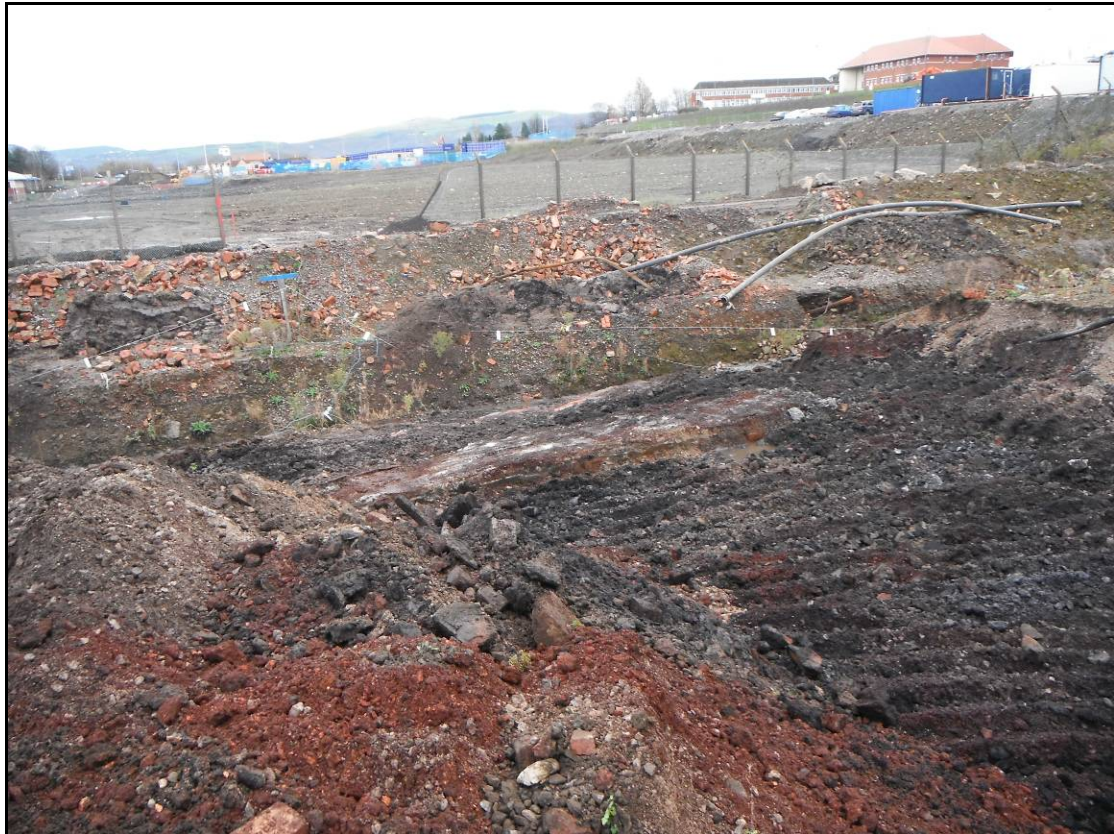
Photograph 11

E ample of turnover of made ground ground conditions consisted of demolition rubble with a concrete structure evident in centre shot

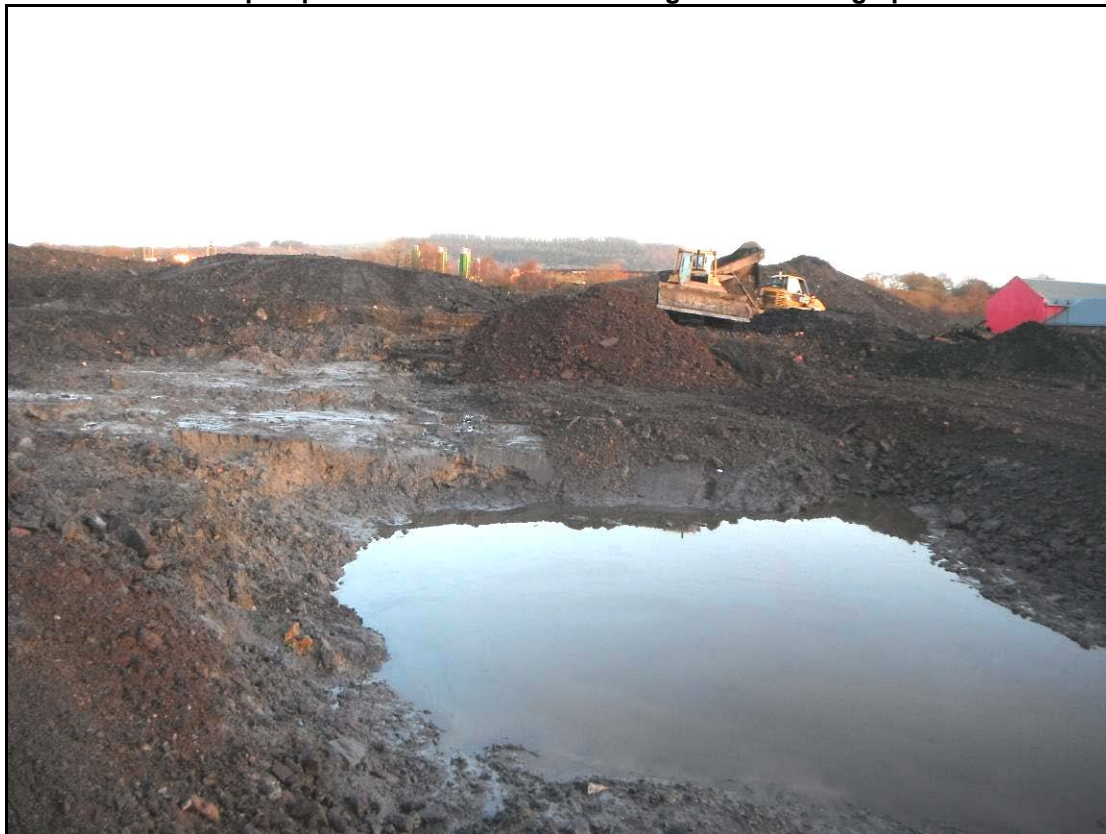
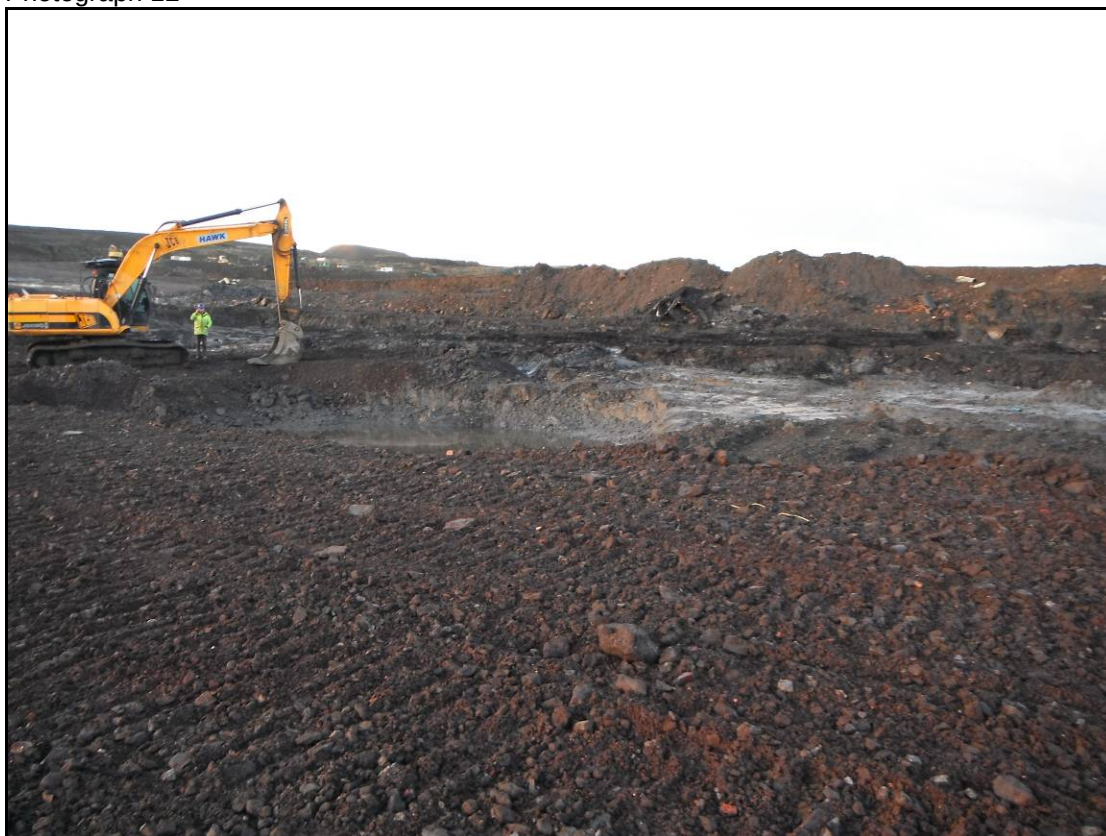
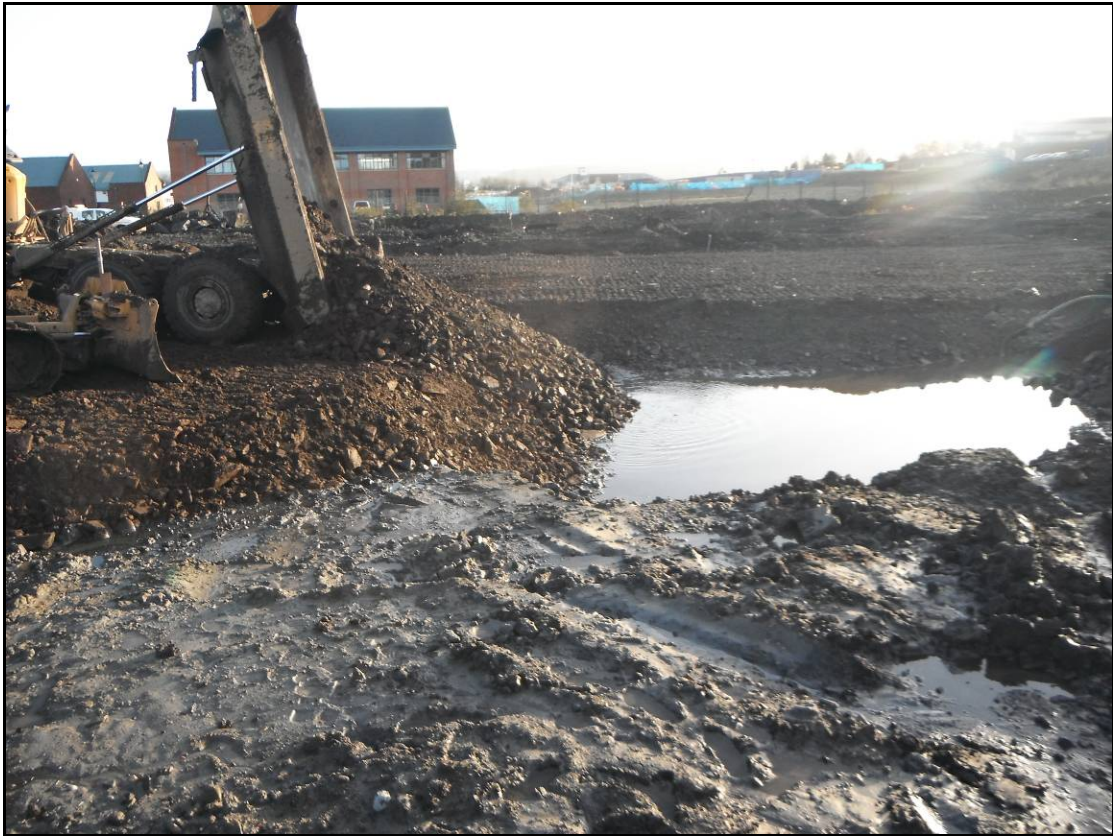
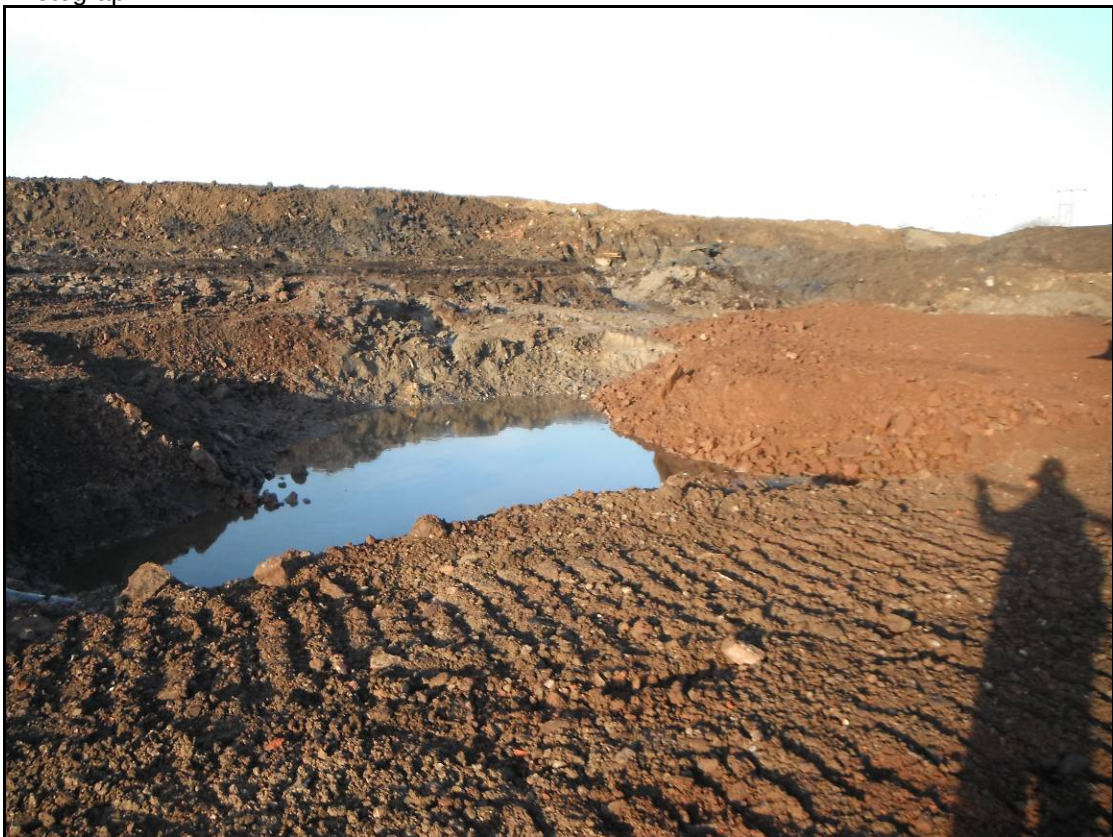
Photographs to  
Back fill or granular material onto remediated clay base of the cavation surface  
Surface water was pumped out of the cavations during the back filling operations

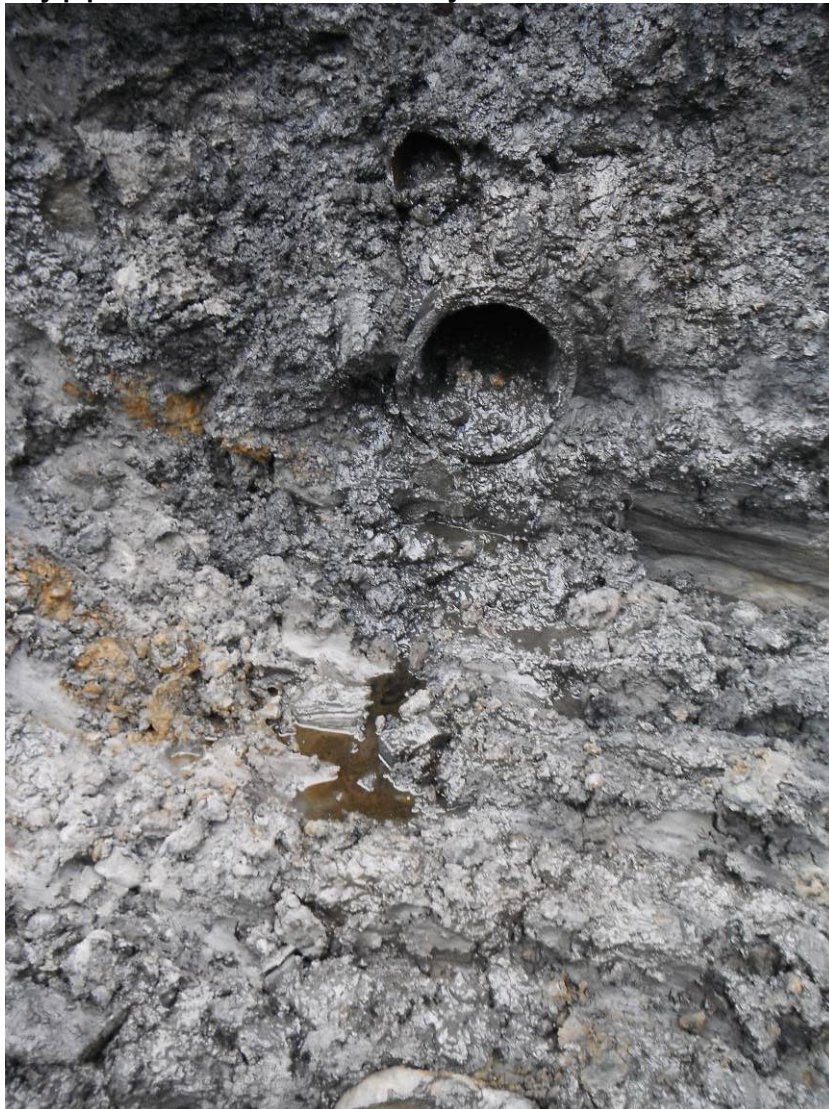
Photograph 16

Photograph  
Oily pipe work      o      bedded in clay

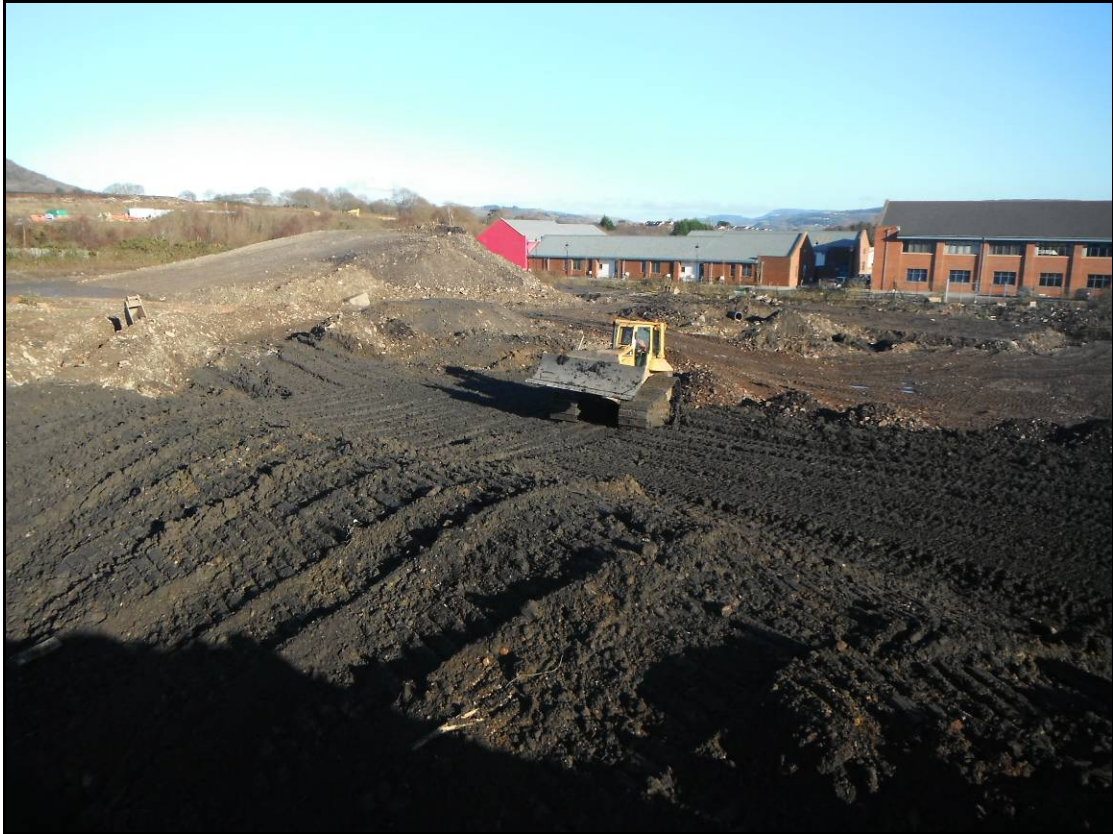
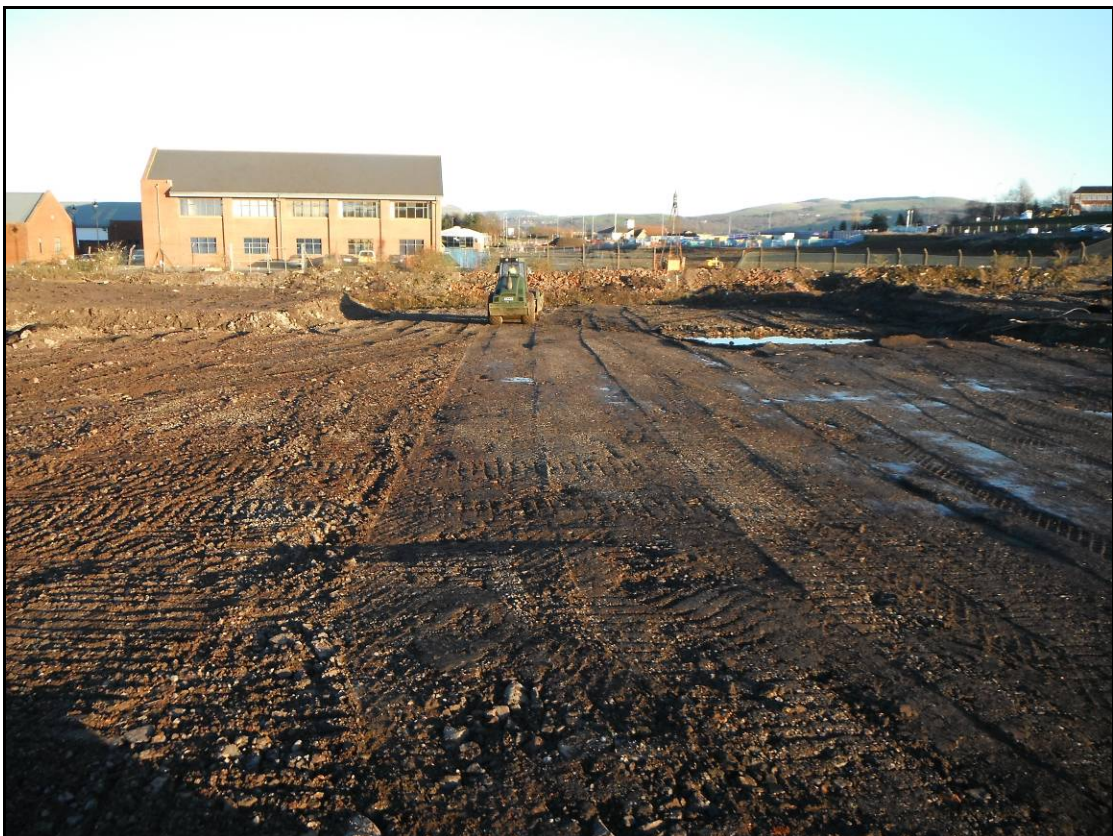
Photograph and  
Re profiling works across base

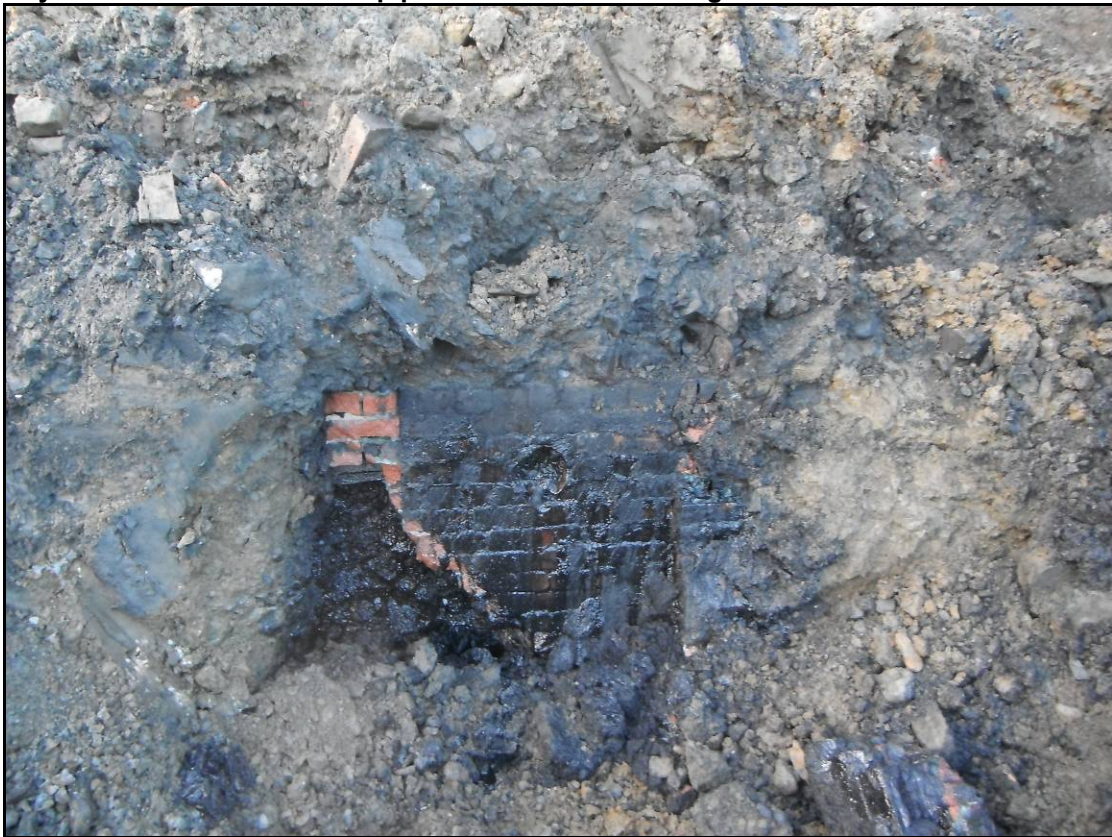
Photograph 19

Photograph  
Oily material associated with pipe work and old retaining wall

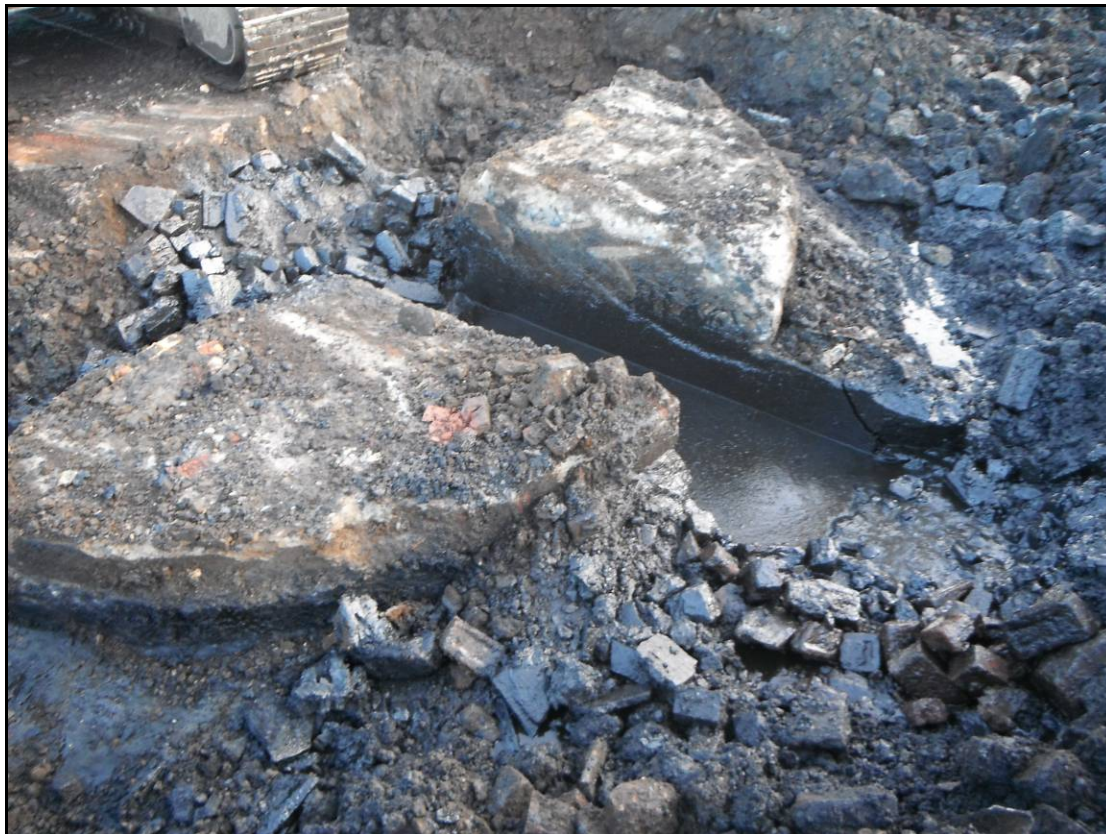
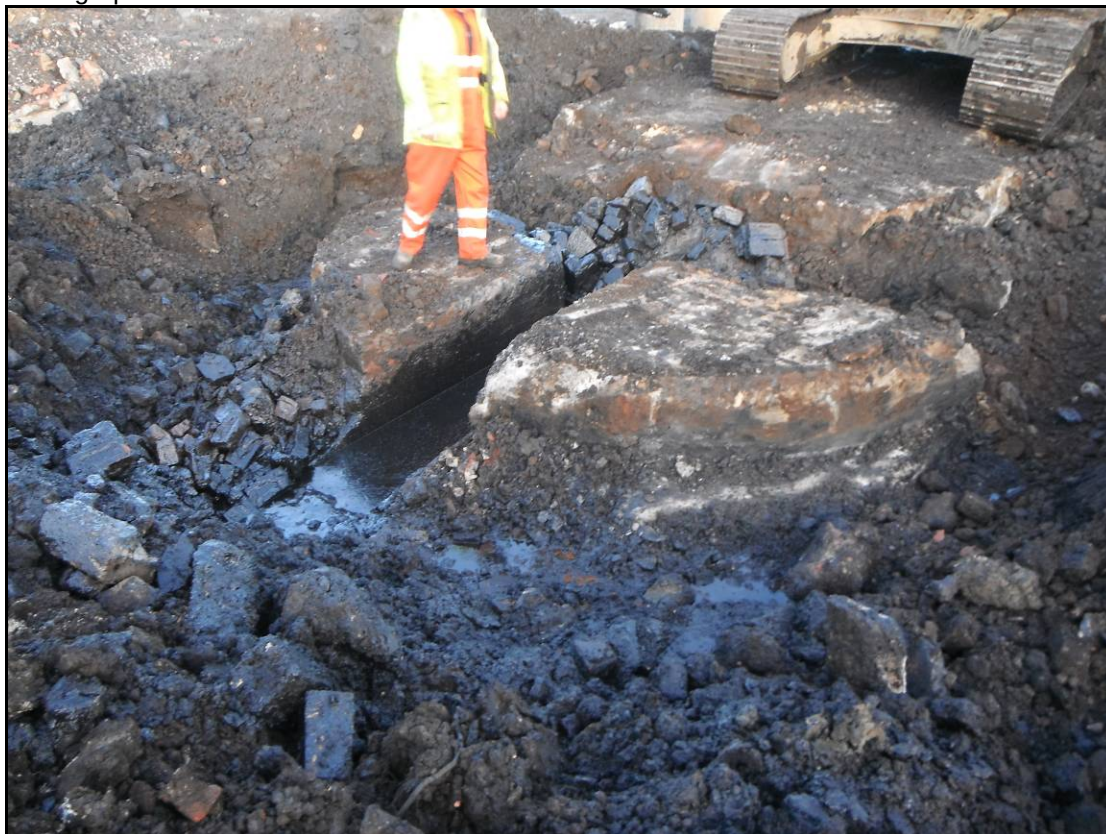
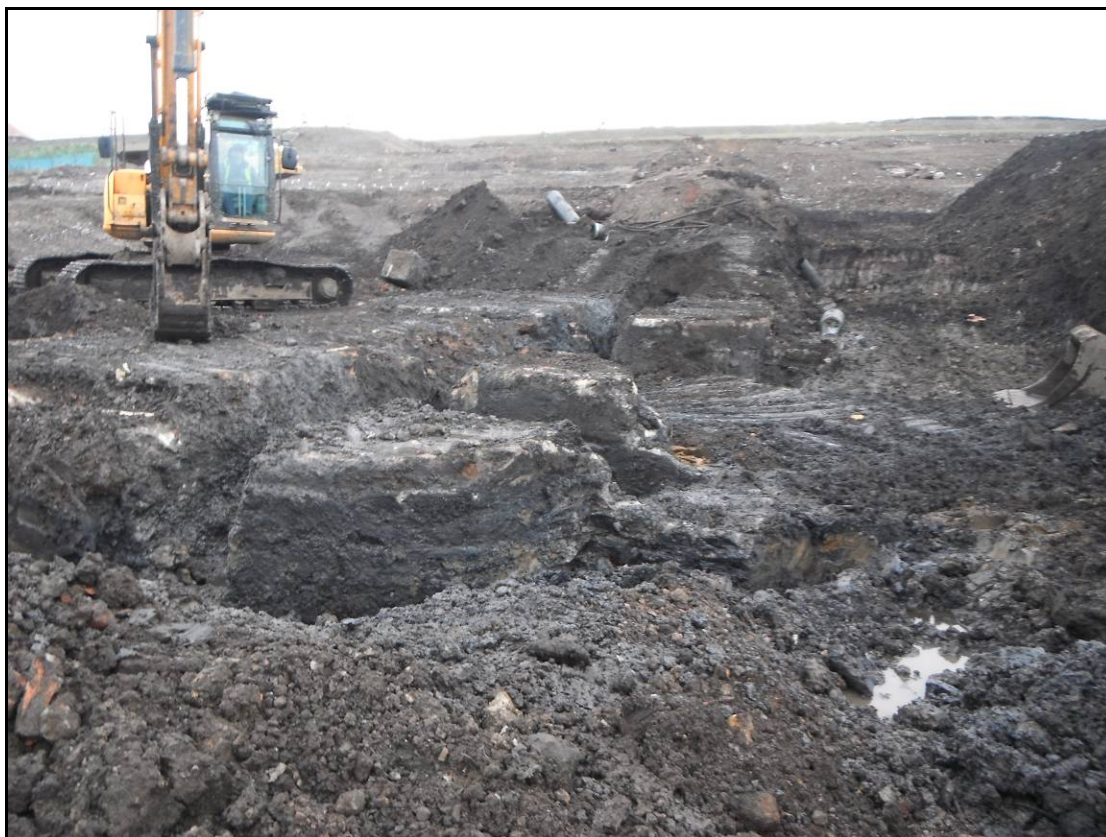
Photographs to  
Concrete tank footings with trapped free product associated with ground around  
structures

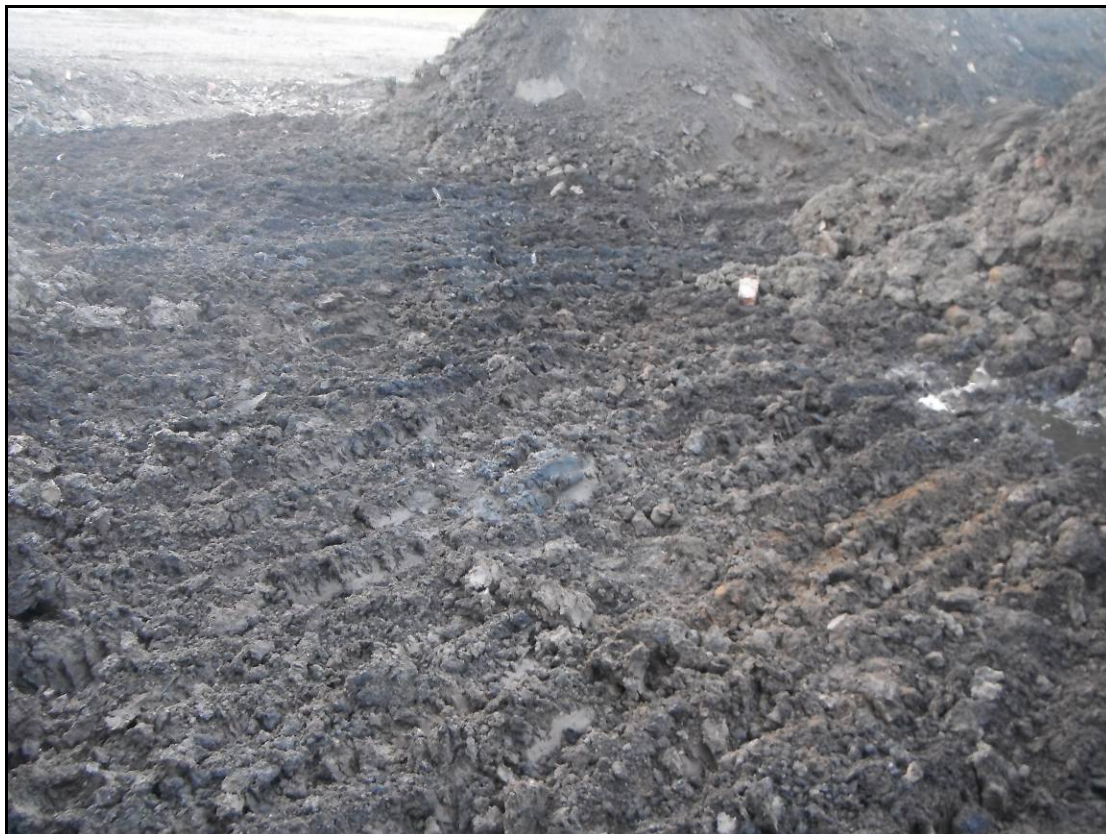
Photograph 23

Photograph  
Base of excavation in turned over area phase

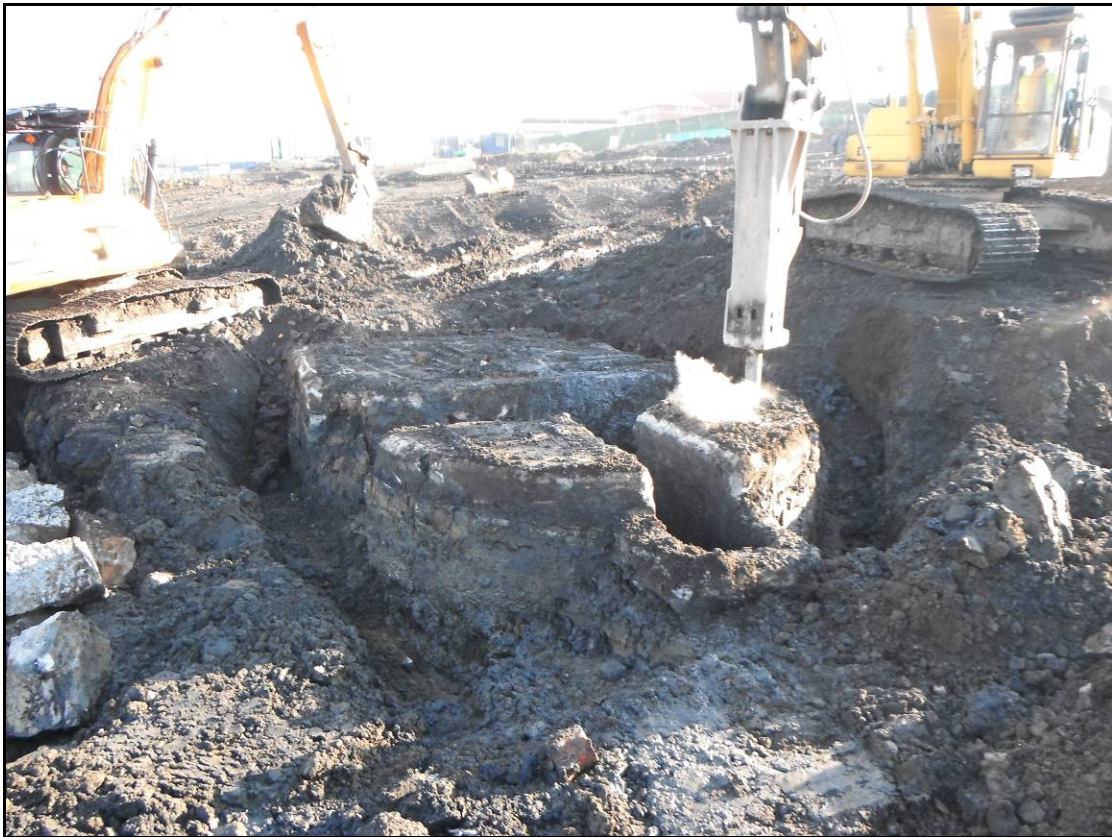
Photograph 24

**Photograph**  
**Breach out of concrete foundations**

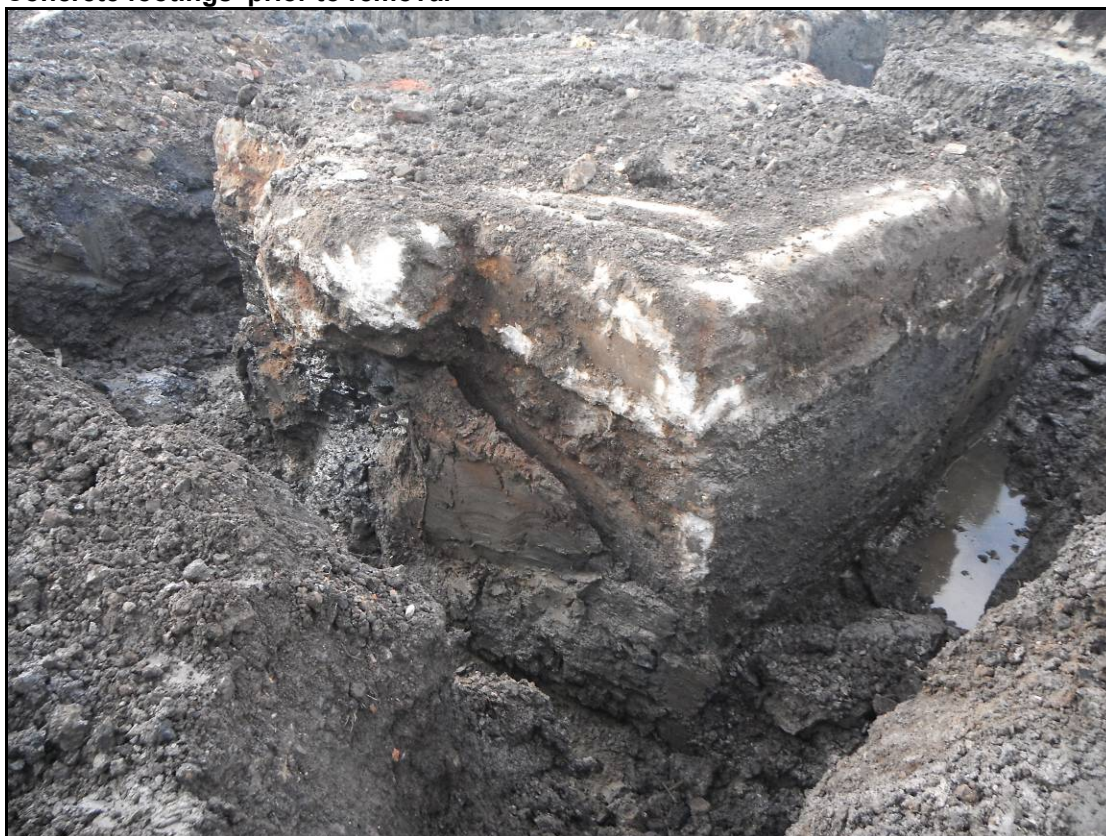
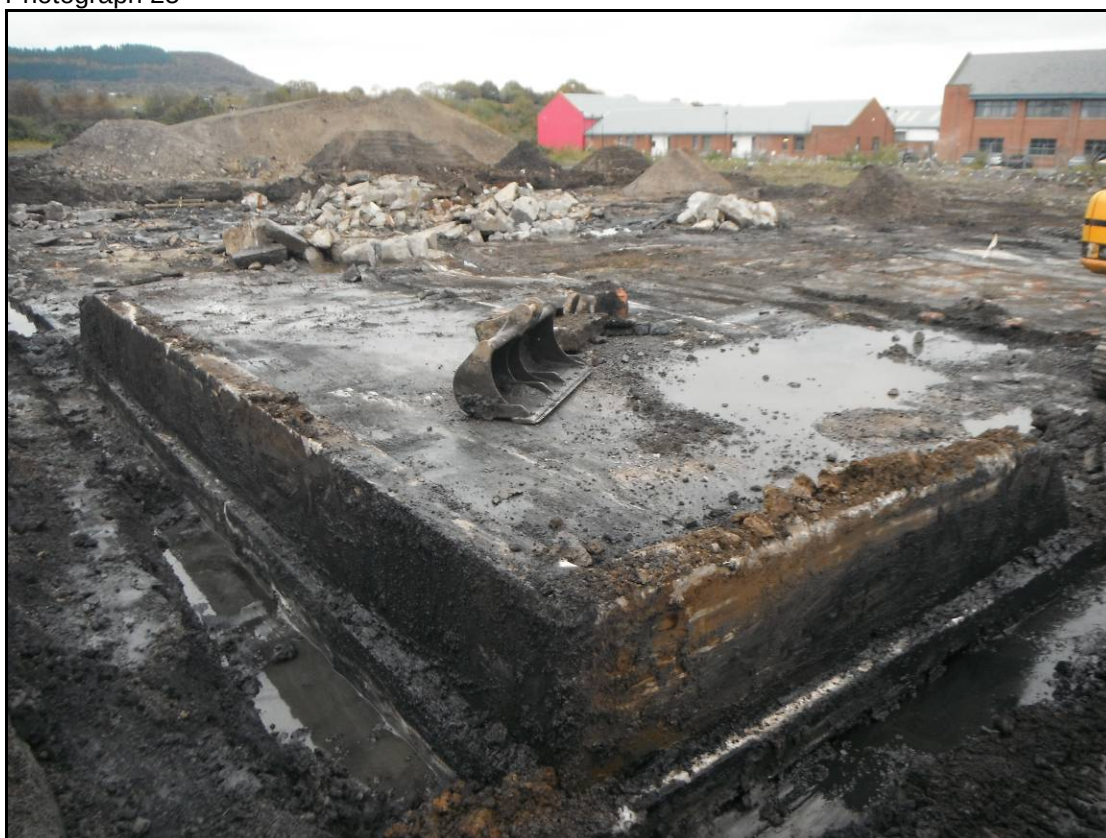
**Photographs**  
**Concrete footings prior to removal**
