| PROJECT <div>COED DARCY</div> | | | |
| DRAWING TITLE <div>COMMERCIAL AREA AS BUILT (FEBRUARY 2009)</div> | | | |

| DRAWING TITLE | COMMERCIAL AREA - ISOPACHYTE<br>BASE OF REMEDIATION EXCAVATION<br>TO FINAL LEVELS - PHASE 3 | | |

# Appendix A

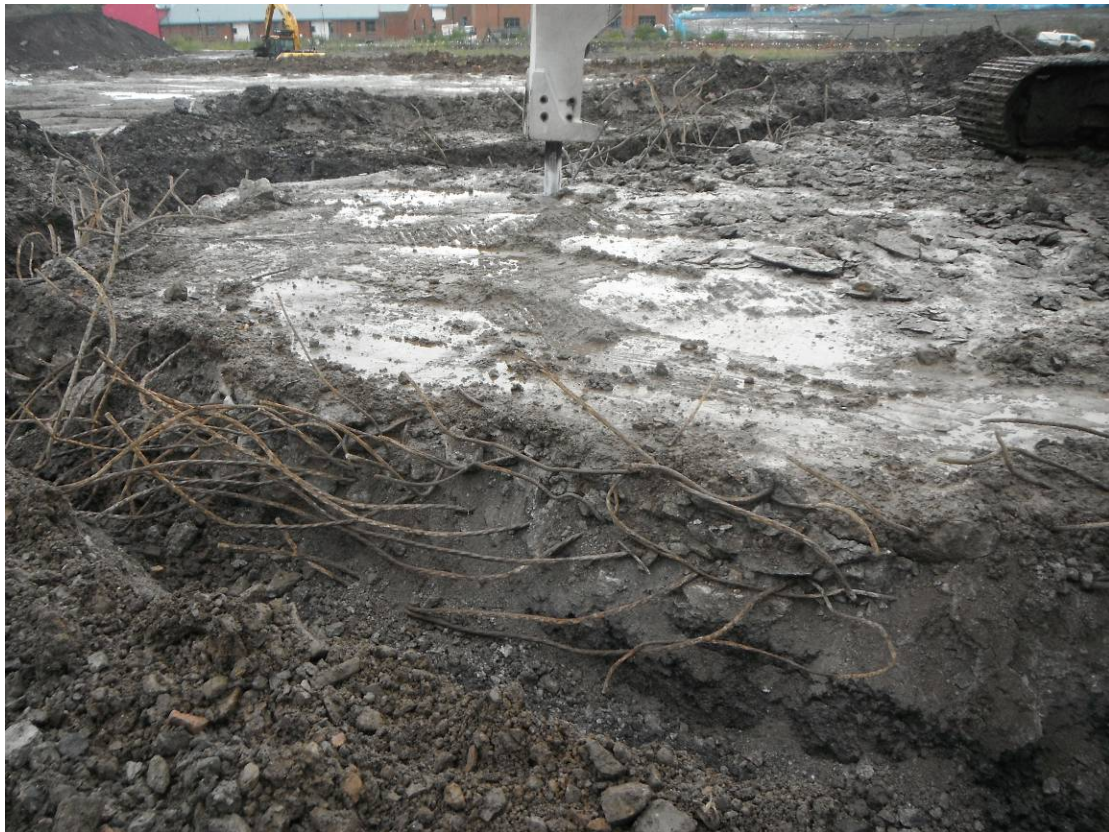
Photograph 27

Photograph  
Break out of reinforced concrete tank base

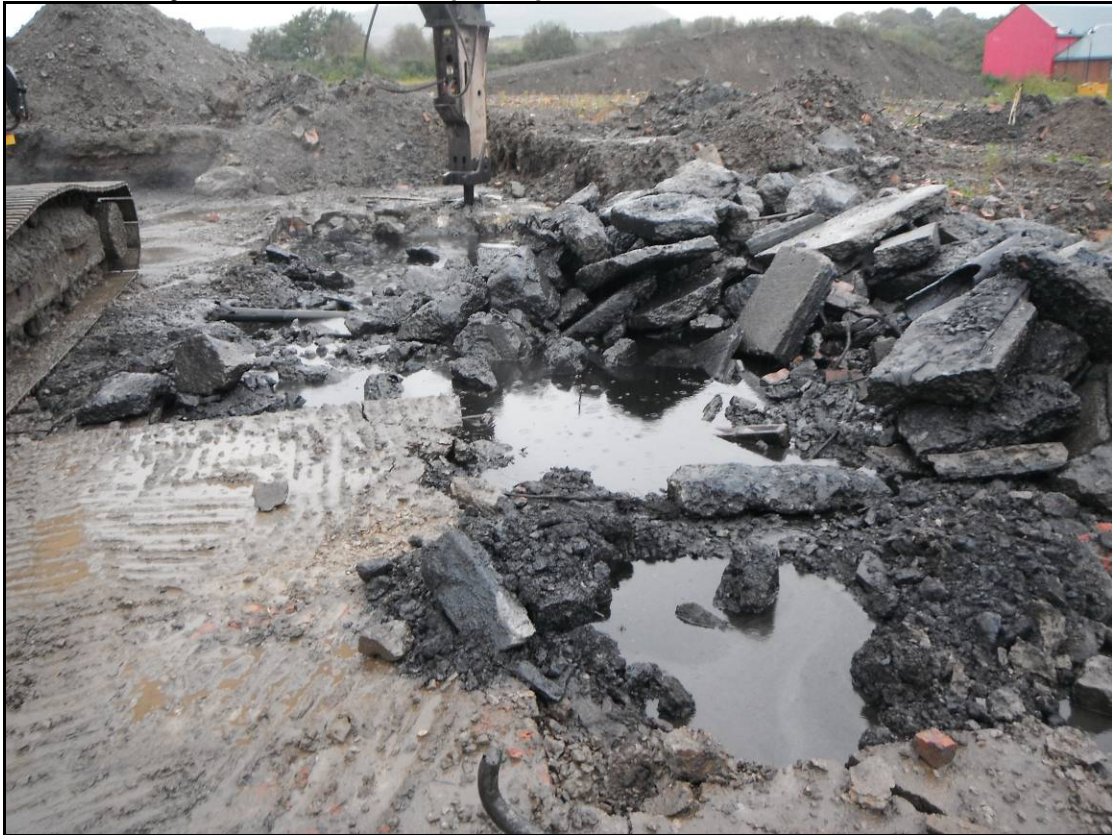
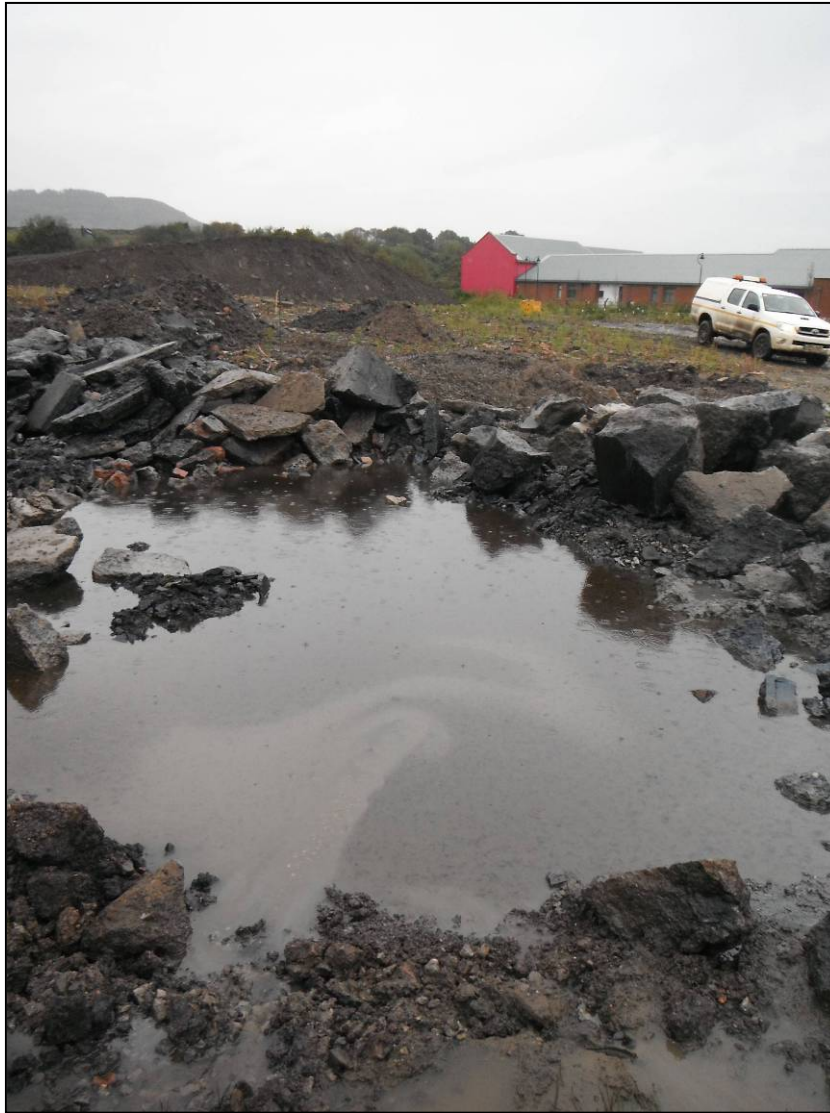
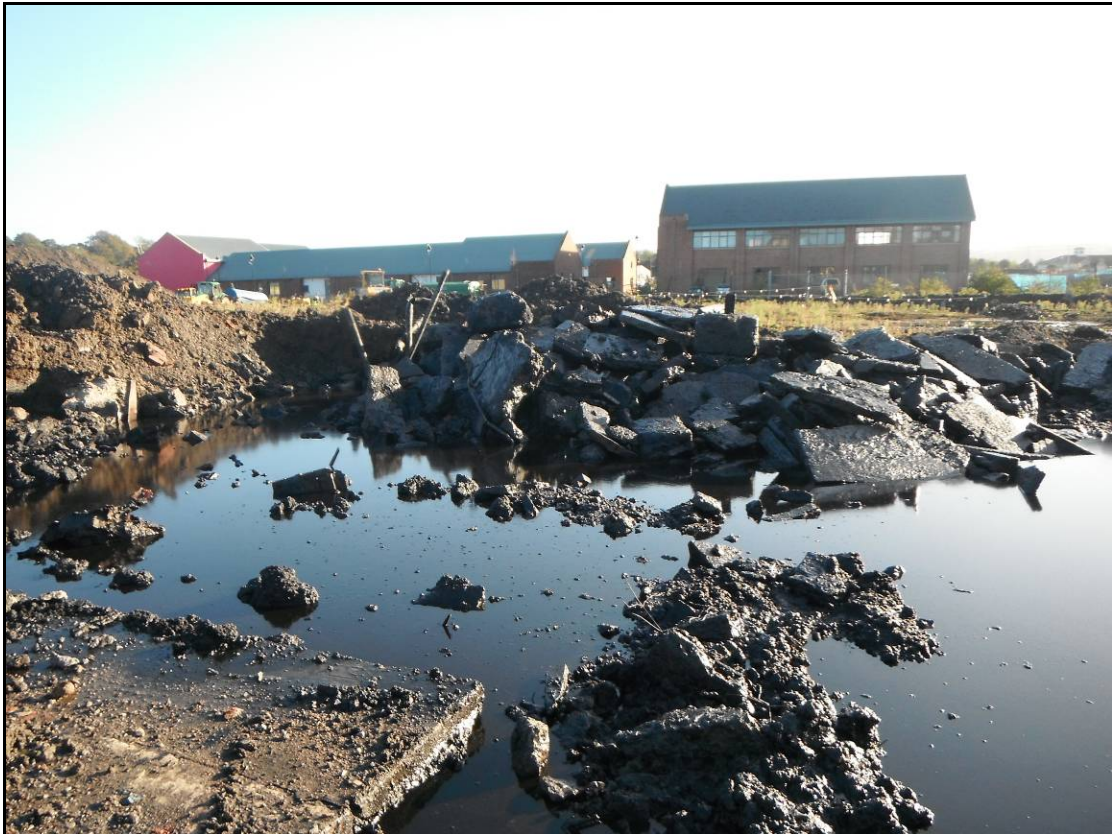
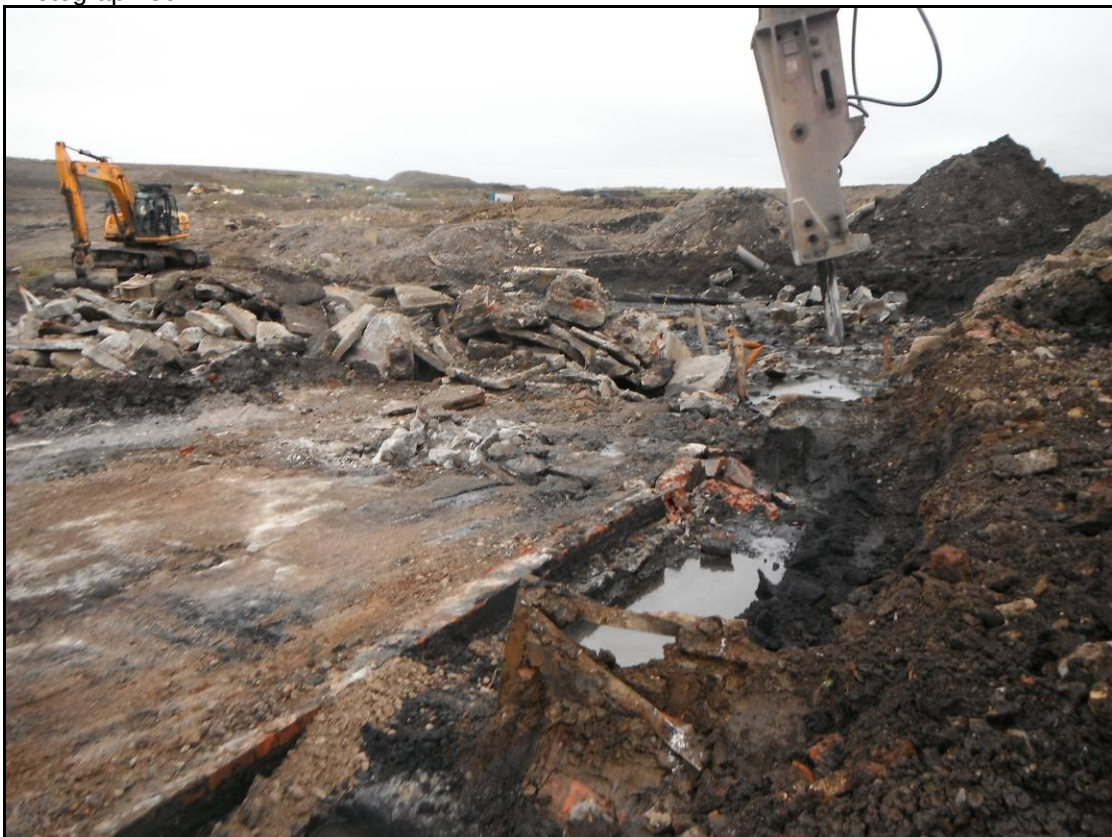
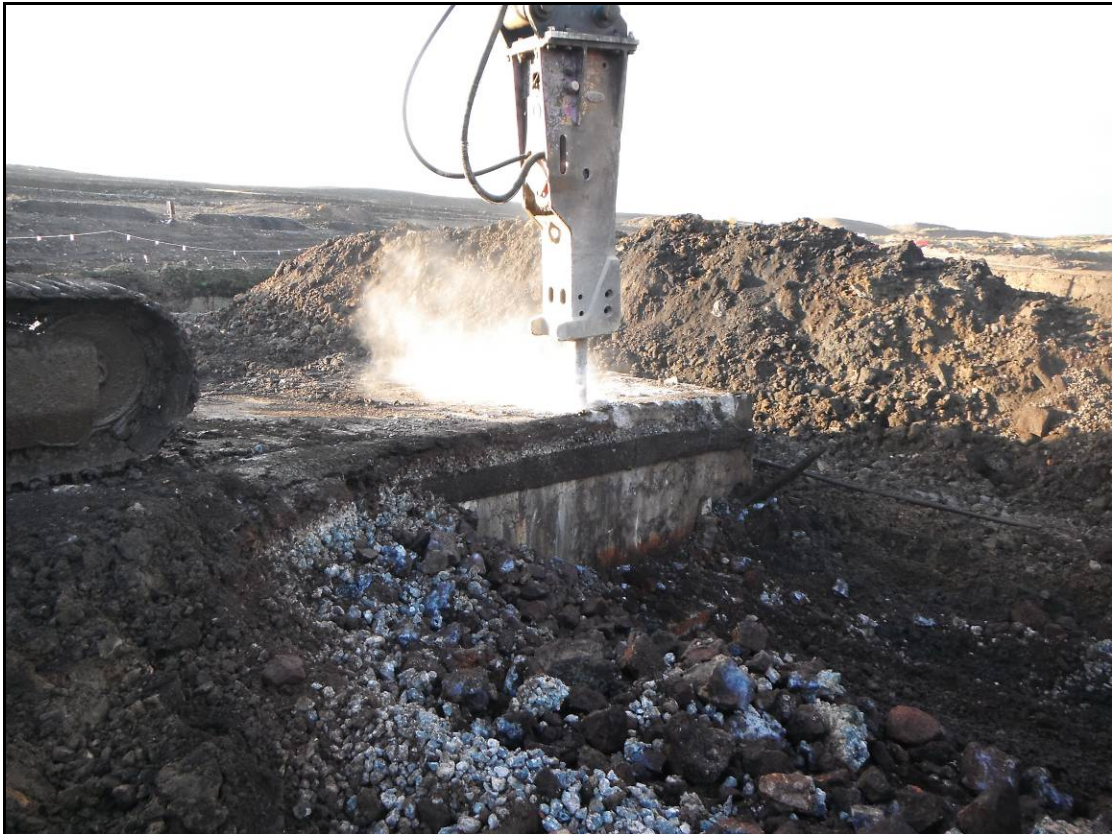
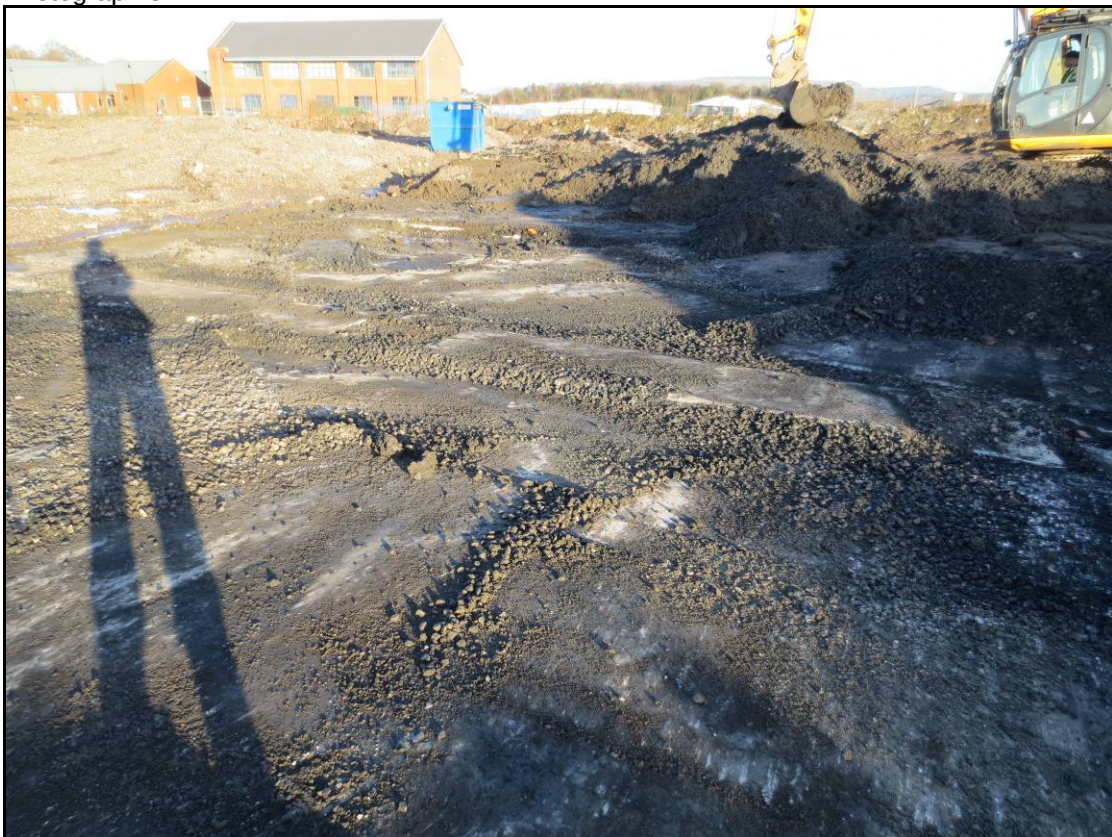
Photographs to  
Brea out of concrete flooring across lower lying areas of phase 1. Concrete was placed directly on the natural clay ground which was heavily impacted with benzene, chlorinated hydrocarbons and free phase product.

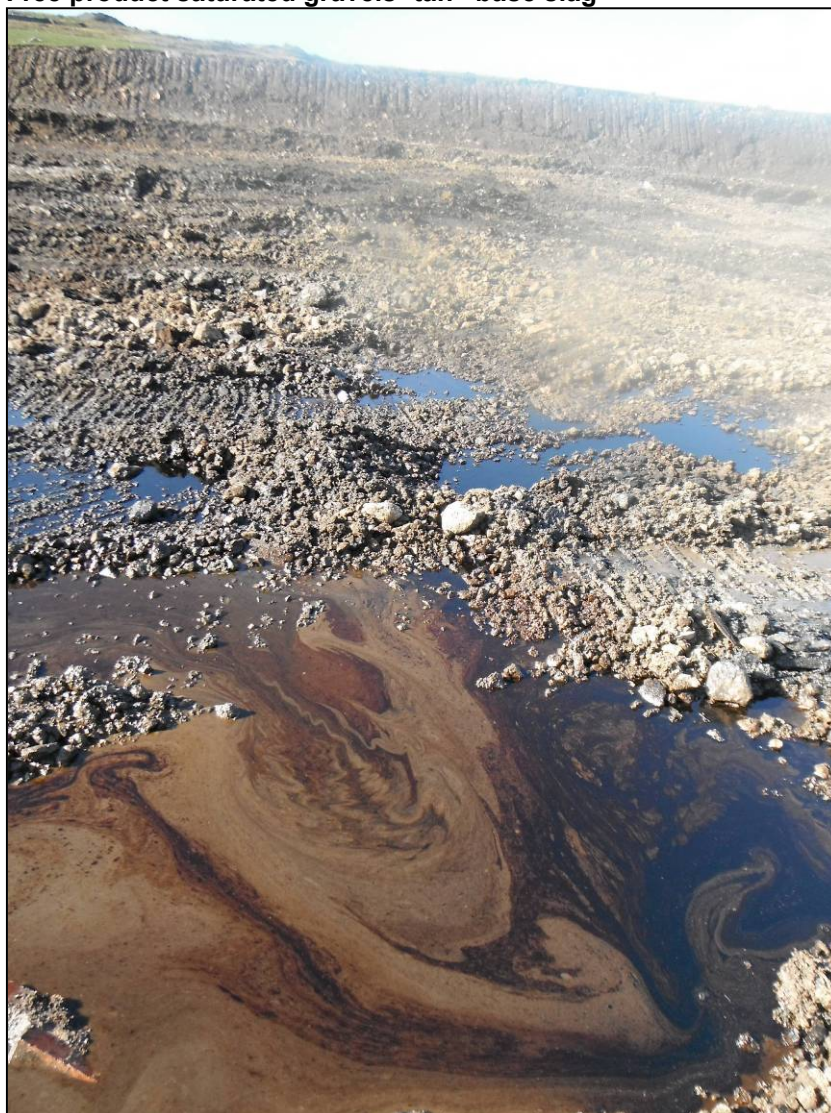
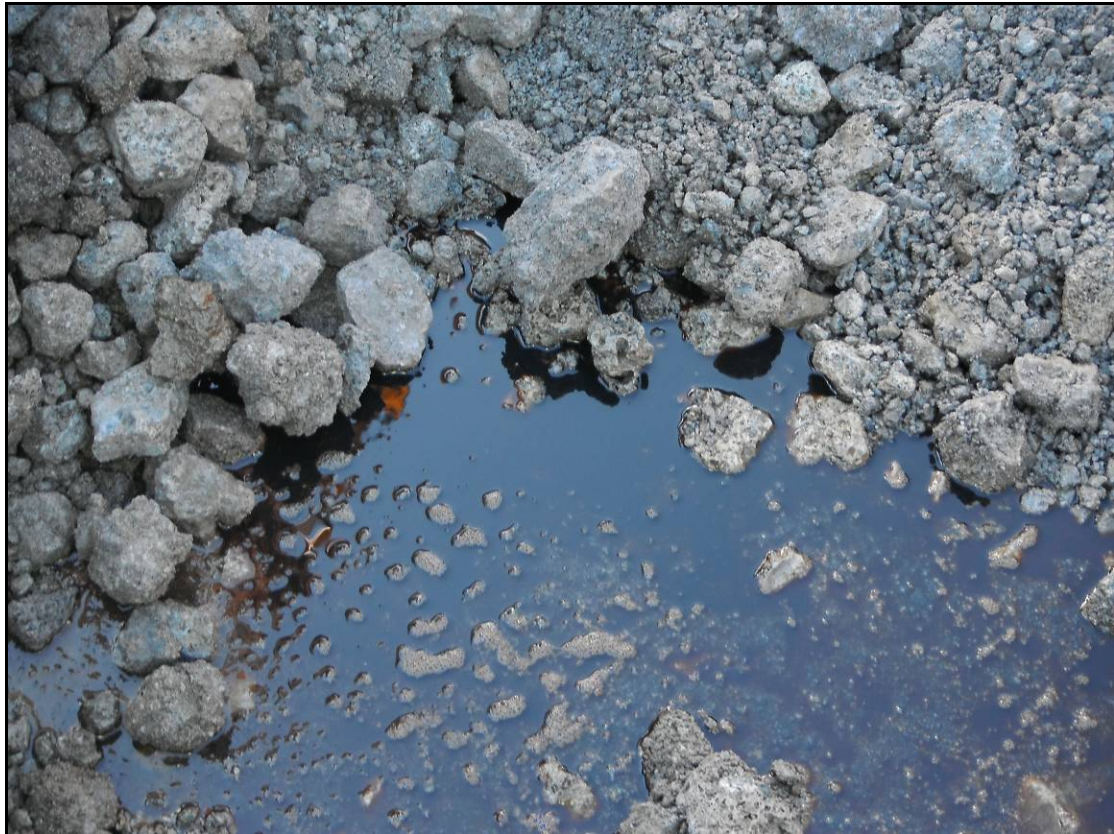
photographs  
Free product saturated gravels tan base slag

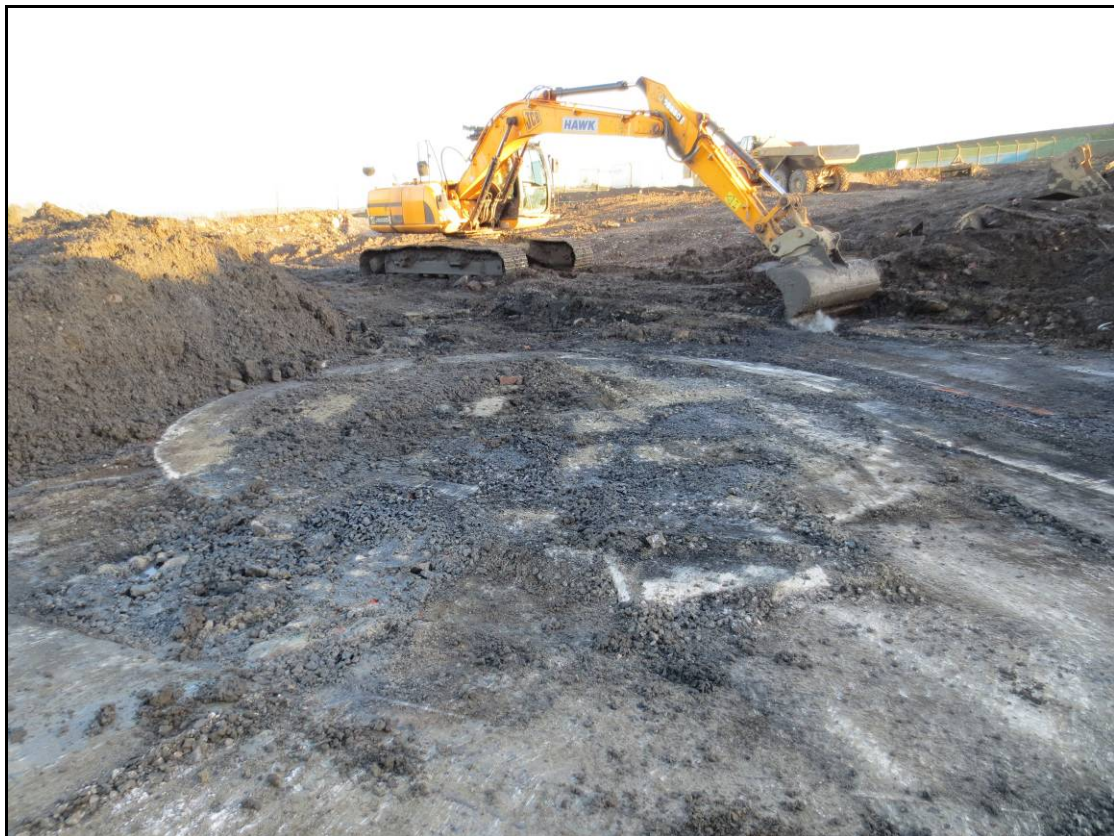
Photograph 36

hotograph  
Old tan Base

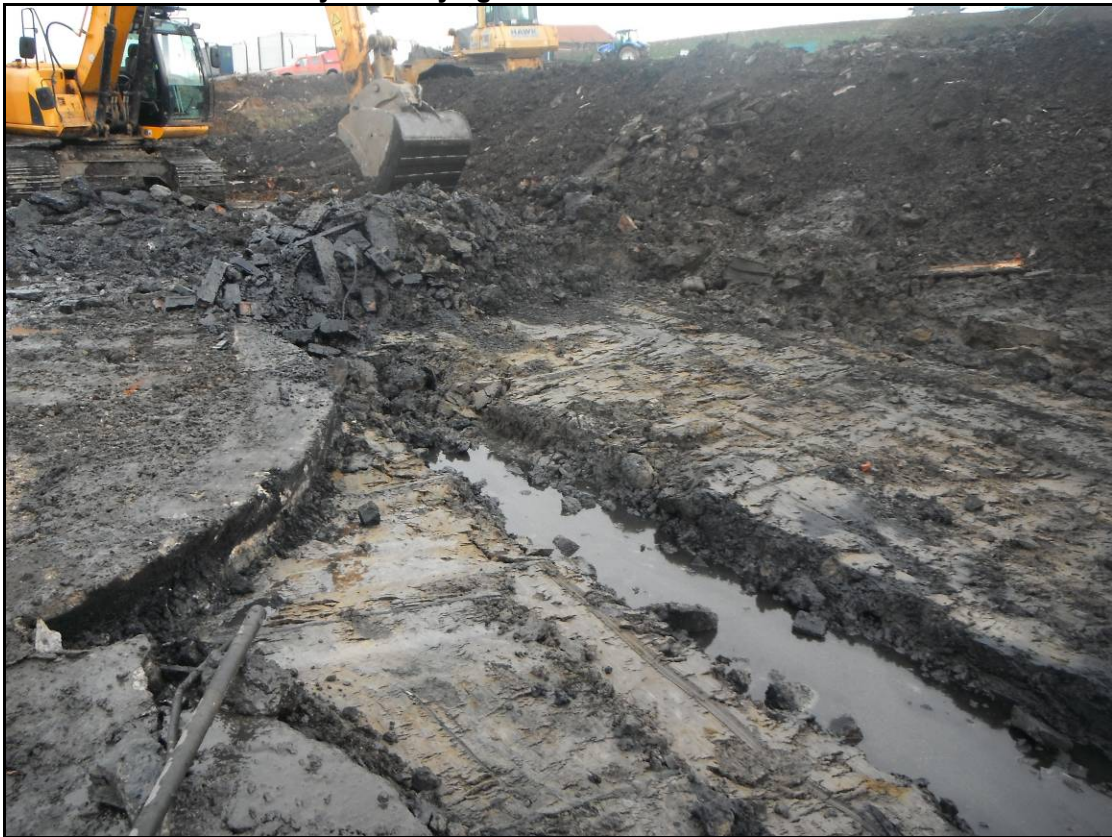
Photograph 37

**Photograph**  
**Base of E cavation Clay underlying concrete slab foundations**

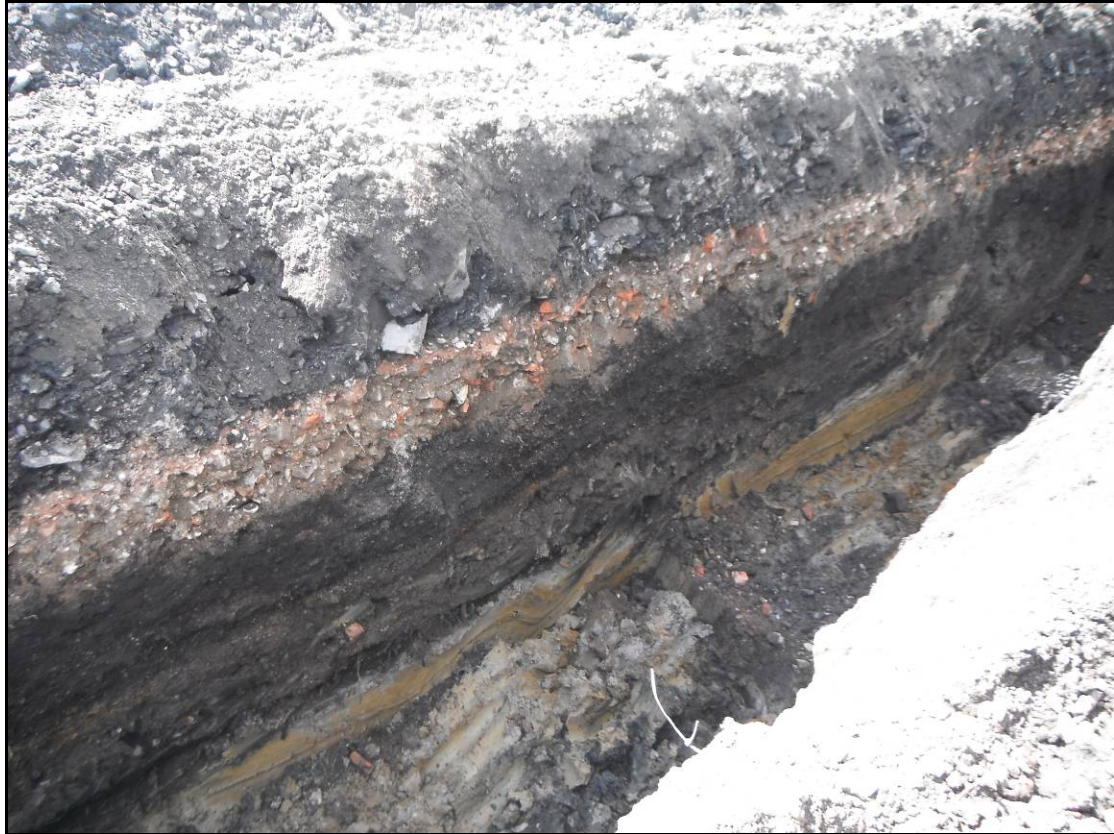
Photograph 39

A typical ground profile sequence on phase

mm Grey mudstone gravel highly friable material

mm Brick and concrete demolition rubble

mm mm Reworbed organic black stained gravelly clay with hydrocarbon odour and pockets of peat

mm Soft grey brown clay natural ground

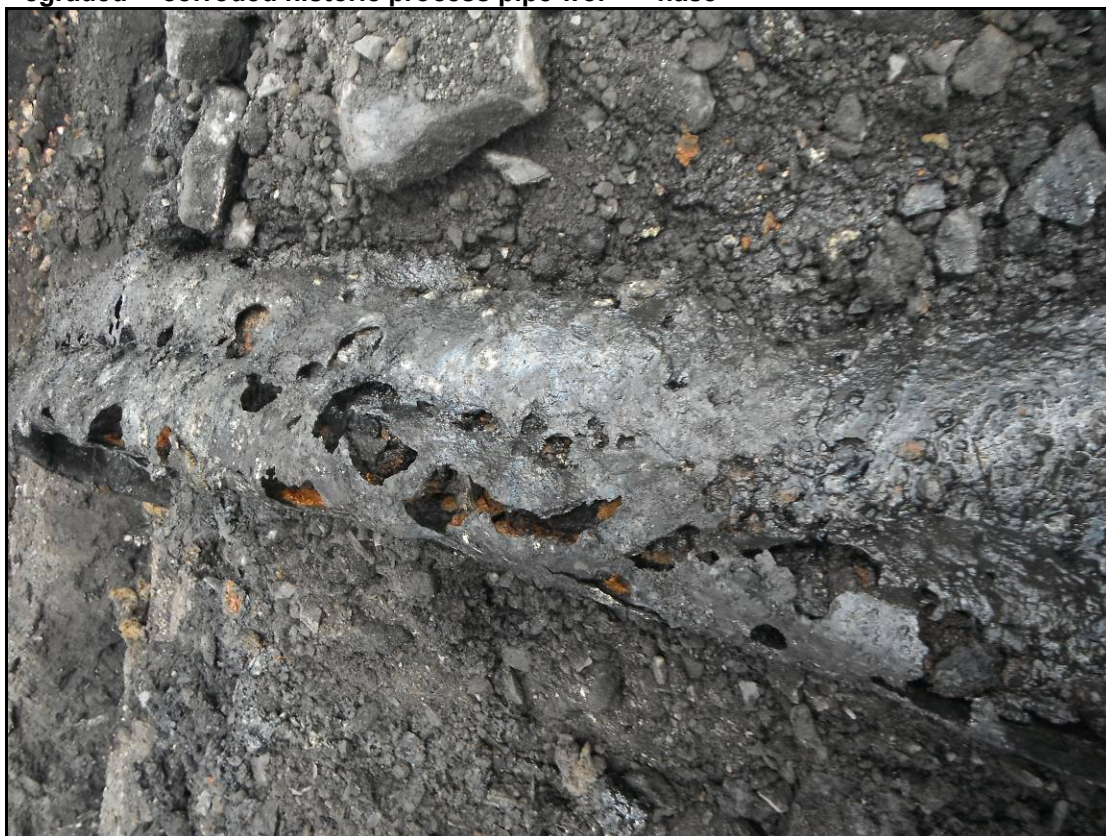
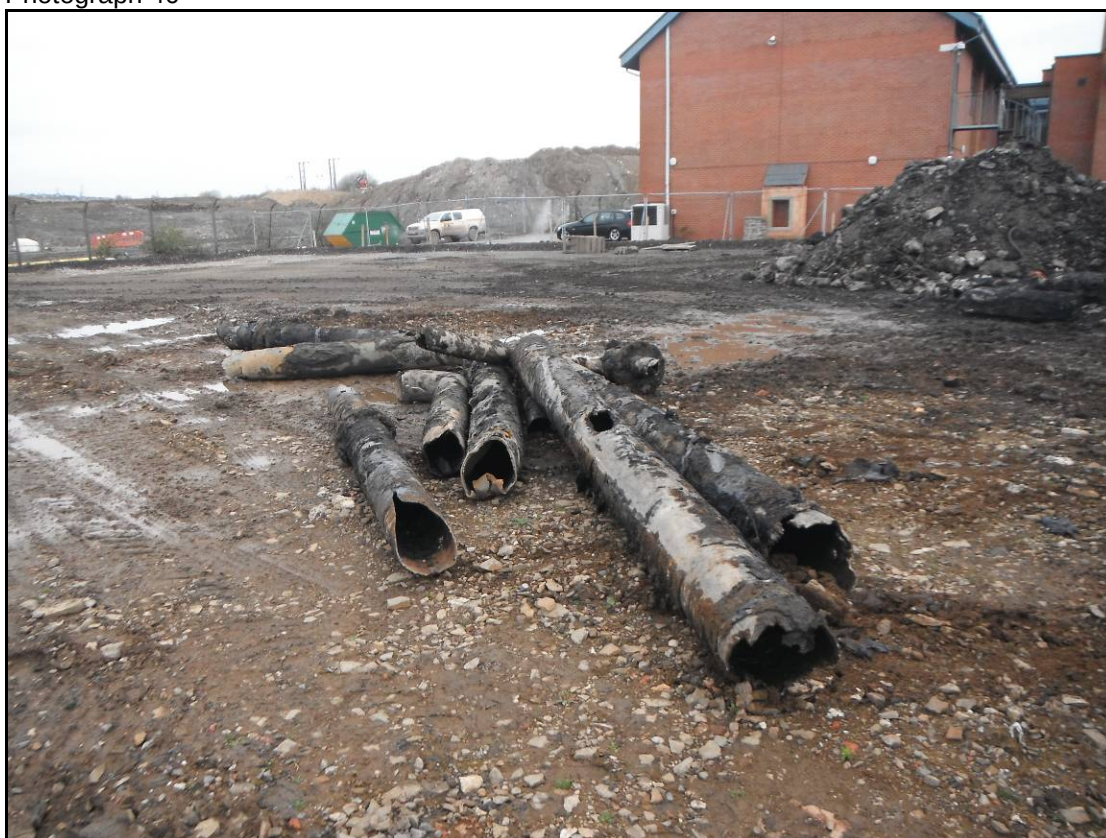
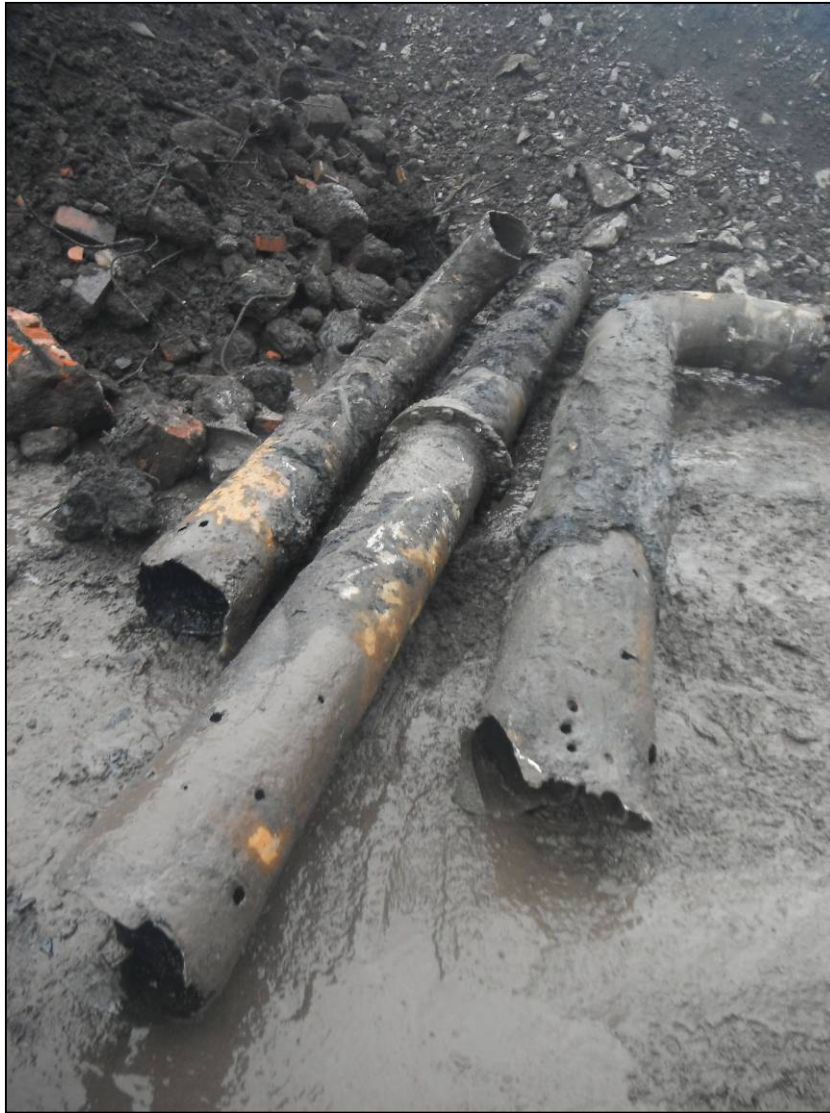
Photographs to  
show the extent of  
corroded historic process pipe work

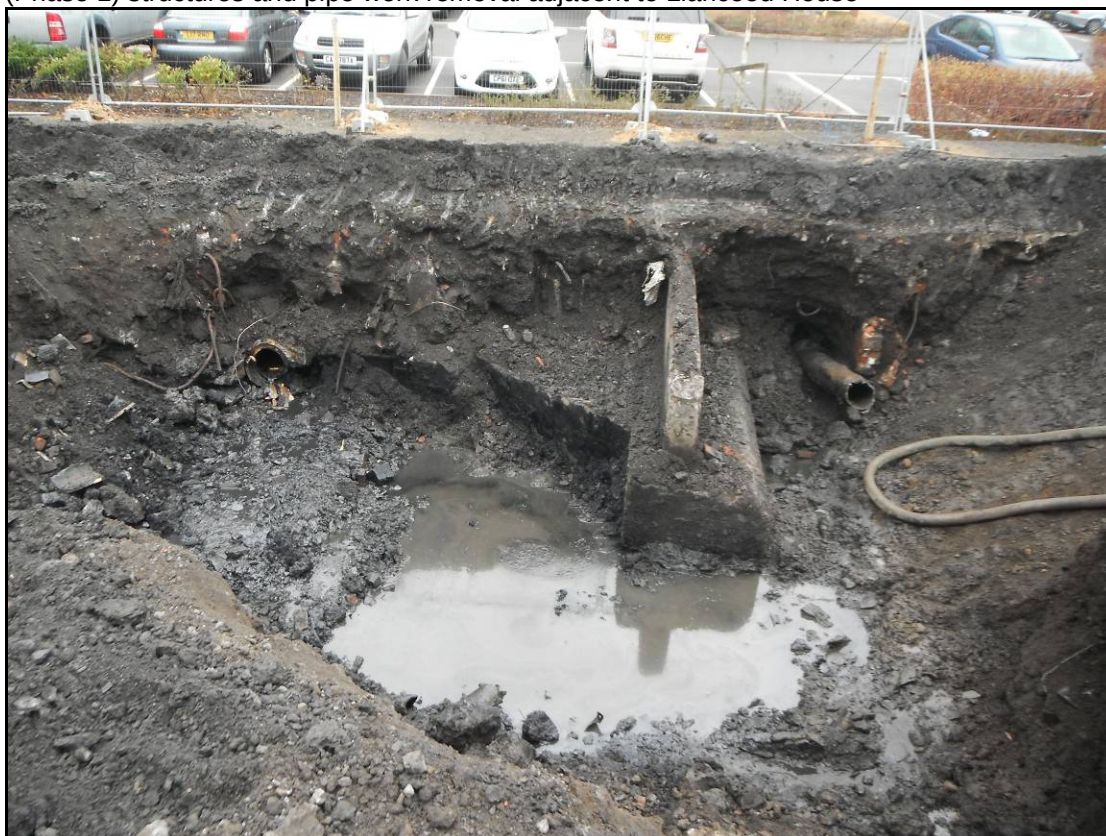
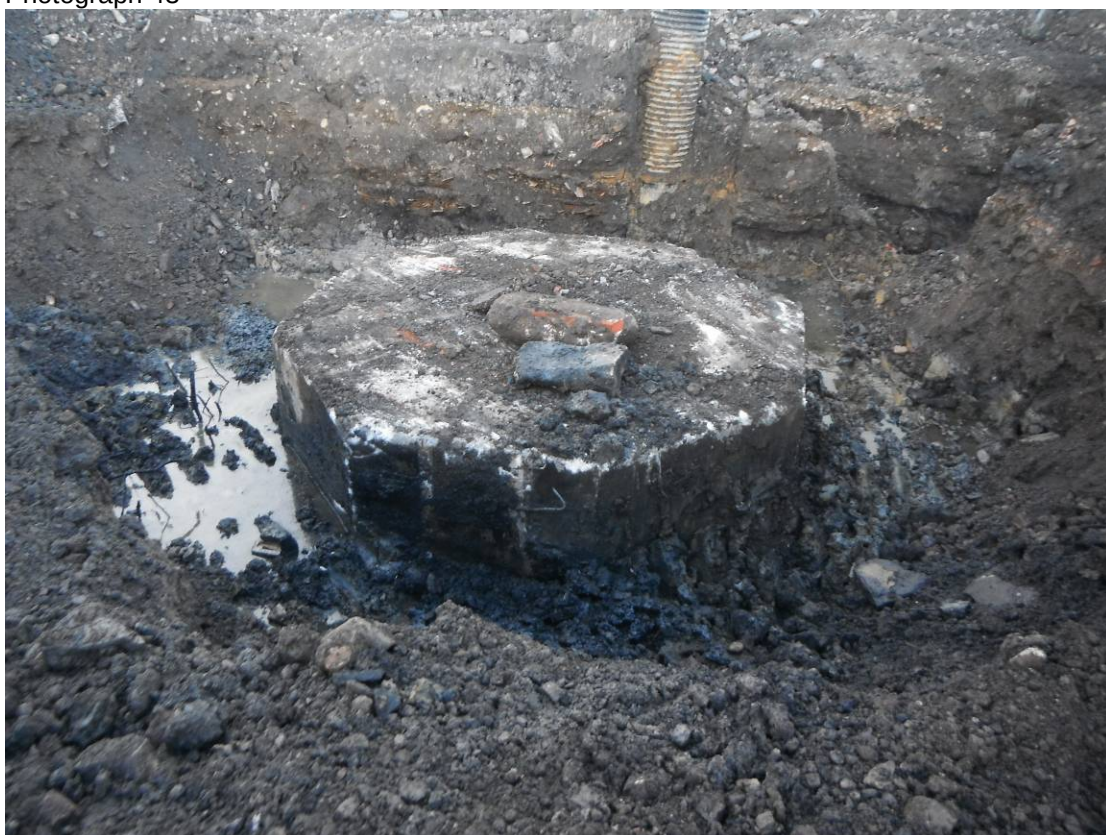
Photographs 43 & 44  
(Phase 1) structures and pipe work removal adjacent to Llancoed House
