# Technical Note 931

| <b>Subject</b> | Coed Darcy – RAP Feature 2, Western Margin Sumps | | |

# Technical Note 1106

| <b>Reference</b> | 5041216-RAP-TN-1106 | <b>Revision</b> | FINAL |

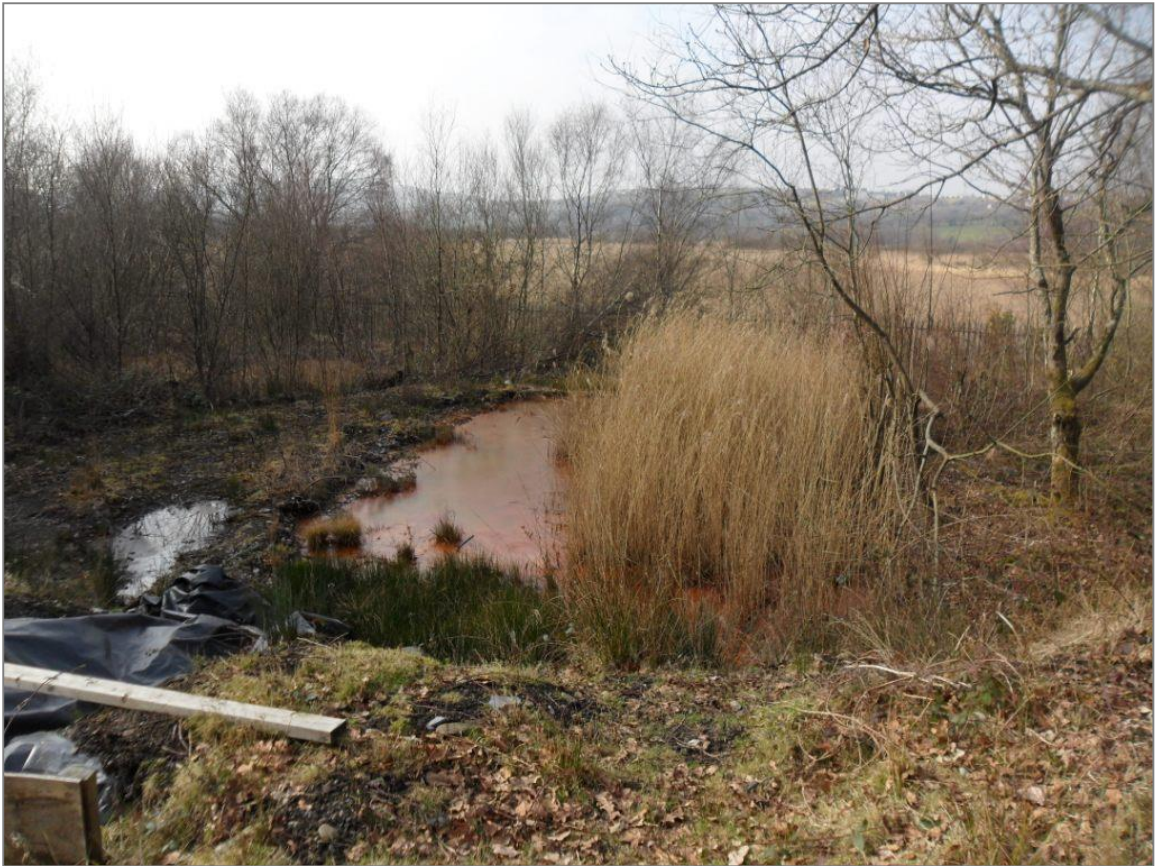
Photograph 15: Reedbed fed by the discharge of the interception trench. Note the ochreous water.

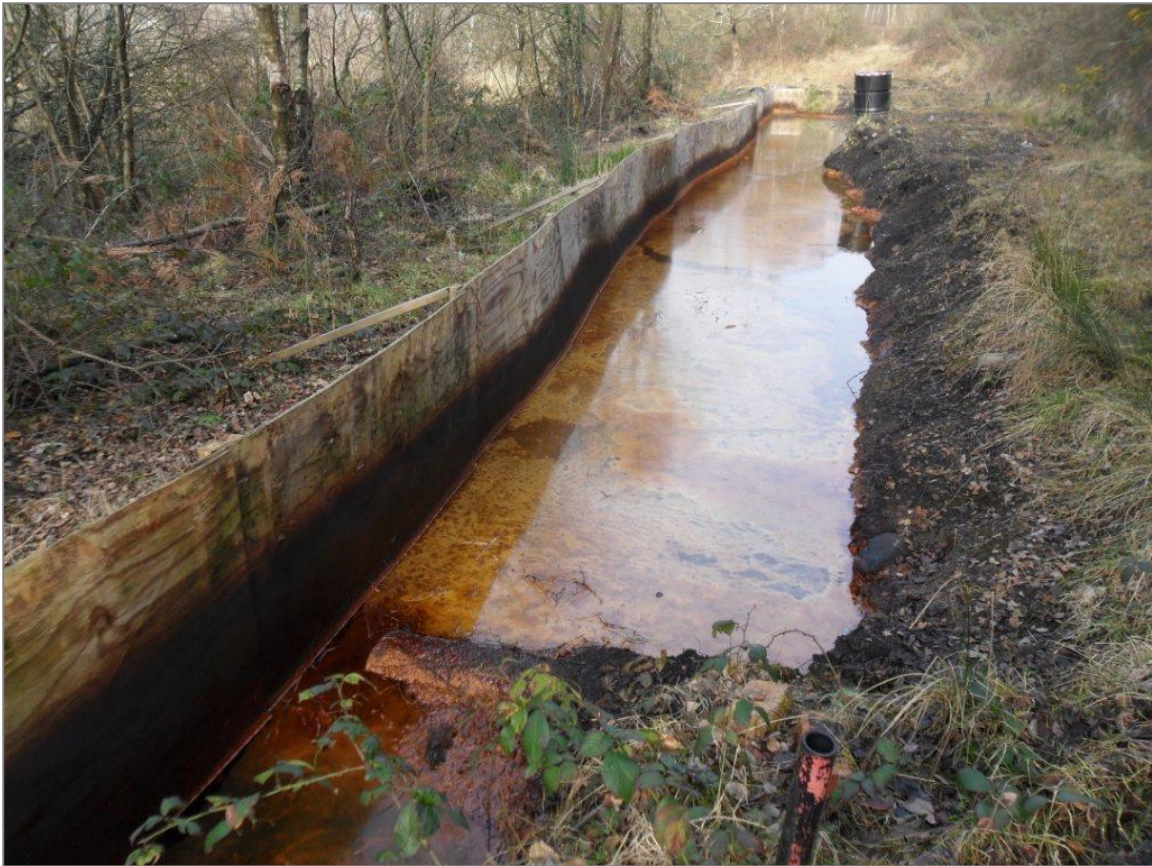
Photograph 17: The western margin interception trench with oil sheen and some free product. Note the 200mm diameter pipe entering the trench.

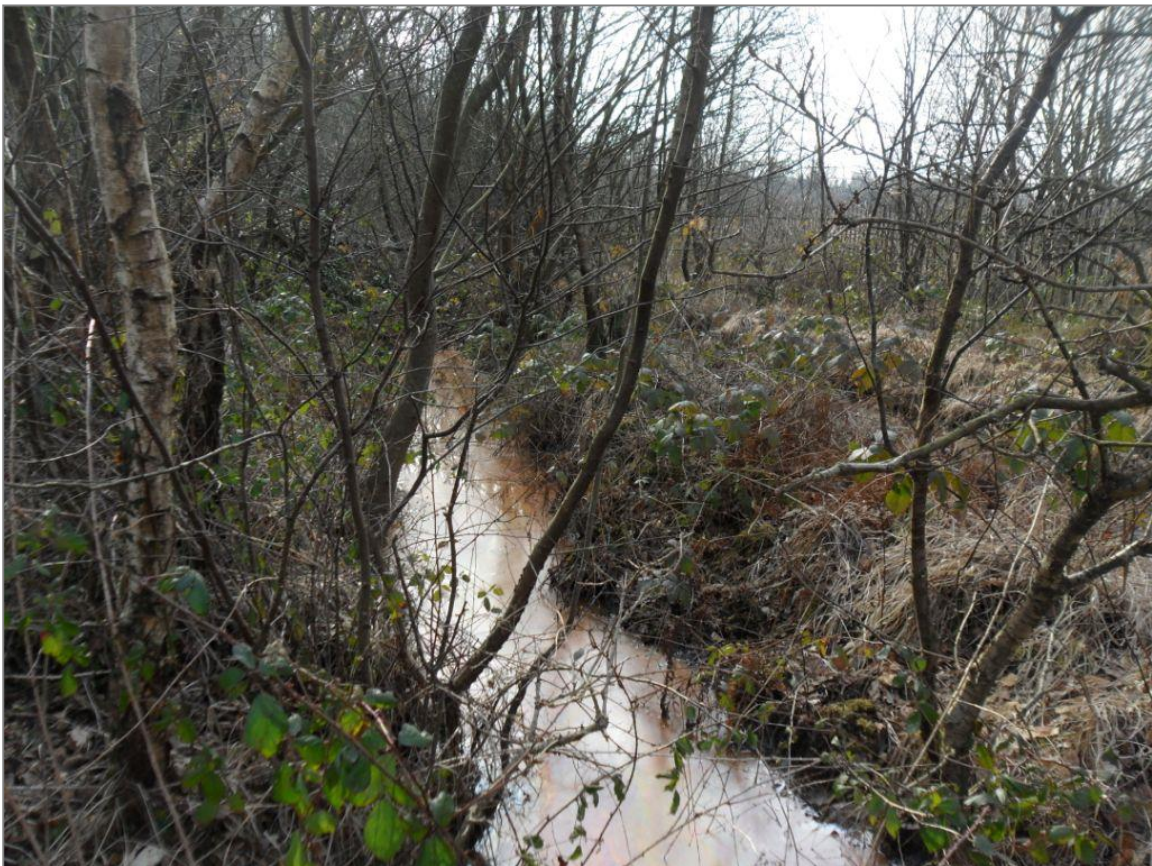
Photograph 18: Historical drainage ditch with abundant ochre noted. The ditch is located within dense woodland and scrub.

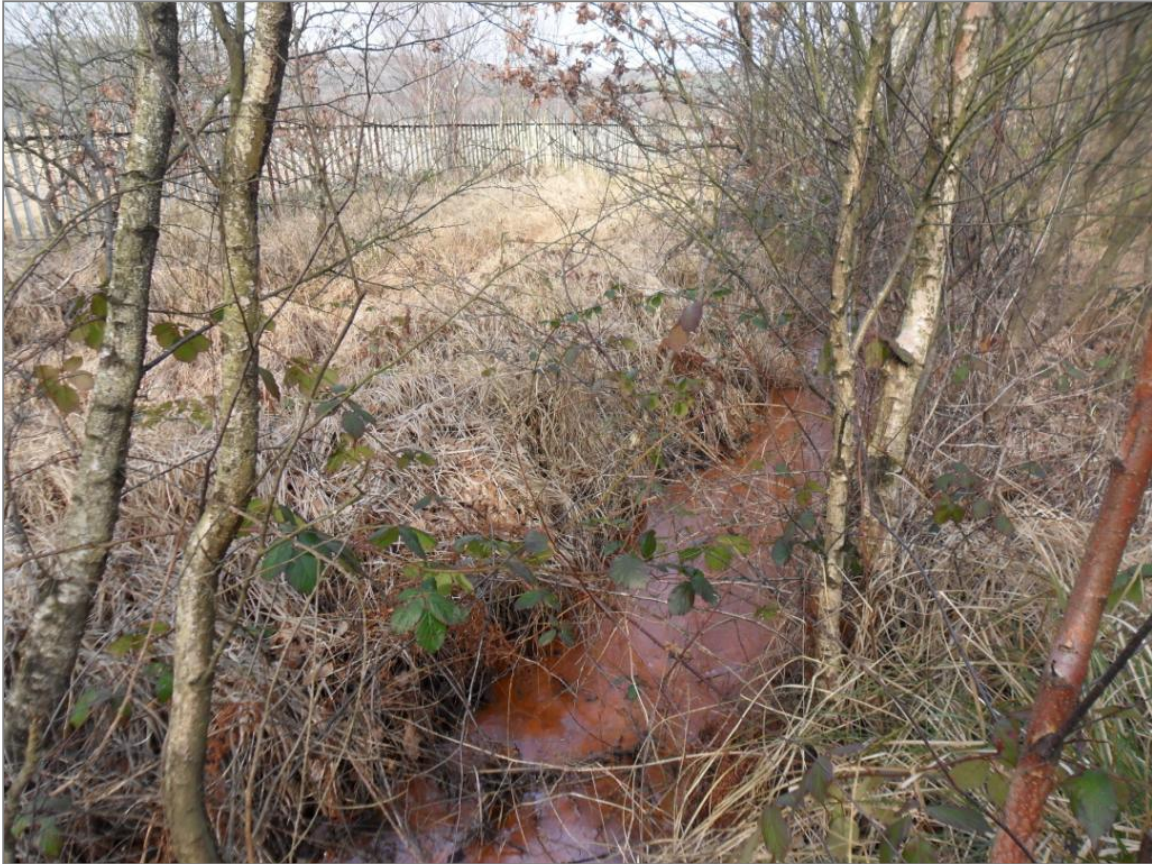
Photograph 19: Historical drainage ditch with abundant ochre noted. The ditch is located within dense woodland and scrub.

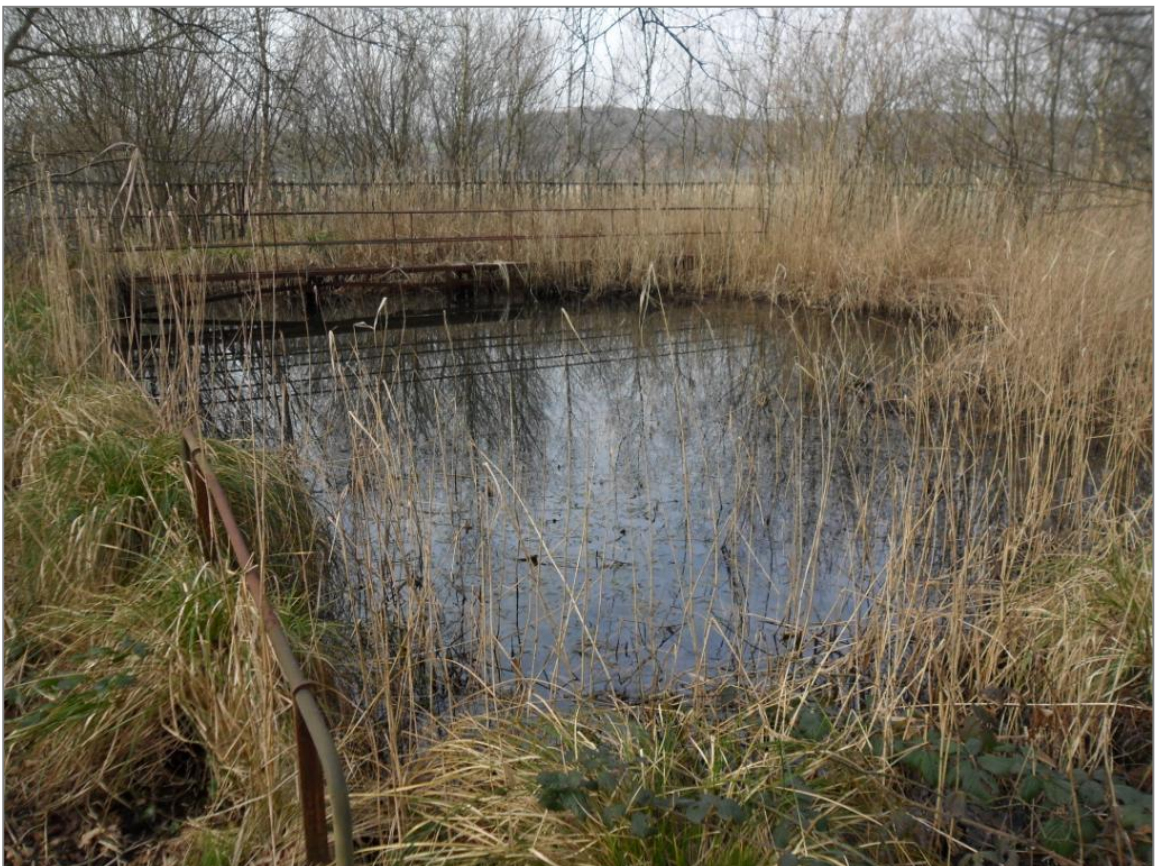
Photograph 26: Railhead separators viewing north westwards. Water appeared clear with no sheen during walkover.

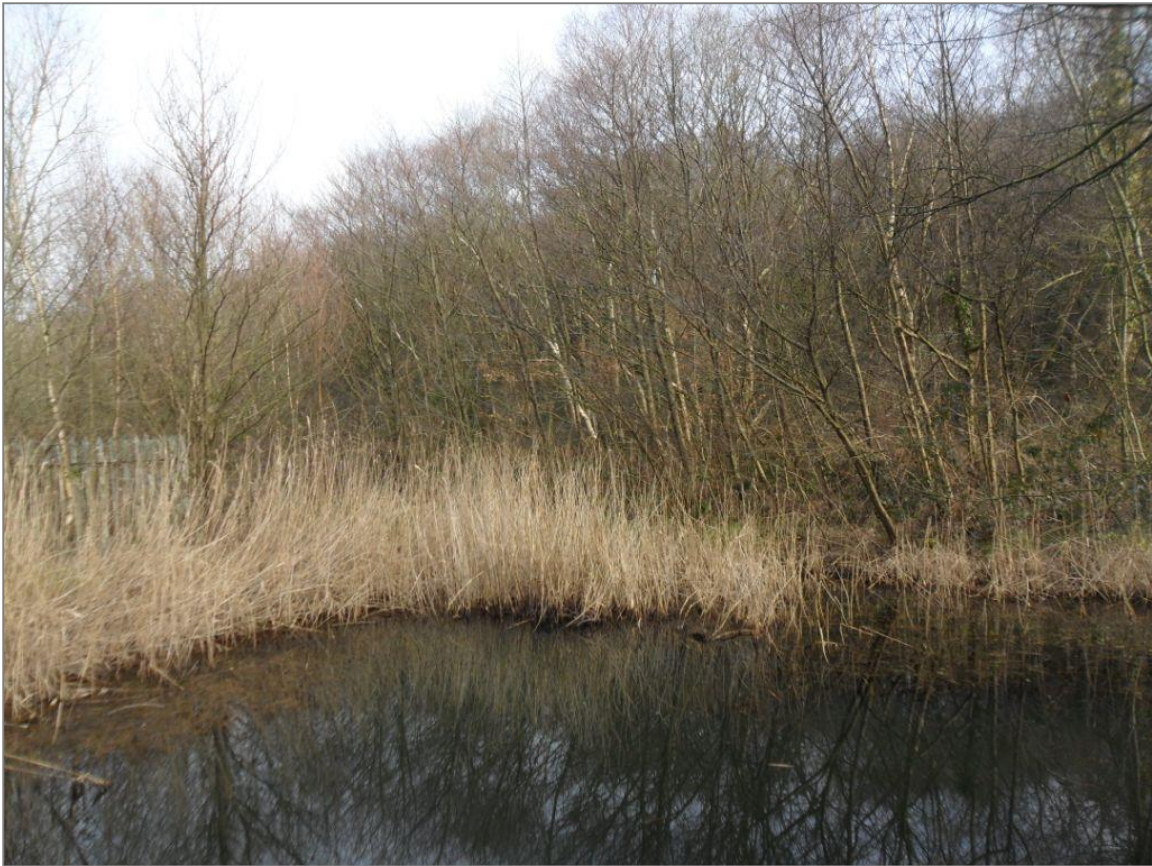
Photograph 27: Railhead separators viewing north eastwards. Water appeared clear with no sheen during walkover.

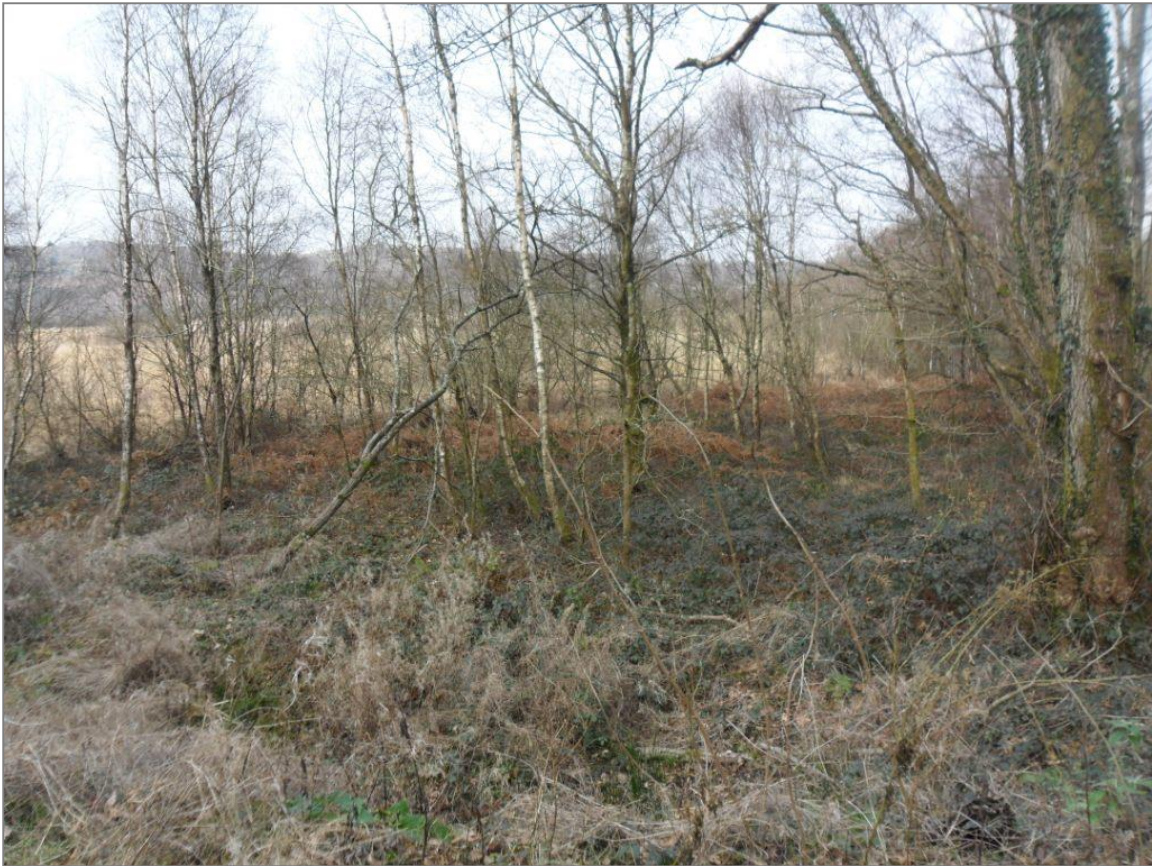
Photograph 29: Semi mature woodland with thick bramble cover. Ground was noted to be boggy in places.

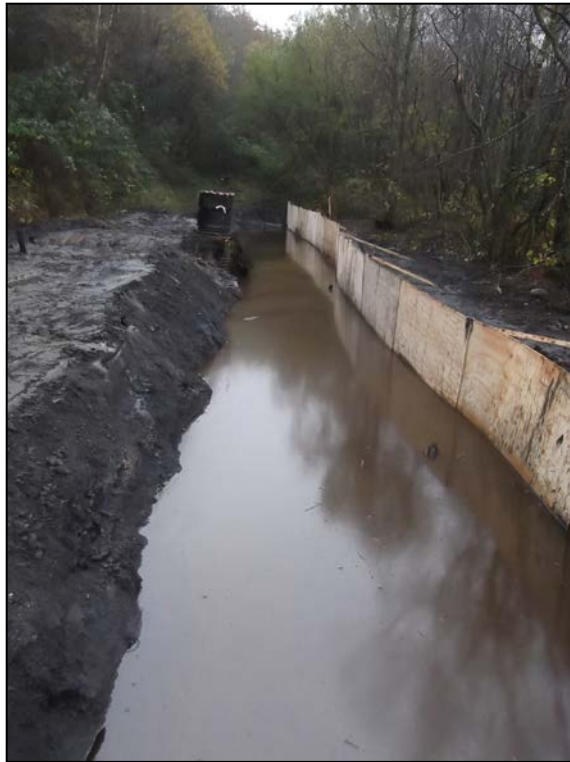
Photograph 1 – Completed trench showing boards to north (facing west)

The completed trench has been lined with marine ply to the north, to assist with the collection of free product (photograph 1). A baffle has been placed at the eastern end of the trench to allow the flow of water out of the trench to prohibit flooding, whilst prohibiting the flow of free product (photograph 2). Water flows from the trench down a spillway into a reed pond (photograph 3).

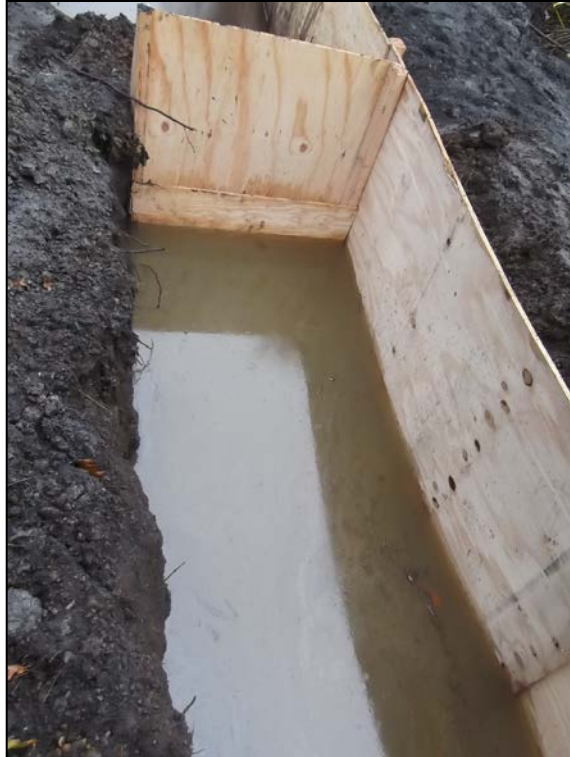
Photograph 2 – Baffle board

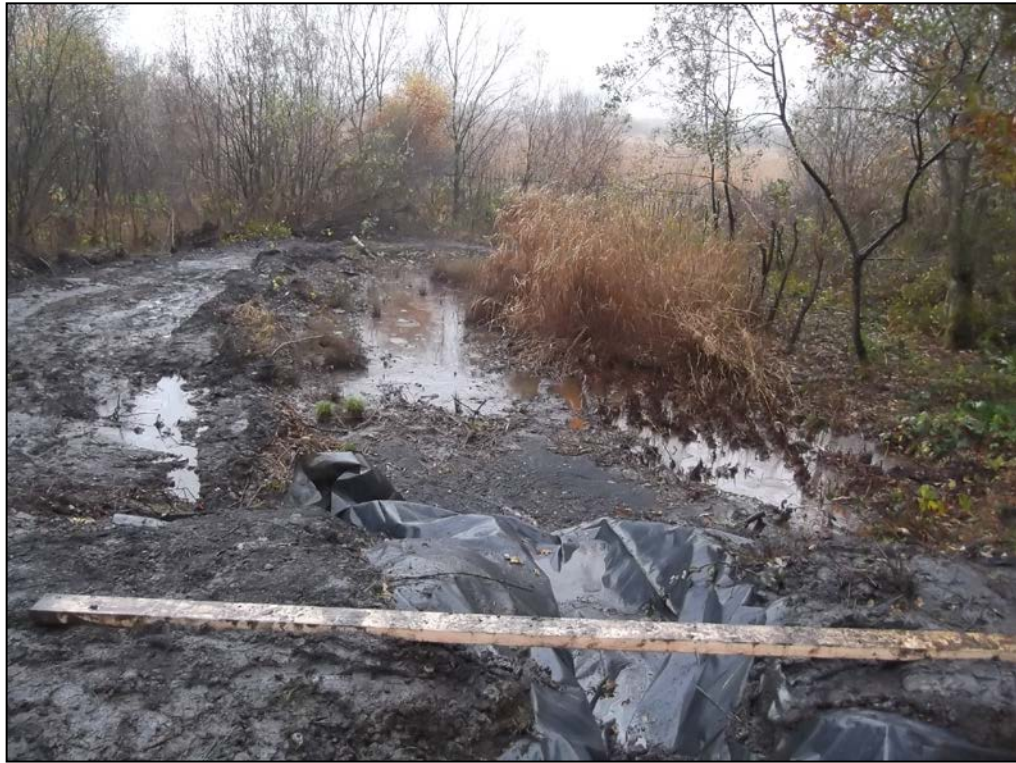
Photograph 3 – Slipway and reed pond

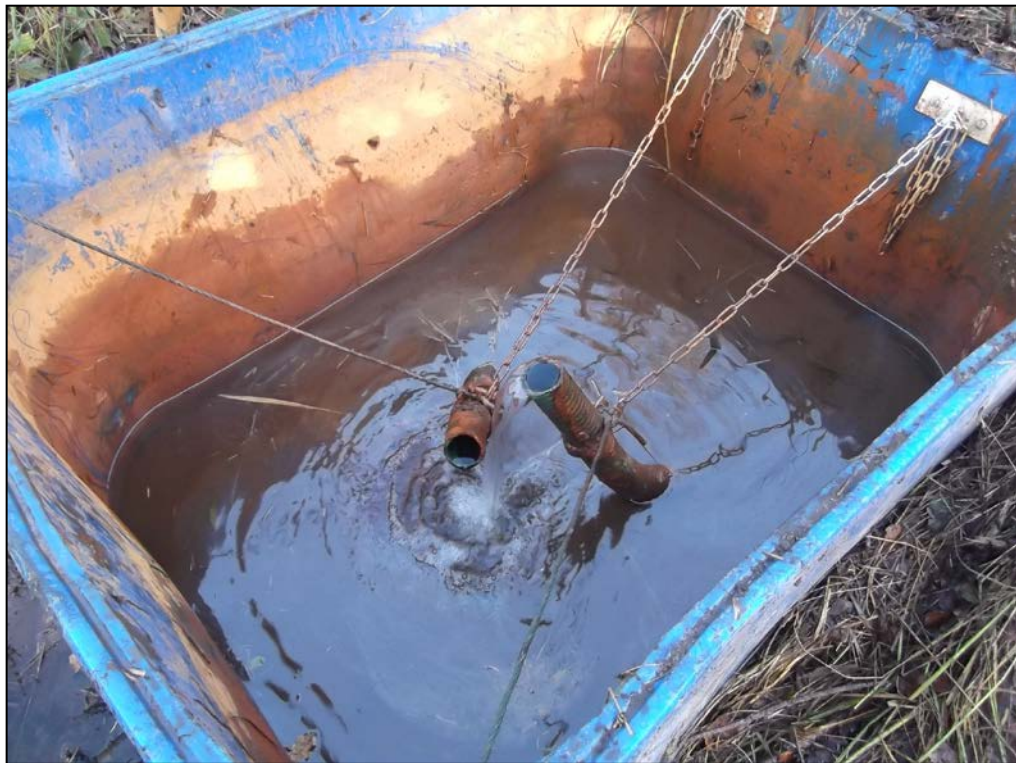
Photographs 4 and 5 – Operational outlet pipe from reed pond into separator

Excess vegetation around the reed pond was cleared as part of the works, and the outlet pipe into the separator tank at the exit from the reed pond was cleaned out such that it is fully functioning to prevent the migration of ochre into Crymlyn Bog SSSI (see photographs 4 and 5).

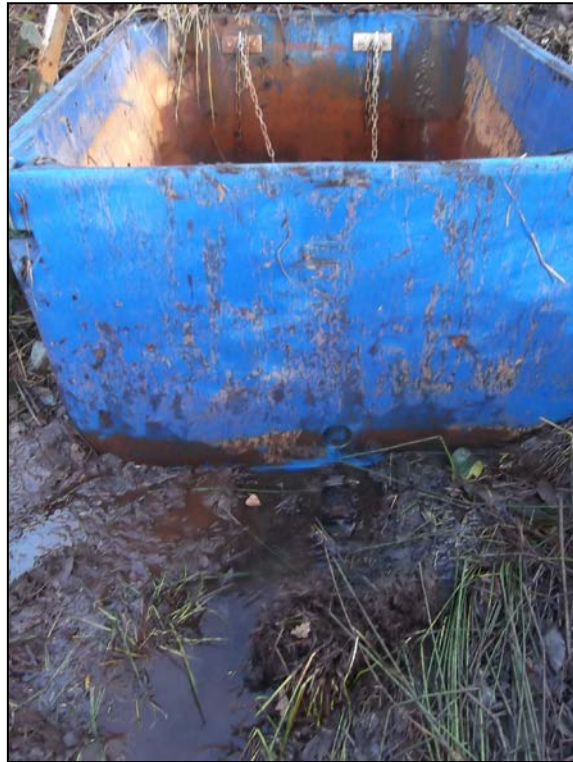
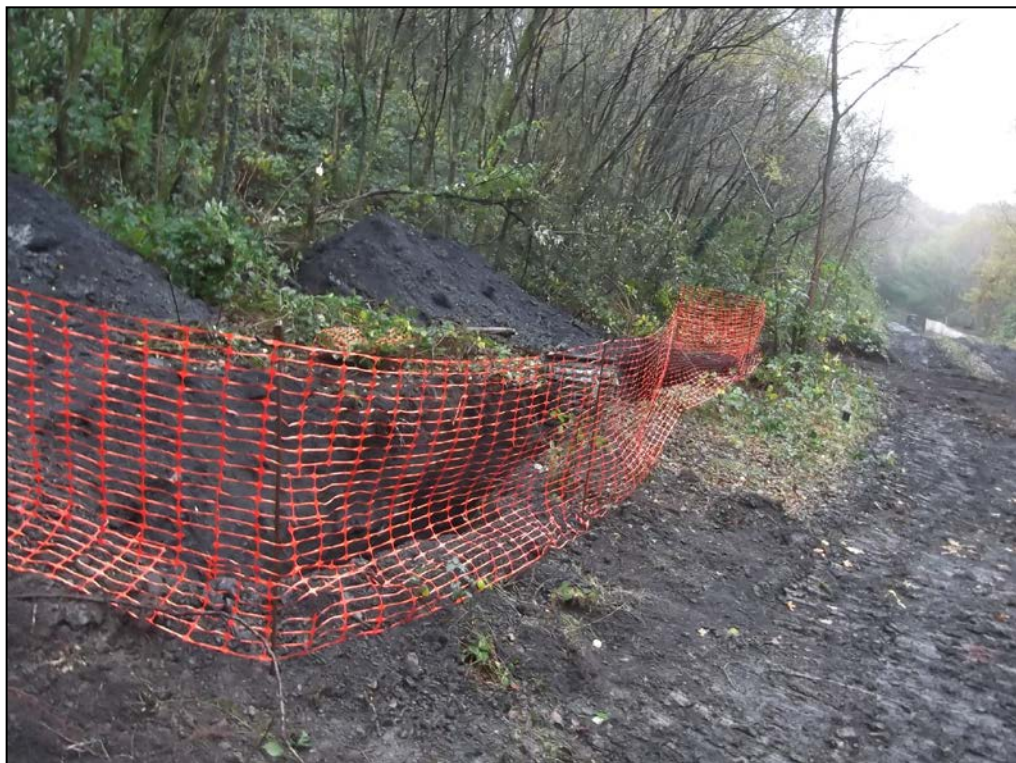
Photograph 6 – Complete excavation to east and west of Sump 5

A slit trench, measuring approximately 8m by 1.2m and 2m in depth, was excavated, in an east-west direction, to either side of Sump 5. This is in agreement with the design as shown on drawing 5041216-RAP-DWG-1512. The completed excavation is shown in photograph 6.

The excavation has been cordoned off to prohibit access (photograph 6).

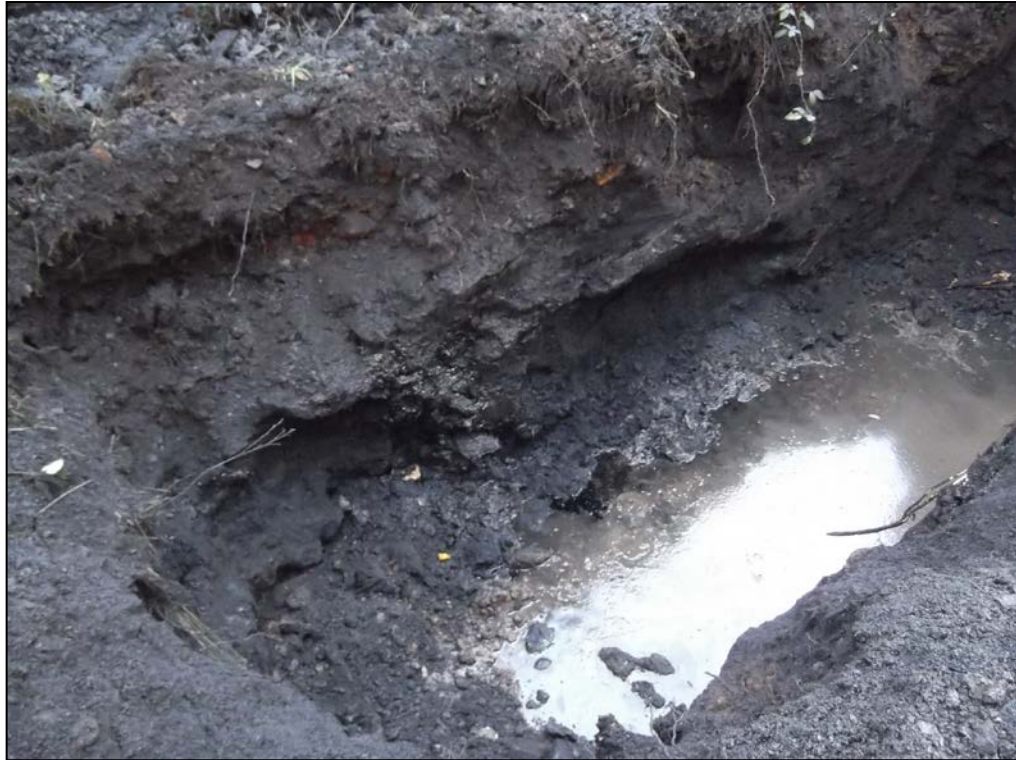
Some free product was noted to flow into the trench onto of the ground water following the completion of the excavation (photograph 7).

Photograph 7 – Observations of groundwater and free product in slit trench

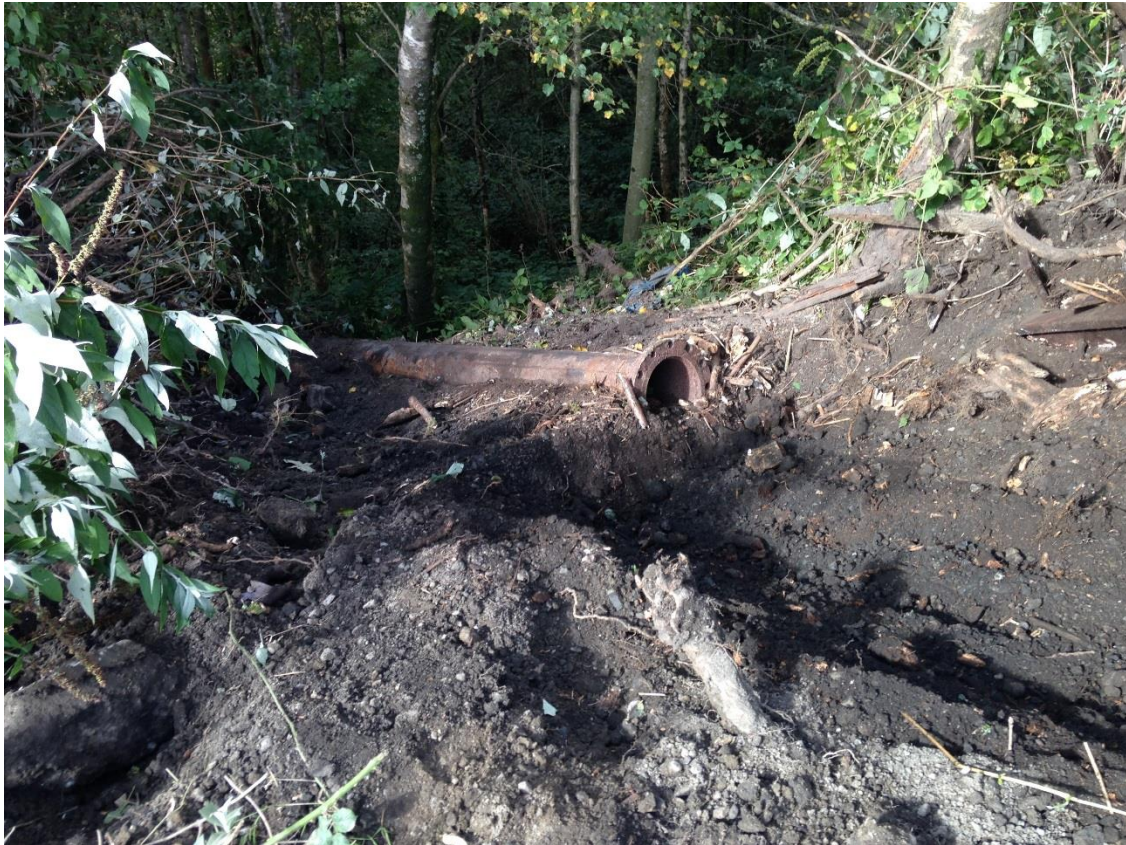
1) Pipe 1 – northern most pipe exposed and removed. Viewing north west

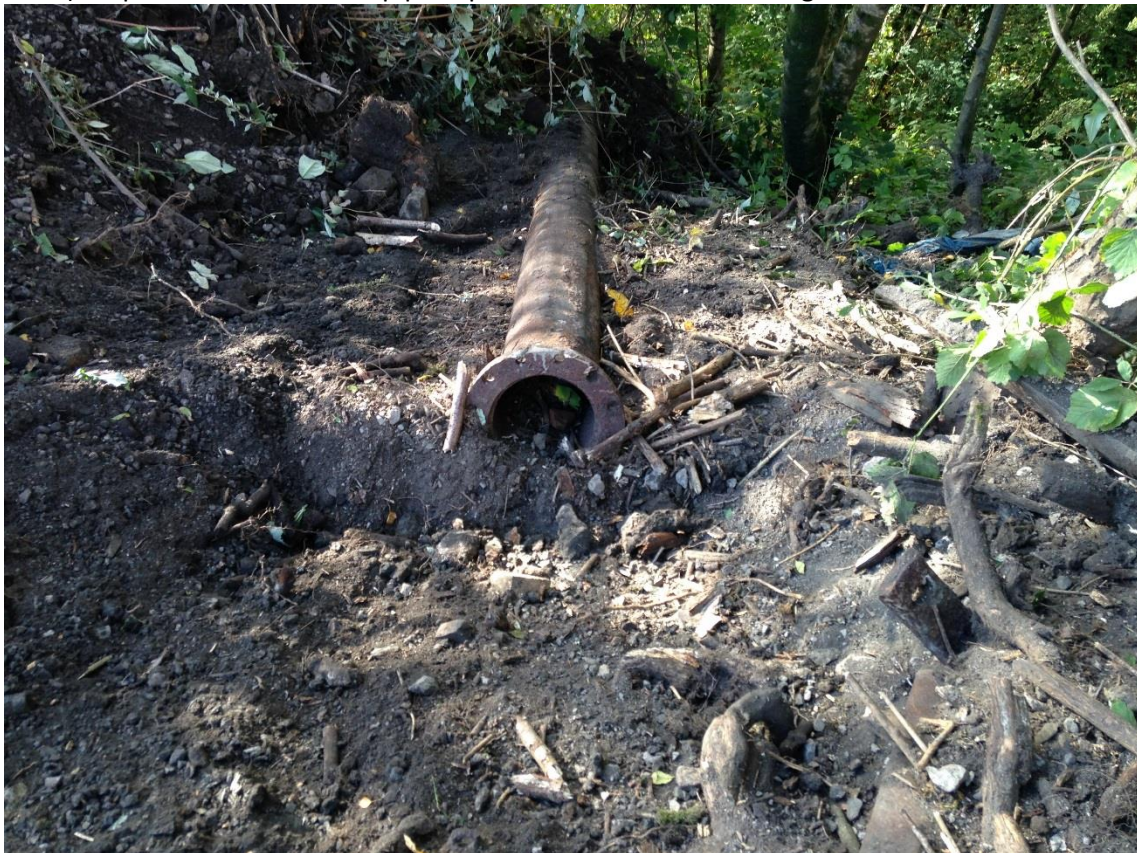
2) Pipe 1 - northern most pipe exposed and removed

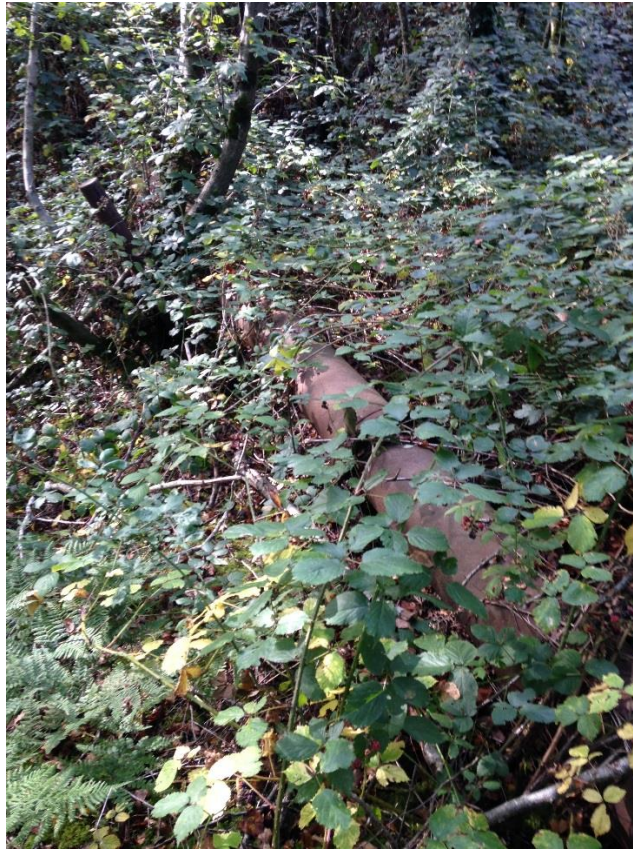
3) Pipe 2 - Southern most pipe exposed and removed. Viewing east

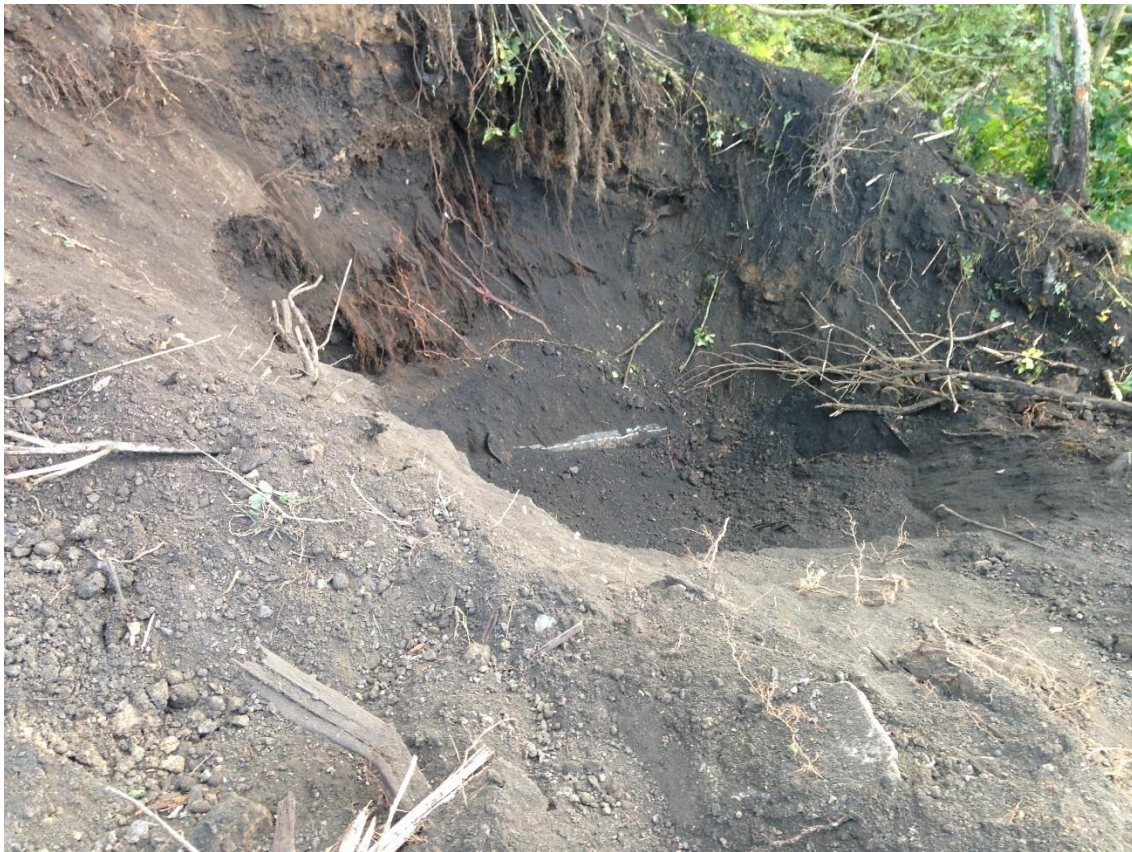
4) Pipe 2 - Southern most pipe exposed and removed. Viewing south west

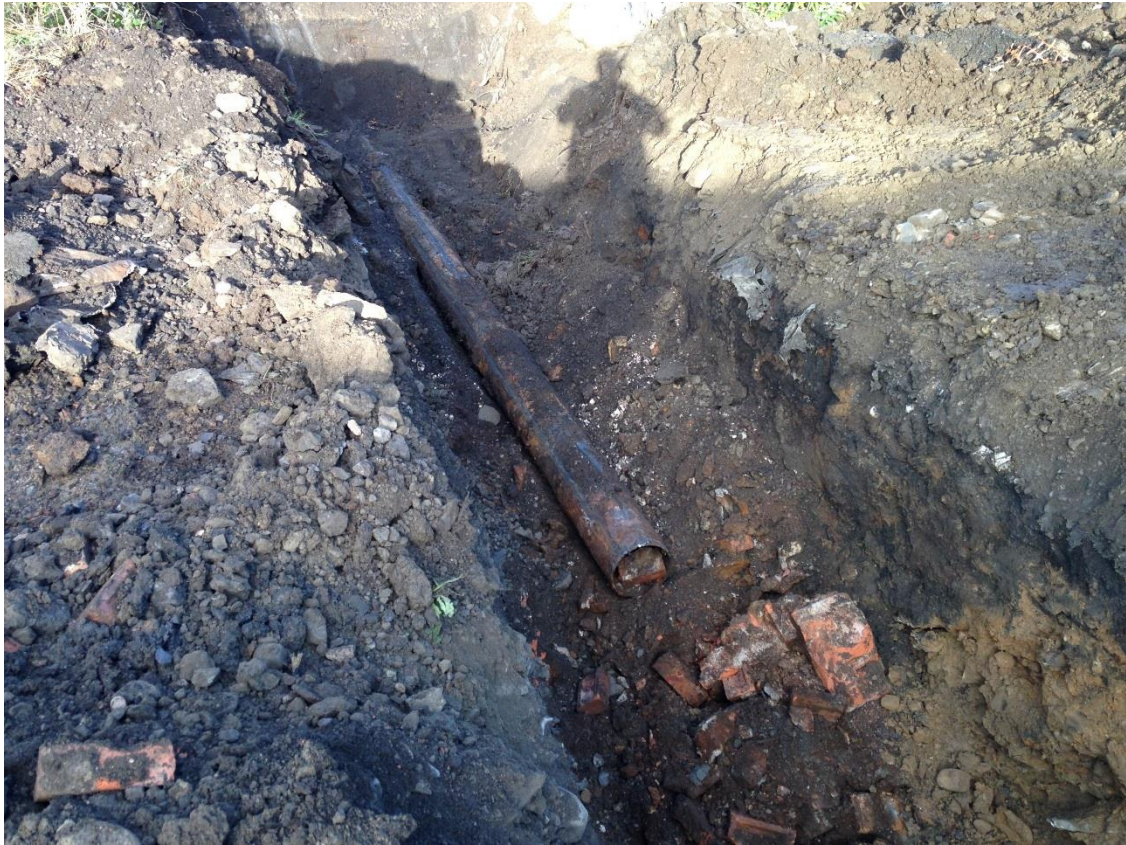
5) Pipe 2 – length of pipe located under the haul road removed

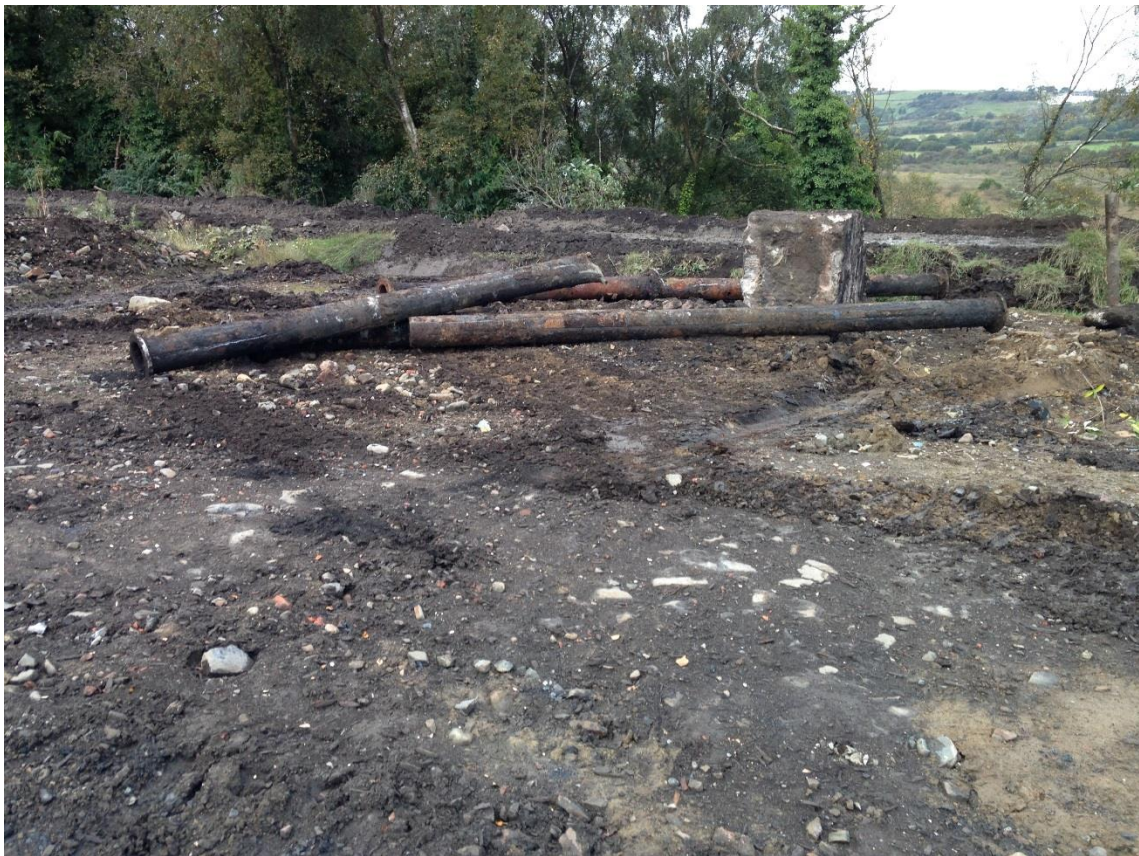
6) Pipe 2 sections removed

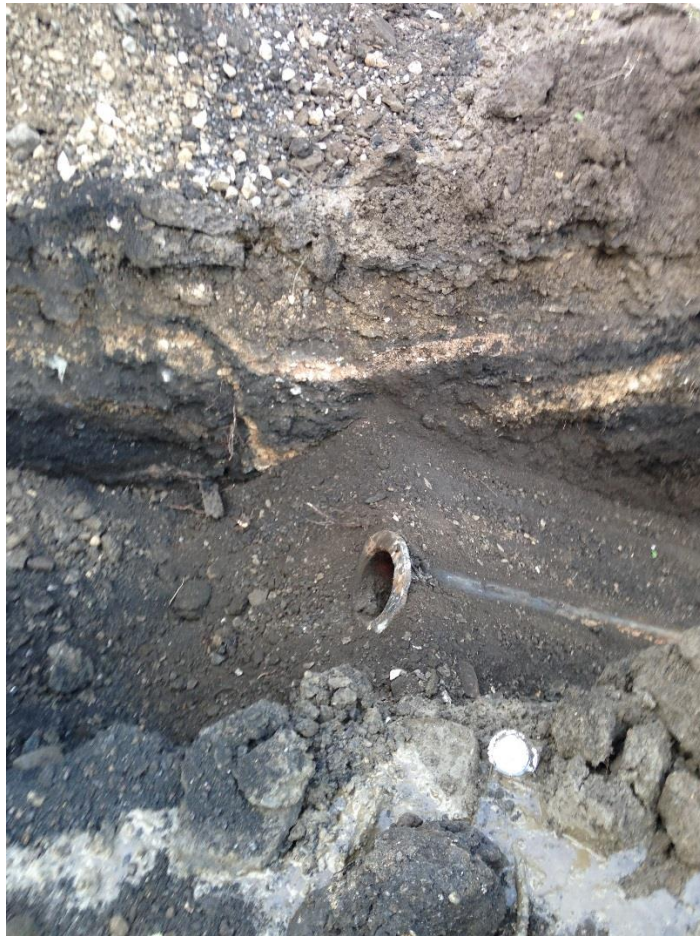
7) Pipe 3 – Middle pipe exposed and removed

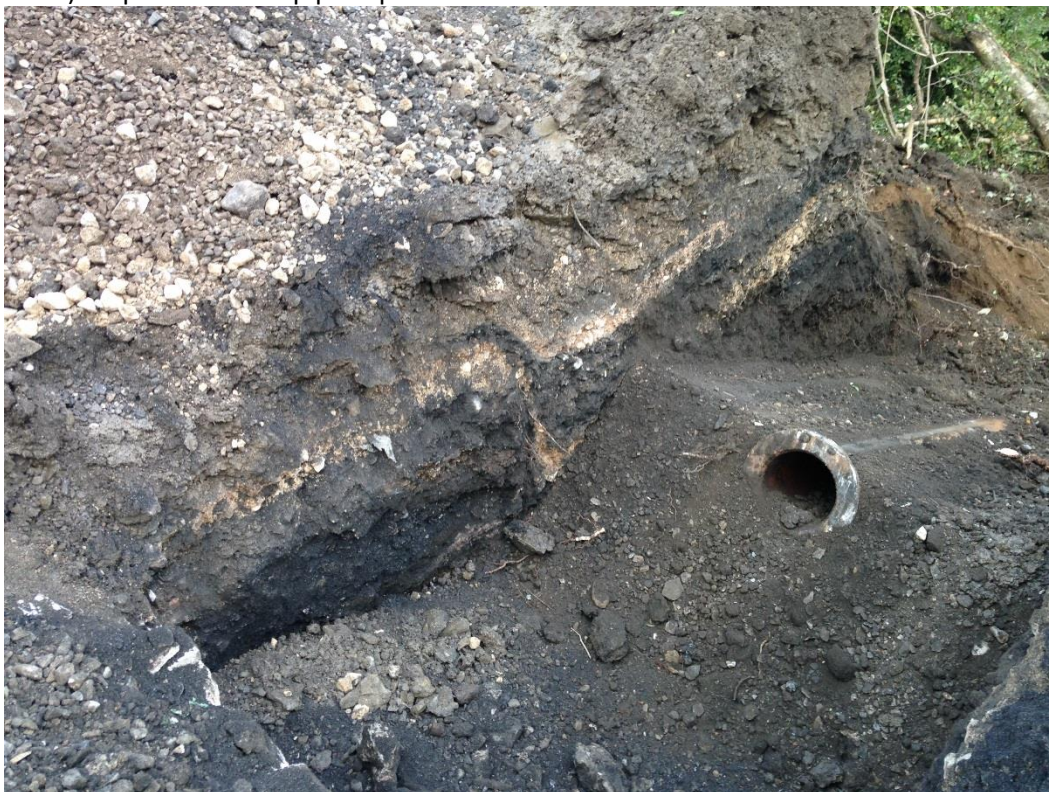
8) Pipe 3 - Middle pipe exposed and removed

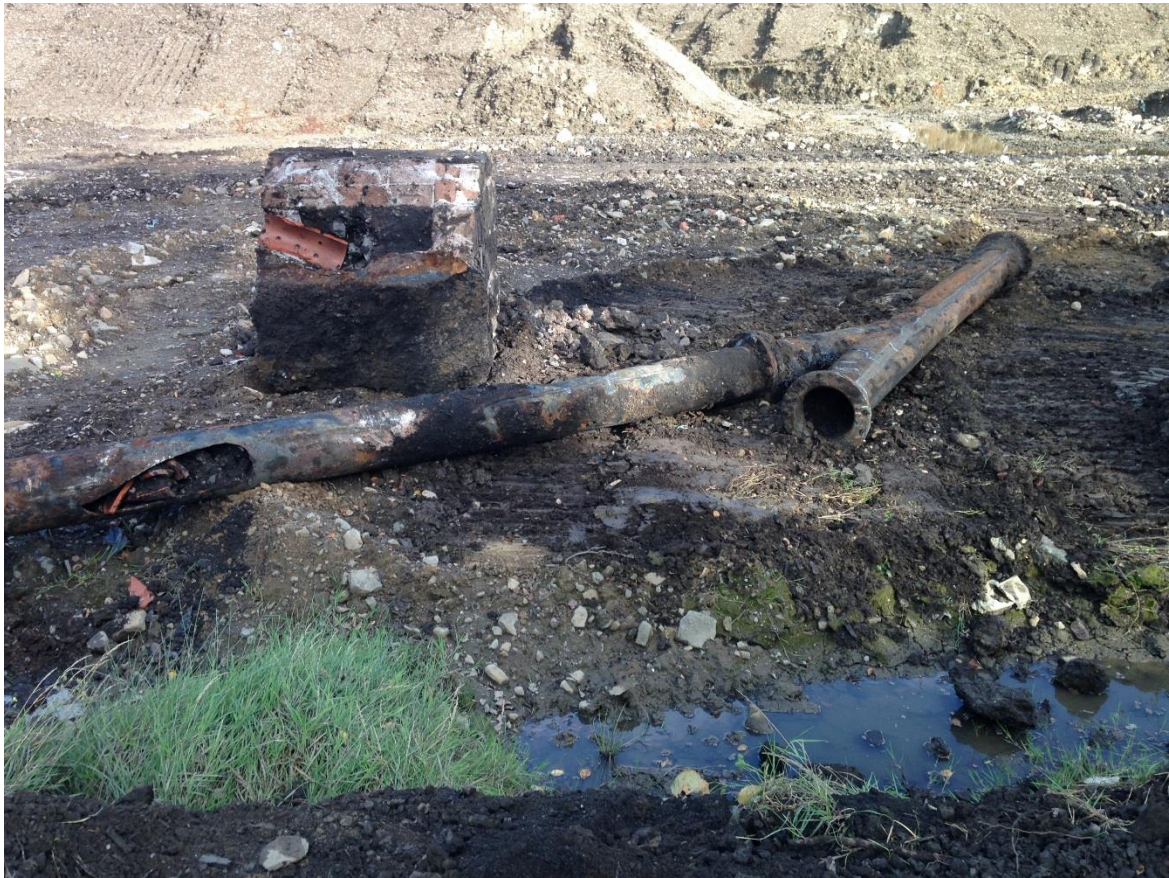
9) Pipe 3 – Sections removed.
