**Structural Survey (Inspection)**

**60 Commercial Street  
Ystalyfera  
Swansea  
SA9 2HS**

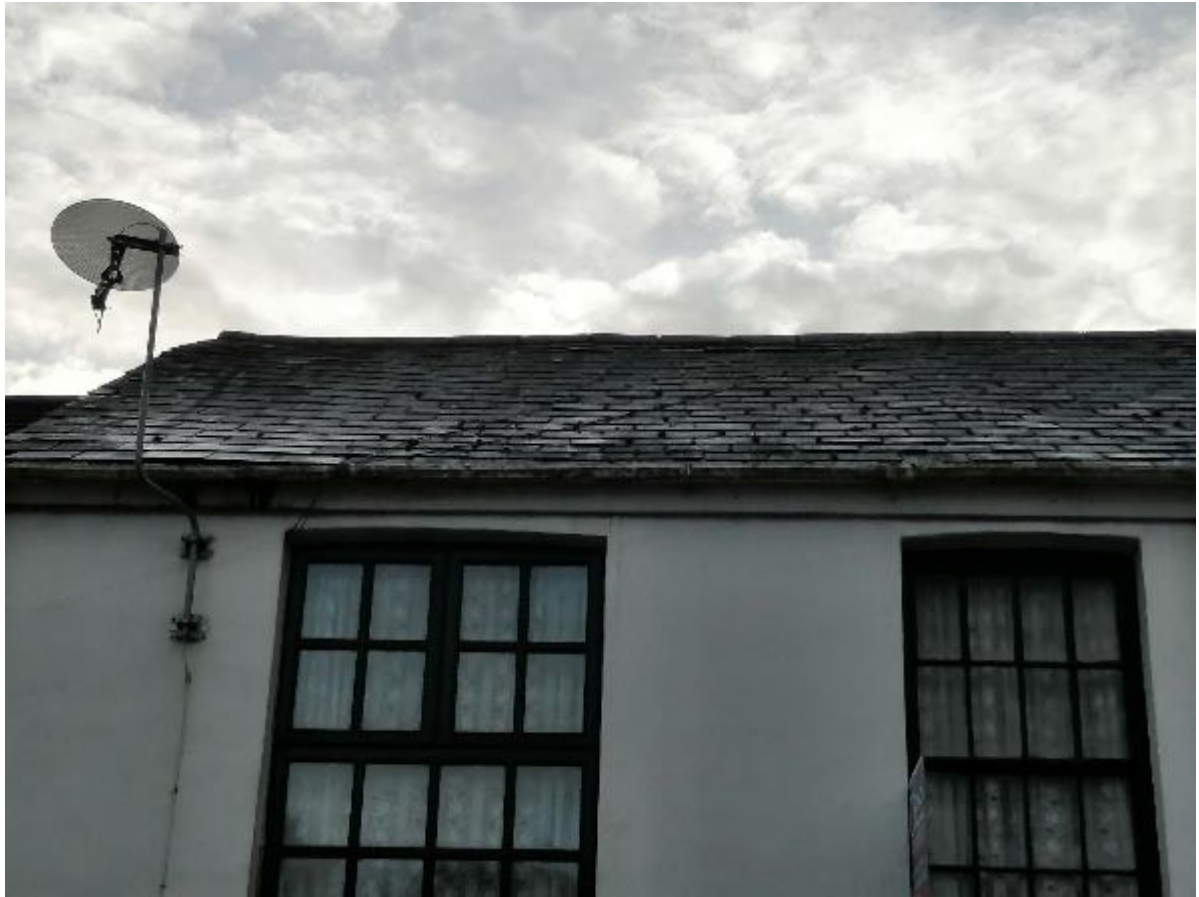
Photo 3 – Bowing to Roof (Front Roof Profile)

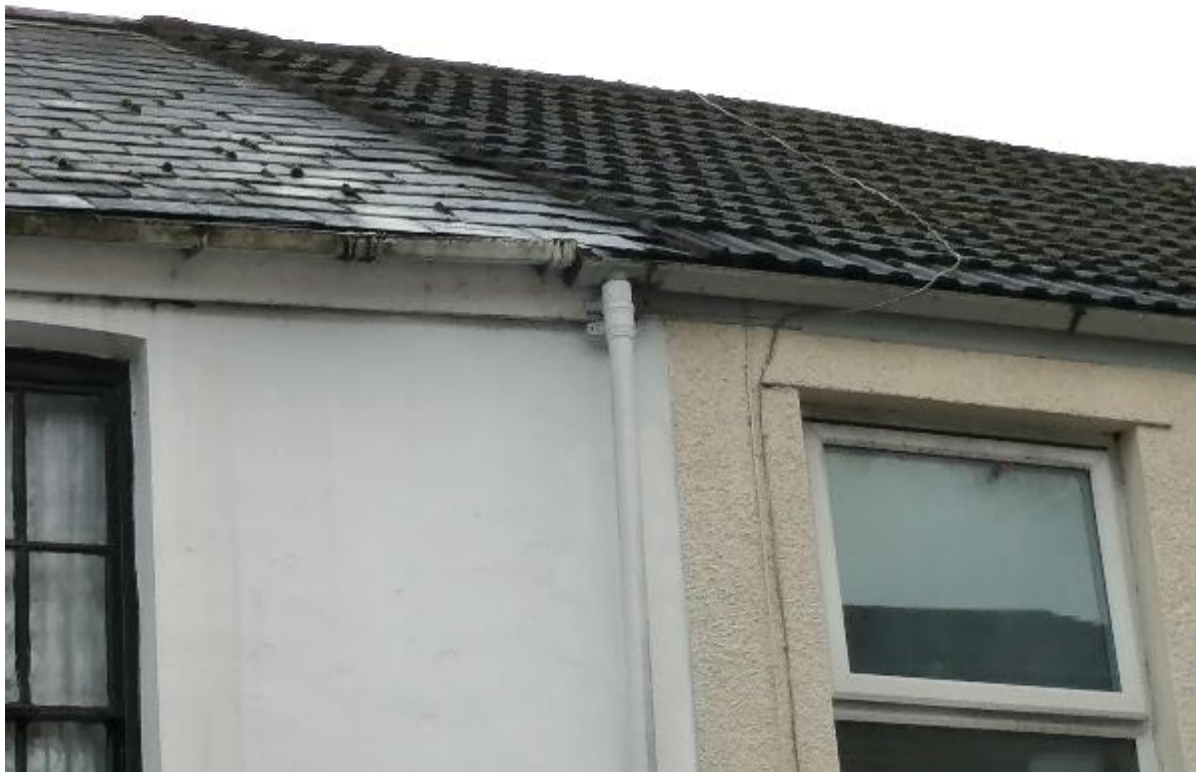
- Defective guttering was evident, see example in Photo 4.
- Several areas of exposed masonry were evident to the rear elevation and some units had deteriorated. A void was also noted where previous infilling had been attempted.

Photo 4 – Defective Guttering (Front Roof Profile)

Defective guttering was evident, see example in Photo 4 above. Roof drainage shall be replaced throughout.

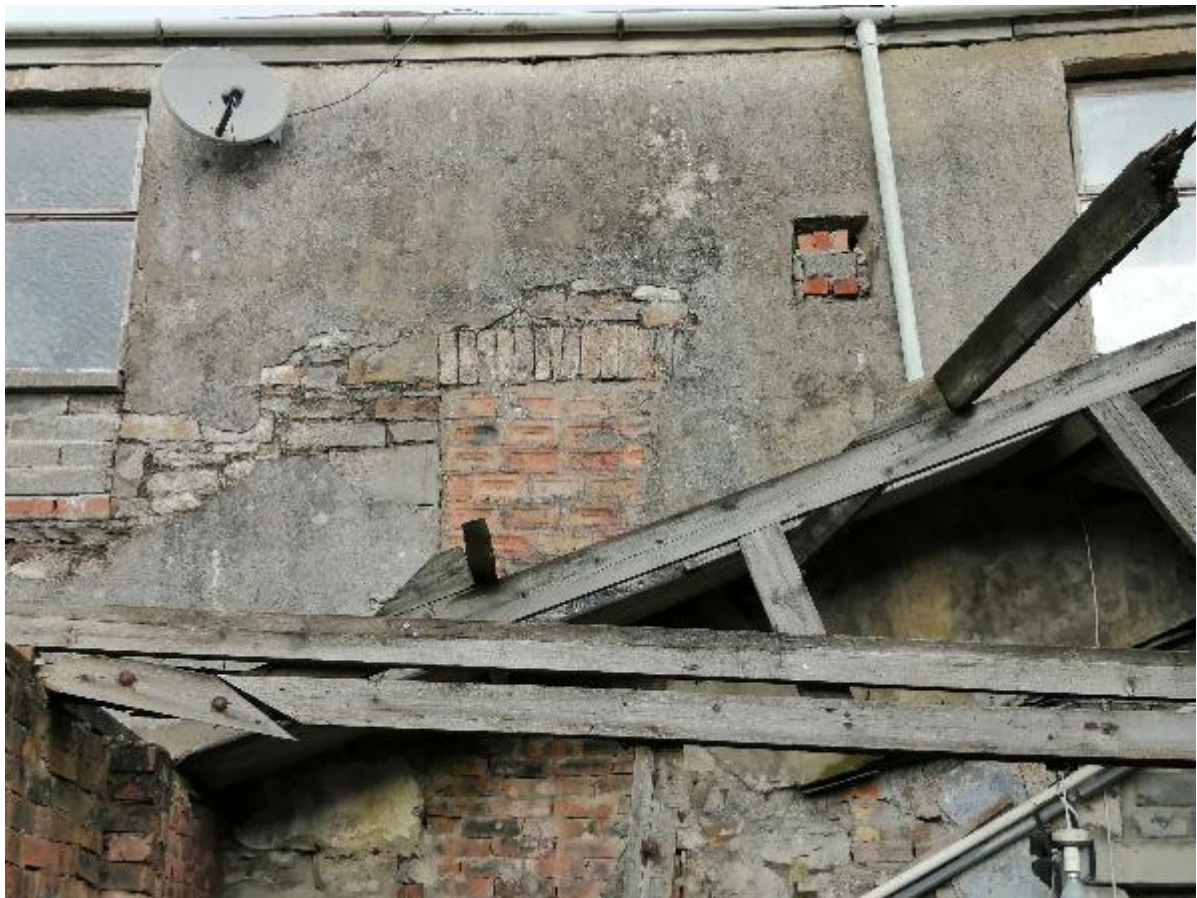
- The survey noted areas of missing render to the rear elevation – see photos 7-8. Due to the condition of the render to the rear of the property it is recommended that the render to the rear of the property is removed in its entirety and replaced.

The survey noted areas of missing render to the rear elevation – see photos 7-8 below. Due to the condition of the render to the rear of the property it is recommended that the render to the rear of the property is removed in its entirety and replaced. Condition Rating **3** See Section 7.0 Recommendations for guidance on repair works required

Photo 7 – Missing Render (Rear Wall Elevation)

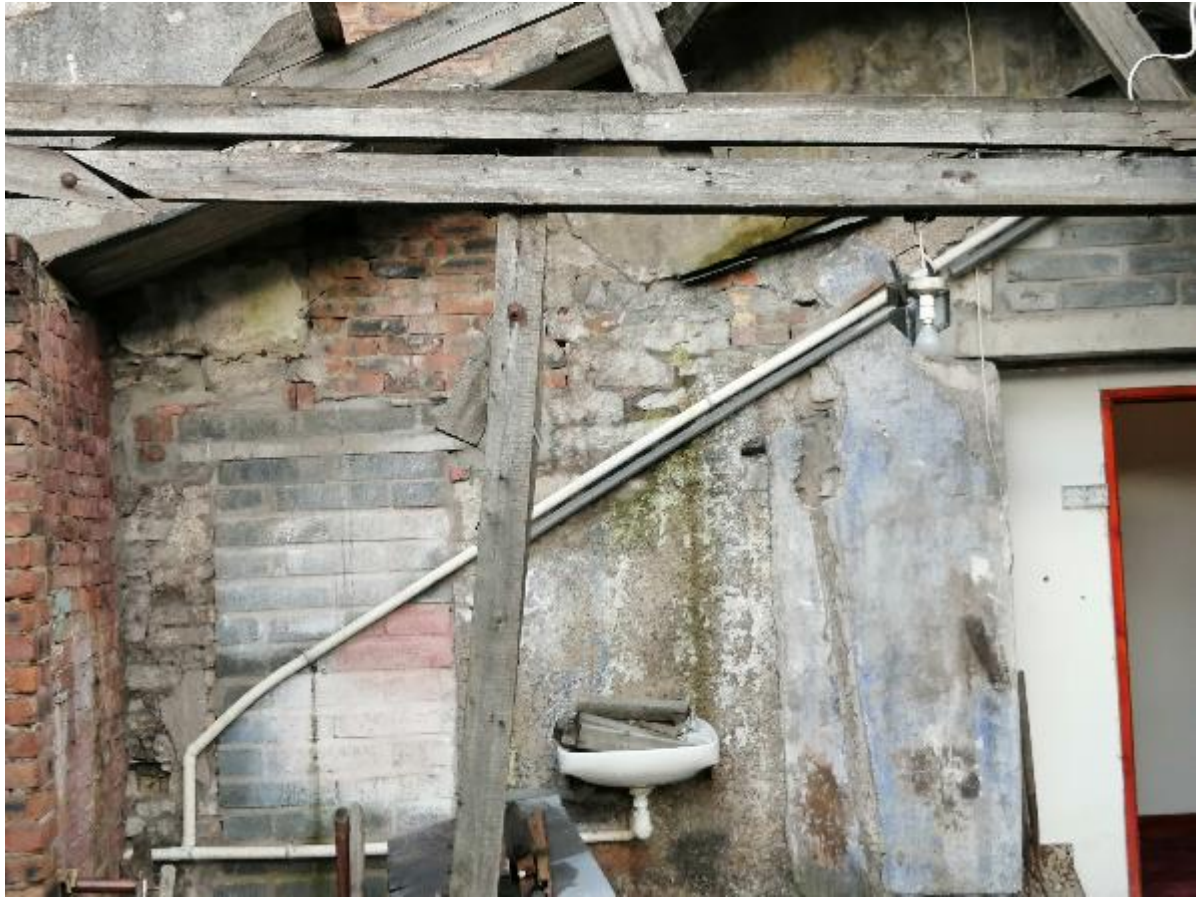
Photo 8 – Missing Render (Rear Wall Elevation)

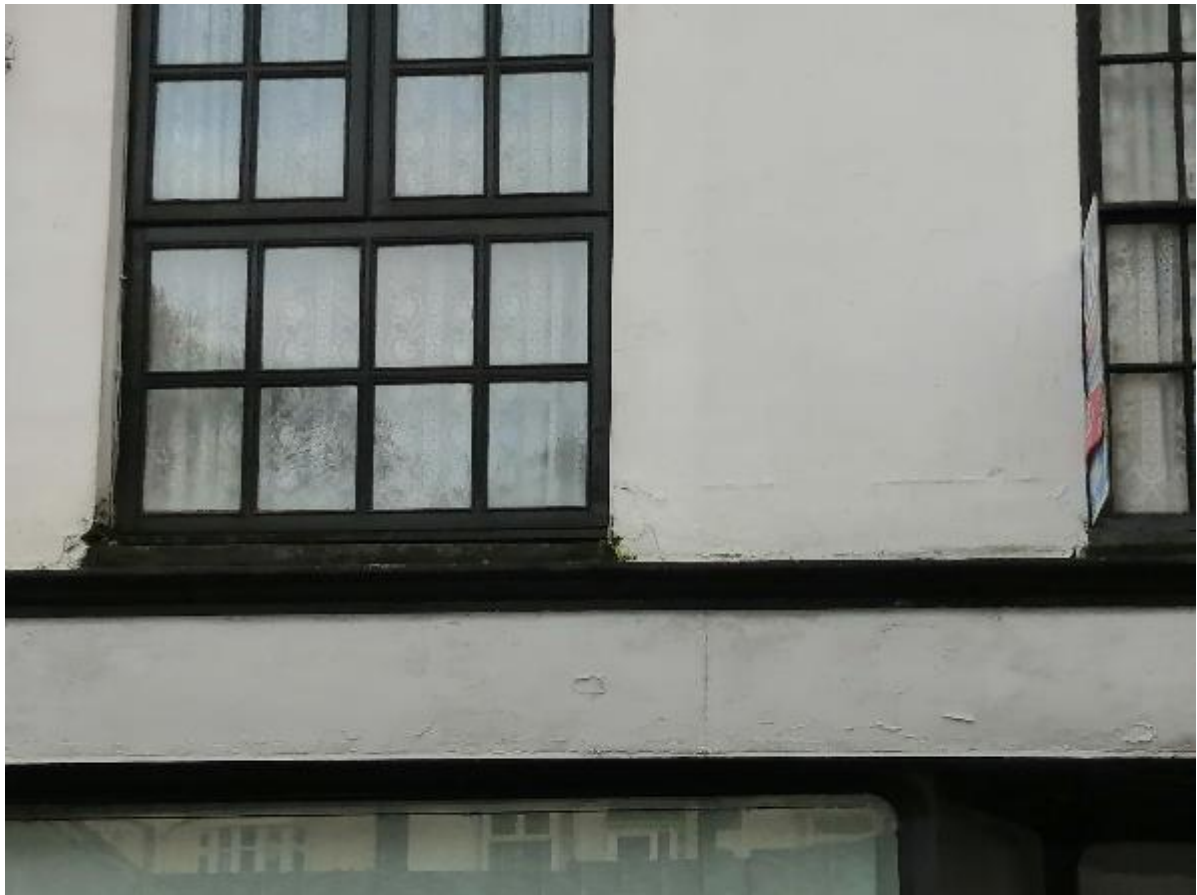
- Render cracking (damage category 1) was noted to both sides of the window on the front wall elevation. It is expected that these cracks have led to de-bonding of the render in these areas and the cause of the penetrating damp into bedroom 2 of the property.

Photo 9 – Render Cracking to Both Sides of the Window (Front Wall Elevation)

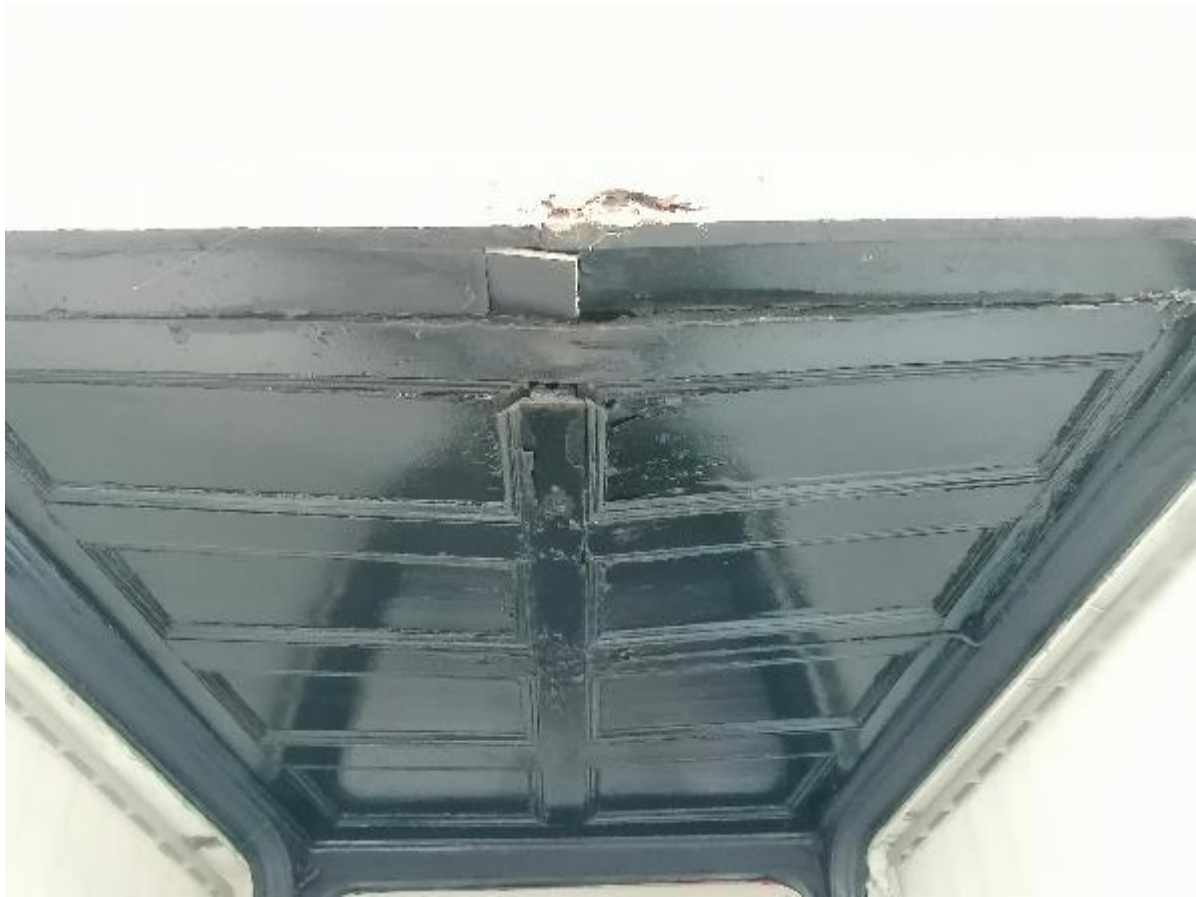
- During the survey bowing was noted to the timber ceiling of the entrance.
- All properties with basements should have provision for a free flowing passage of air into the basement.

Photo 10 – Bowing to Entrance Ceiling (Front Wall Elevation)

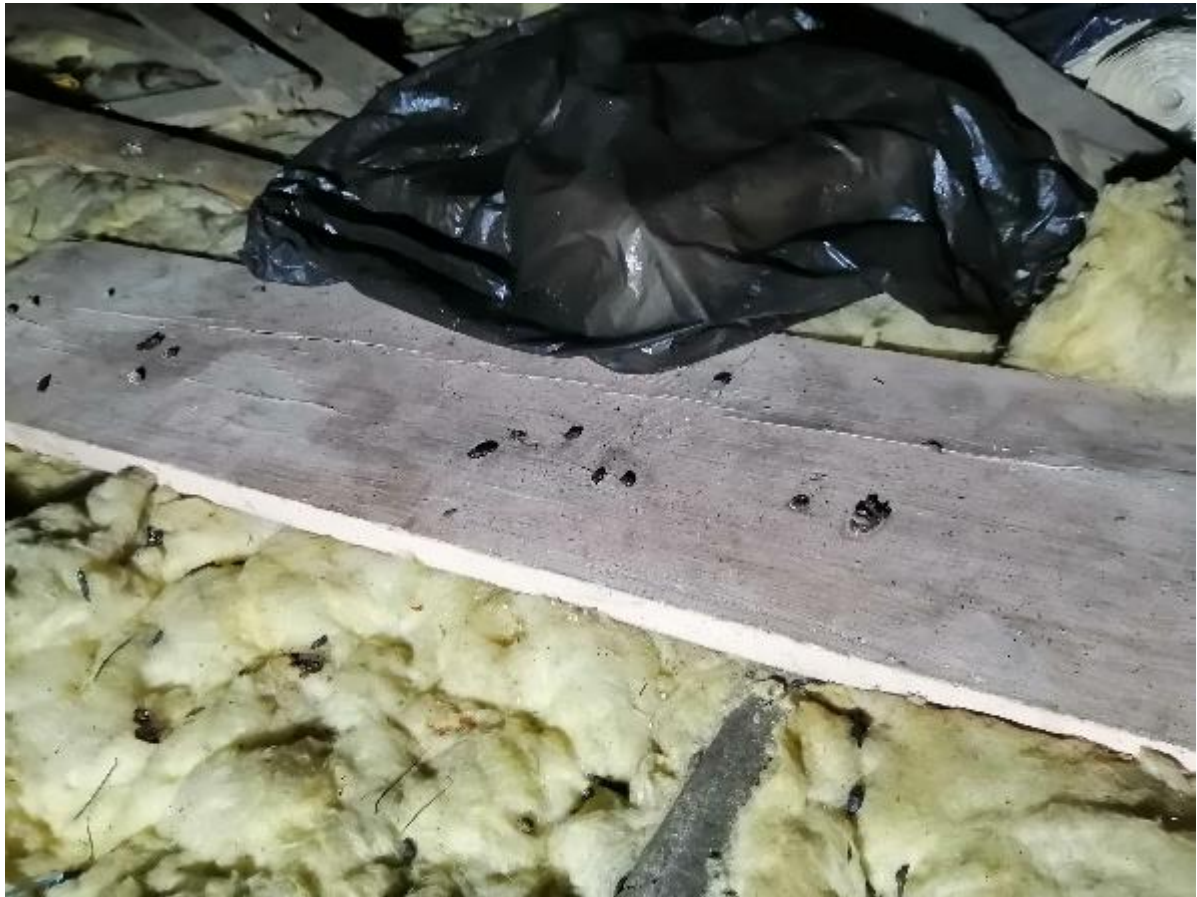
Indications of vermin were noted within the roof void – see photos 14-15 below. It is recommended that a pest control specialist is consulted which can provide specialist advice on removing the wildlife from the property - Condition Rating **2** See Section 7.0 Recommendations for guidance on repair works required.

Photo 14 – Indications of Vermin (Main Roof Profile)

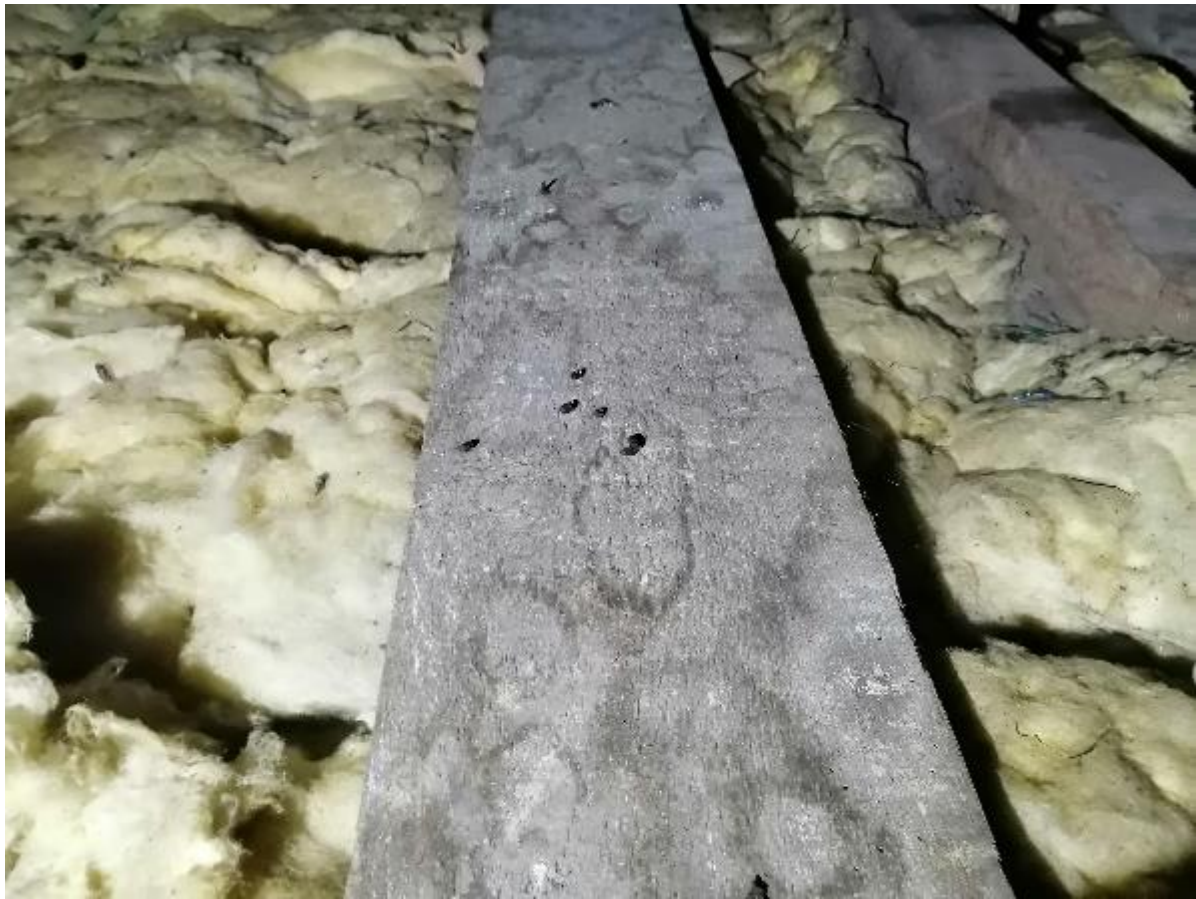
Photo 15 – Indications of Vermin (Main Roof Profile)

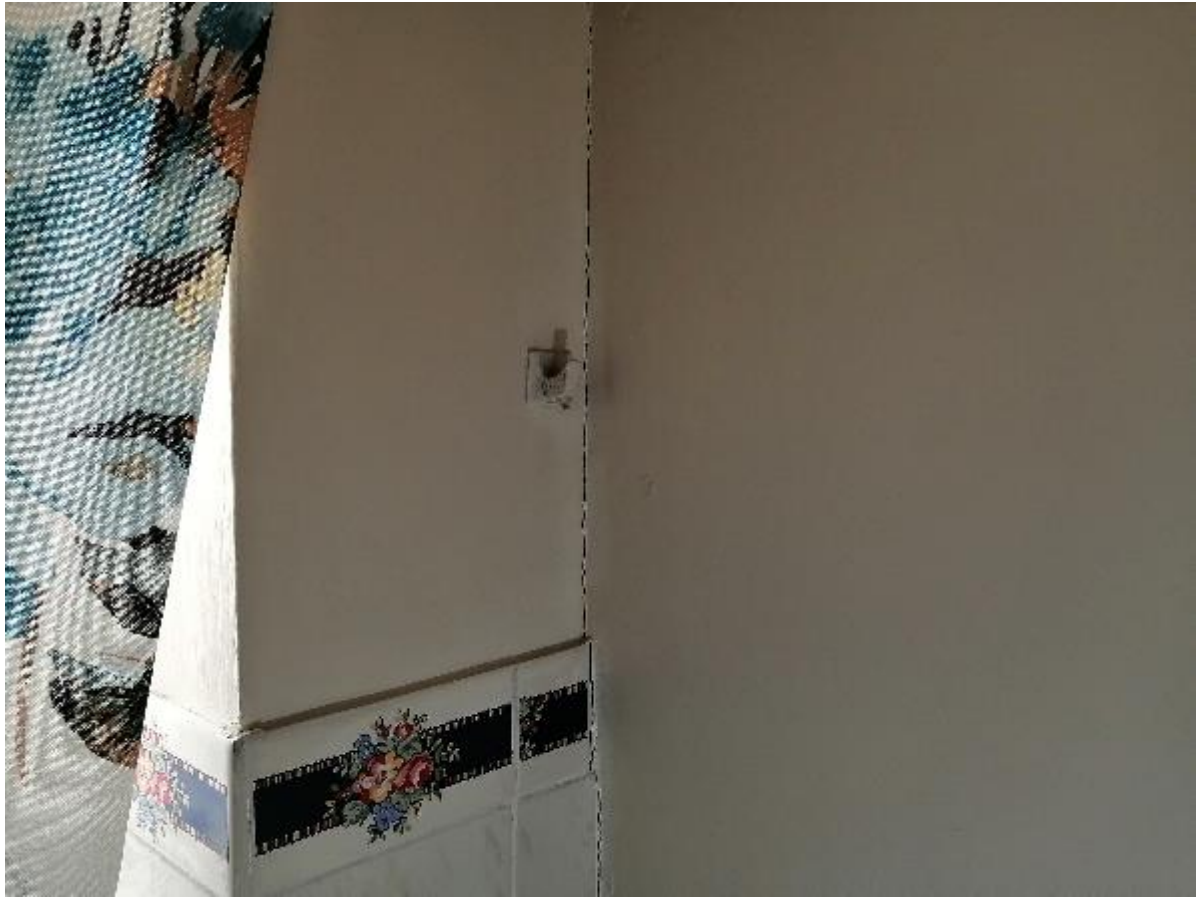
Photo 22 – Cracking to Edge of Studwork Wall (Kitchen)

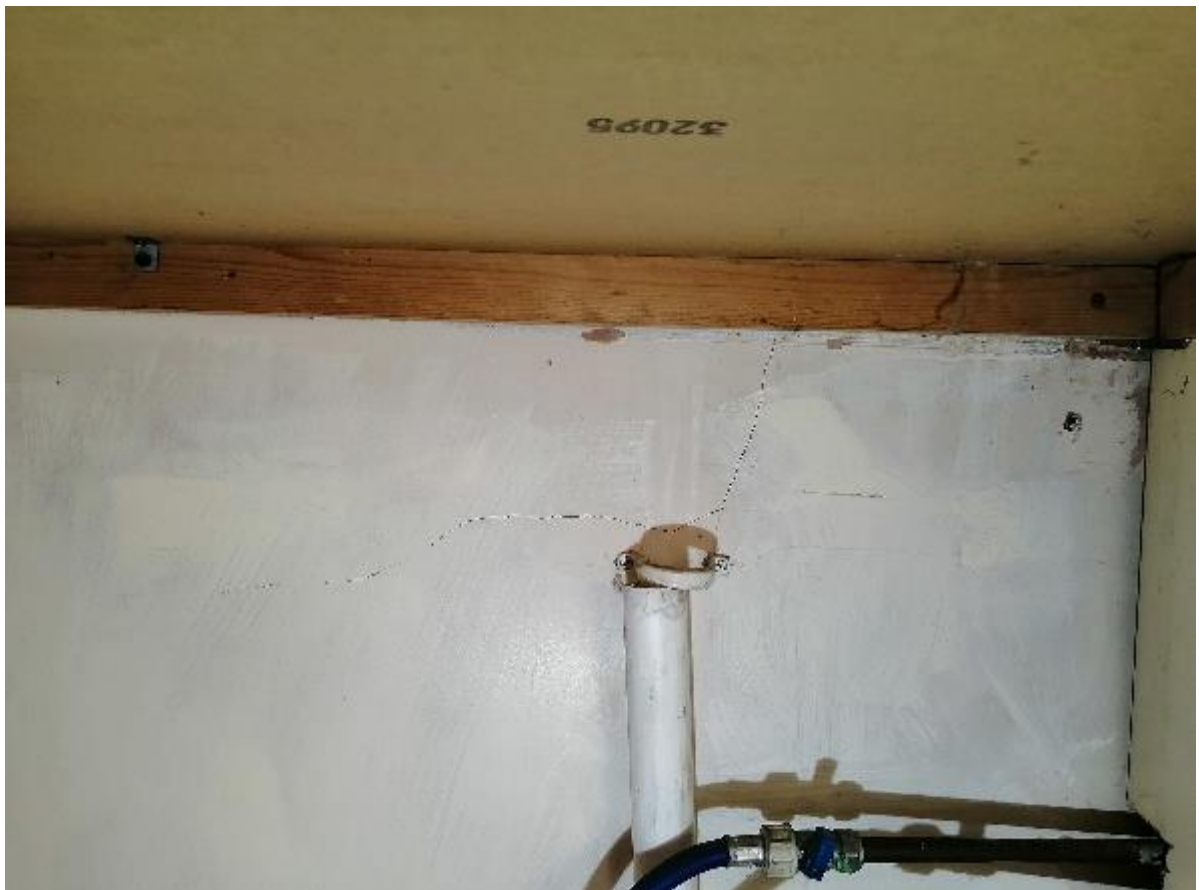
Photo 23 – Wall Plaster Cracking (Kitchen)

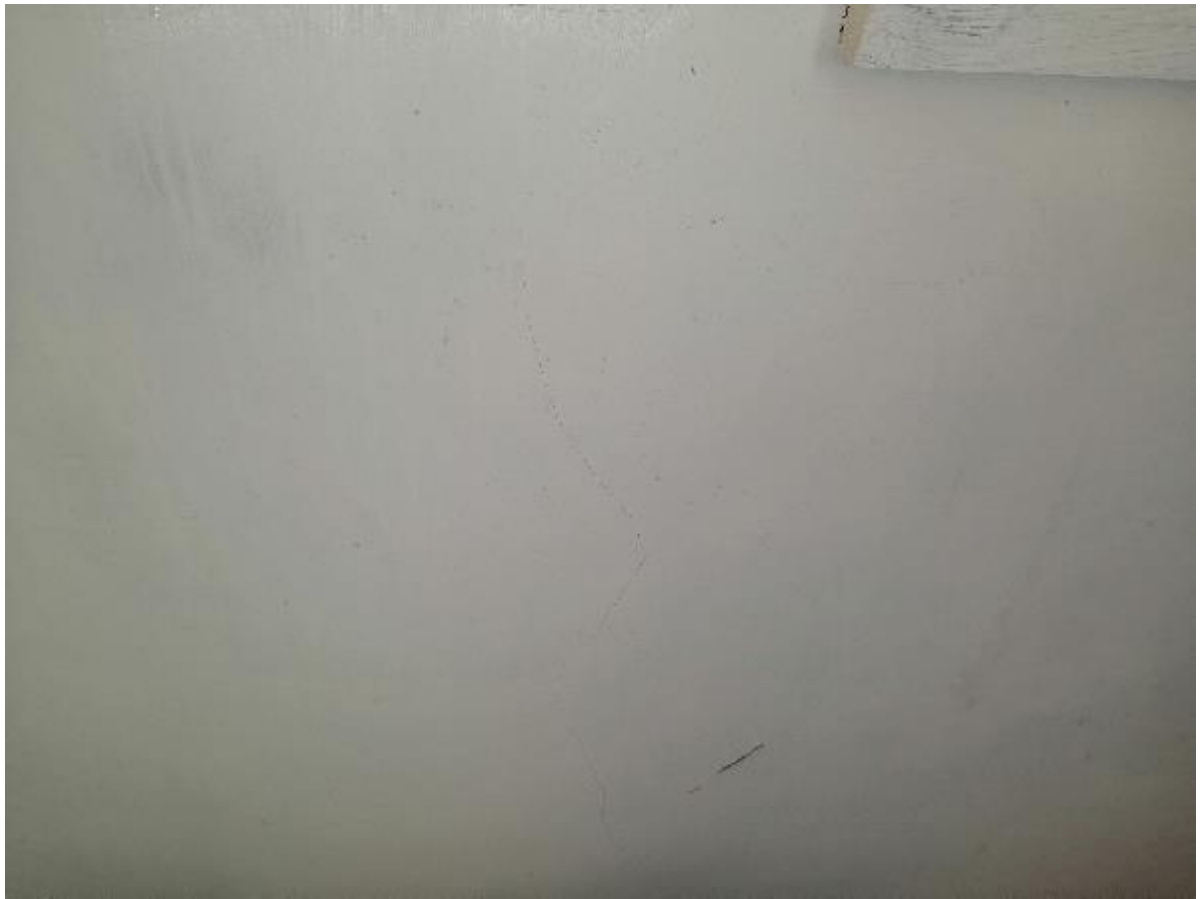
Photo 24 – Wall Plaster Cracking (Kitchen)

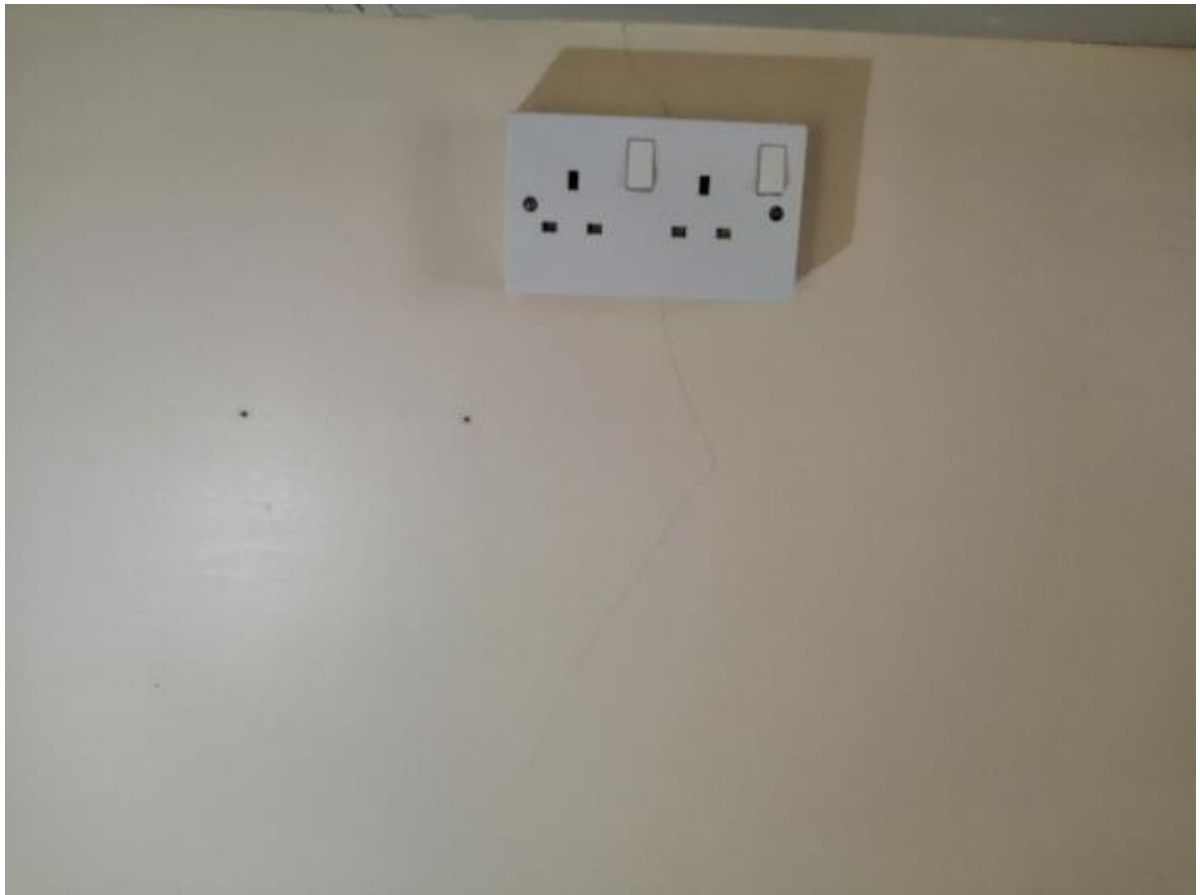
Photo 25 – Wall Plaster Cracking (Kitchen)

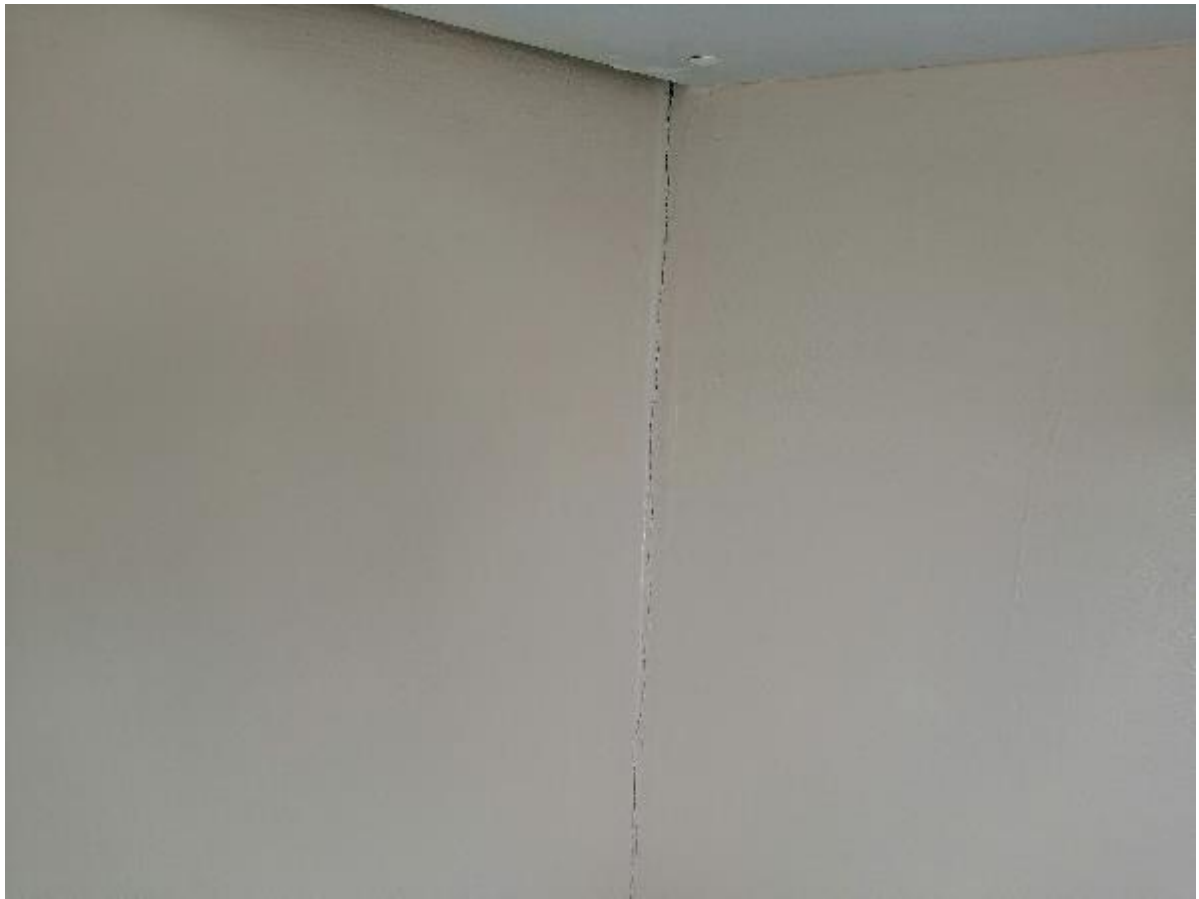
Photo 26 – Cracking to Edge of Studwork Wall (Kitchen)

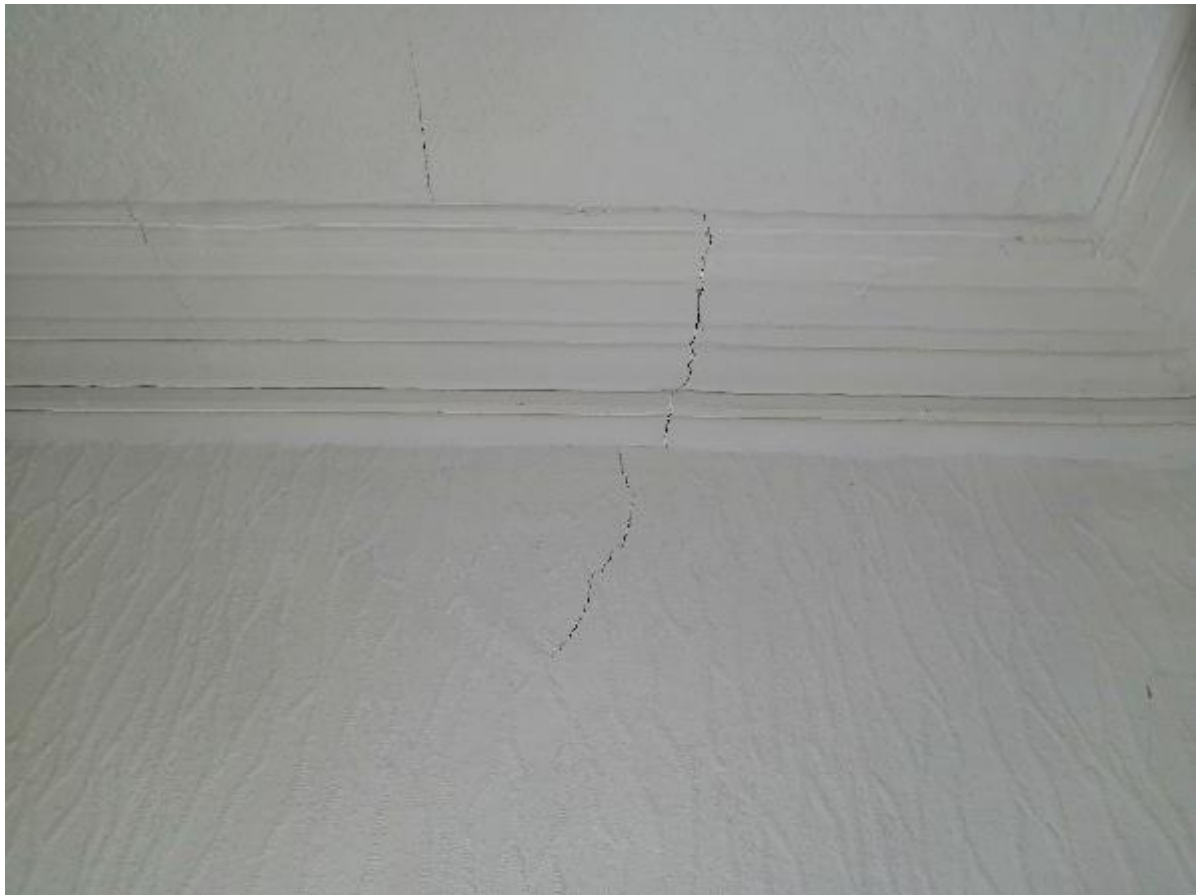
Photo 27 – Cracking to Studwork Wall (Bedroom 1)

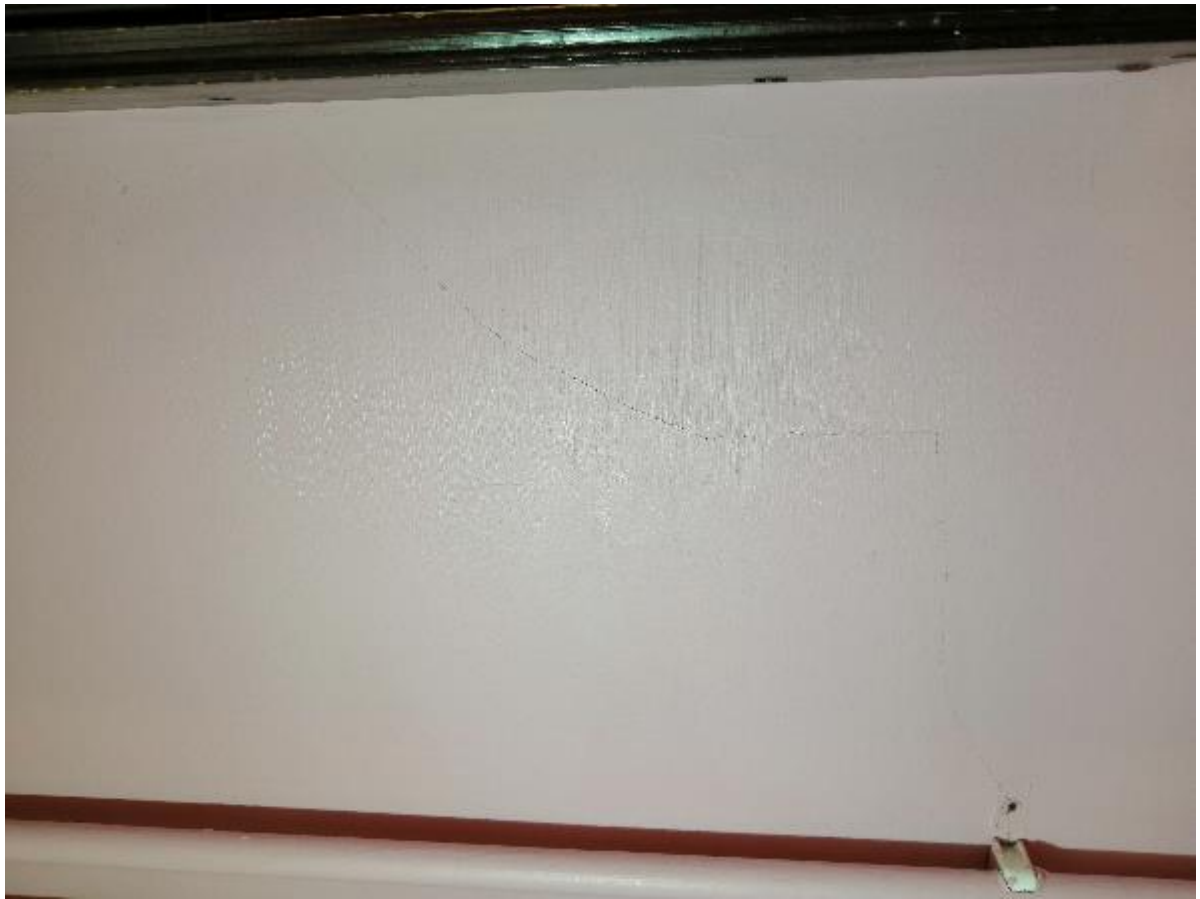
Photo 28 – Wall Plaster Crack (Bathroom)

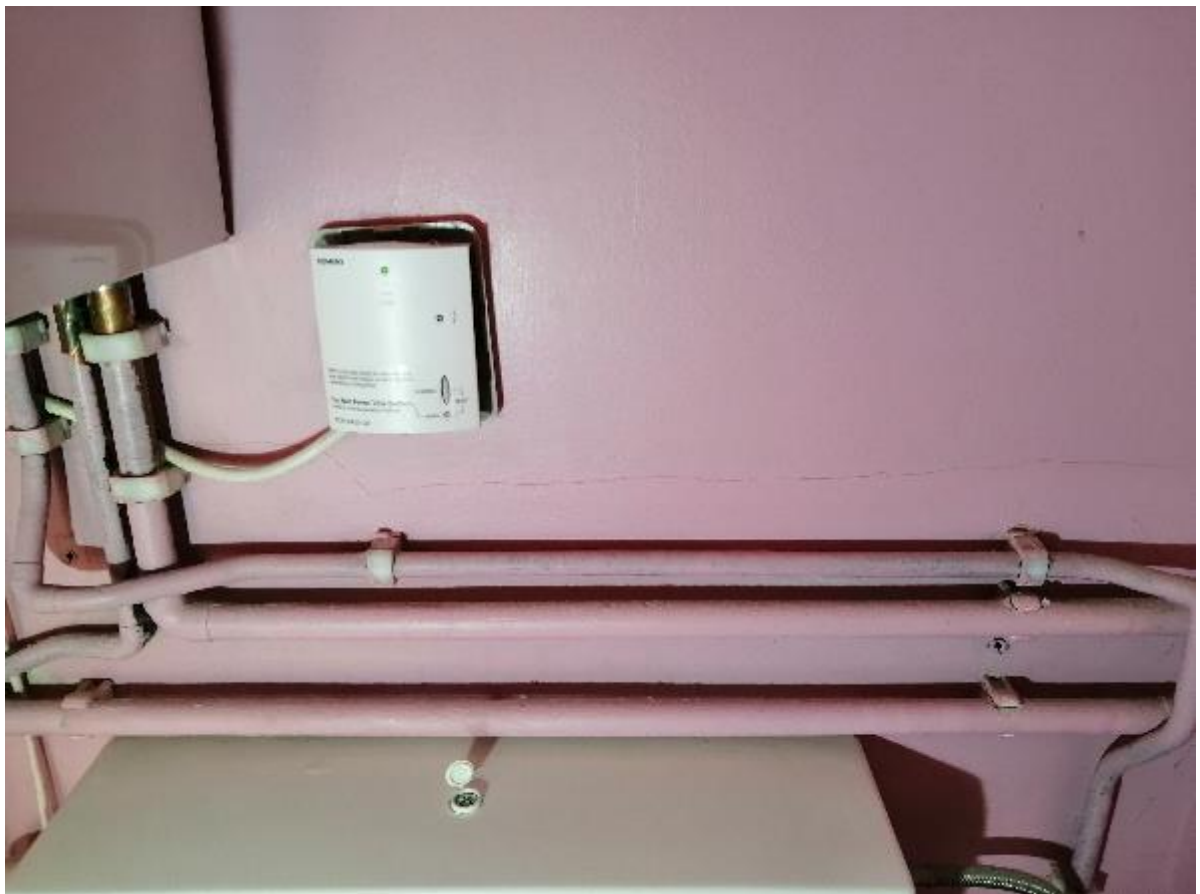
Photo 29 – Wall Plaster Crack (Bathroom)

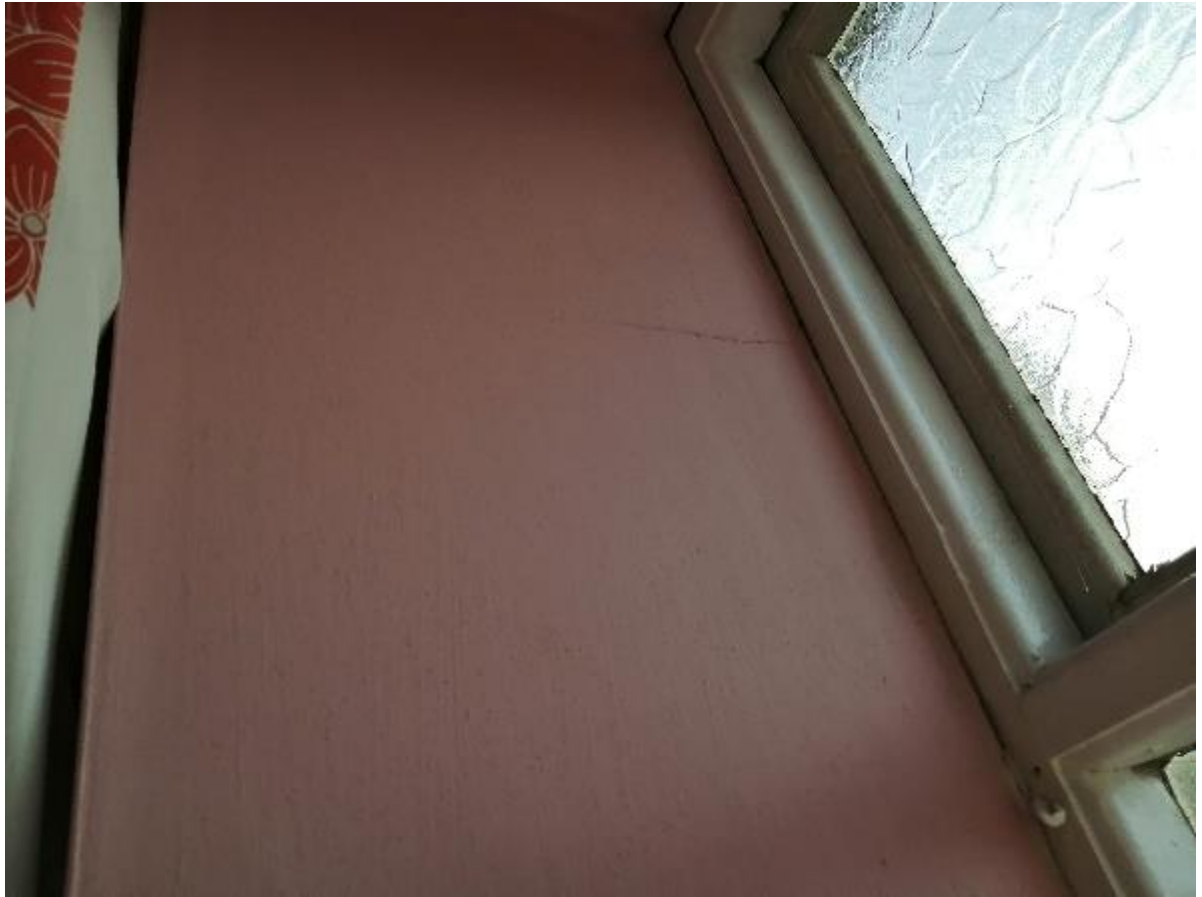
Photo 30 – Wall Plaster Crack (Bathroom)

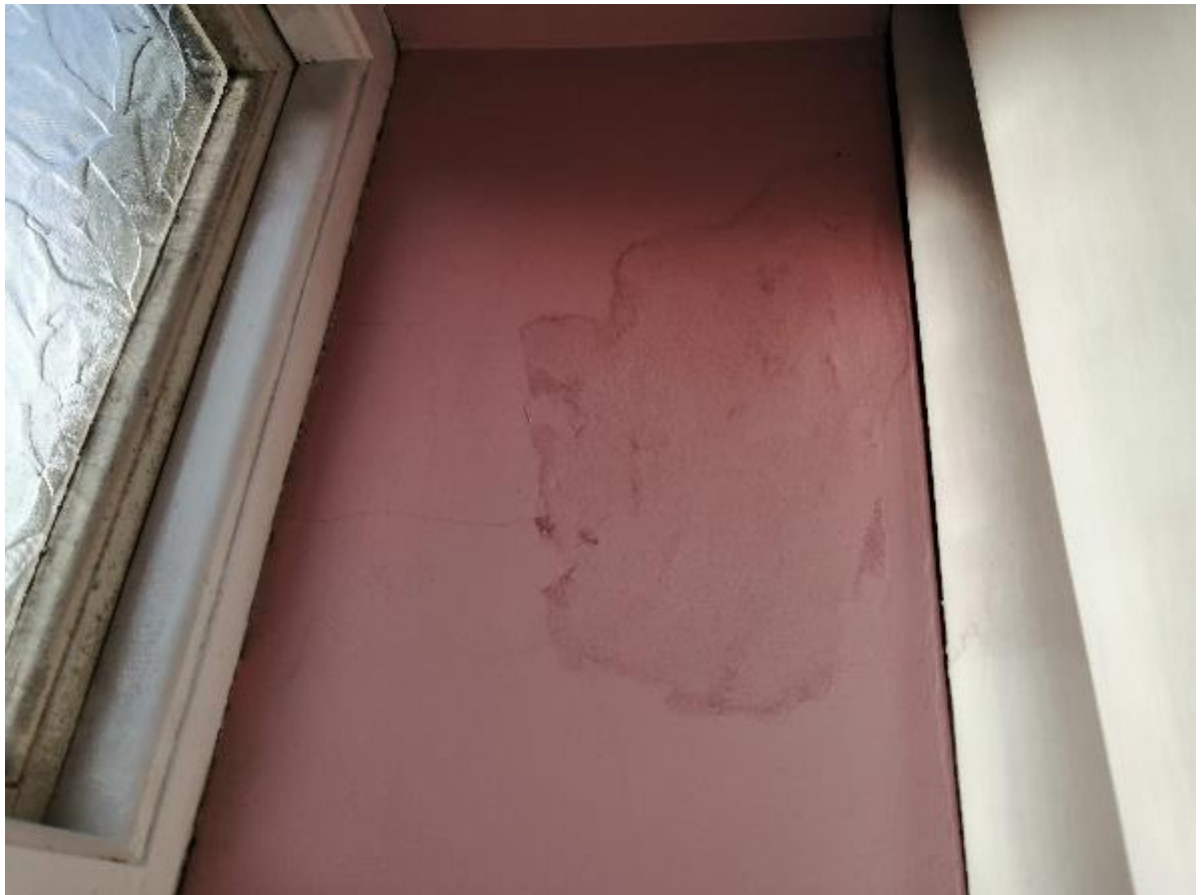
Photo 31 – Wall Plaster Crack (Bathroom)

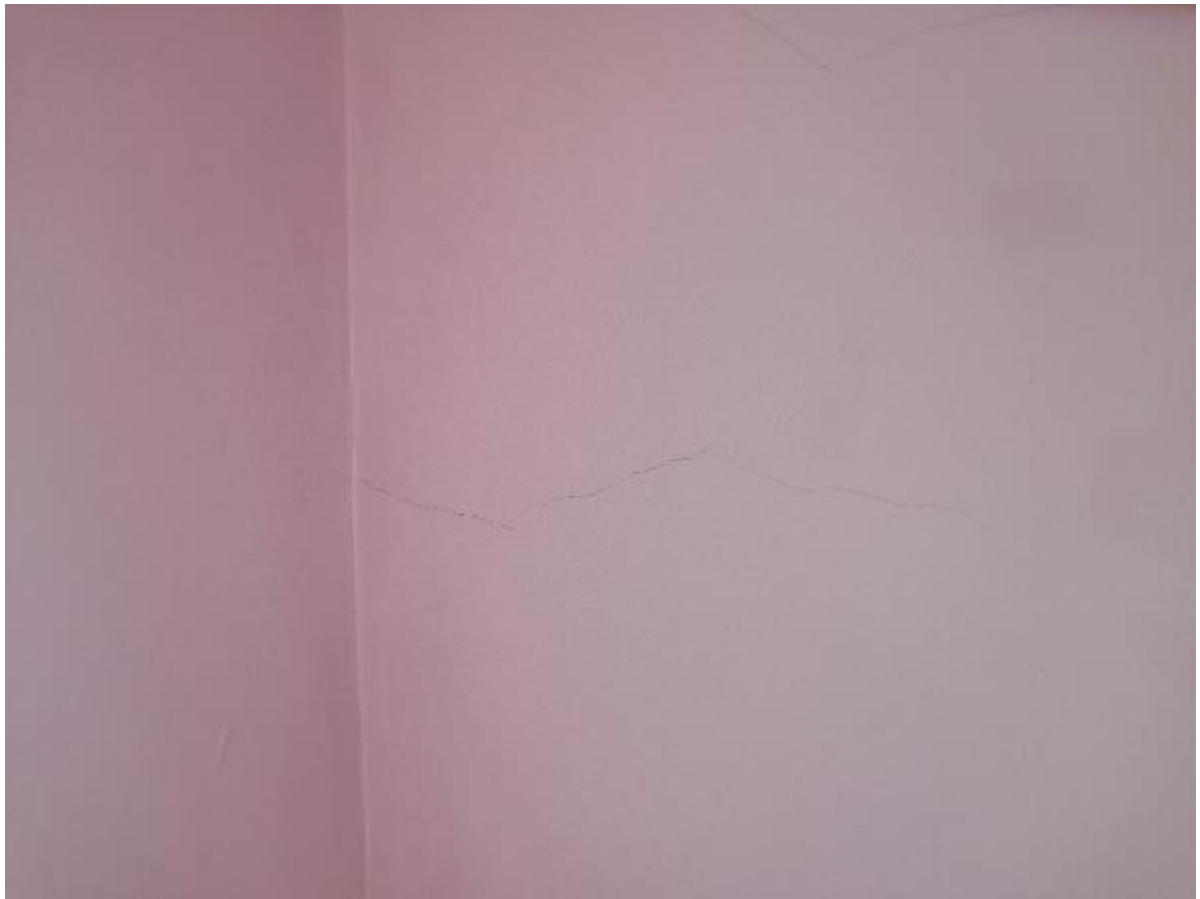
Photo 32 – Wall Plaster Crack (Bathroom)

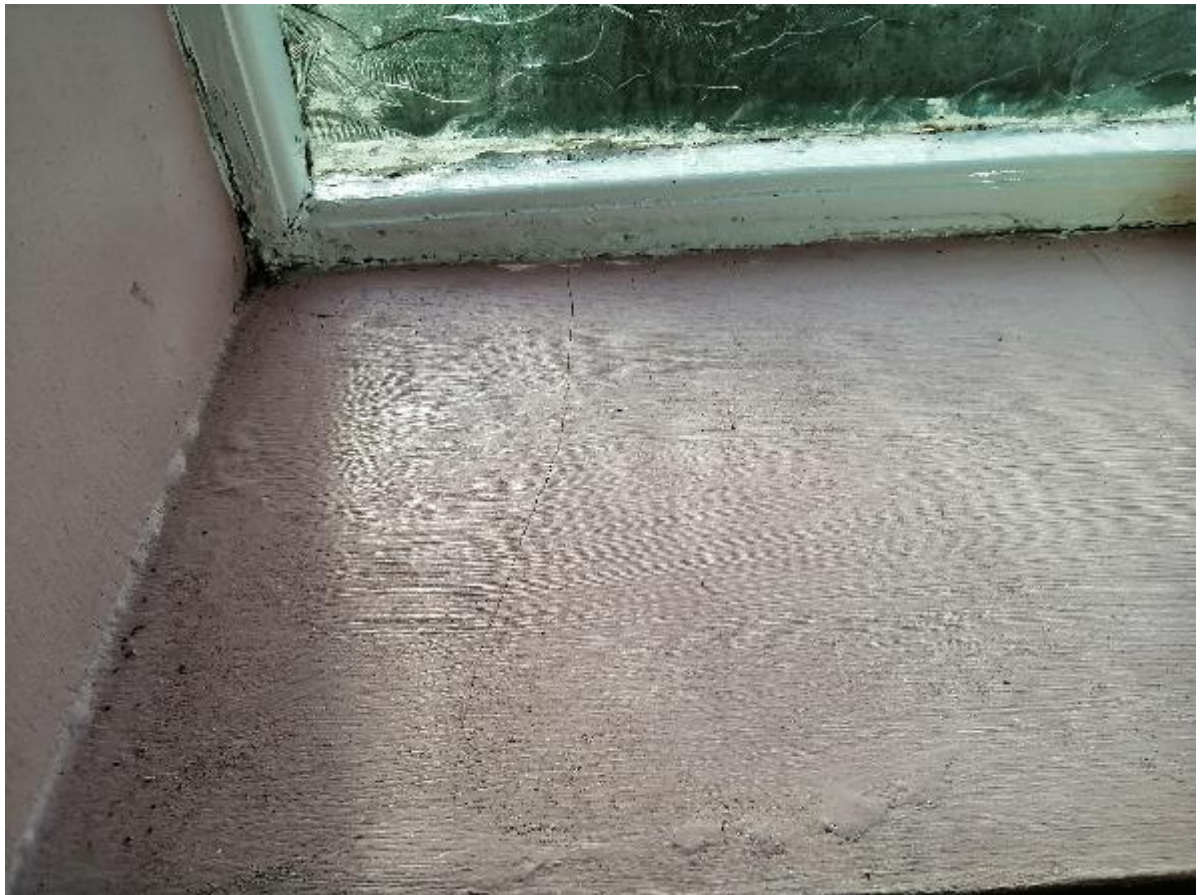
Photo 33 – Crack to Windowsill (Bathroom)

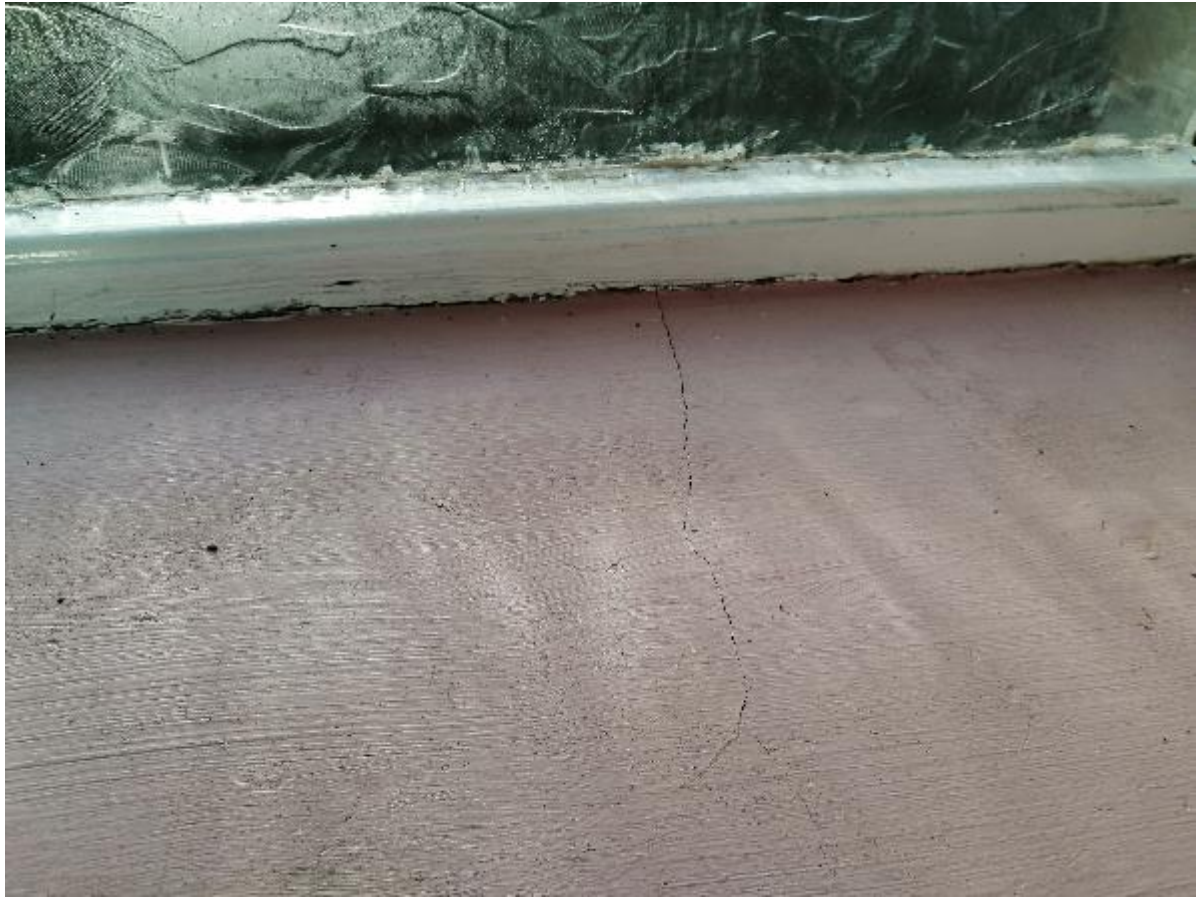
Photo 34 – Crack to Windowsill (Bathroom)
