**Structural Survey (Inspection)**

**60 Commercial Street  
Ystalyfera  
Swansea  
SA9 2HS**

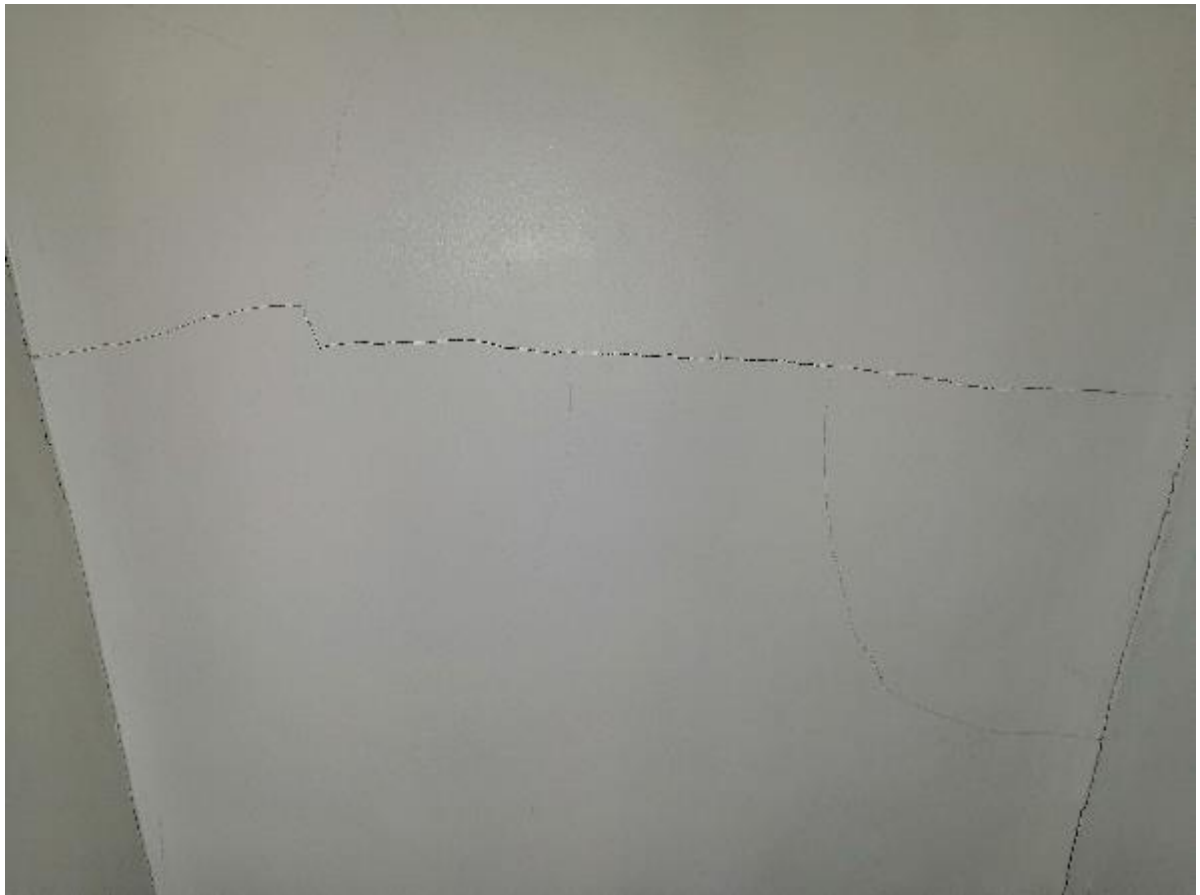
Photo 35 – Wall Plaster Crack (Landing)

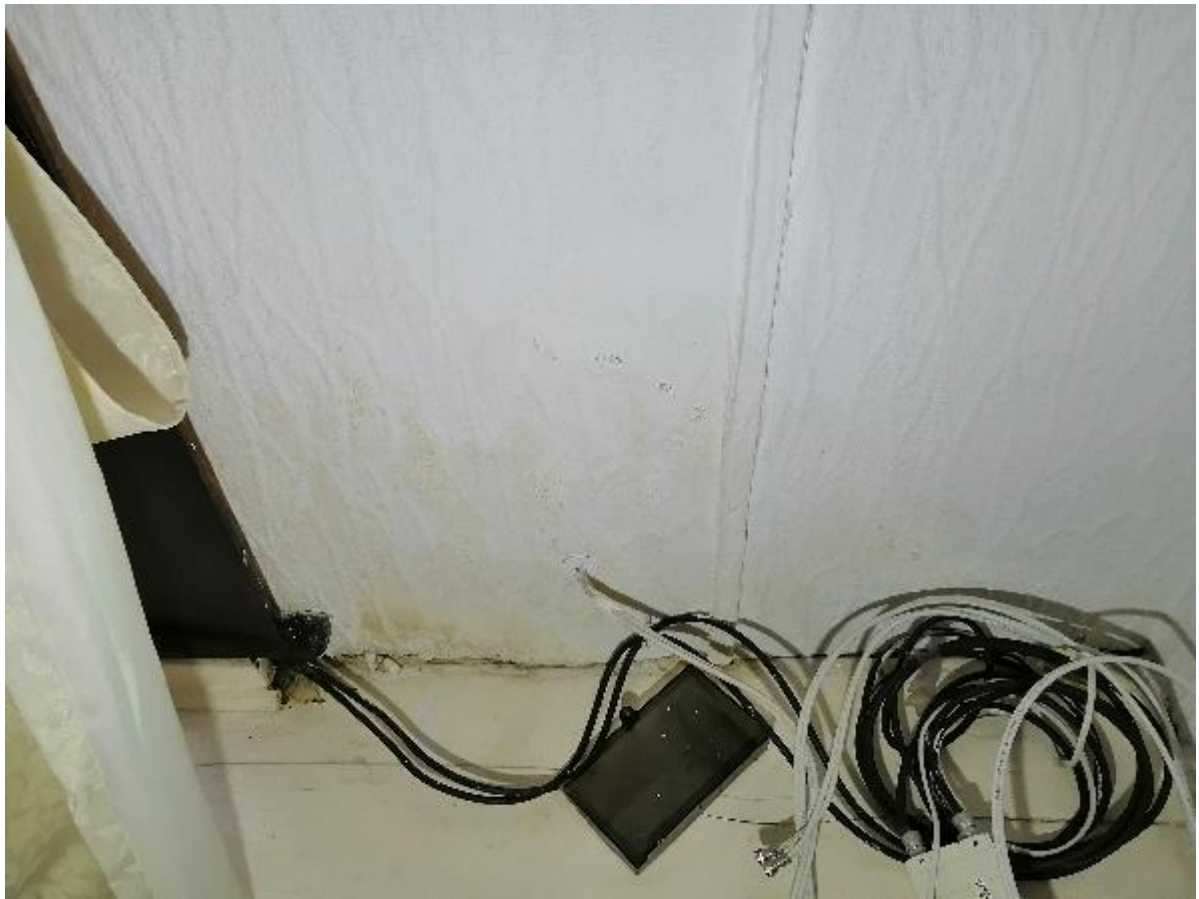
- Penetrating damp was noted to the front wall elevations in bedroom 1 and 3 and penetrating damp was noted to the rear wall elevation on the landing – see photos 36-40. We'd expect that the cause of these areas of penetrating damp is the condition of the external render to the front and rear wall elevation along with the substandard roof drainage.

An inspection was undertaken to confirm the presence of damp in the property. Penetrating damp was noted to the front wall elevations in bedroom 1 and 3 and penetrating damp was noted to the rear wall elevation on the landing – see photos 36-40 below. We'd expect that the cause of these areas of penetrating damp is the condition of the external render to the front and rear wall elevation along with the substandard roof drainage. It shall be recognised that solid wall construction as adopted throughout the original property offers less protection against penetrating damp when compared to cavity wall construction. Damp can be more prevalent during winter months and can be exacerbated by cracked or defective external render and mortar joints / pointing. Damage to internal wall surfaces most commonly occur due to inadequate passive ventilation into the habitable rooms (i.e. no trickle vents or secondary locks in the window frames), where moisture and condensation is not given an opportunity to escape and ends up damaging the internal wall finishes over time (i.e. condensation damage). Condensation damp was evident to a number of internal surfaces. To minimize and control the build up of moisture internally (and thus damage to internal wall surfaces), a passive means of ventilation is necessary as discussed above regarding trickle vents in the window frameworks - Condition Rating **3** See Section 7.0 Recommendations for guidance on repair works required.

Photo 36 – Penetrating Damp (Bedroom 1)

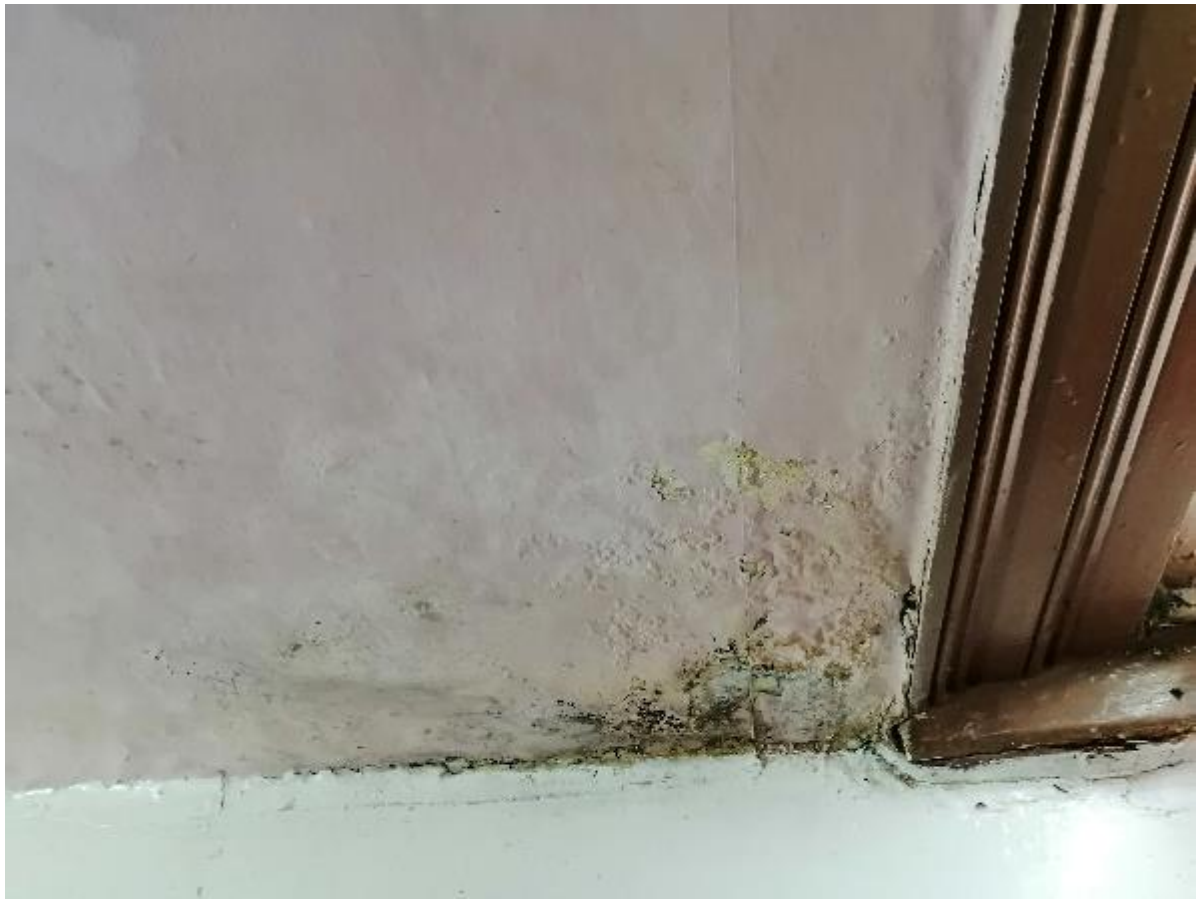
Photo 38 – Penetrating Damp (Bedroom 3)

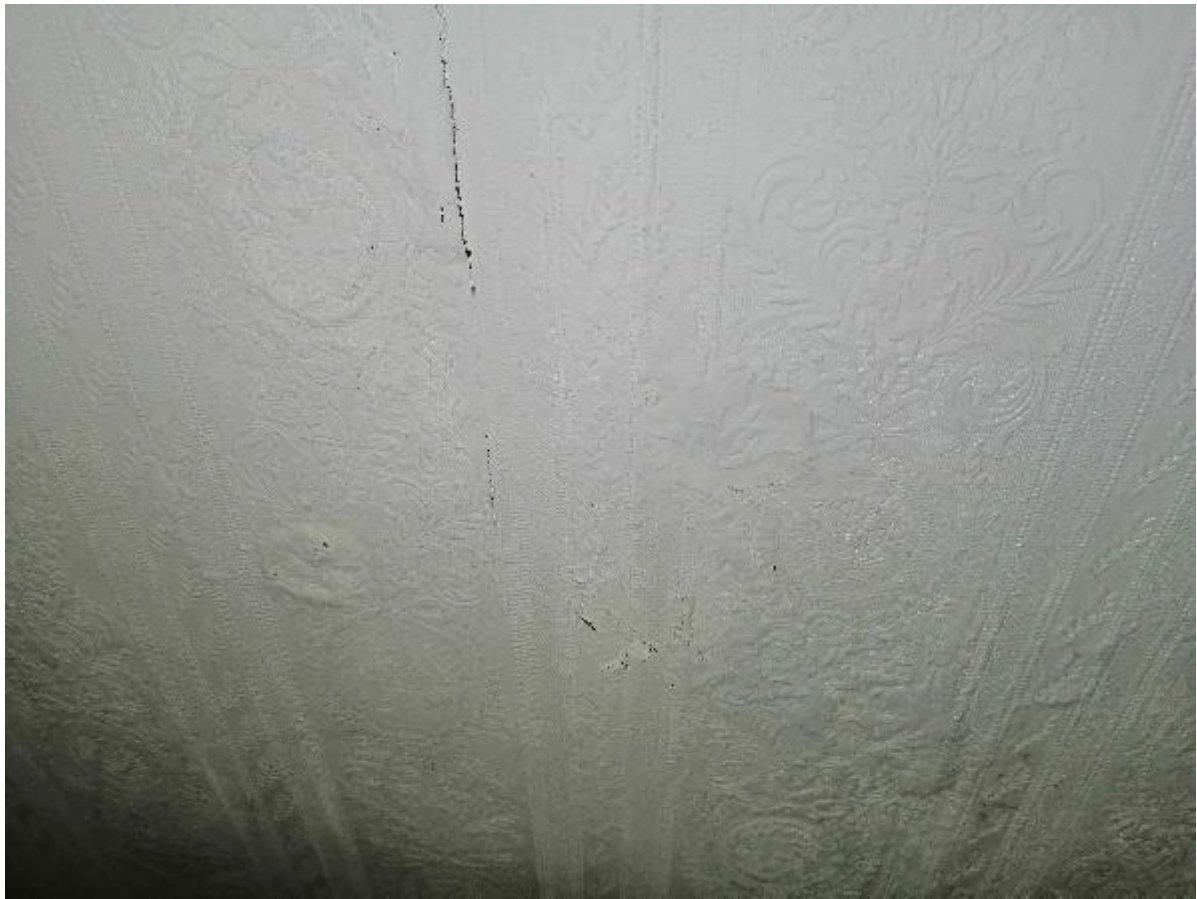
Photo 40 – Penetrating Damp (Landing)

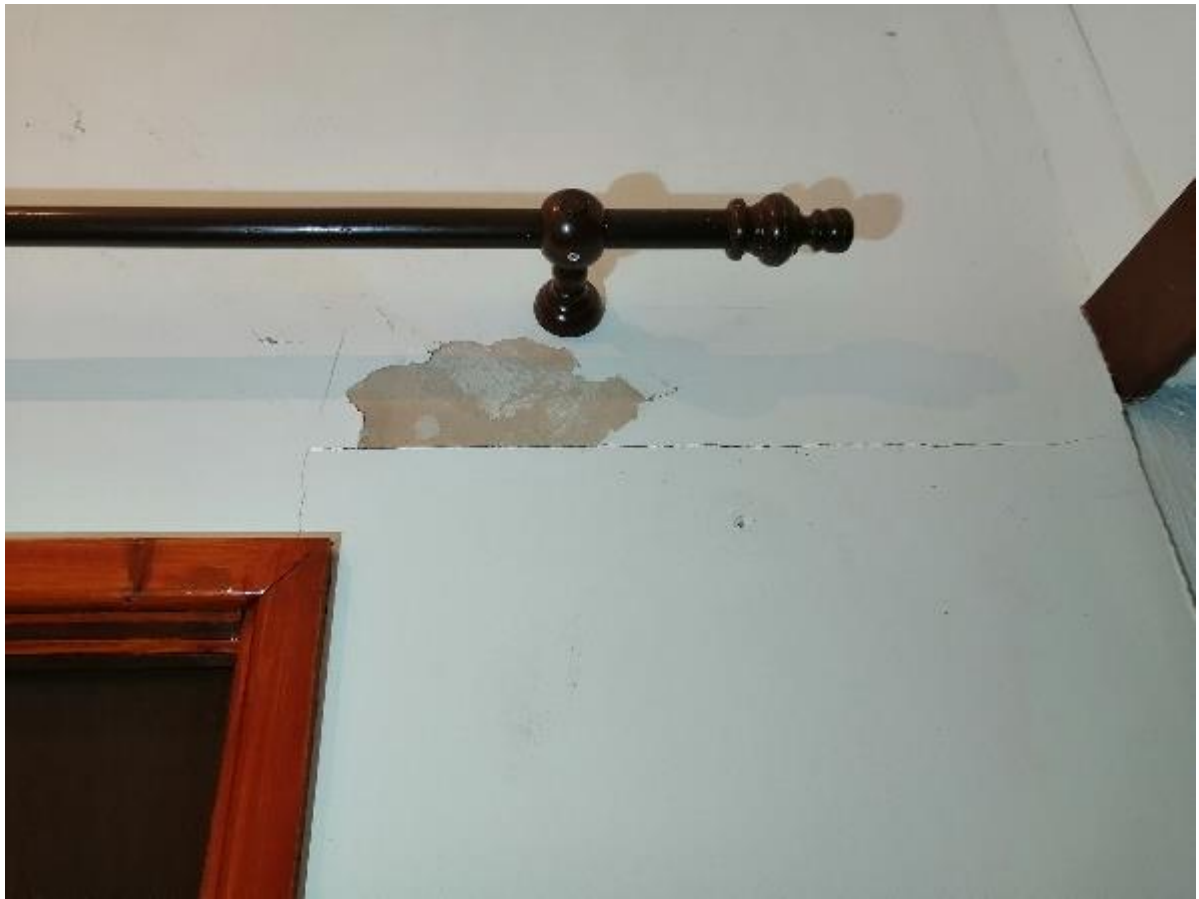
Photo 46 – Cracking to Studwork Wall (Base of Stairs)

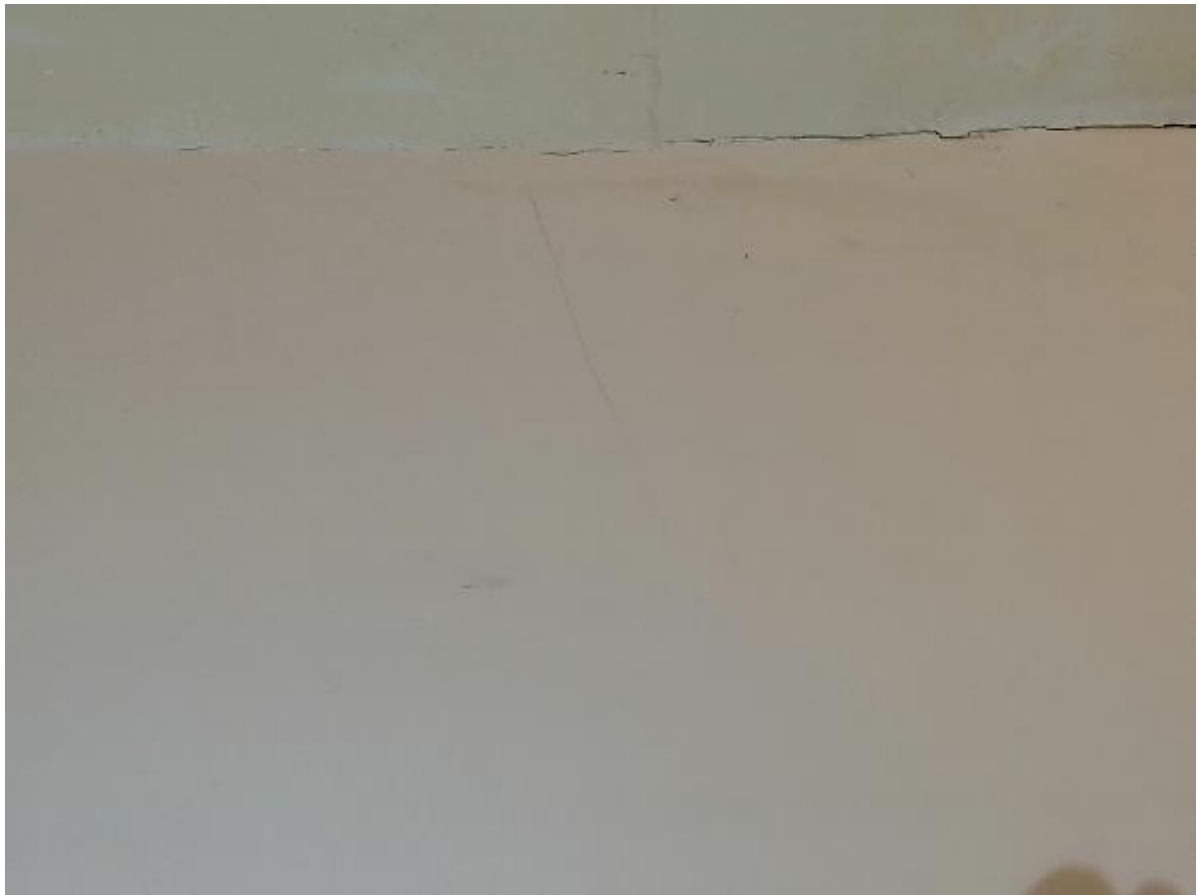
Photo 47 – Cracking to Studwork Wall (Base of Stairs)

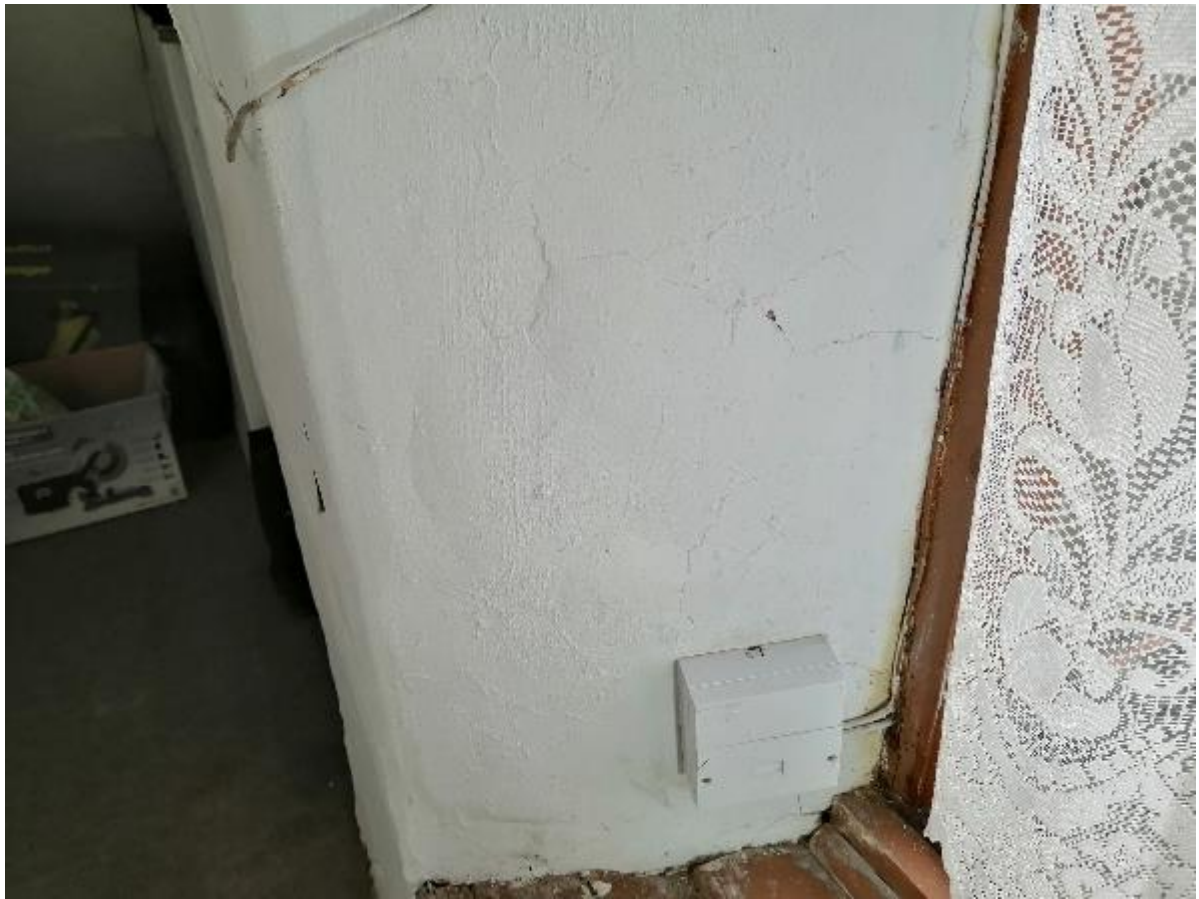
Photo 48 – Detached Plaster (Storeroom)

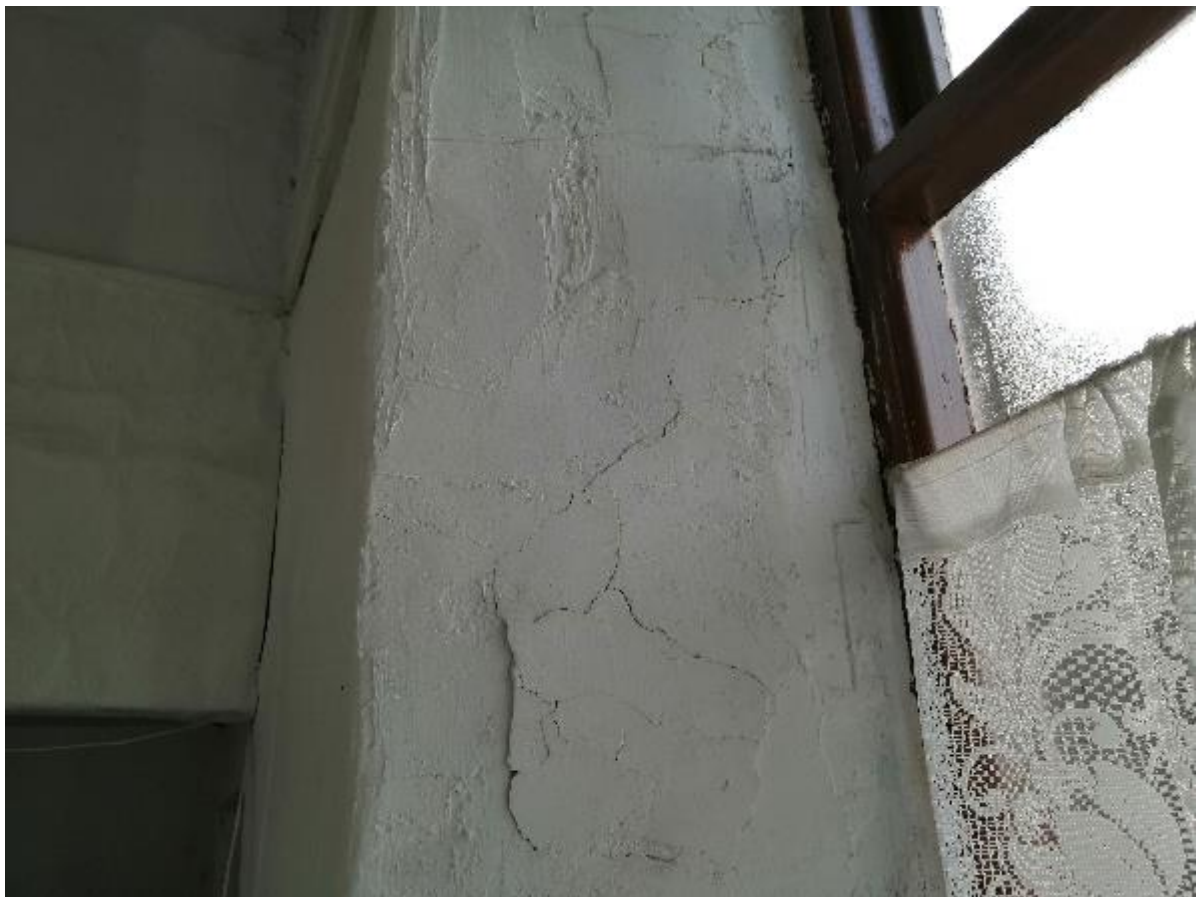
Photo 49 – Cracked and Detached Plaster (Storeroom)

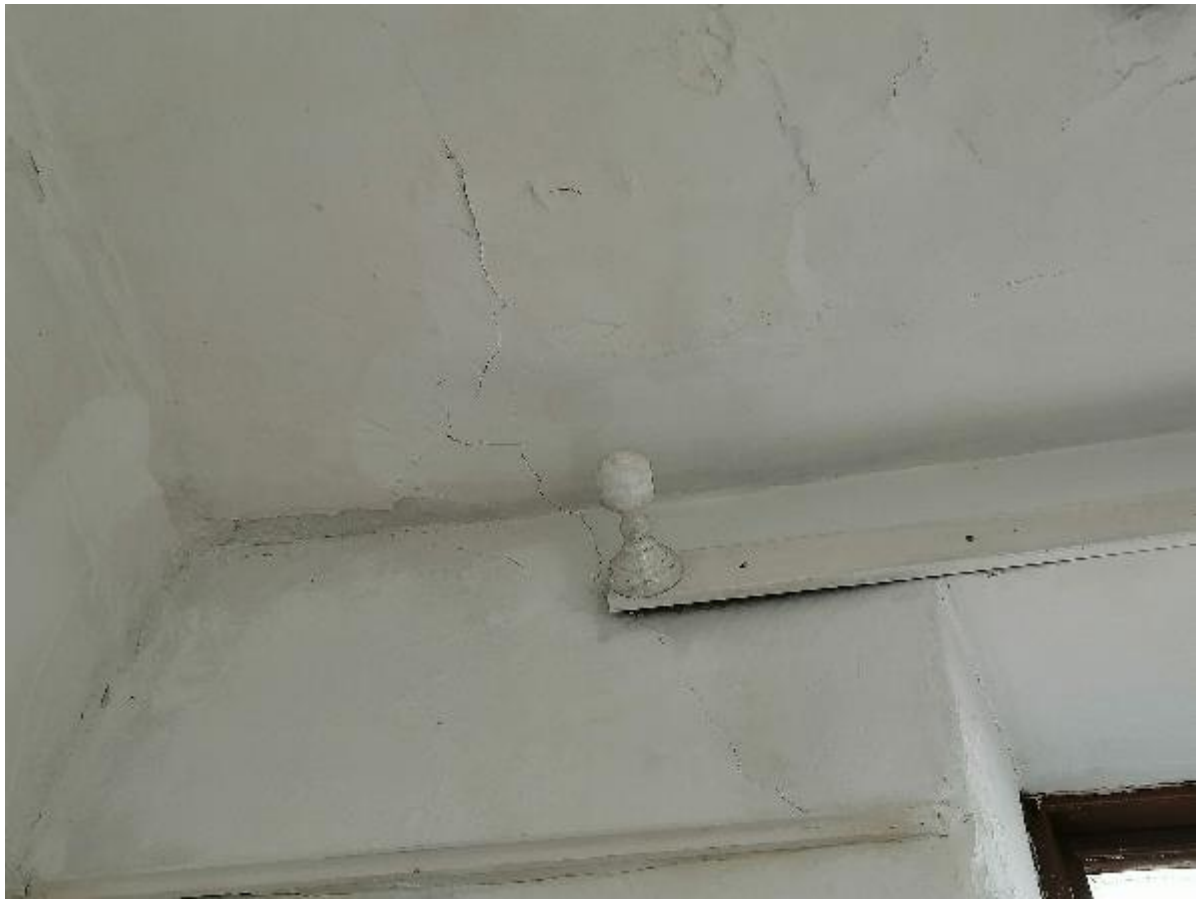
Photo 50 – Cracking to Wall and Ceiling (Storeroom)

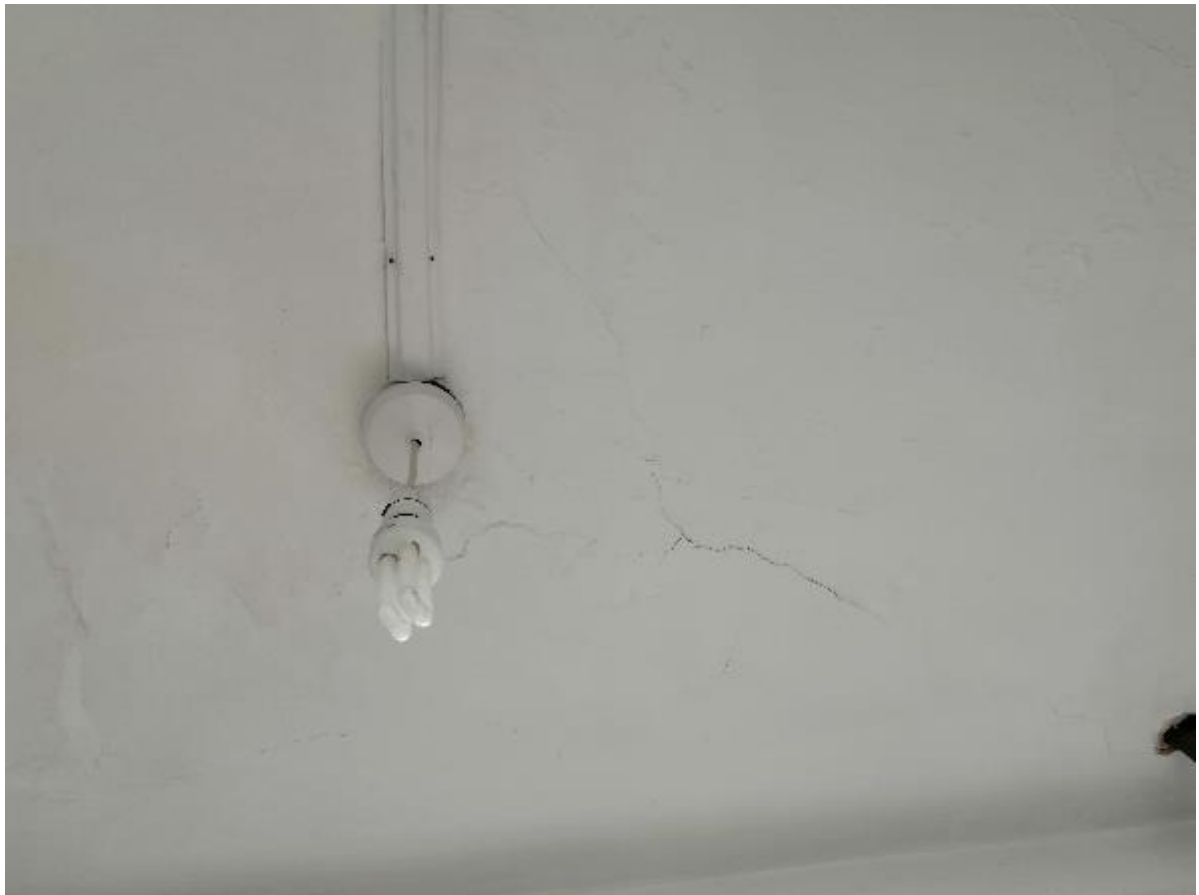
Photo 51 – Ceiling Cracking (Storeroom)

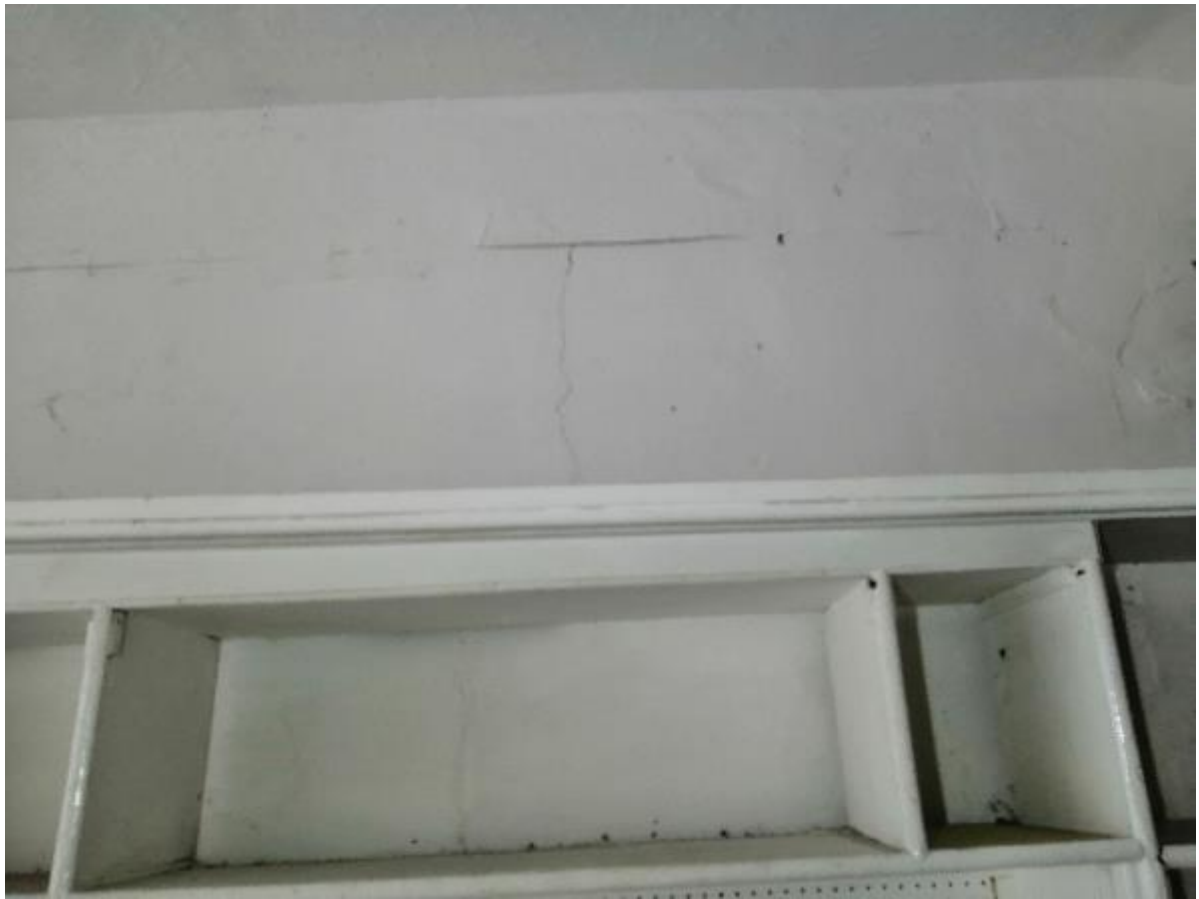
Photo 52 – Wall Plaster Crack (Living Room 2)

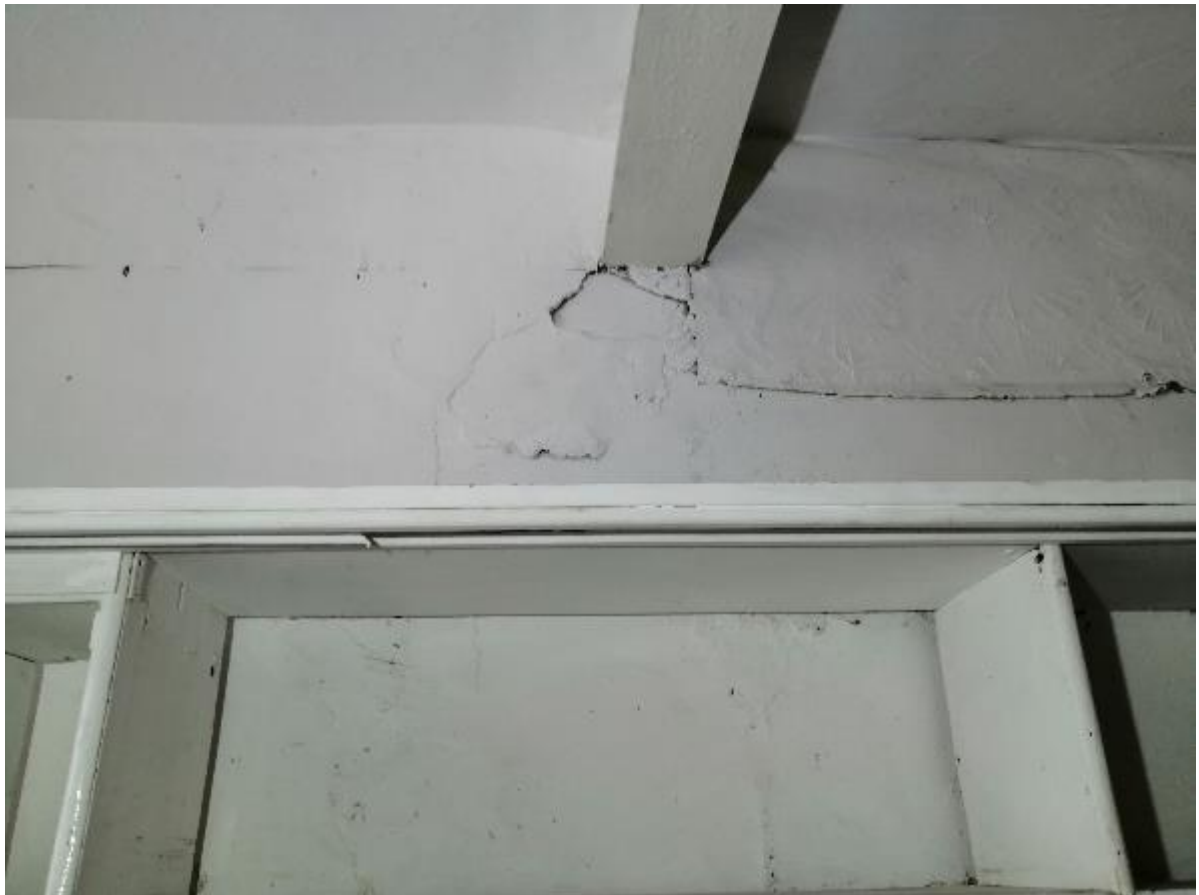
Photo 53 – Cracked and Detached Plaster (Living Room 2)

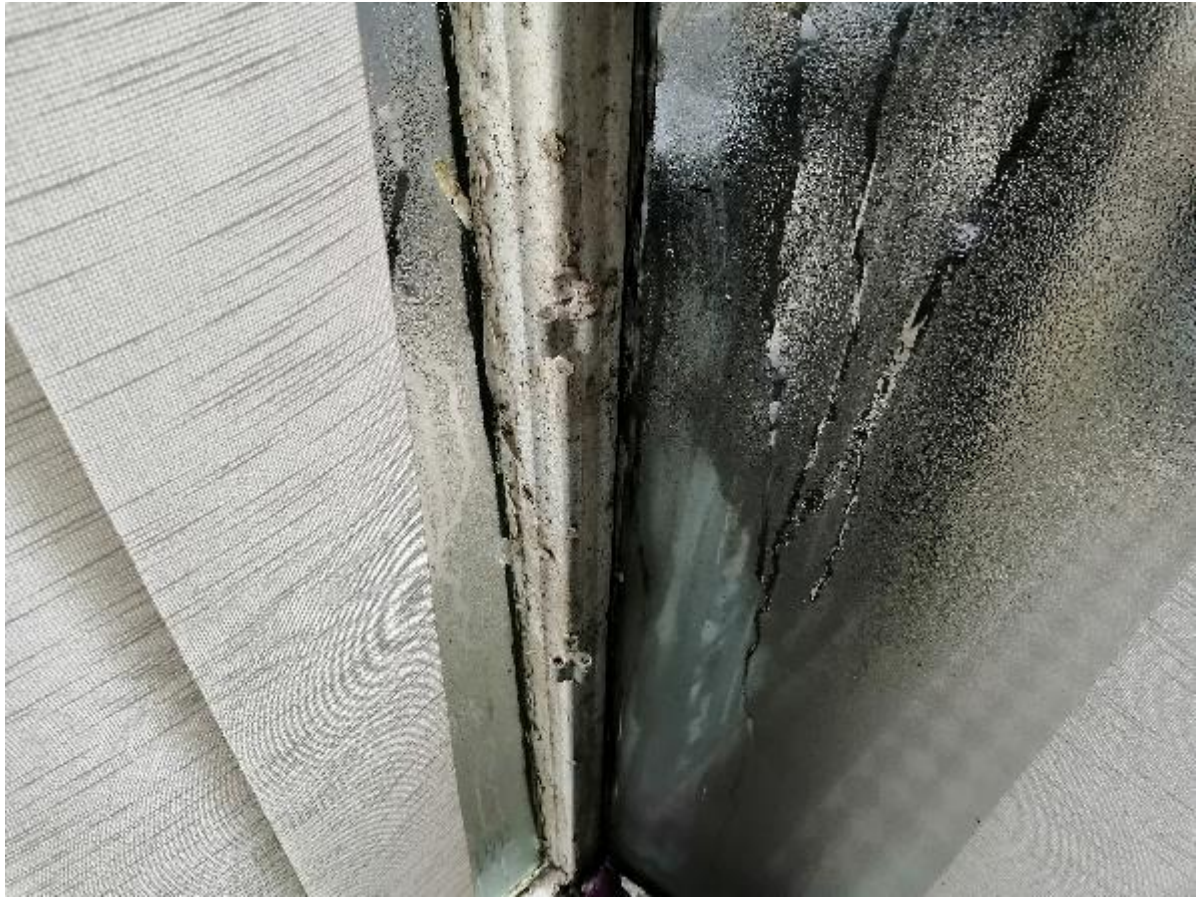
Photo 54 – Condensation Damp (Living Room 1)

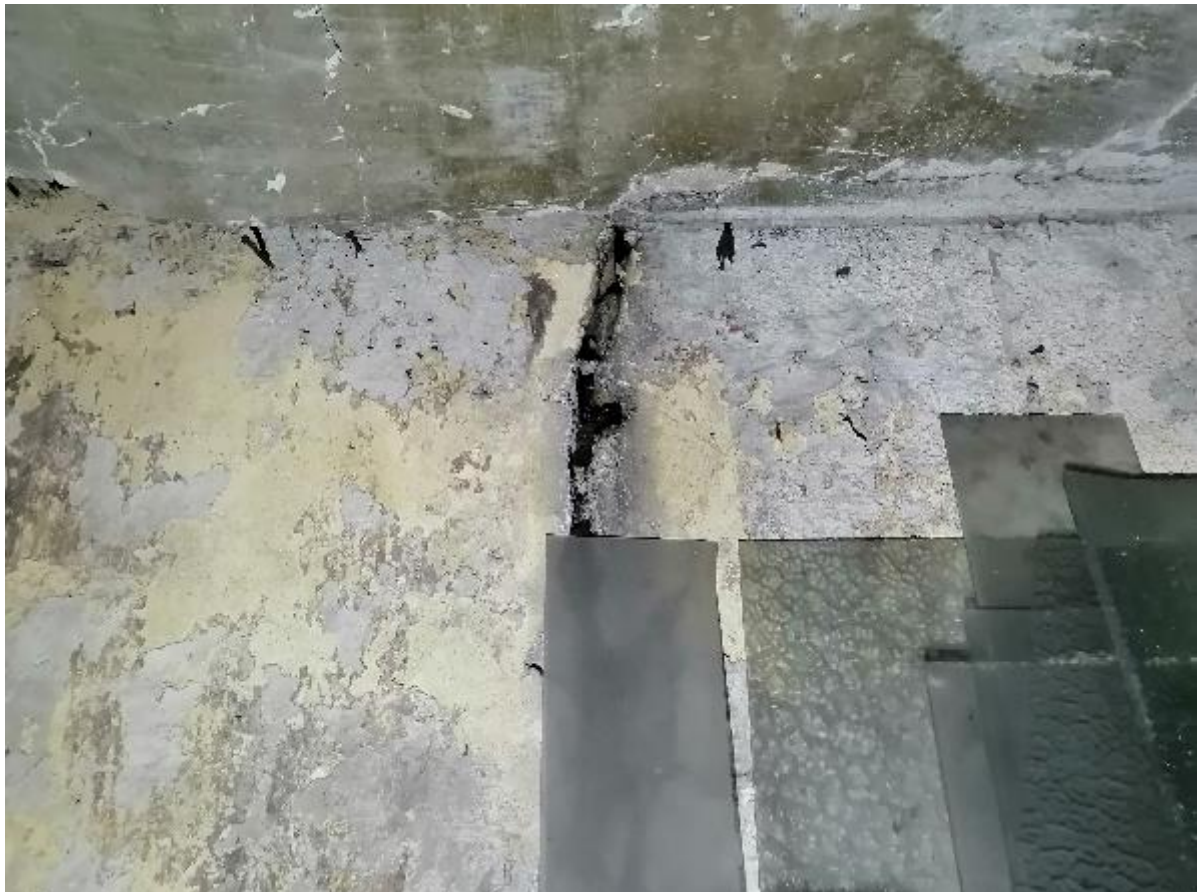
Photo 59 – Crack Above Fire Place (Basement Room 2)

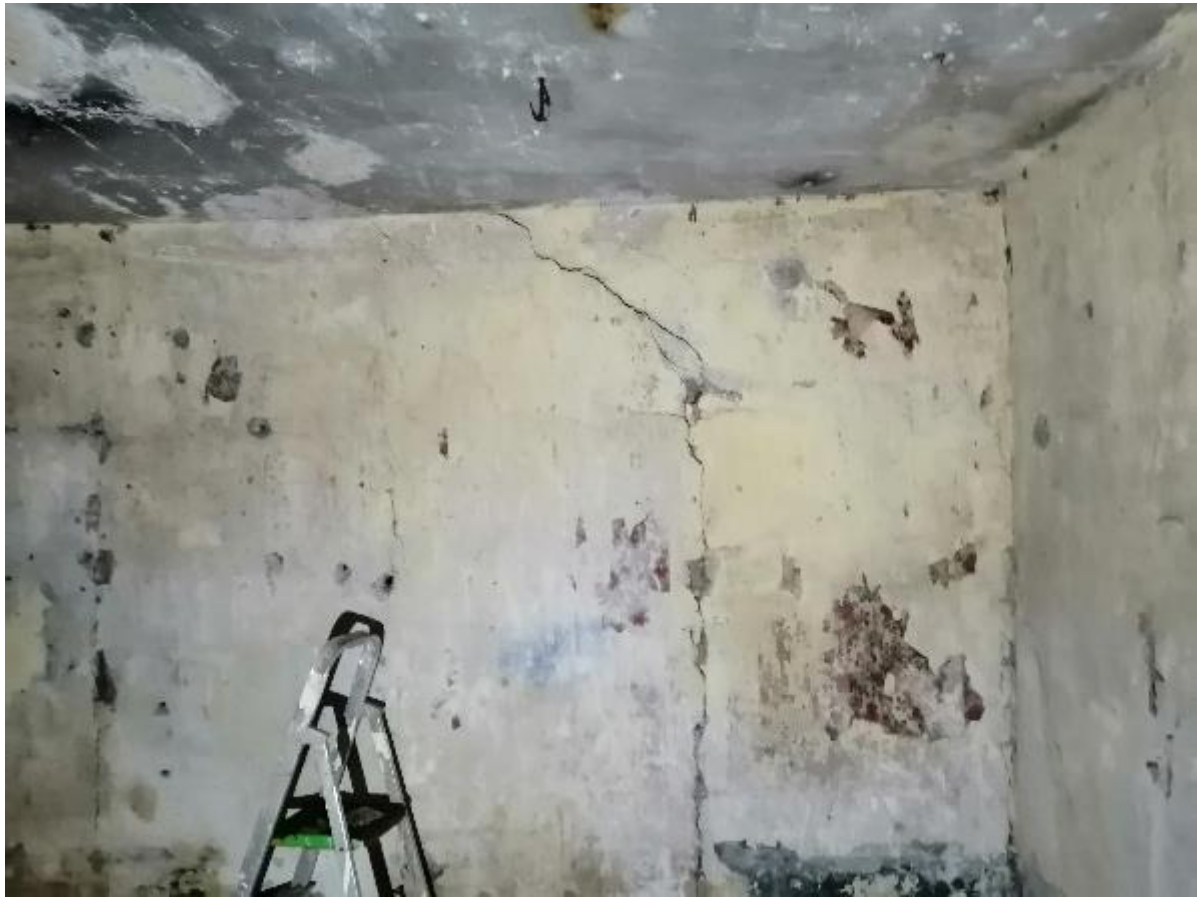
Photo 60 – Crack to Internal Wall (Basement Room 2)

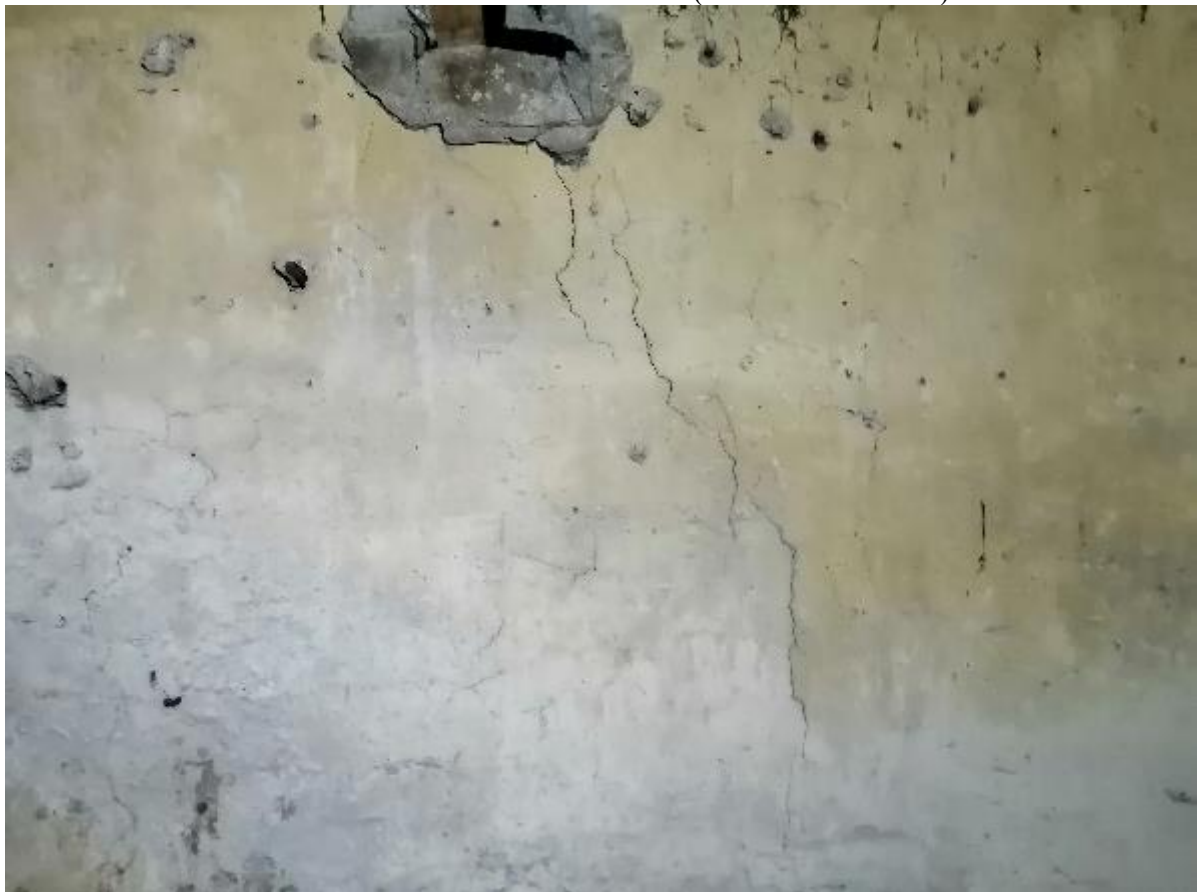
Photo 61 – Crack to External Wall (Basement Room 3)

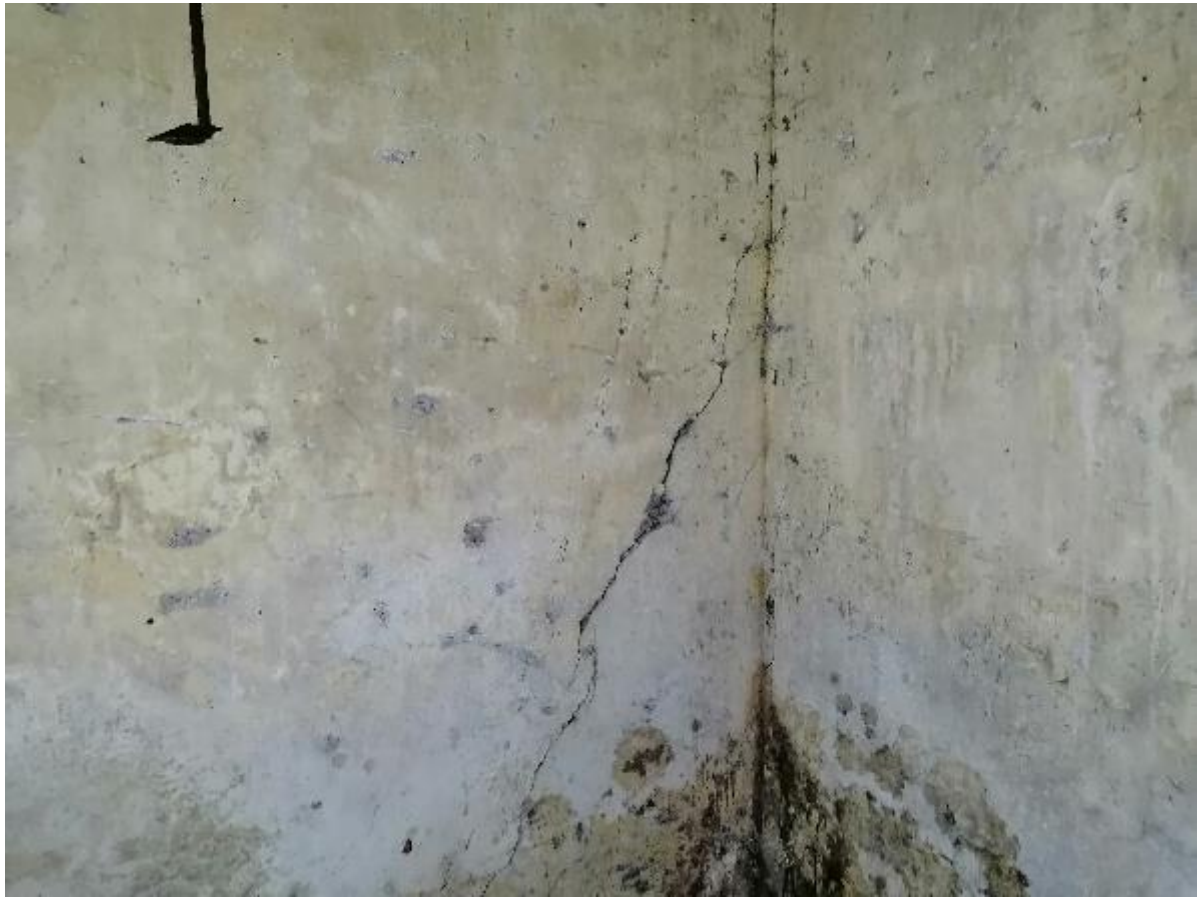
Photo 62 – Crack to External Wall (Basement Room 3)

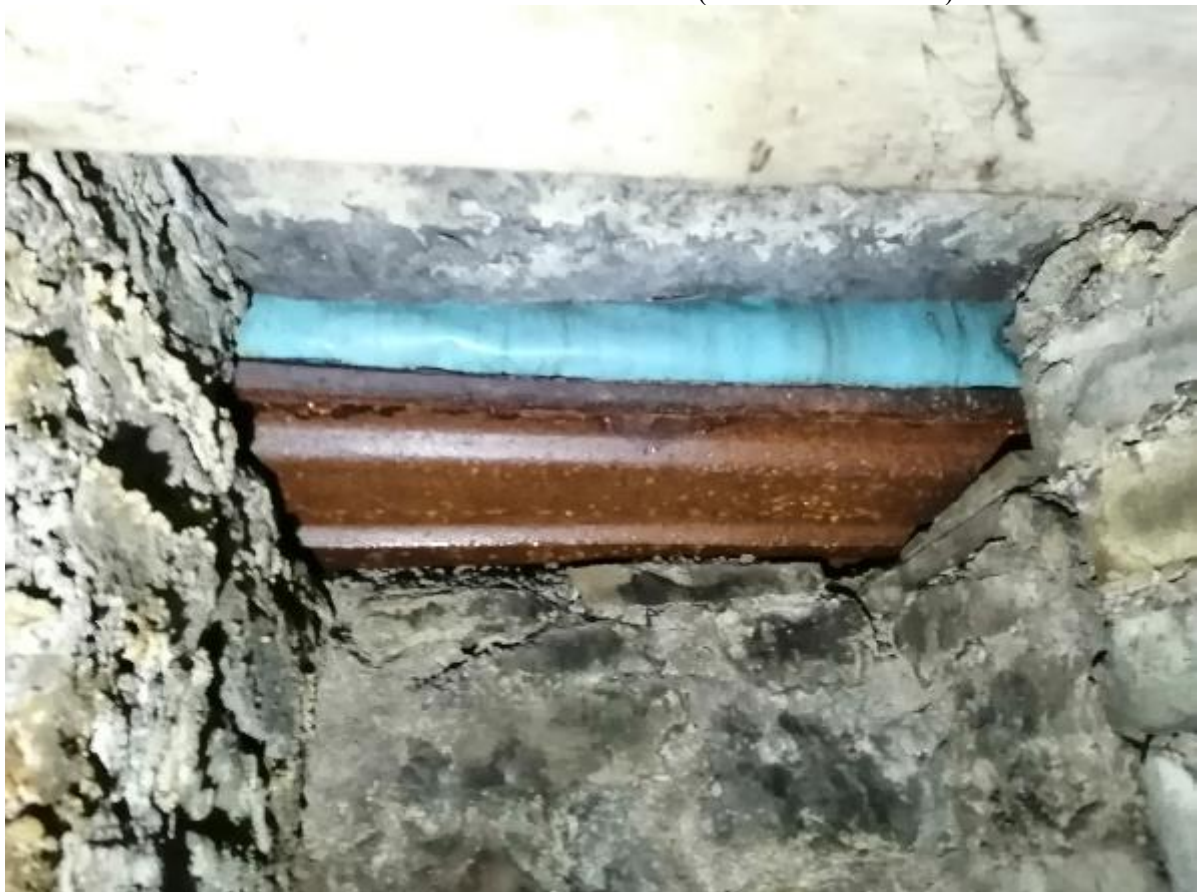
Photo 63 – Corrosion to Beam Below Pavement (Basement Room 4)

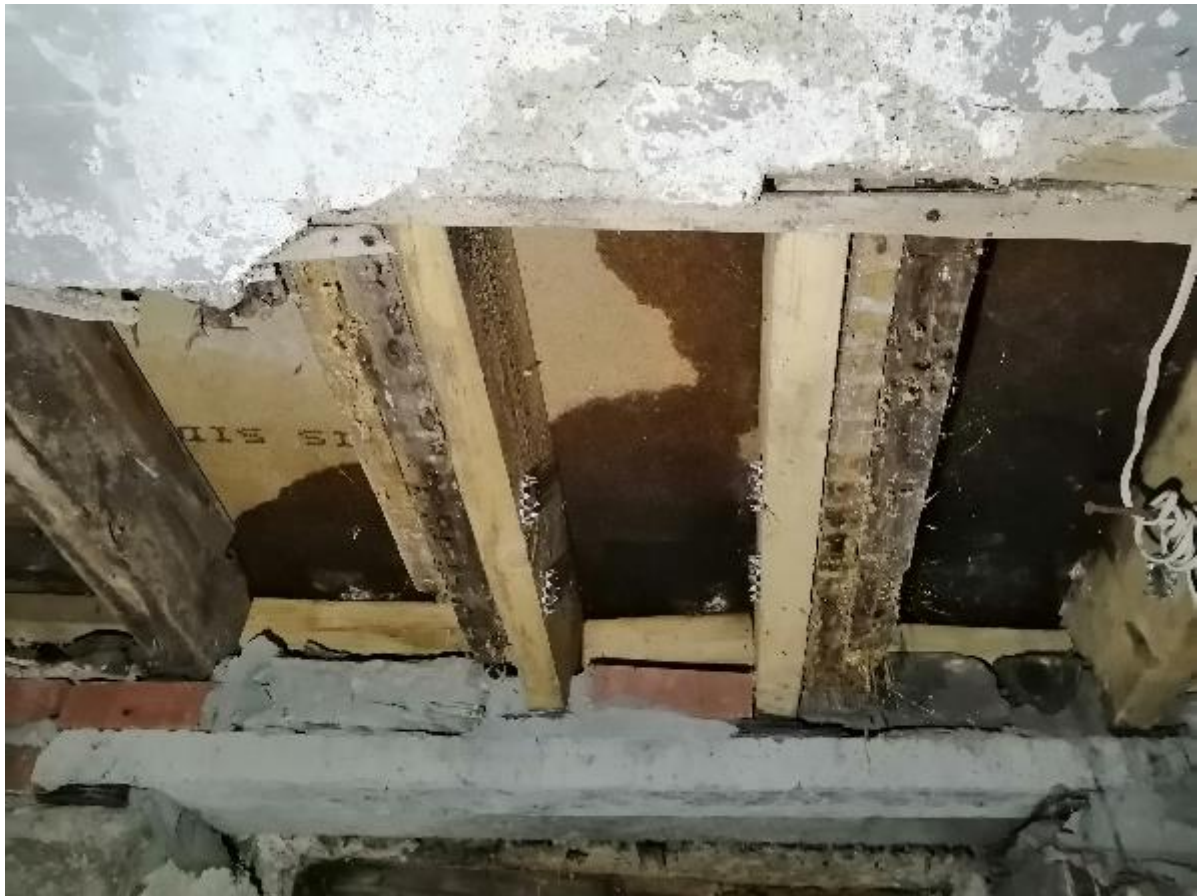
- Damp and mould growth were noted to the ground floor boards and joists in basement room 2 and 4 – see photos 64 and 66-69. This is expected to be due to the beam ends being supported directly by the solid walls (and so susceptible to moisture attack) and a lack of passive ventilation into the basement.

Damp and mould growth were noted to the ground floor boards and joists in basement room 2 and 4 – see photos 64 and 66-69 below. This is expected to be due to the beam ends being supported directly by the solid walls (and so susceptible to moisture attack) and a lack of passive ventilation into the basement. Repairs will be needed - Condition Rating **3** See Section 7.0 Recommendations for guidance on repair works required

Photo 64 – Damp to Floorboards and Joists (Basement Room 2)

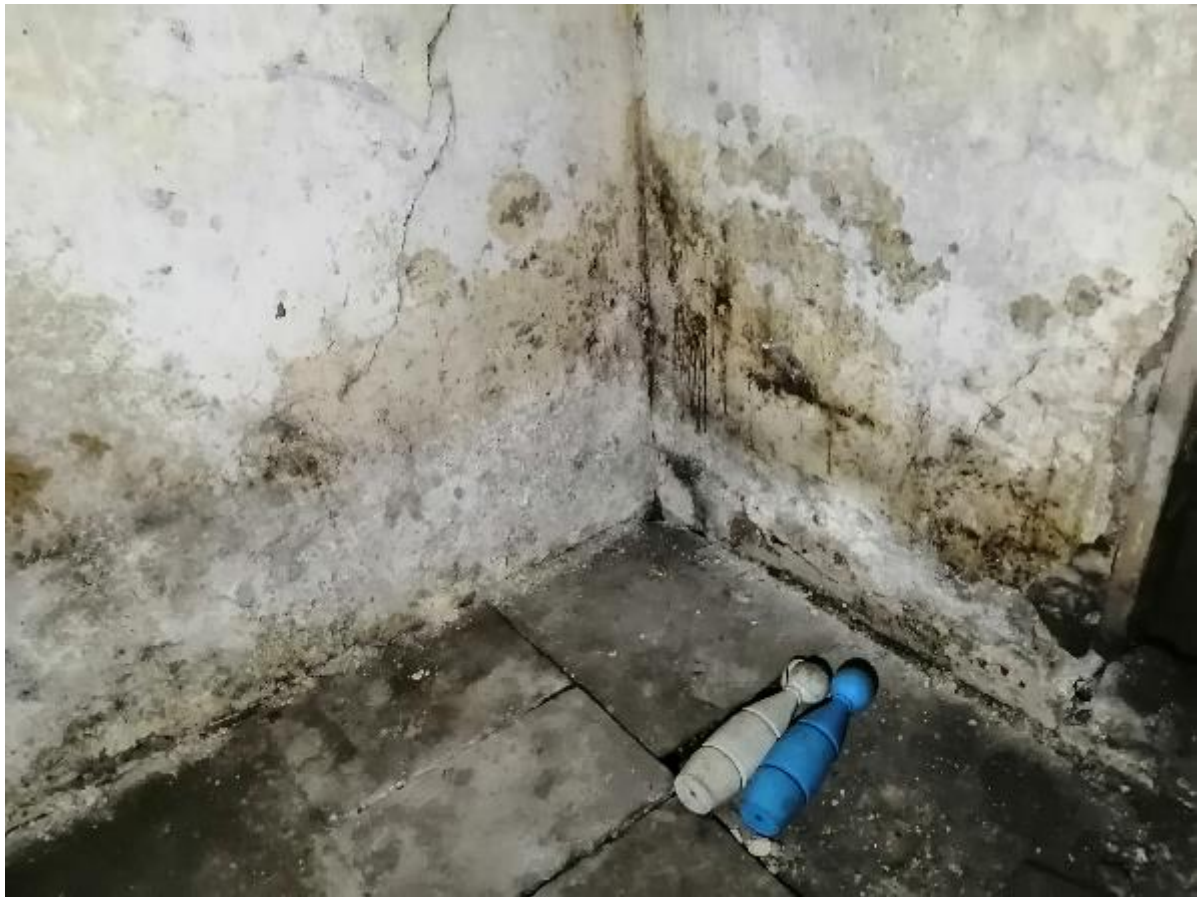
An inspection was undertaken to confirm the presence of damp in the property. Penetrating damp was noted to the internal basement walls (see examples in Photos 70-71 below) along with rising damp (see example in Photo 65 below.) It shall be recognised that solid wall construction as adopted throughout the original property offers less protection against penetrating damp when compared to cavity wall construction. Damp can be more prevalent during winter months and can be exacerbated by cracked or defective external render and mortar joints / pointing. The damp to the basement is exacerbated by the lack of tanking or other internal protection that would otherwise prevent damp migrating into the wall and slabs. Remedial works will be necessary to ensure the basement can remain dry - Condition Rating **3** See Section 7.0 Recommendations for guidance on repair works required.

Photo 65 – Rising Damp (Basement Room 3)
