**Structural Survey (Inspection)**

**60 Commercial Street  
Ystalyfera  
Swansea  
SA9 2HS**

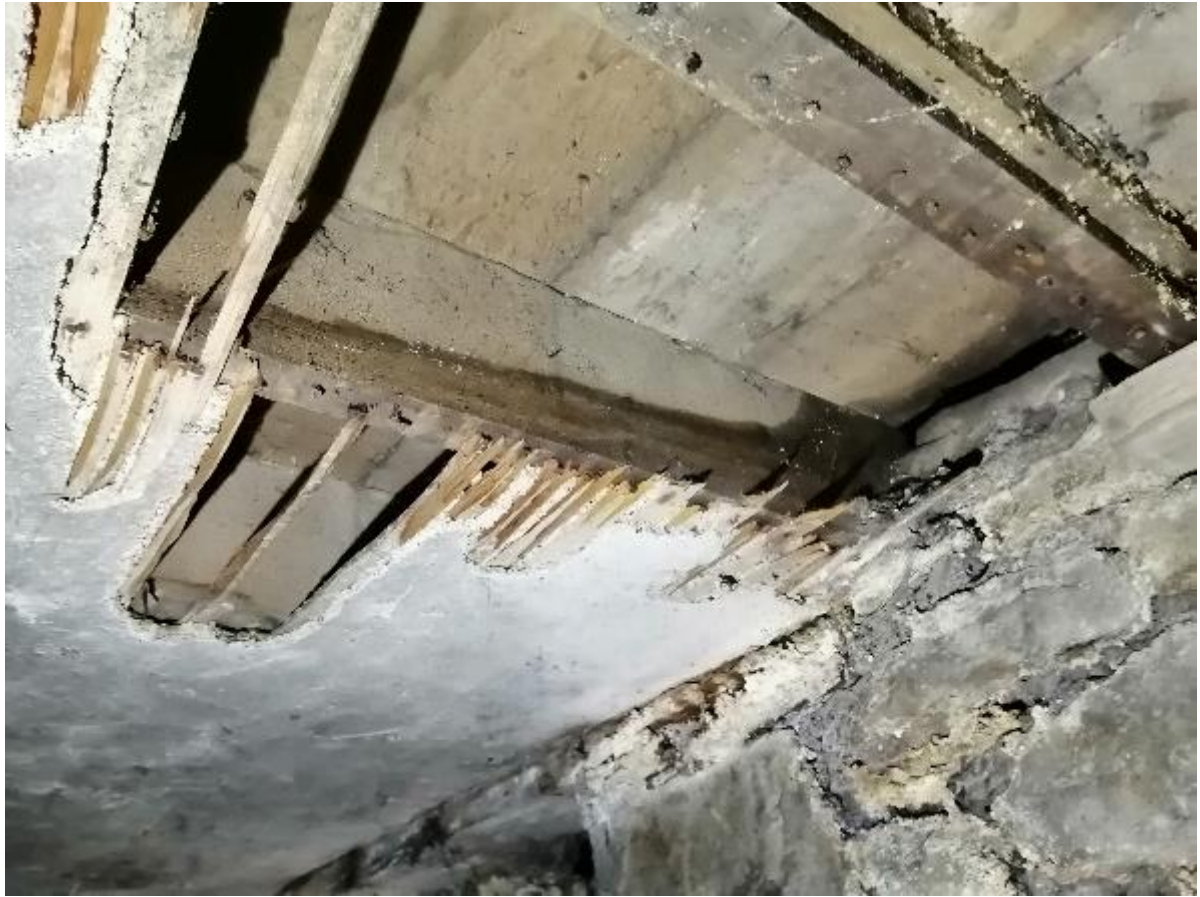
Damp and mould growth were noted to the ground floor boards and joists in basement room 2 and 4 – see photos 64 and 66-69 below. This is expected to be due to the beam ends being supported directly by the solid walls (and so susceptible to moisture attack) and a lack of passive ventilation into the basement. Repairs will be needed - Condition Rating **3** See Section 7.0 Recommendations for guidance on repair works required

Photo 67 – Damp to Ends of Floor Joists (Basement Room 4)

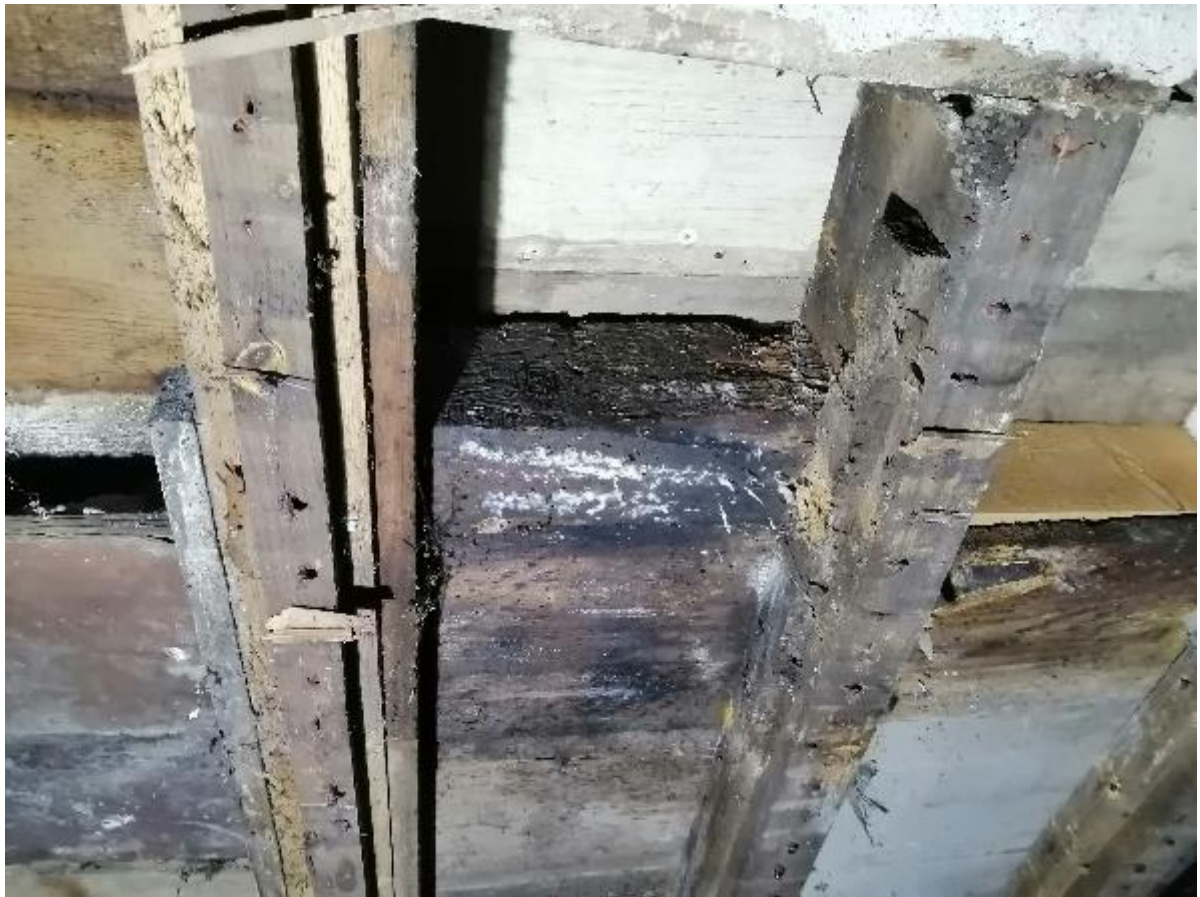
Photo 69 – Rot and Mould Growth to Floor Joists (Basement Room 4)

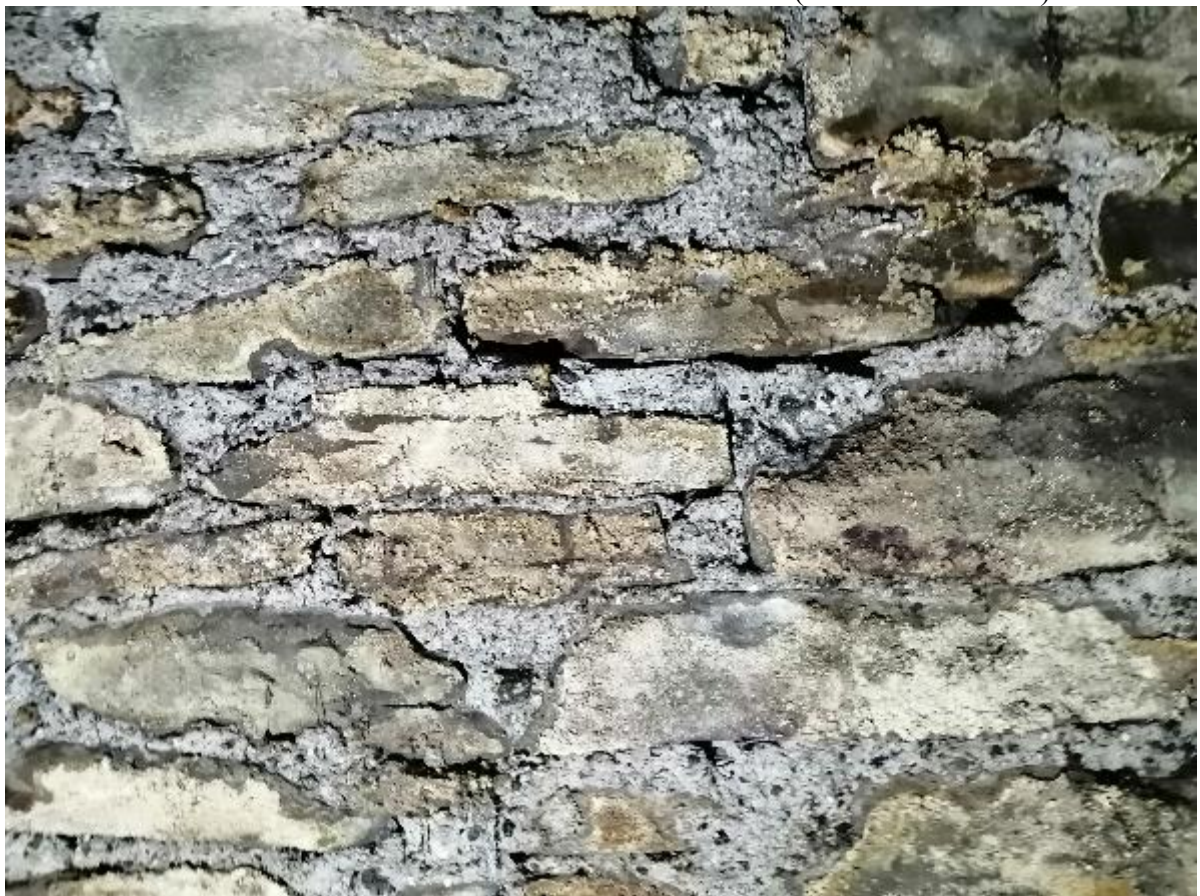
An inspection was undertaken to confirm the presence of damp in the property. Penetrating damp was noted to the internal basement walls (see examples in Photos 70-71 below) along with rising damp (see example in Photo 65 below.) It shall be recognised that solid wall construction as adopted throughout the original property offers less protection against penetrating damp when compared to cavity wall construction. Damp can be more prevalent during winter months and can be exacerbated by cracked or defective external render and mortar joints / pointing. The damp to the basement is exacerbated by the lack of tanking or other internal protection that would otherwise prevent damp migrating into the wall and slabs. Remedial works will be necessary to ensure the basement can remain dry - Condition Rating **3** See Section 7.0 Recommendations for guidance on repair works required.

Photo 70 – Penetrating Damp (Basement Room 4)

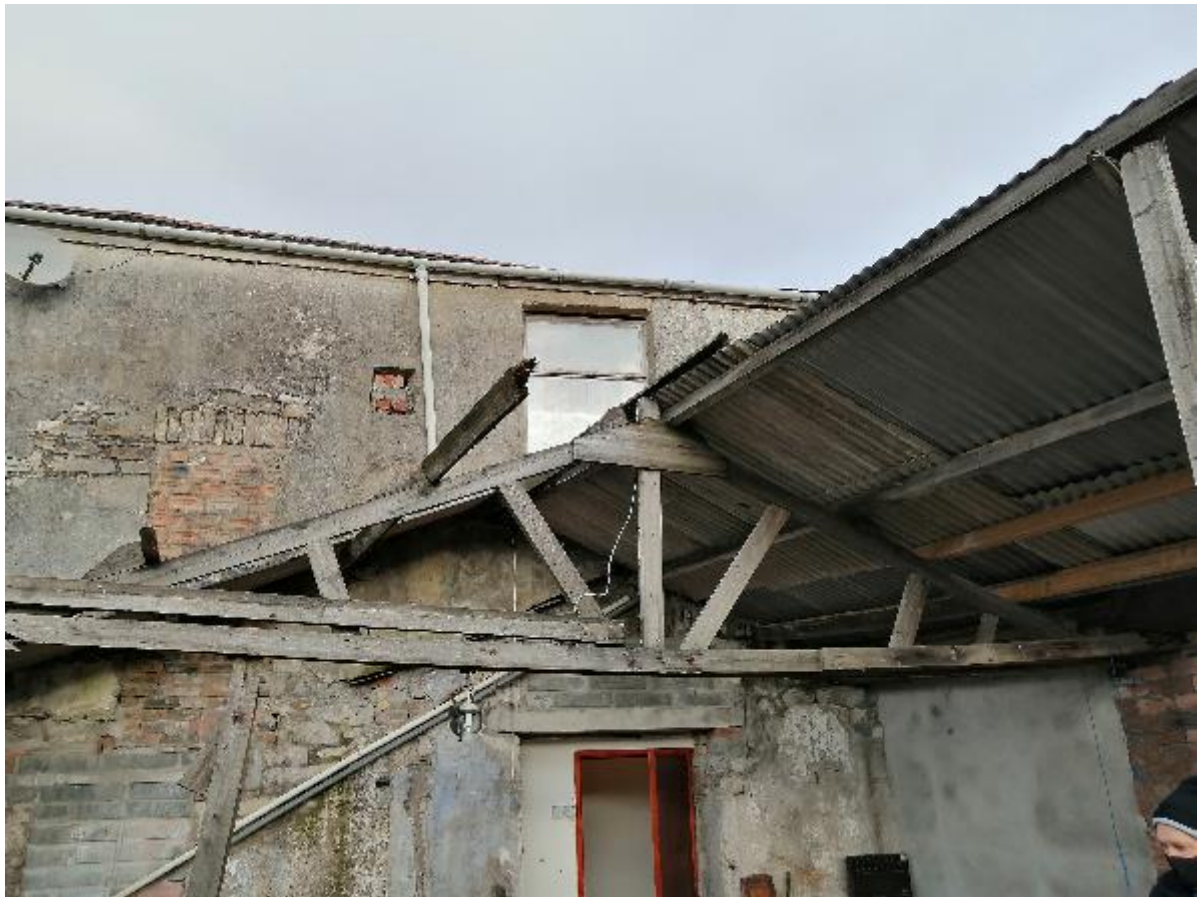
A 2 storey timber structure was located at the rear of the property. The timber structure is in a significant state of disrepair. The roof structure was mostly missing and has exposed the internal timbers to the elements. Rotten and damaged timber boards and members as well as corrosion to steelwork were present throughout the timber structure - see Photos 72-77 below. This timber structure is in an unsafe condition and it is recommended that the structure is demolished. It should be noted that the timber structure is not suspected to provide structural support to the main property. During demolition of the structure it is recommended that closer inspection of the areas where the timber structure connects to the original property should be undertaken to confirm if any damage has been caused to the original property from the degradation of the timber structure. Condition Rating **3** See Section 7.0 Recommendations for guidance on repair works required.

Photo 72 – Timber Structure Roof

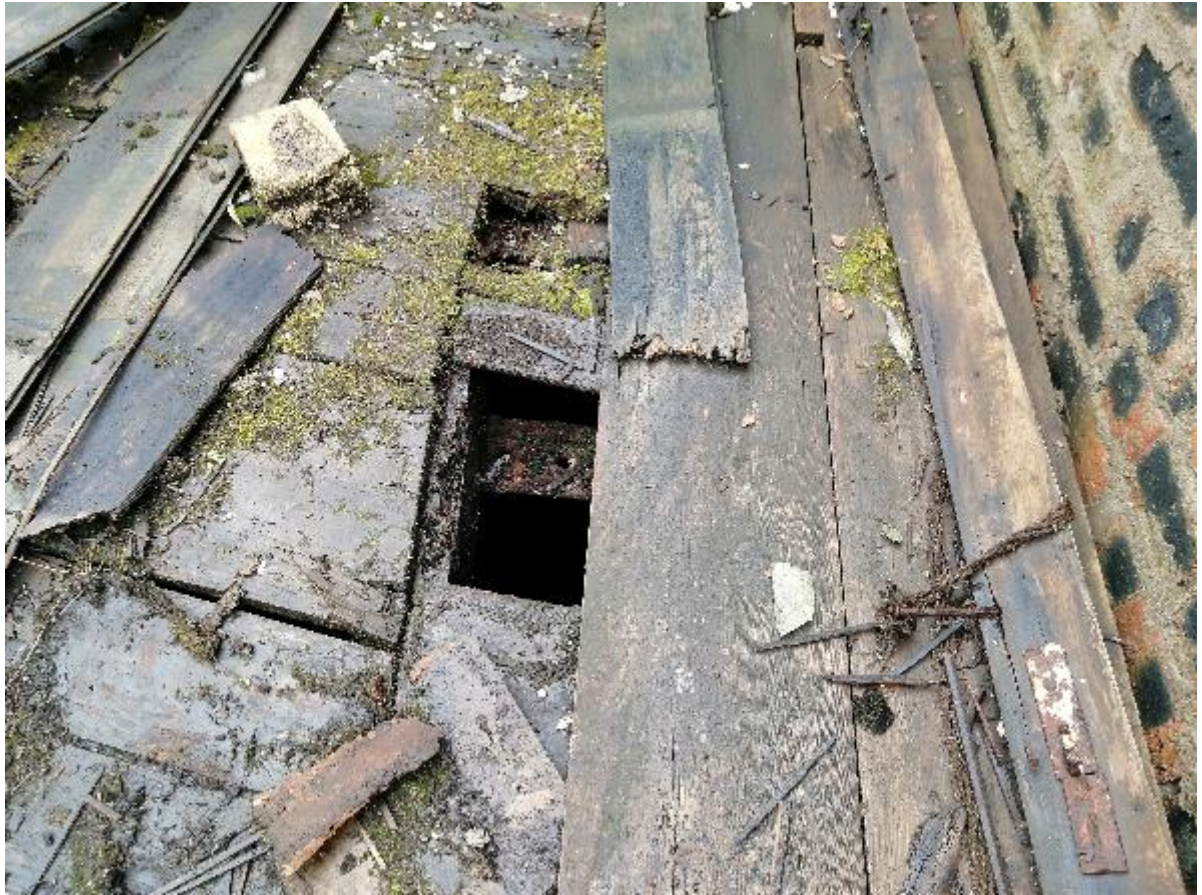
Photo 74 – Timber Structure Floor

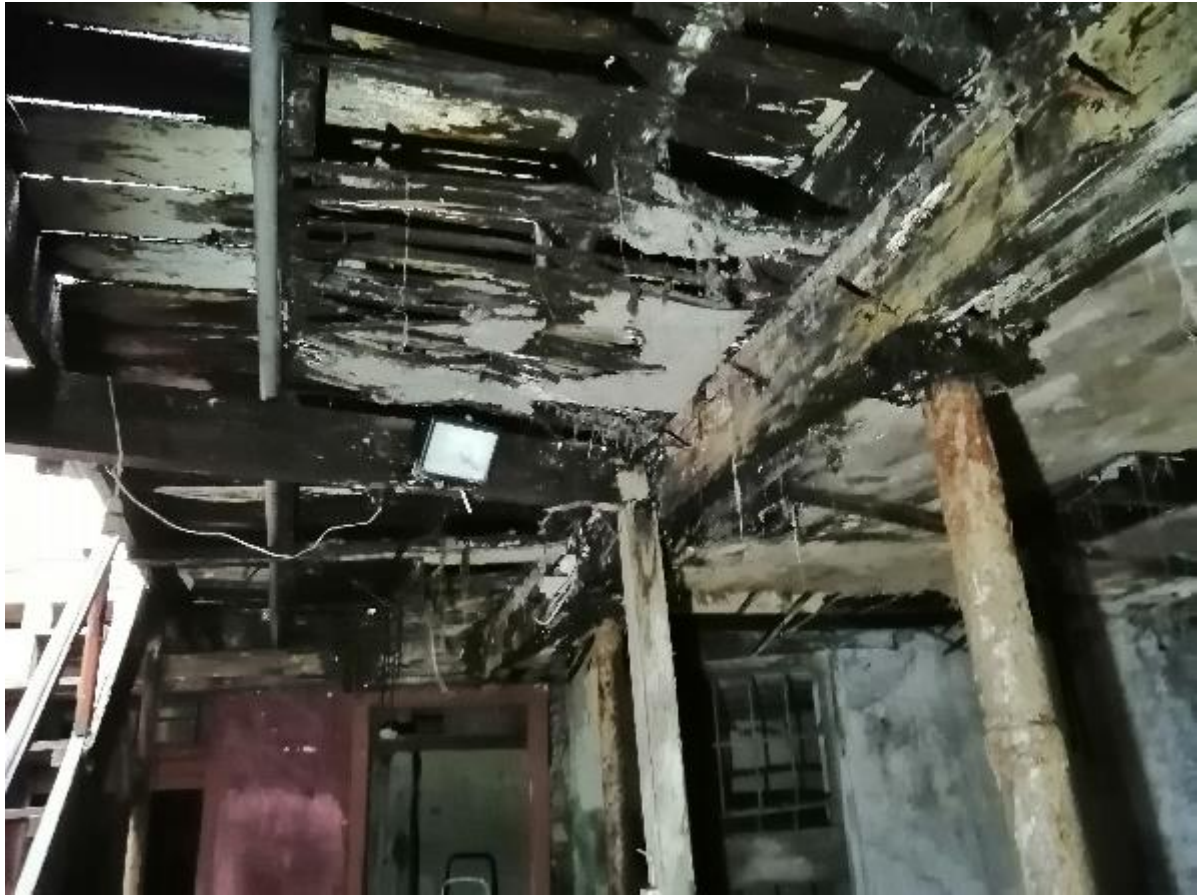
Photo 76 – Timber Structure Floor

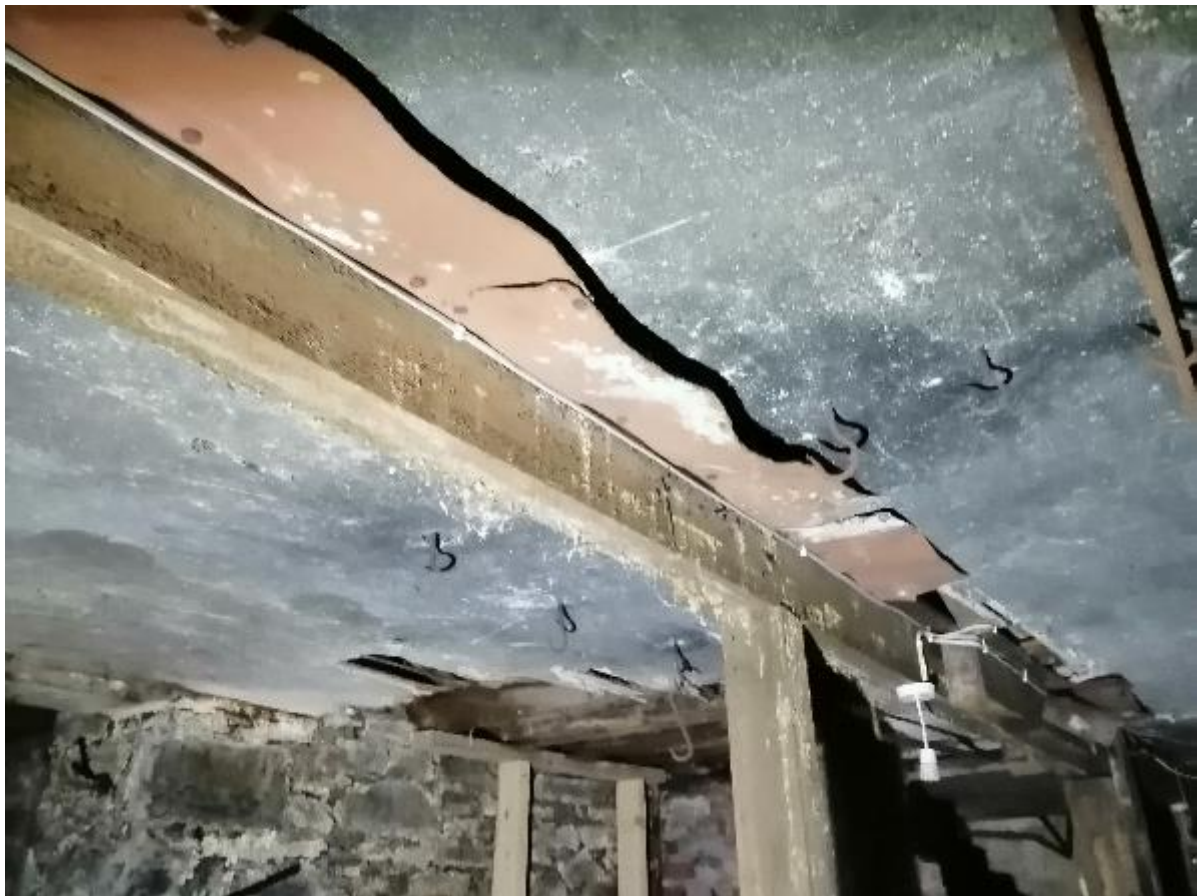
Photo 78 – Timber Column and Beam (Basement Room 4)

If the timber column is required to be removed or a longer-term solution is required it is suggested that the timber beam and column arrangement is replaced with a steel beam supported on the existing walls. Structural design and calculations would be required for the sizing of the steel beam and if a steel column is required.
