## **Structural Appraisal**

**Project:**            **Structural Appraisal of Barn at  
Tirlan Farm, Cilfrew, Neath**

**Project Ref:**    **21/140**                      **Revision:**    **A**

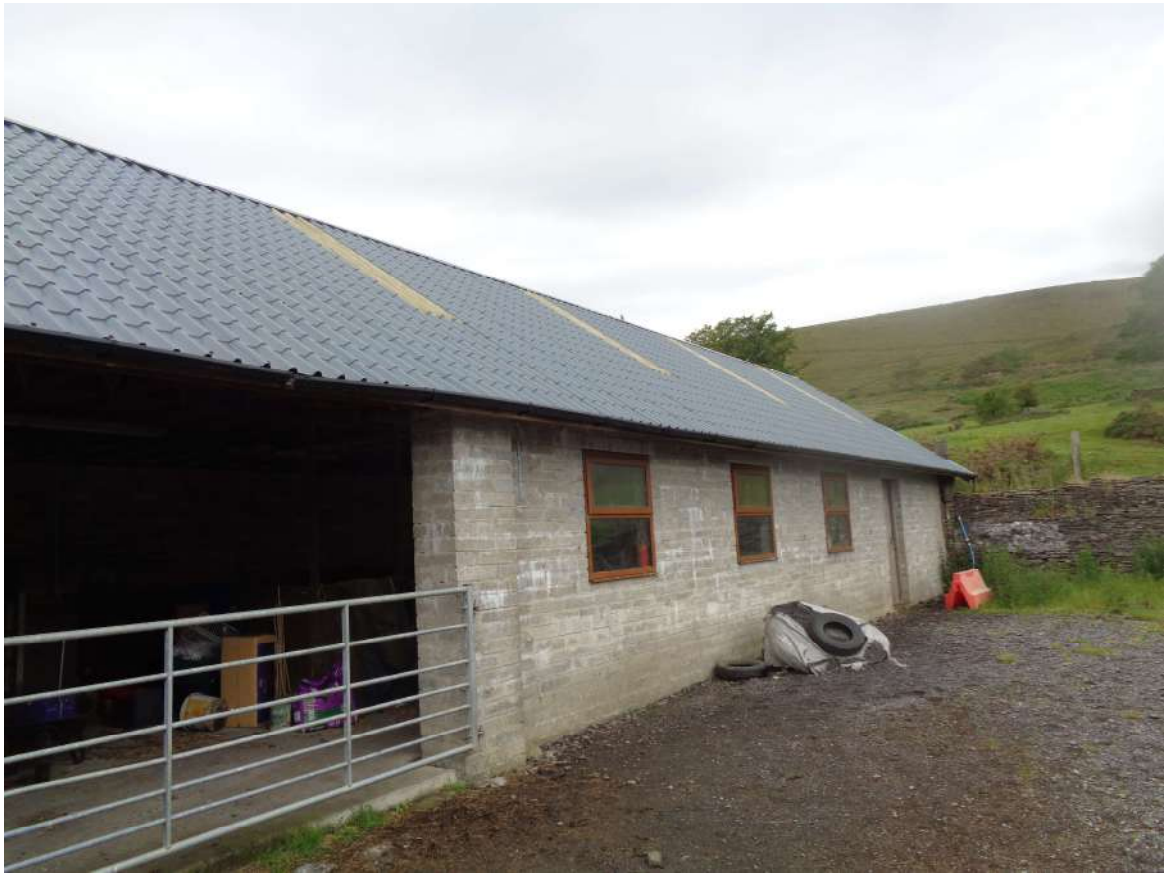
Photograph 1 – Front elevation, viewed from the south-east corner.

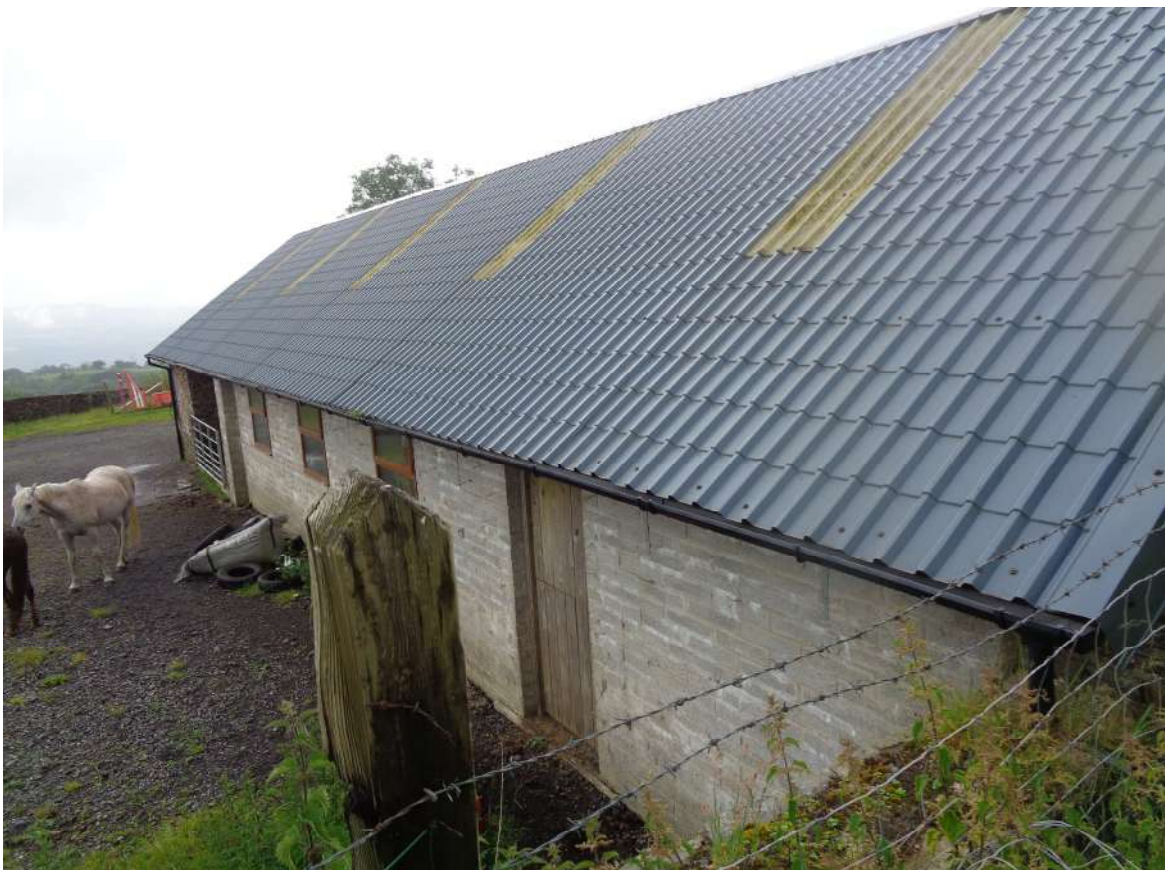
Photograph 2 – Front elevation, viewed from the north-east corner.

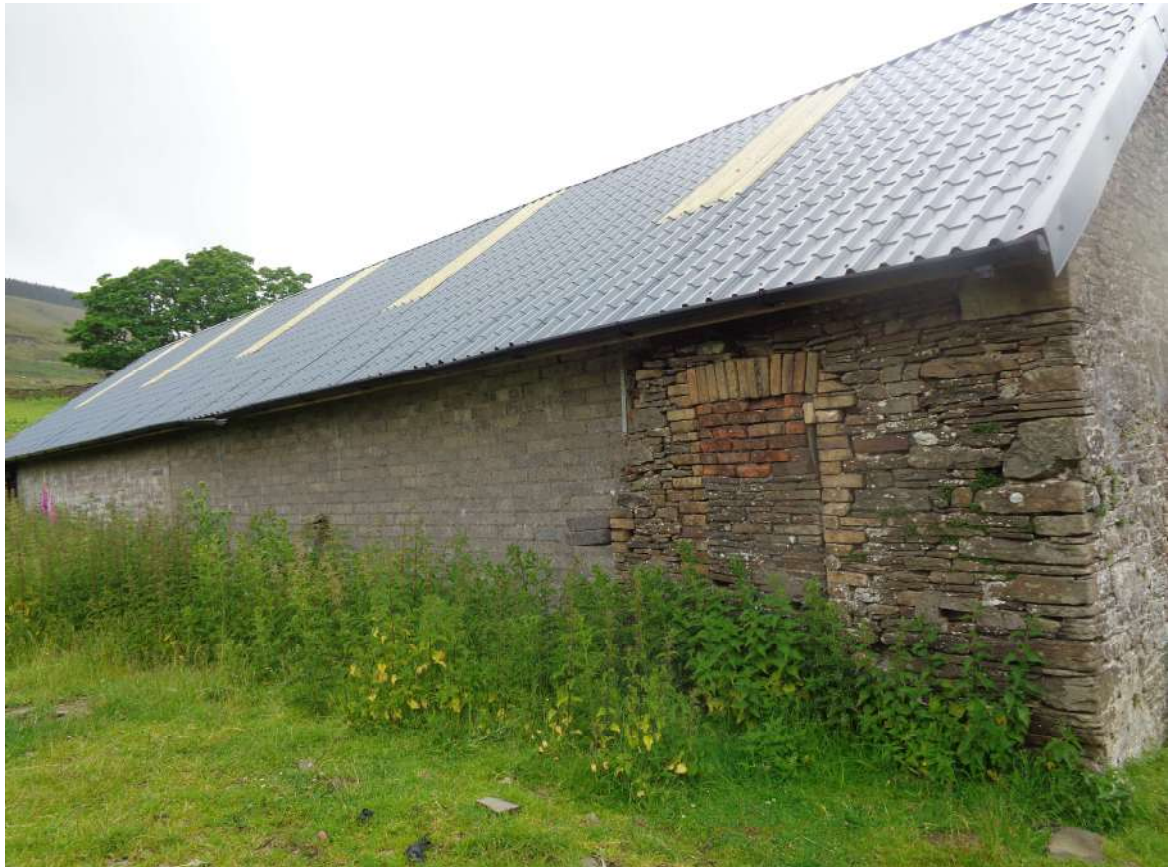
Photograph 3 – Rear elevation, viewed from the south-west corner.

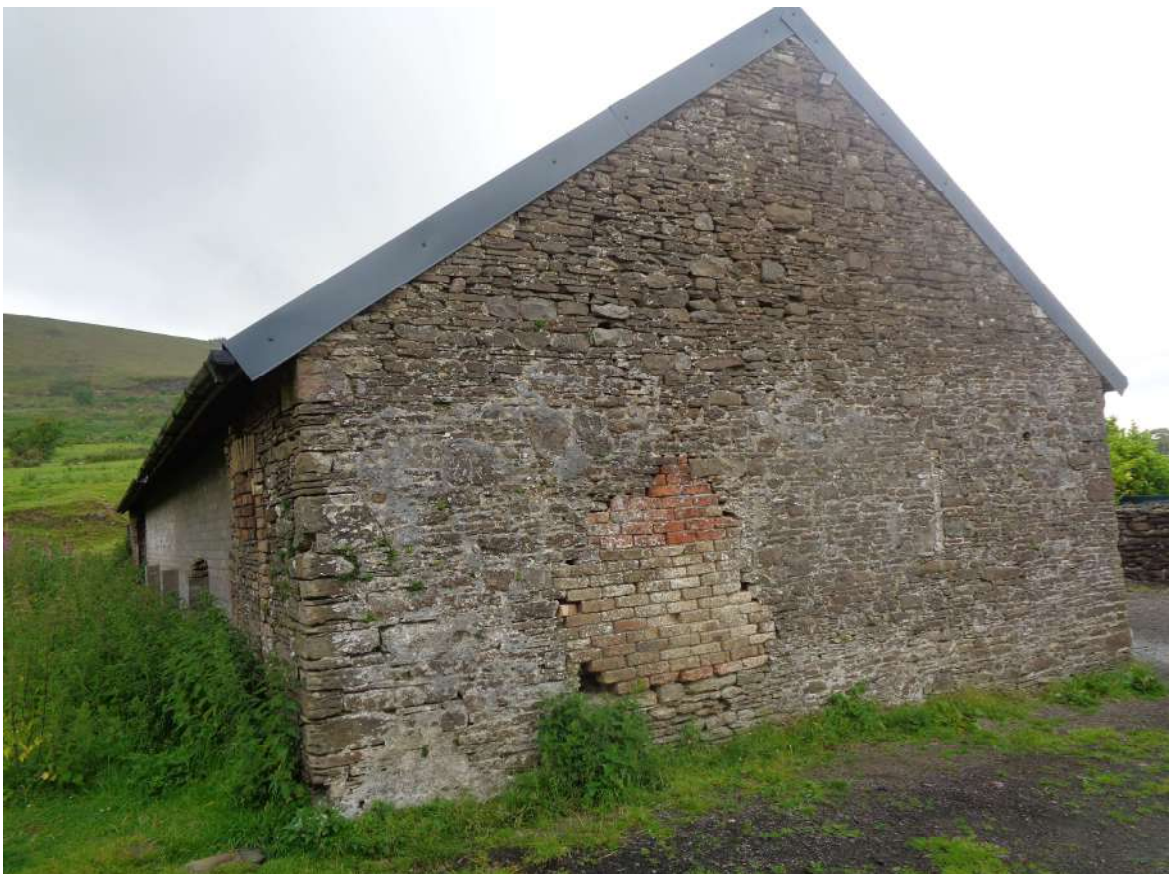
- 4.4 To the southern gable there is a section of brickwork located towards the centre of the wall measuring roughly 1.2m by 1.2m. Presumably this was constructed to either infill a former opening or to repair a defect. In any event, this brick-built section is free from any significant issues, although there are a few gaps to the sides of the lowest brick course.

Photograph 4 – South-facing gable elevation.

- 6.5 Where minor gaps are present these will need to be infilled using masonry and mortar.

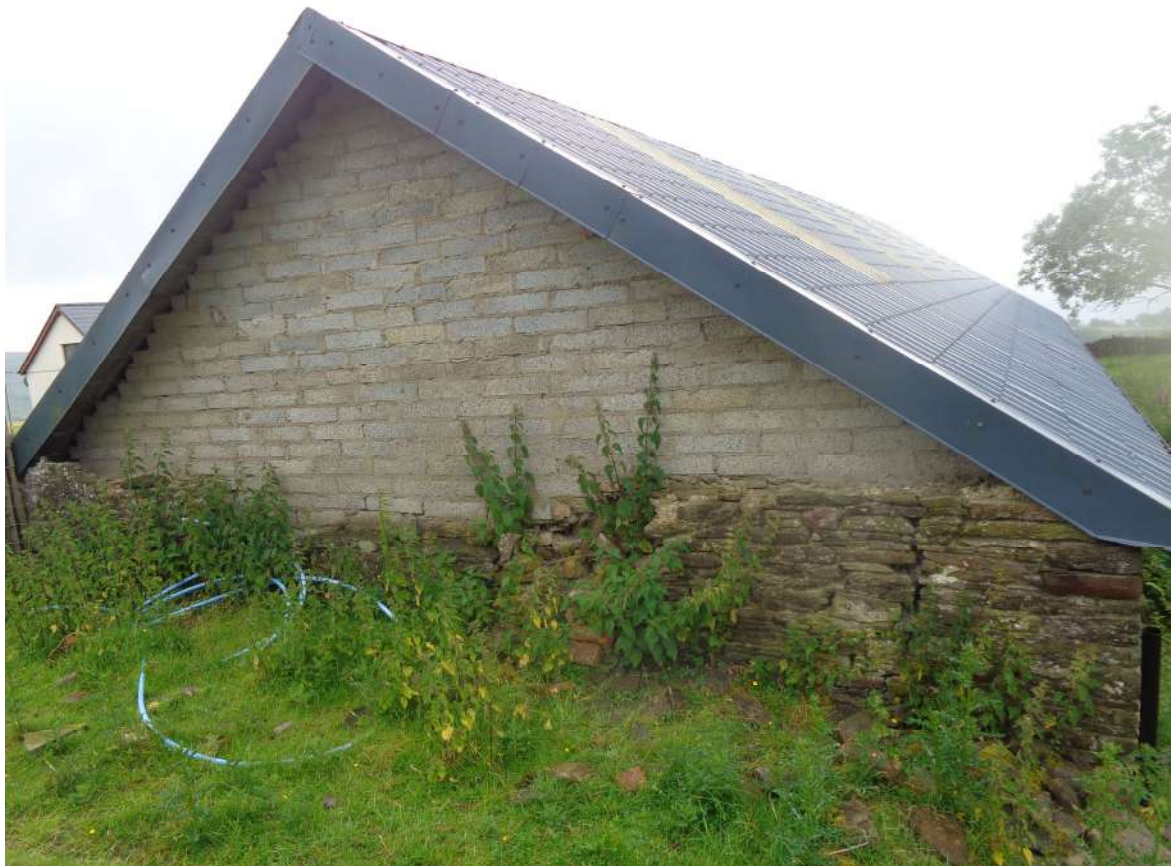
- 4.5 There are a few minor patches of vegetation growing on the face of the northern gable as well as to the faces of the stone walls at the barns south-western corner.

Photograph 5 – North-facing gable elevation.

- 6.3 All patches of vegetation shall be carefully removed with use of a suitable herbicide.
- 6.4 Generally, any mortar to the stone walls which is found to be unduly loose will require its joints to be carefully raked-out and then be re-pointed. Any open joints should also be re-pointed as necessary. For stonework construction, the new mortar will need to be lime-based as this provides a degree of flexibility to accommodate thermal-relating movement. We would envisage that all mortar joints to the building would be completely re-pointed as a matter of course for aesthetic purposes. Alternatively the exact extent of re-pointing works could be left to the discretion of the contractor and agreed directly with the client.

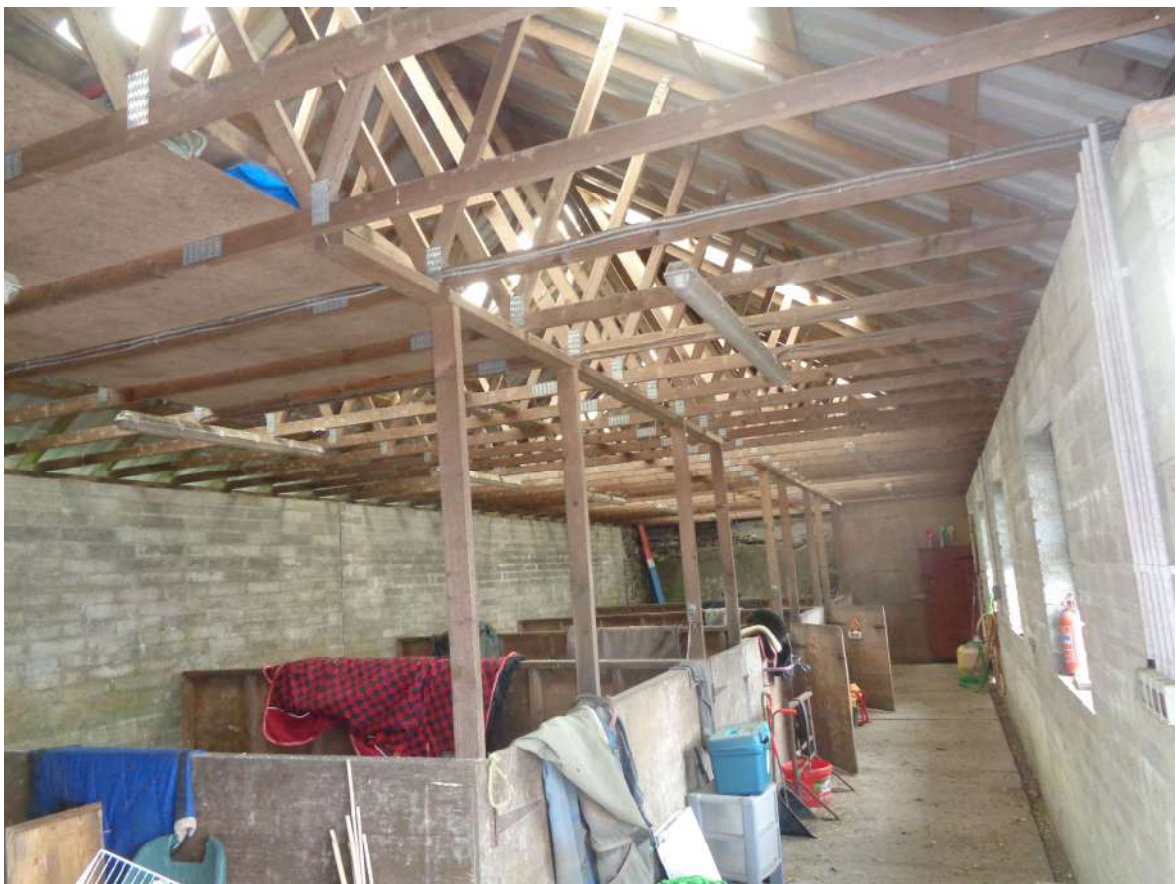
Photograph 6 – Internal view of building, facing northwards.
