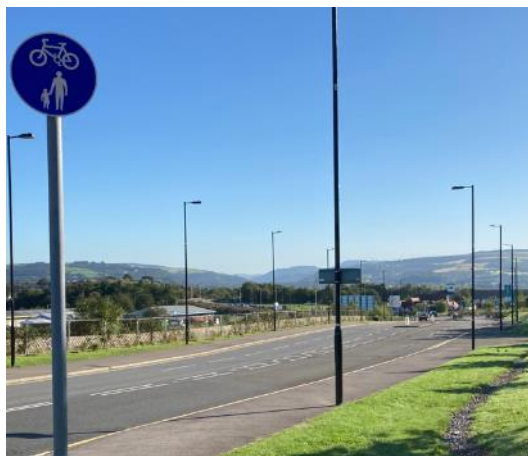
**Photo 2-1 - Shared facility on southern side of Ffordd Coed Darcy**

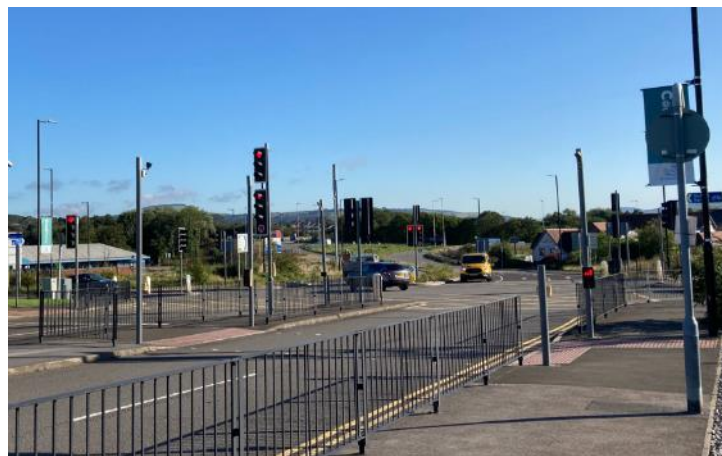
**Photo 2-2 - Toucan crossing at Ffordd Coed Darcy/B4290 junction**

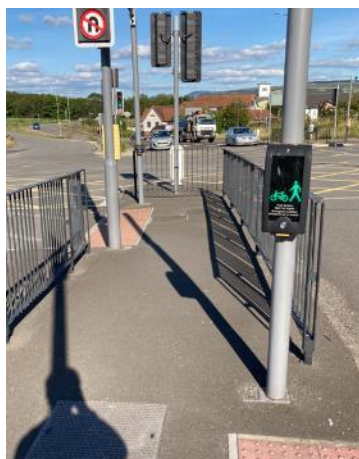
**Photo 2-3 - Narrow island at staggered toucan crossing at Ffordd Coed Darcy/B4290 junction**

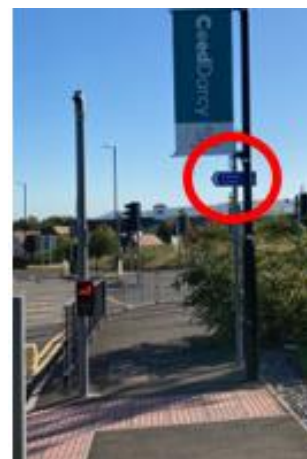
**Photo 2-4 - Shared facility pinch point and partially blocked signage due to street furniture**

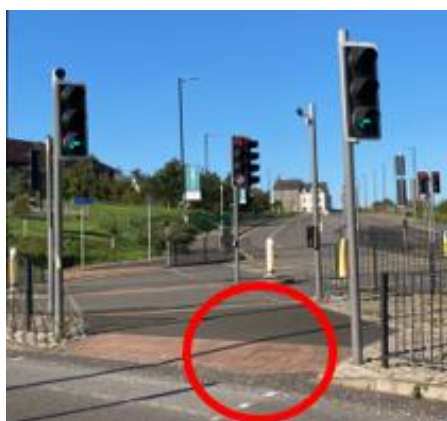
**Photo 2-5 - Evidence of minor ponding on south-eastern Toucan crossing across B4290 at the Ffordd Coed Darcy/B4290 junction**

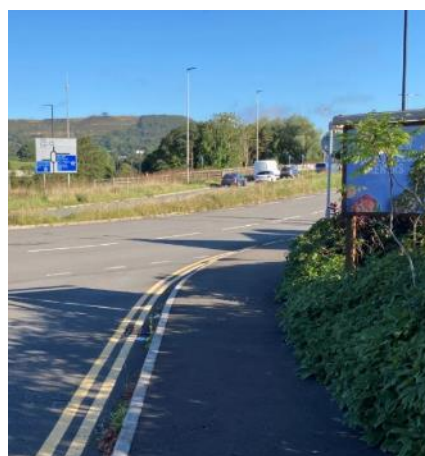
**Photo 2-6 - Poor visibility from the southern side of the Harvester access uncontrolled crossing**

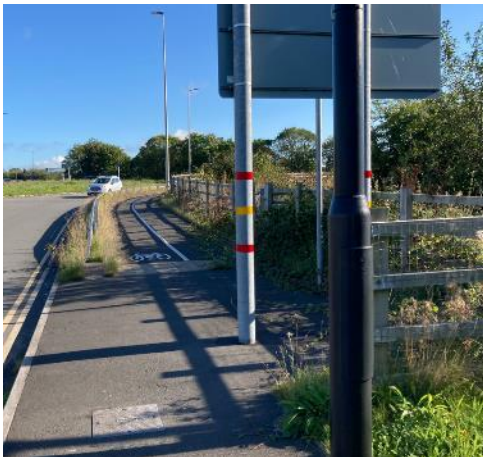
**Photo 2-7 - Shared/segregated connection hampered by alignment issues and street furniture**

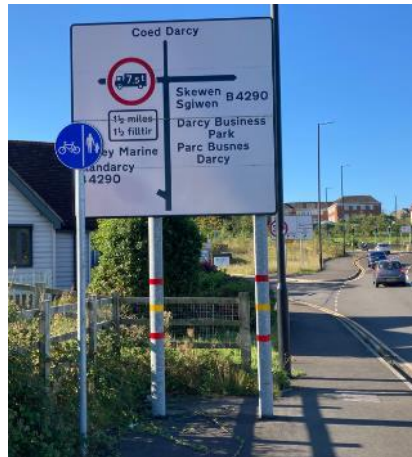
**Photo 2-8 - Incorrect signage indicating wrong footway type**

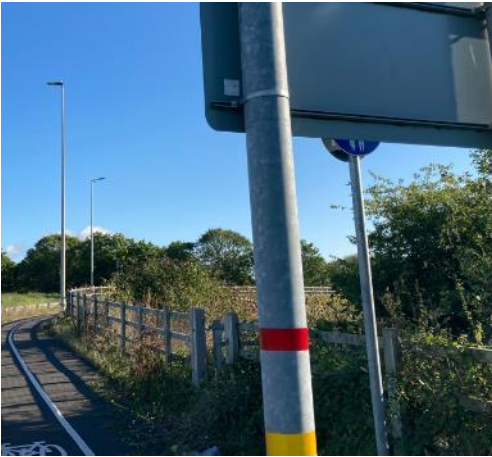
**Photo 2-9 - Existing advanced directional signage hides the footway status sign that also indicates incorrect status**

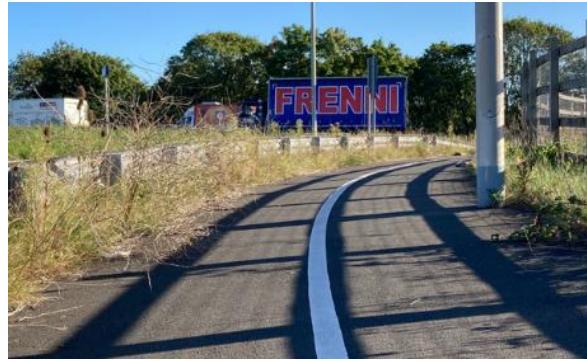
**Photo 2-10 - Narrow segregated footway/cycleway which is starting to be hampered by overgrowing vegetation**

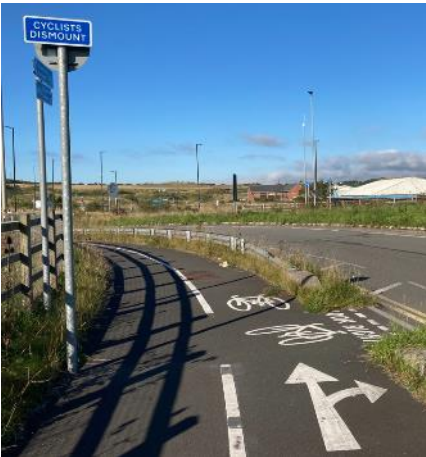
**Photo 2-11 - Crossing point across B4290 arm leading to Coed Darcy business park.**

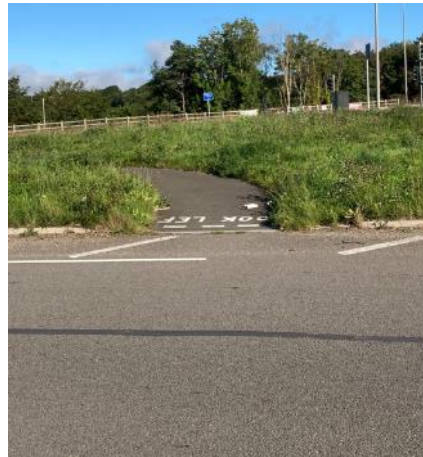
**Photo 2-12 - Uncontrolled crossing point across B4290 leading to Coed Darcy business park**

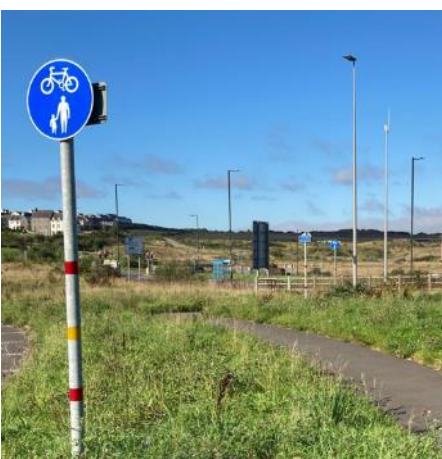
**Photo 2-13 - B4290 splitter island narrow shared provision**

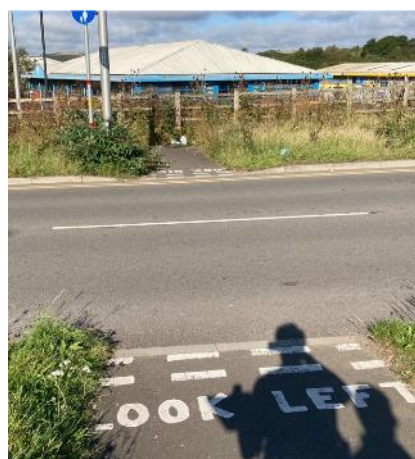
**Photo 2-14 - Northern crossing point of the B4290 leading to Coed Darcy business park - vegetation hampers usable width**

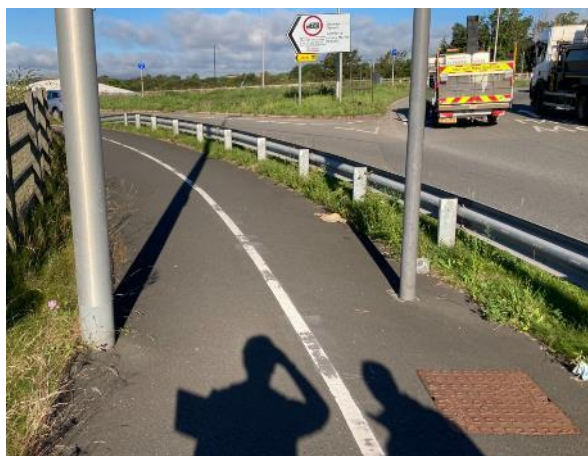
**Photo 2-15 - Pinch point on segregated path due to sign posts and unsuitable utility cover for cyclist tyres.**

There is an opportunity to replace any utility cover within the scheme extents to one that is more suitable for cyclists. Photo 2-15 shows an example of a utility cover that may cause a cyclist to lose grip if ice were to build up on it during colder periods. A utility cover that incorporates the same material as the surrounding surface should be installed on these occasions.

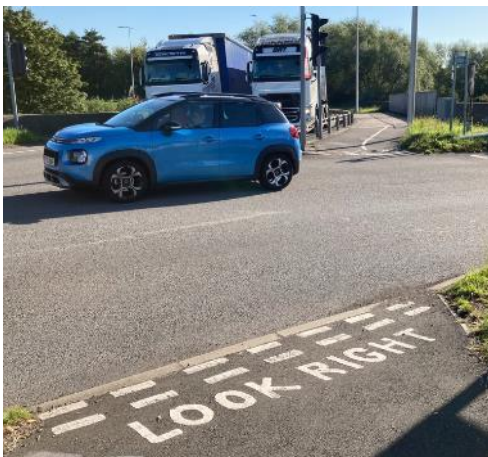
**Photo 2-16 - Uncontrolled crossing across M4 J43 westbound off-slip (looking north)**

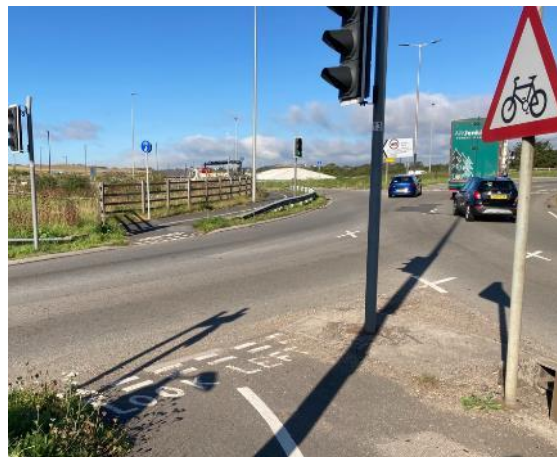
**Photo 2-17 - Uncontrolled crossing across M4 J43 westbound off-slip (looking south)**

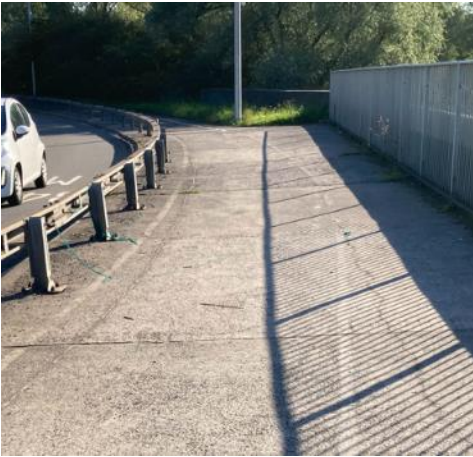
**Photo 2-18 - Faded segregation markings across the junction**

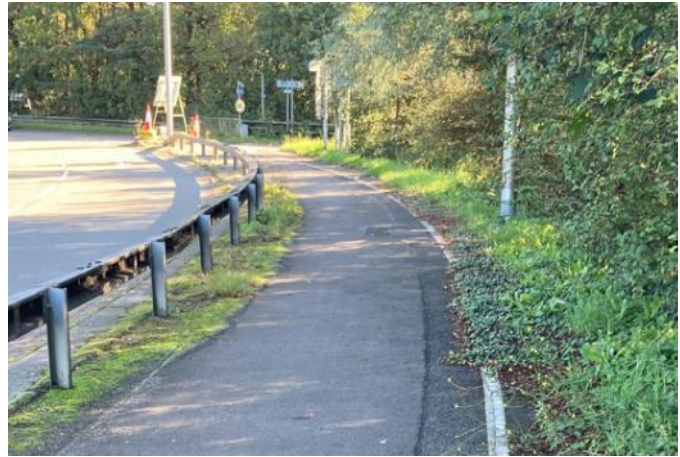
**Photo 2-19 - Verge creep completely blocks pedestrian side of segregated path**

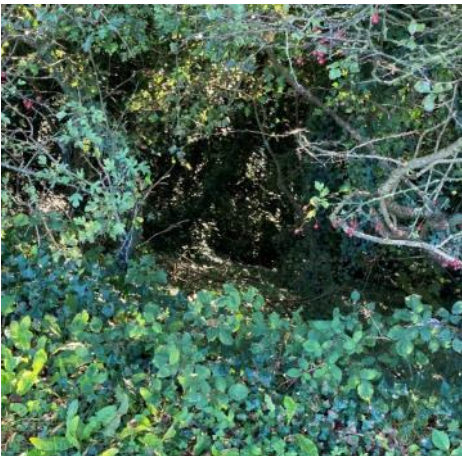
**Photo 2-20 - There is no barrier to protect segregated provision users from the steep bank at the rear of the provision**

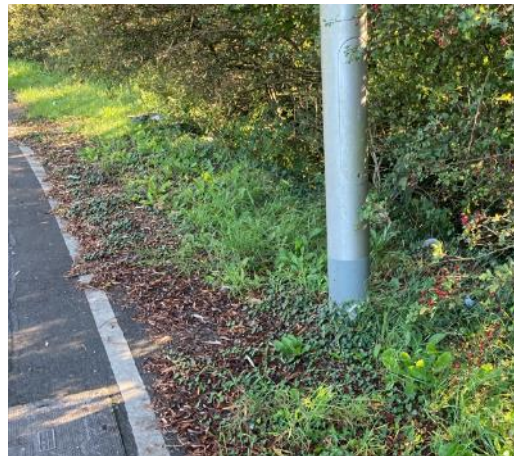
**Photo 2-21 - Verge creep blocks pedestrian side of segregated provision and a lighting column is also placed in the centre of it**

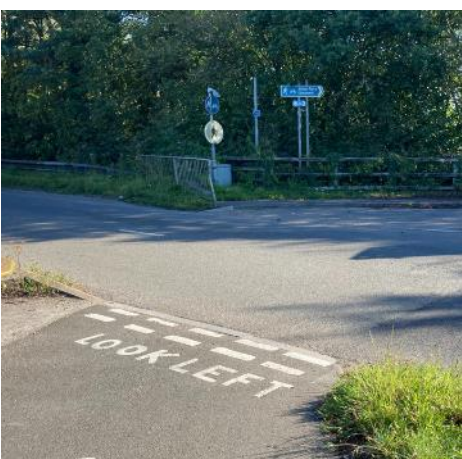
**Photo 2-22 - Uncontrolled crossing across M4 J43 eastbound on-slip (looking north)**

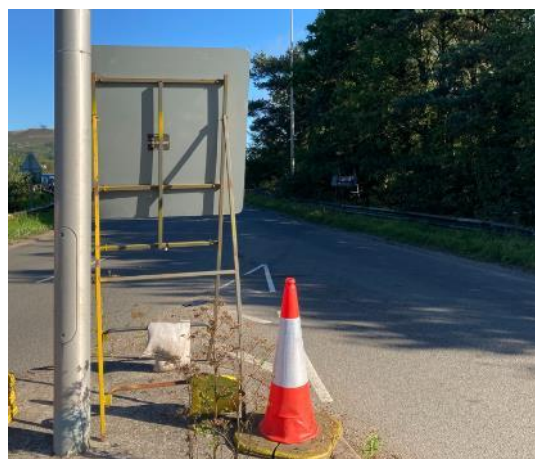
**Photo 2-23 - Temporary signage completely blocks visibility between motor vehicles and segregated path users (looking towards A465 from the southern side of the eastbound on-slip crossing)**

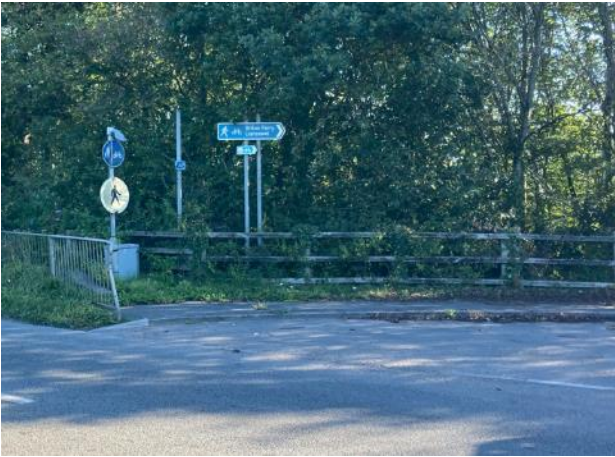
**Photo 2-24 - Signage on the northern side of the M4 Junction 43 eastbound on-slip includes a segregated provision sign facing the wrong direction**

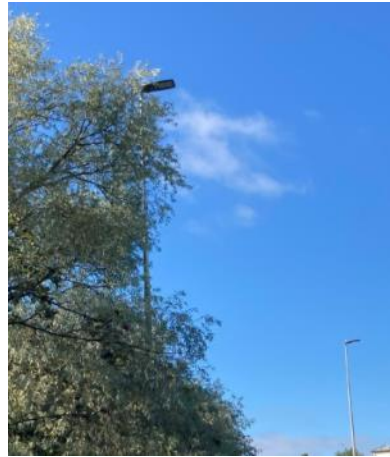
**Photo 2-25 - Vegetation blocking existing lighting column above segregated provision**

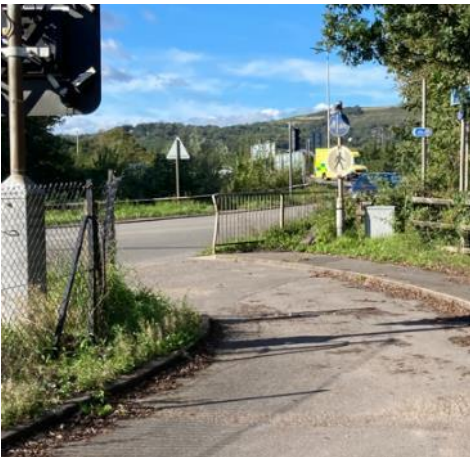
- The segregated link connecting the M4 junction to NCN 4 was unlit (Photo 2-26).
- No users were seen on the path whilst the assessment team were on-site.

**Photo 2-26 - Northern side of the M4 Junction 43 eastbound on-slip uncontrolled crossing where visibility is poor looking towards the A465 arm of the junction**

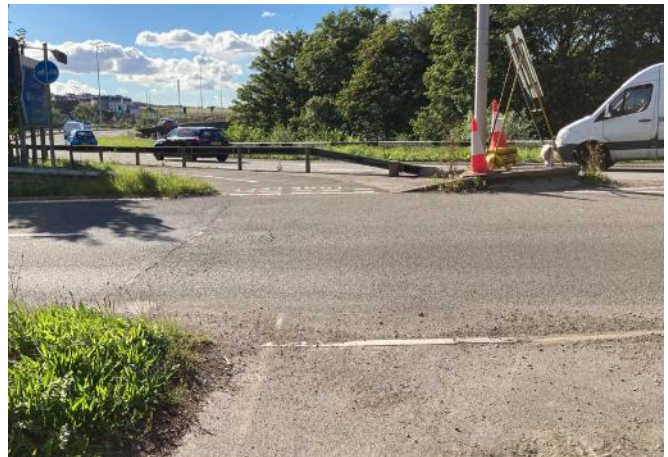
**Photo 2-27 - The crossing point across the eastbound on-slip is not aligned, lacks tactile paving and shows signs of minor ponding**

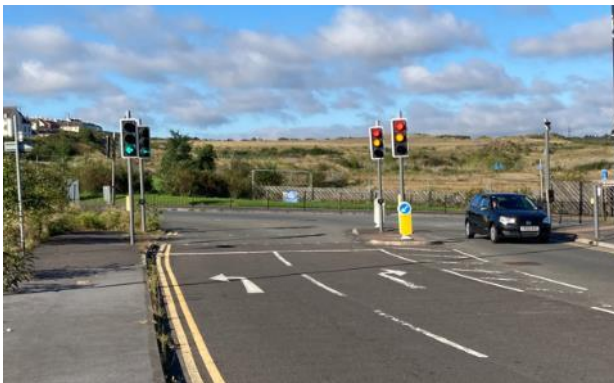
**Photo 2-28 - Pen-Y-Heol (B4920)/Coed Darcy Business Park junction**

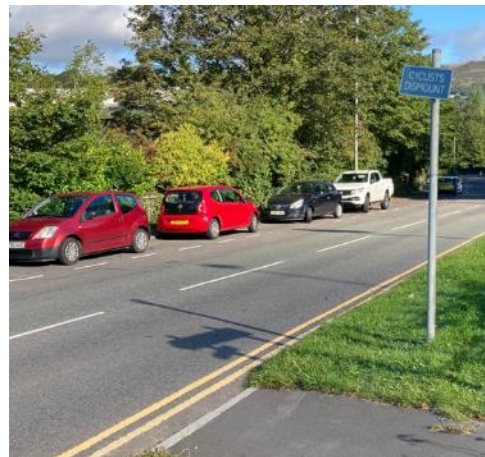
**Photo 2-29 - Cyclist dismount signage as shared provision ends**

Photos 2-29 & 2-30 show the existing uncontrolled crossing on Pen-Y-Heol (B4290). Currently, there is no tactile paving at this location. On the northern side of the crossing point, the assessment team found the existing visibility between motorists and pedestrians using the feature is poor when the parking bay is being used. This increases the chance of a collision between a vehicle and a pedestrian. The subsequent footway on this northern side leading towards the link that connects to Heol Crymlyn is also poor with usable width of less than 0.5m due to overgrown vegetation. The assessment team were forced onto the carriageway to carry on towards the Heol Crymlyn link due to a swarm of insects in one of the overgrown vegetation. There is an opportunity to address these issues by putting in a suitable crossing point which has good visibility splays between pedestrians and motorists, cutting back vegetation and widening the footway. The parking bay could also be relocated to accommodate a widened footway.

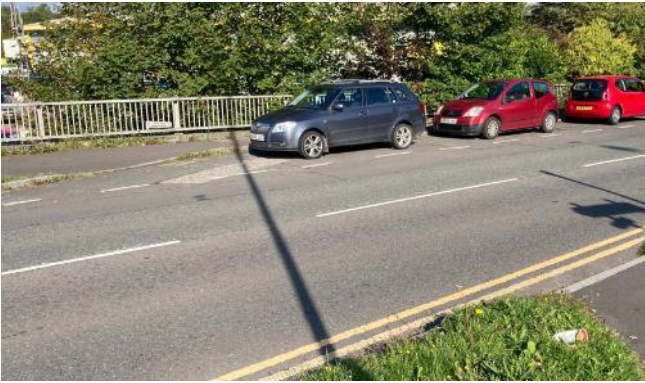
**Photo 2-30 - Uncontrolled crossing across Pen-Y-Heol (B4290) (lacks tactile paving and visibility is poor on opposite side due to parked vehicles)**

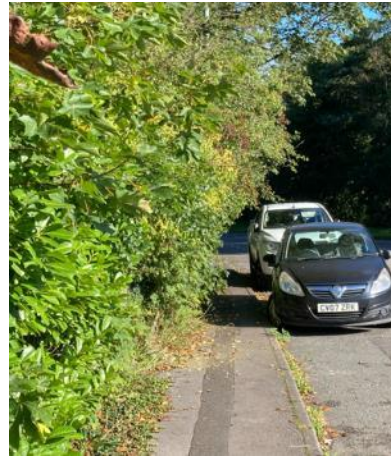
**Photo 2-31 - Narrow footway (approx. 0.5m) due to vegetation, which also housed a swarm of insects**

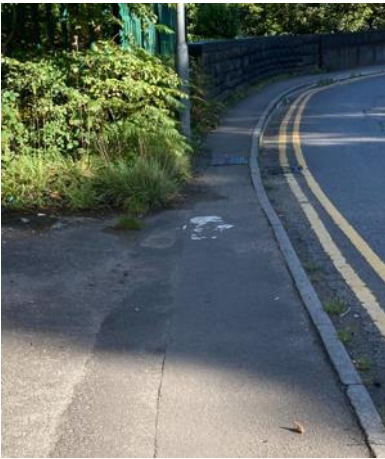
**Photo 2-32 - Narrow footway (approx. 0.3m) across railway line on Pen-Y-Heol**

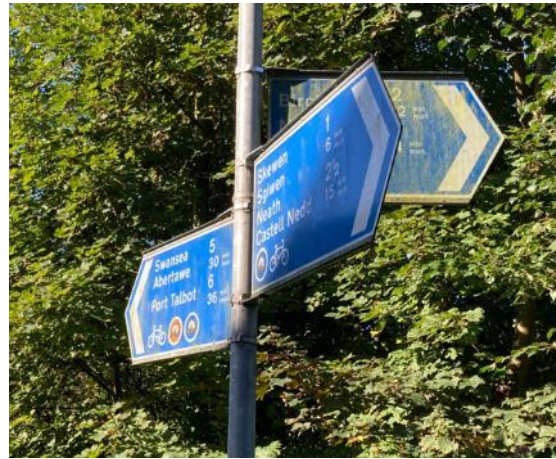
**Photo 2-33 - Worn signage prior to Heol Crymlyn link**

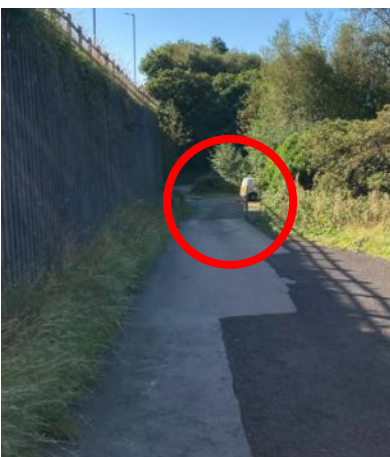
**Photo 2-34 - Start of Heol Crymlyn link (with access gate open)**

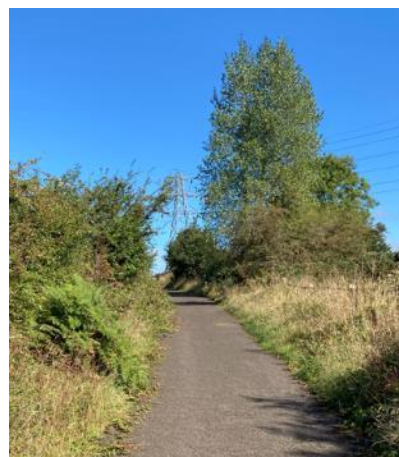
**Photo 2-35 - Steep section of shared provision (approx. 2.5m width)**

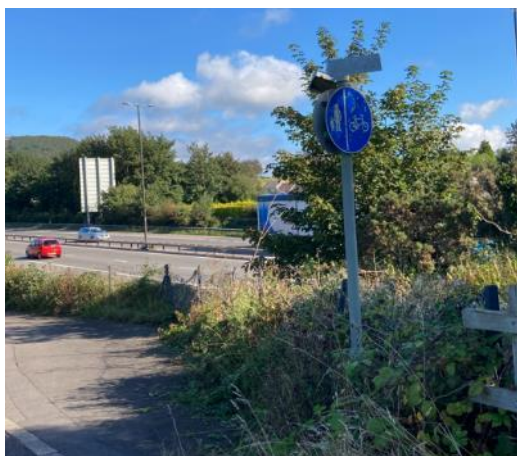
**Photo 2-36 - First indication of path status - segregated route signage half-way along link (shared signage is on the reverse)**

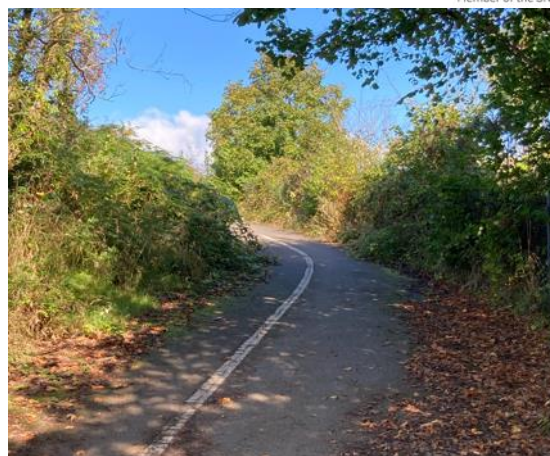
**Photo 2-37 - Windy and steep section of the segregated route. There is poor visibility on the bend due to overgrown vegetation**

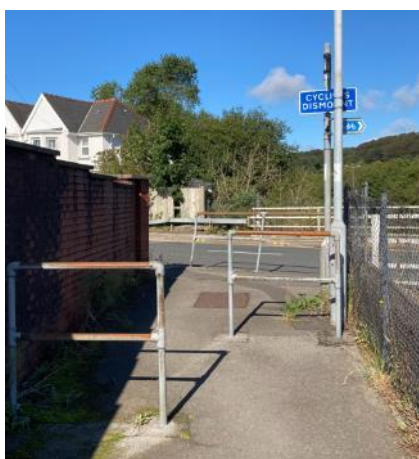
- There is a staggered barrier arrangement at the Heol Crymlyn end of the link and no onward provision for cyclists. (Photo 2-38).
- Two pedestrians were seen using the link.

**Photo 2-38 - Staggered barrier at the Heol Crymlyn end of the link (cyclist dismount/direction signage partially blocked by lamp column)**

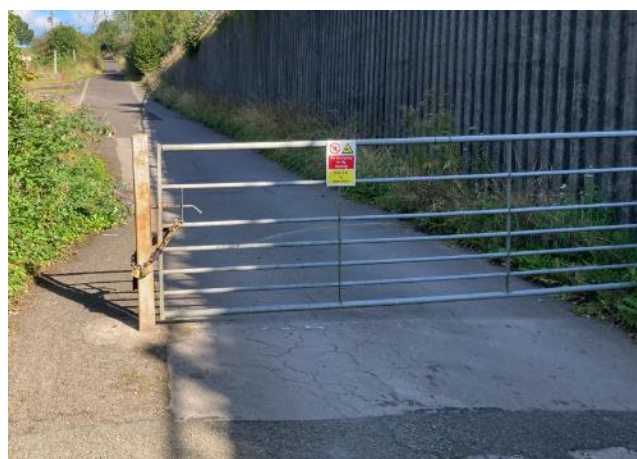
**Photo 2-39 - Access gate is closed at the Pen-Y-Heol (B4290) end of the link.**
