# Neath Castle Willow

Tree Condition Survey 22nd February

| Site Location: Neath Castle | Report Reference: 02.22/NTC/V2 |
| Client: Amanda Holmes Neath Town Council | Date of Report: 22 <sup>nd</sup> February 2022<br>Date of Site Visit(s): 14 <sup>th</sup> February 2022 |

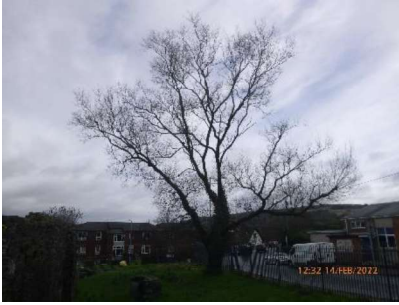
T1 from west

3.1 T1 is a mature crack willow growing in a well-maintained grassy area adjacent to the public highway.

3.2 T1 measures approximately 14m in height with a crown spread of approximately 7m with one large, overextended limb growing towards the road measuring approximately 9m. The stem diameter has been measured at 850mm.

3.3 The stem is covered with ivy; small areas of the ivy have been removed to check for any visible defects. Tapping the stem at these points with a sounding mallet did not reveal any signs of decay.

- Remove ivy from stem.
- Reduce large limb on south side by 4m to leave a lateral 5m in length.
- Reduce height of tree from 14m to 11m.
- Reduce laterals north side (castle) of crown by 3m to balance crown.
- Climber to inspect wound site for any signs of decay not visible from ground.
- Pruning cuts should be made to appropriate growth points and where possible retaining a lateral branch of at least 1/3 of the removed portion.
- All treeworks should be carried out in accordance with BS3998:2010 Recommendations for Treework.
- T1 is a large mature specimen and should be inspected on an annual basis for any signs of deterioration with particular care given to any signs of decay at the large stem wound caused by the branch failure.

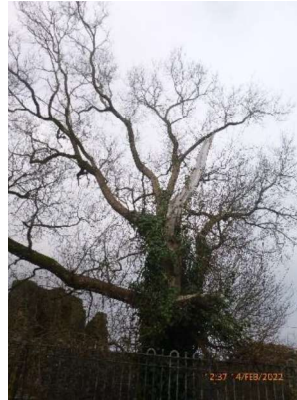
T1 from south

3.4 A large branch has split out at the stem break (2m above ground) on the south side facing Castle View. The branch failure has left a large, jagged stub and wound in the stem; no decay or fungal brackets were observed at the wound site at the time of this inspection. The remaining crown of the tree is in good condition with no signs of dieback or disease.

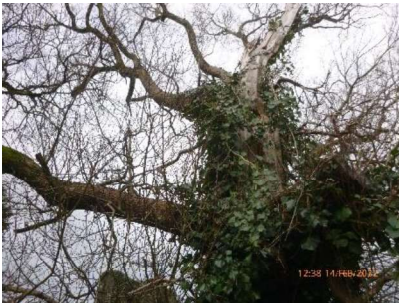
4.1 T1 is in good condition, and it is likely that the branch failure was caused by mechanical factors such as wind or, possibly, given the tree's proximity to the highway, being struck by a vehicle. The size of the failed branch is not known but if it is comparable with the adjacent branch on the south side of the tree, it is also likely that the branch failed under its own weight.

Stem wound from below

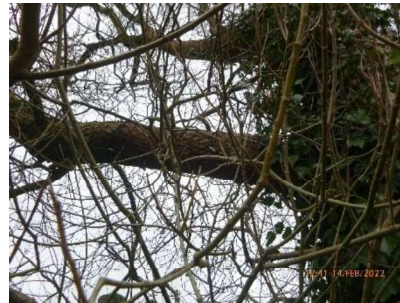
4.2 The adjacent large branch appears to be beginning to show signs of bark congestion near the union with the stem and this limb should be reduced to prevent the failure of this branch.

Union of large branch on south side

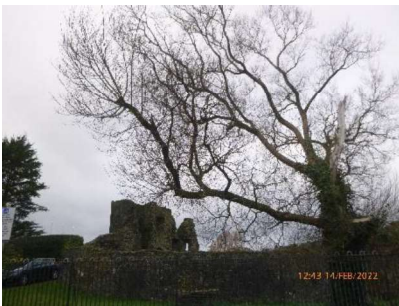
T1 from south – large branch  
to reduce on left of photo
