**BARN OUTBUILDING  
AT  
PLAS FARM  
CILYBEBYLL**

**PROPOSED  
CONVERSION  
TO  
SERVE  
HOLIDAY  
COTTAGES**

**STRUCTURAL SURVEY  
REPORT**

**JULY 2021**

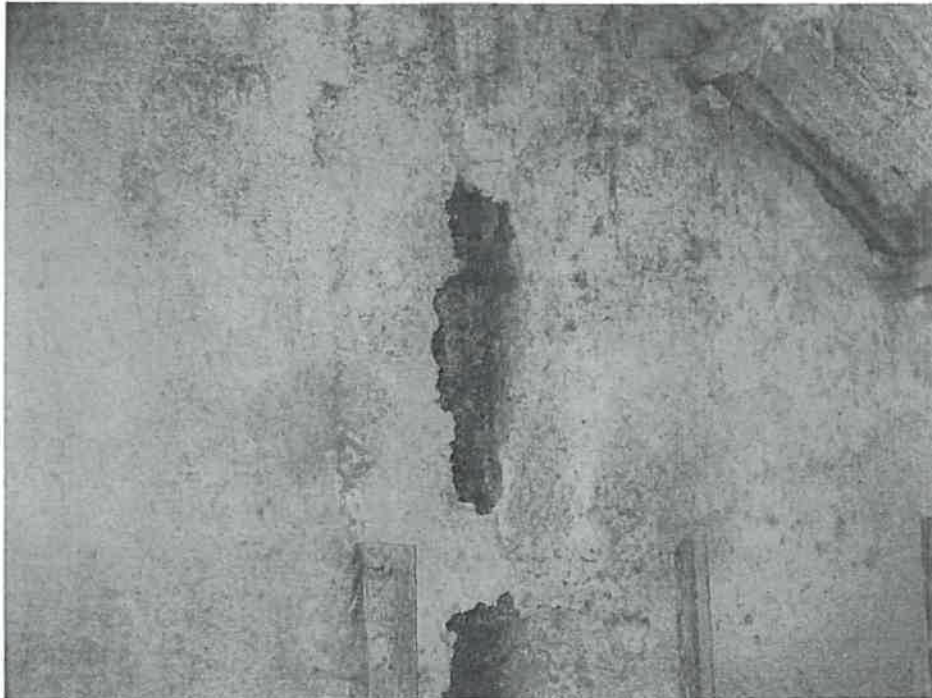
4] Sulphate damage around the chimney stacks is still present and needs attention,

Photograph number 13-Sulphate damage to the gable wall

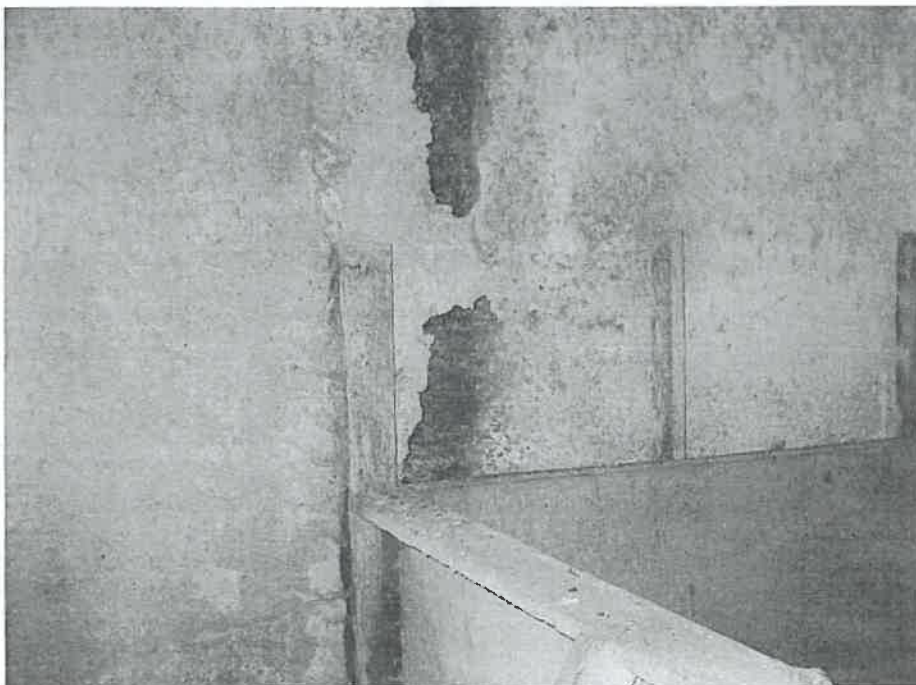
Photograph number 14-Sulphate damage to the gable wall

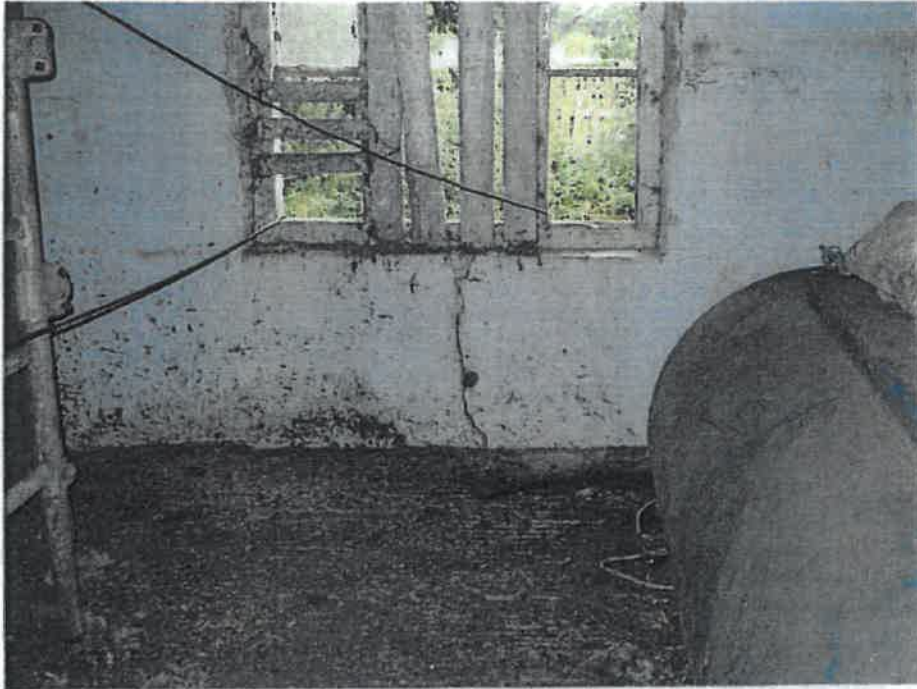
Whilst the cracking is limited in places there is a large vertical crack in one elevation that also needs local rebuild and recasting of a section of wall to tie all together

Photograph number 15-Vertical crack  
in wall

At other crack locations it is recommended that specialist stitching is introduced with stainless ties used to tie the original walls together and a compatible concrete mix used to seal the cracks .A detailed drawing /svy and specification should be drawn up for implementation

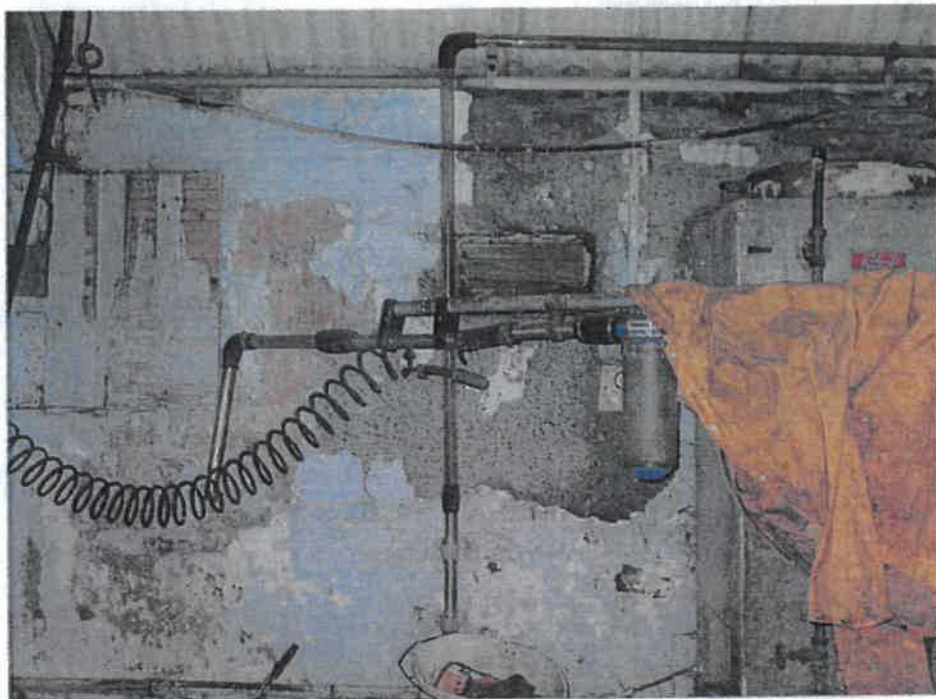
Photograph number 16-Poor condition  
of the internal render
