# **Stage 3 Road Safety Audit Report (Post Construction) (FINAL)**

**Aldi Store  
A474 Neath Abbey Road, Neath  
S278 Highway Works  
(Designers response )**

**Project Name:** Aldi Store, A474 Neath Abbey Road, Neath - S278 Highway Works.

**Report Title:** Stage 3 Road Safety Audit (FINAL).

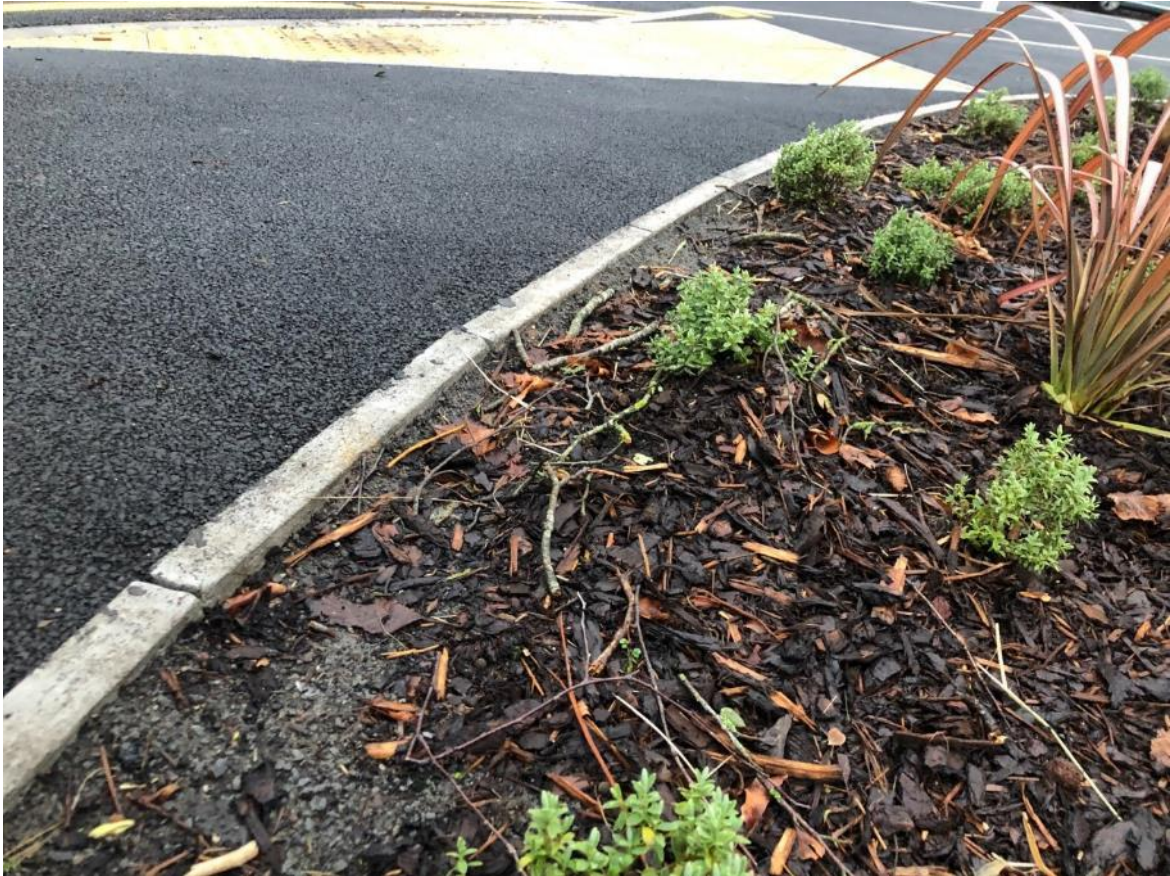
| 8.1 *Problem* (Item C1.4) | |
|---|---|
| <b>Location:</b> | Neath Abbey Road. Northeast corner into side road |
| <b>Summary:</b> | Trip hazard at rear of footway due to level difference on verge. |
| <p>There is a level difference to the rear of the footway and the verge that will result in a trip hazard for pedestrians should they deviate slightly from the route. Undertake remedial works to remove trip hazard from rear of new footway by infilling verge.</p> | |
| Pedestrians tripping over edge of footway. | |

| 8.1 *Problem* (Item C1.4) | |
|---|---|
| Undertake remedial works to rear of footway to remove trip hazard by infilling verge. | |

| <p style="text-align: center;">Stage 3 Road Safety Audit (FINAL)</p> <p style="text-align: center;">DESIGNER'S ROAD SAFETY AUDIT RESPONSE</p> <p><b>Scheme Name: Aldi Store, Neath Abbey Road, Neath - S278 Highway Works.</b></p> | | |
|---|---|---|
| 8.1 | Trip hazard at rear of footway due to level difference on verge. | Agree – Landscape contractor to place additional verge material to eliminate level difference at back of footway. |

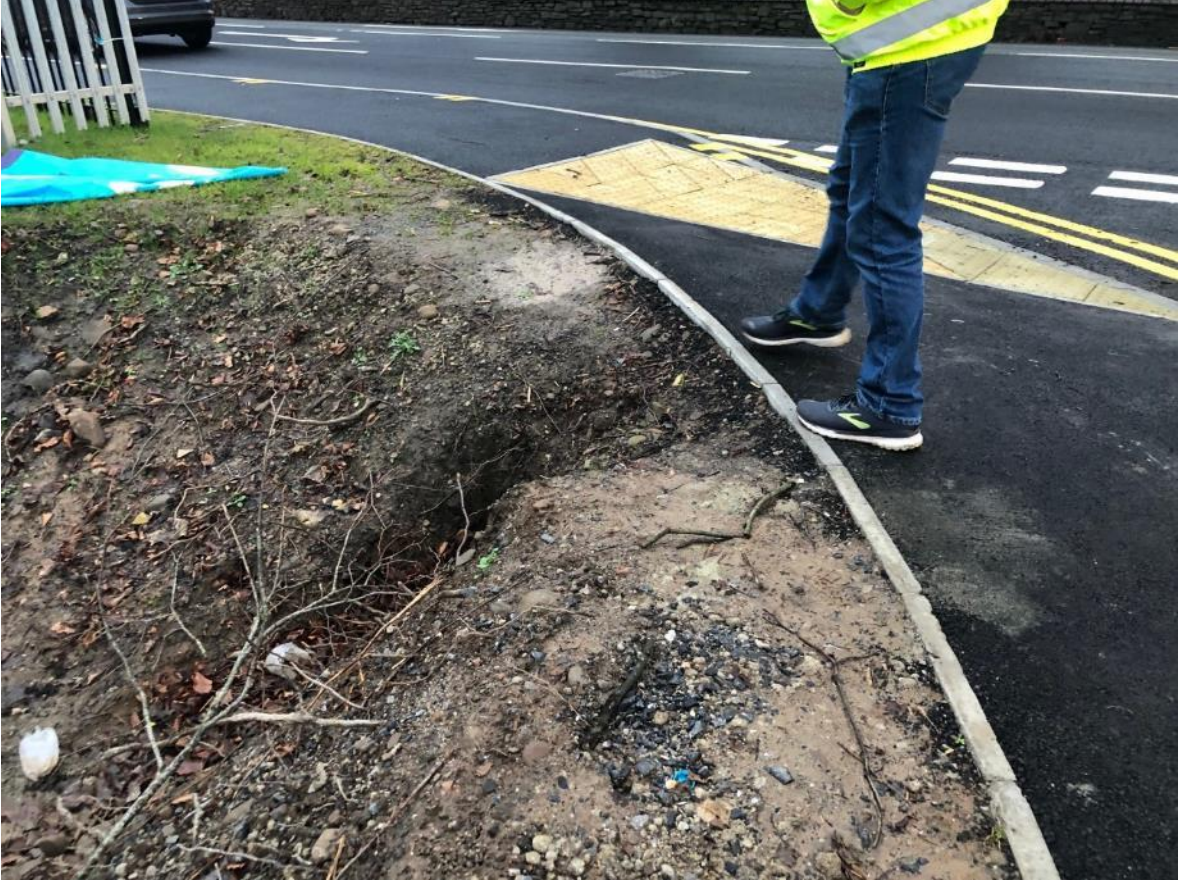
| 8.2 *Problem* (Item C1.4) | |

| 8.2 *Problem* (Item C1.4) | |
|---|---|
| <b>Location:</b> | Neath Abbey Road. Southwest corner into side road |
| <b>Summary:</b> | Deep hole directly adjacent to new footway |
| <p>There is a deep hole adjacent to the new footway. This will cause a problem for any pedestrian that may wander from the rear of the new footway. Infill hole/verge adjacent to new footway</p> | |
| Pedestrians falling down hole /verge adjacent to footway. | |

| 8.2 *Problem* (Item C1.4) | |
|---|---|
| Infill hole /verge adjacent to new footway. | |

| <p style="text-align: center;">Stage 3 Road Safety Audit (FINAL)</p> <p style="text-align: center;">DESIGNER'S ROAD SAFETY AUDIT RESPONSE</p> <p><b>Scheme Name: Aldi Store, Neath Abbey Road, Neath - S278 Highway Works.</b></p> | | |
|---|---|---|
| 8.2 | Deep hole directly adjacent to new footway | Agree – Landscape contractor to fill large hole in between footway and infiltration basin. |

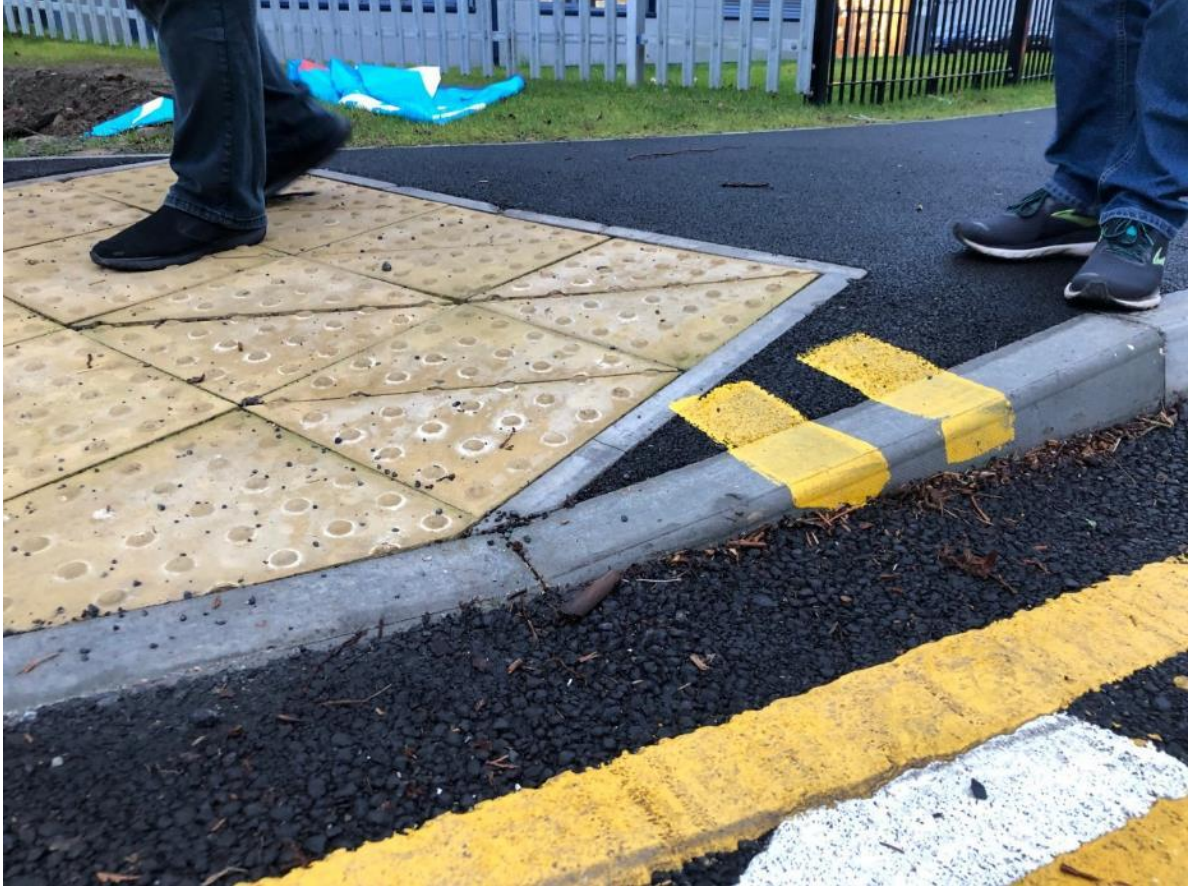
| 8.3 *Problem* (Item C4.2) | |
|---|---|
| <b>Location:</b> | Neath Abbey Road / new access road junction, southwest side. |
| <b>Summary:</b> | Excessive gradient on tactile paving at pedestrian crossing point. |
| <p>The gradient of the tactile paving and footway at the pedestrian crossing point appears to be greater than the 1/12 that is acceptable. This will result in problems for Non-Motorised Users (NMUs) travelling along the footway, particularly manual wheelchair users.</p> | |
| Pedestrians losing their balance / stability issues for wheelchair users. | |

| 8.3 *Problem* (Item C4.2) | |
|---|---|
| Regrade footway and reinstall the tactile paving to remove excessive gradient. | |

| <p style="text-align: center;">Stage 3 Road Safety Audit (FINAL)</p> <p style="text-align: center;">DESIGNER'S ROAD SAFETY AUDIT RESPONSE</p> <p><b>Scheme Name: Aldi Store, Neath Abbey Road, Neath - S278 Highway Works.</b></p> | | |
|---|---|---|
| 8.3 | Excessive gradient on tactile paving at pedestrian crossing point. | Agree – Contractor to install double length dropper kerbs (thus reducing gradient) as per approved design and detail. |

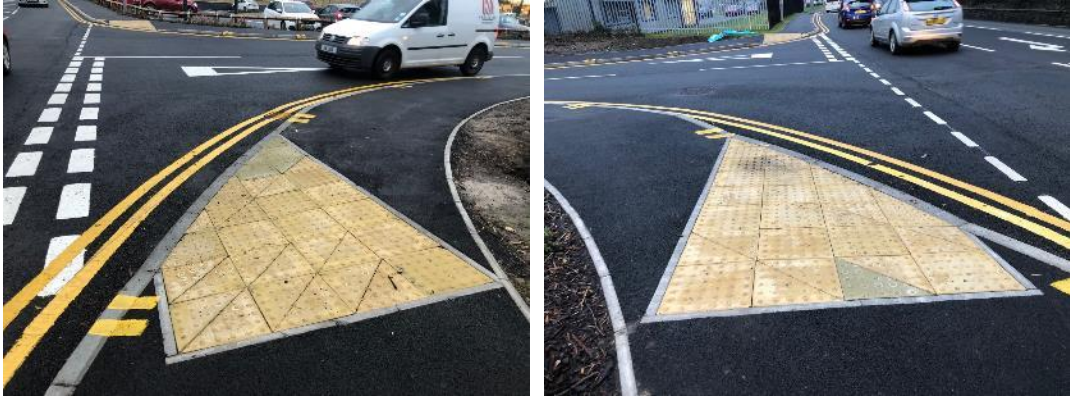
| 8.4 *Problem* (Item C4.2) | |
|---|---|
| <b>Location:</b> | Neath Abbey Road across side road |
| <b>Summary:</b> | Insufficient depth of tactile paving installed at ahead / in line pedestrian crossing points (Not as detailed ). |
| <p>There are ahead / in-line pedestrian crossing points installed with an inadequate depth of tactile paving (Not as detailed). Current guidance recommends a minimum depth of three full rows of tactile paving (1200mm) at ahead / in-line crossings to ensure that the crossing point is detected by visually impaired pedestrians walking at speed.</p> | |
| Vehicle / pedestrian collision due to visually impaired pedestrians not detecting tactile paving and walking out into the carriageway without due care. | |

| 8.4 *Problem* (Item C4.2) | |
|---|---|
| Increase depth of tactile paving to a minimum of three full rows at crossing points as detailed. | |

| <p style="text-align: center;">Stage 3 Road Safety Audit (FINAL)</p> <p style="text-align: center;">DESIGNER'S ROAD SAFETY AUDIT RESPONSE</p> <p><b>Scheme Name: Aldi Store, Neath Abbey Road, Neath - S278 Highway Works.</b></p> | | |
|---|---|---|
| 8.4 | Insufficient depth of tactile paving installed at ahead / in line pedestrian crossing points (Not as detailed ). | Agree – Contractor to install additional row of blister tactile paving as per approved design and detail. |

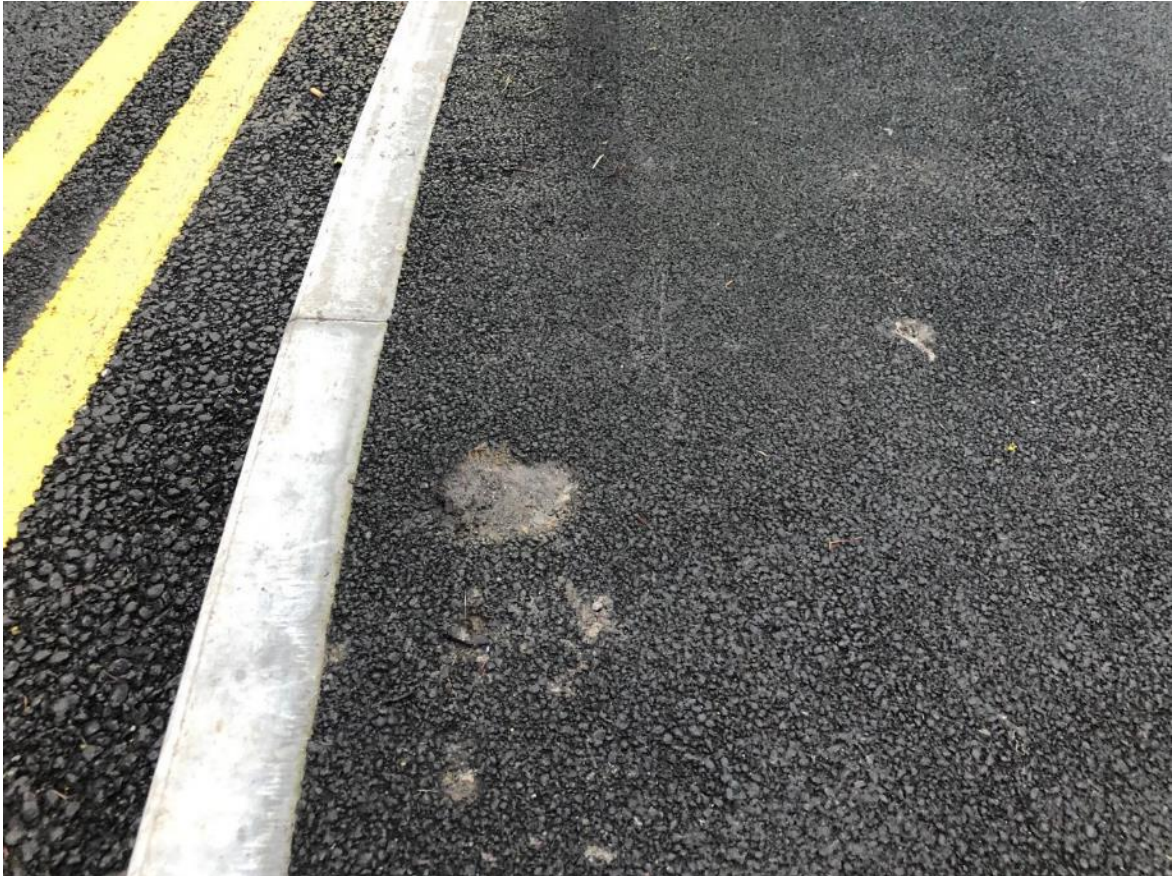
| 8.5 *Problem* (Item C4.2) | |
|---|---|
| <b>Location:</b> | Neath Abbey Road. Footway along store frontage |
| <b>Summary:</b> | Trip hazard on uneven footway surfacing |
| <p>New footway surfacing has been installed. There is a trip hazard on the new surfacing that will result in pedestrians tripping over and falling into the adjacent carriageway. Carry out remedial works to remove trip hazard on footway surfacing.</p> | |
| Pedestrians tripping over uneven footway surfacing. | |

| 8.5 *Problem* (Item C4.2) | |
|---|---|
| Undertake remedial works to remove trip hazard on footway. | |

| <p style="text-align: center;">Stage 3 Road Safety Audit (FINAL)</p> <p style="text-align: center;">DESIGNER'S ROAD SAFETY AUDIT RESPONSE</p> <p><b>Scheme Name: Aldi Store, Neath Abbey Road, Neath - S278 Highway Works.</b></p> | | |
|---|---|---|
| 8.5 | Trip hazard on uneven footway surfacing | Agree – Contractor to removed excess material creating trip hazard. |

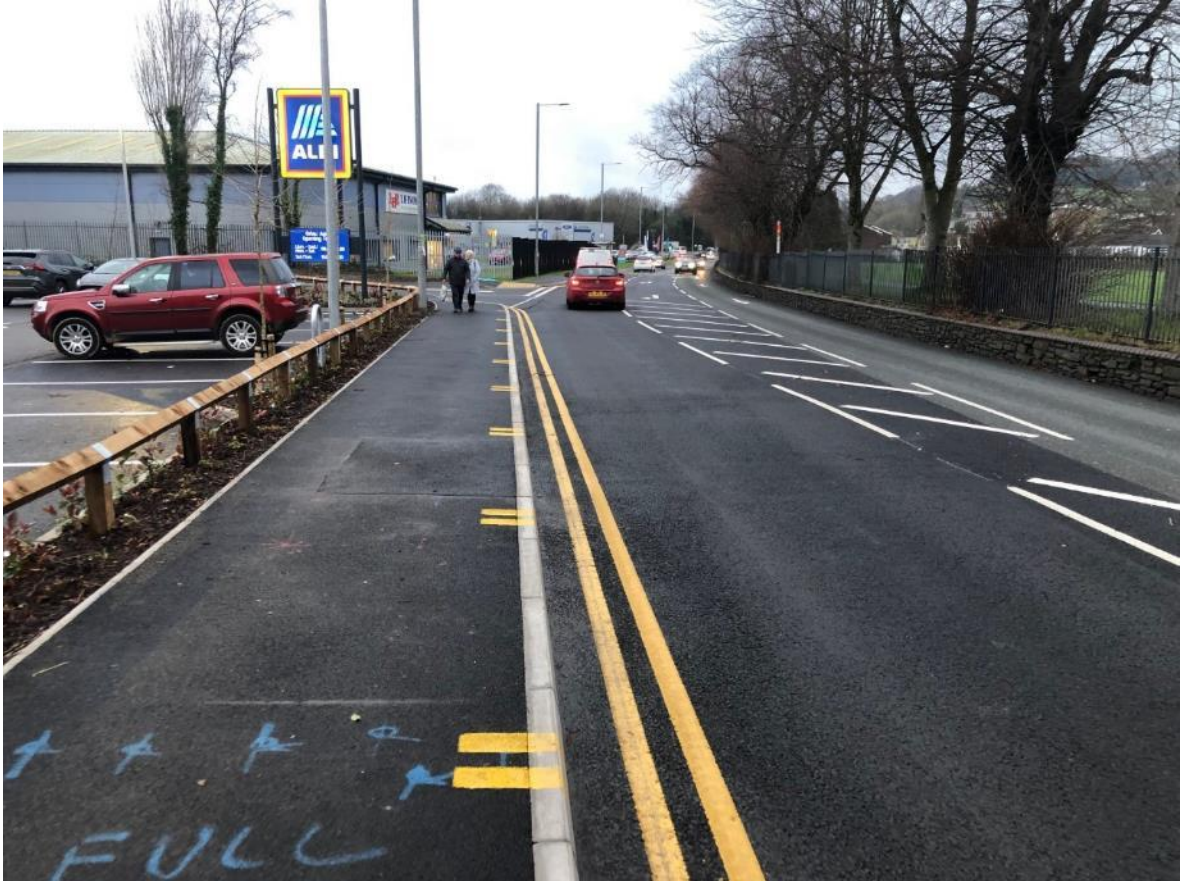
| 8.6 *Problem* (Item C5.1) | |
|---|---|
| <b>Location:</b> | Neath Abbey Road & side road |
| <b>Summary:</b> | No loading restriction time plates not installed to back up markings as legally required |
| <p>A new No loading restriction has been installed around the junction. There are no time plates installed to back up the no loading restriction as legally required to ensure the restriction is legal and can be enforced. Install missing time plates.</p> | |
| Illegal unenforceable loading restriction. | |

| 8.6 *Problem* (Item C5.1) | |
|---|---|
| Install missing time plates where required. | |

| <p style="text-align: center;">Stage 3 Road Safety Audit (FINAL)</p> <p style="text-align: center;">DESIGNER'S ROAD SAFETY AUDIT RESPONSE</p> <p><b>Scheme Name: Aldi Store, Neath Abbey Road, Neath - S278 Highway Works.</b></p> | | |
|---|---|---|
| 8.6 | No loading restriction time plates not installed to back up markings as legally required | Disagree – Signage for the 'no loading at any time' restriction was not proposed, as permitted by Section 13.4.12 of Traffic Signs Manual Chapter 3. |

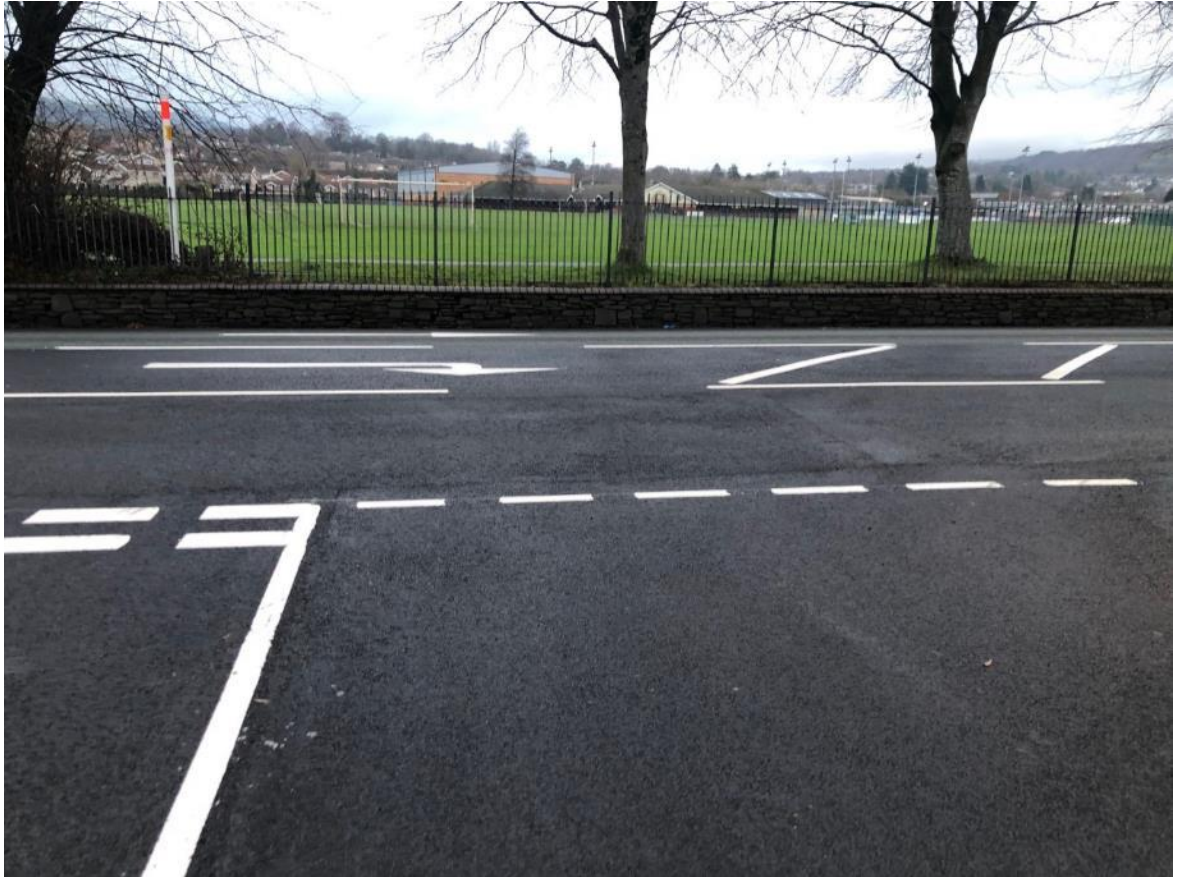
- 9.1 Central hatching cross bar extends too close into junction resulting in right turning vehicles into side road undercutting turn and conflicting with vehicles exiting side road. The carriageway surfacing is being resurfaced after being rejected by the Local Authority this change can be implemented at the same time.
