**TREE RISK SURVEY AT LAND  
NEAR CWM NANT-LLWYDD  
ROAD JULY 2022**

A survey of the condition of trees at land near Cwm Nant-Llwyd Rd was carried out in July 2022. Only trees that were found with an associated hazard were identified within this report.

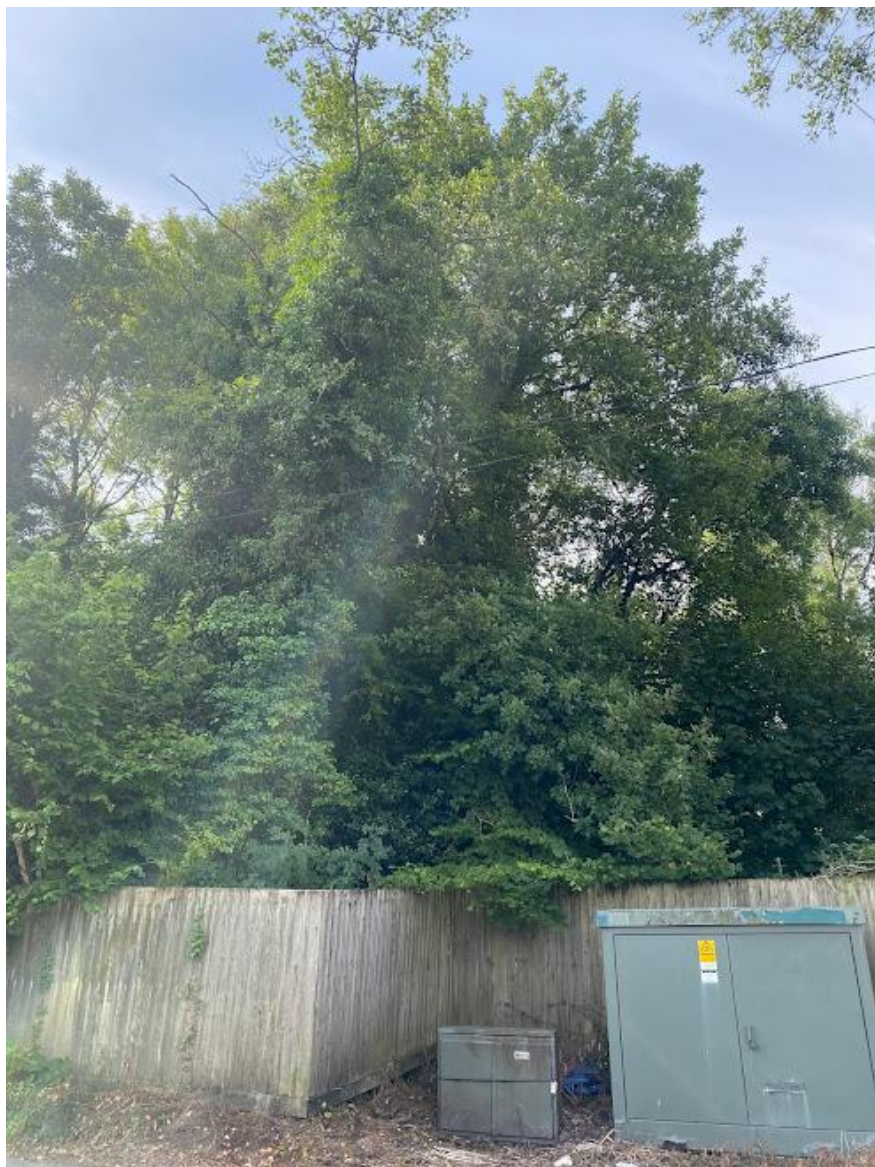
| Tree<br>ref<br>Tree<br>Tag | Species | Location | H | Stem<br>Diam | Age | Observations | OA | SOD | POF | Management<br>recommendations | Priority |
|---|---|---|---|---|---|---|---|---|---|---|---|
| T1 | Alder<br><i>Alnus glutinosa</i> | In the NE corner of the site by Cwm Nant-Llwydd road. | 15 | 350* | EM | Heavily Ivy clad tree, wire fence wrapped around and possibly affecting vascular system, poor vigour and poor condtion overall. | H | S | L | Remove tree to ground level or 2.5m monolith. | Low |

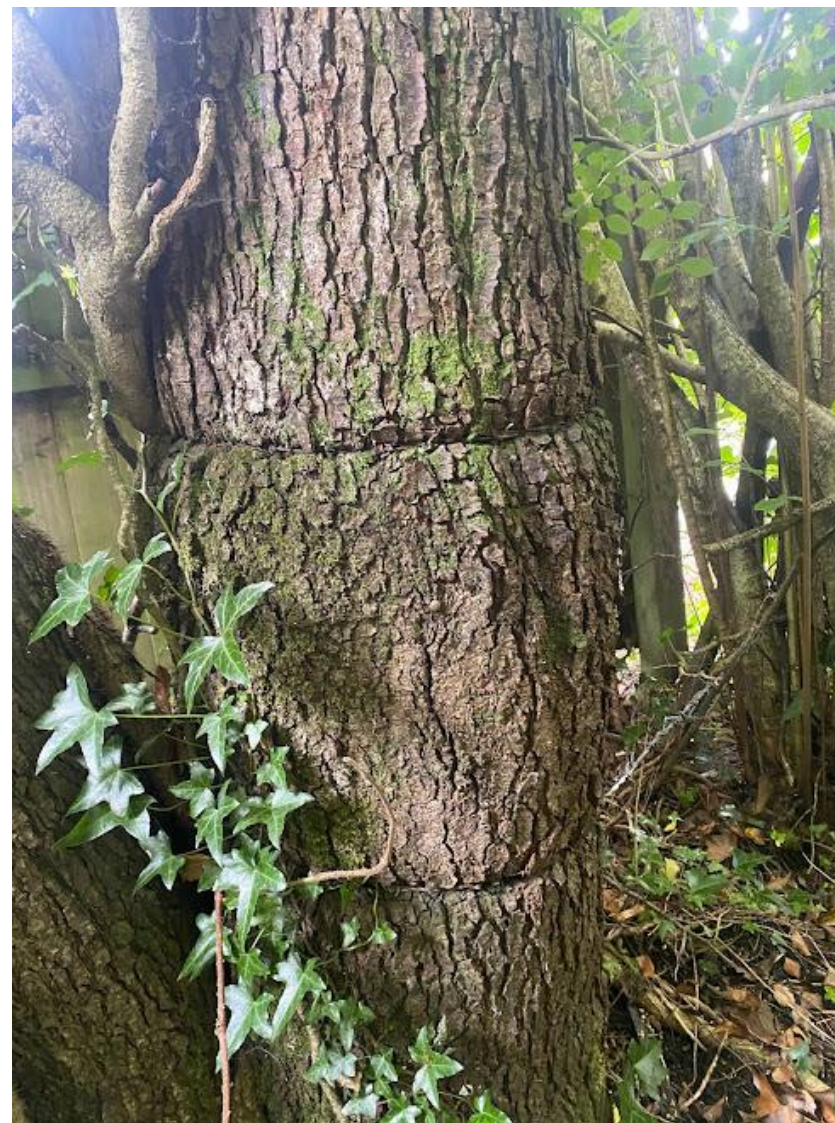
Wire fence around stem of T1

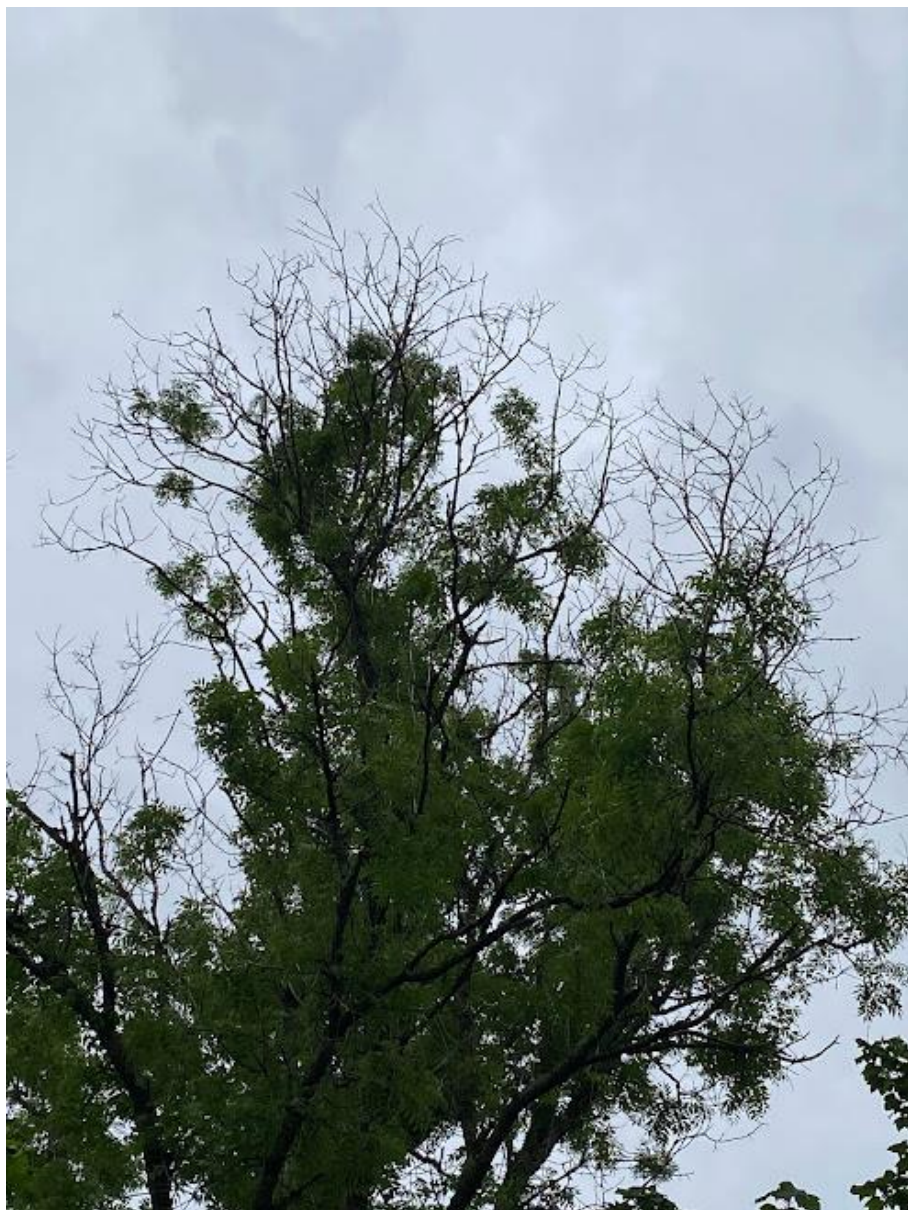
T 2

| Tree<br>ref<br>Tree<br>Tag | Species | Location | H | Stem<br>Diam | Age | Observations | OA | SOD | POF | Management<br>recommendations | Priority |
|---|---|---|---|---|---|---|---|---|---|---|---|
| T2 | Ash<br><i>Fraxinus excelsior</i> | Large ash tree in middle of woodland. | 17 | 350* | EE | 20% crown dieback, lean to west | M | M | M | Remove tree to ground level or 2.5m monolith. | Medium |

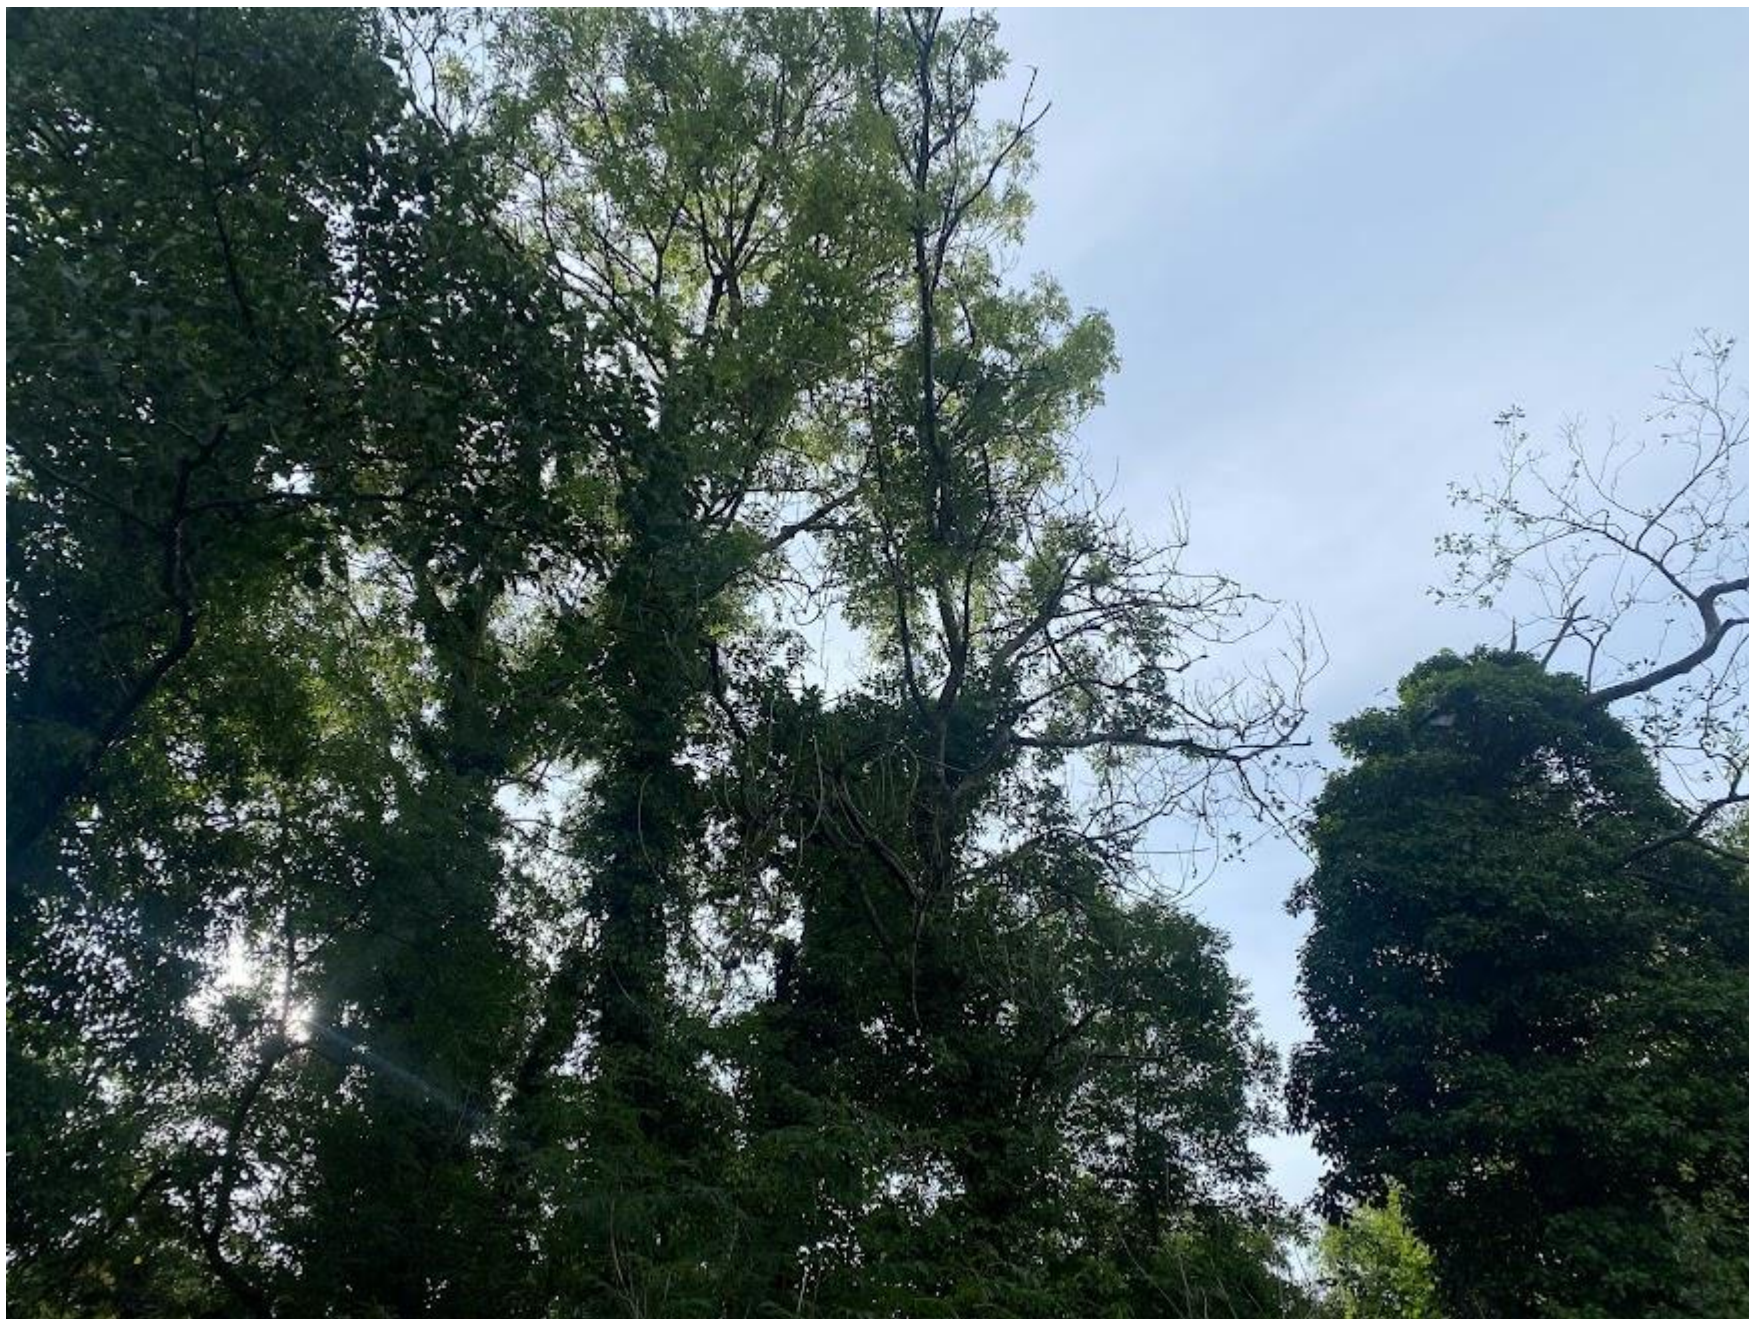
T 3 & T4

| Tree<br>ref<br>Tree<br>Tag | Species | Location | H | Stem<br>Diam | Age | Observations | OA | SOD | POF | Management<br>recommendations | Priority |
|---|---|---|---|---|---|---|---|---|---|---|---|
| T3 | Ash<br><i>Fraxinus excelsior</i> | SW corner of woodland next to track. | 15 | 280* | EM | 25% crown dieback lean to west, medium diameter deadwood present. | H | S | M | Remove to ground level. | Medium |
| T4 | Ash<br><i>Fraxinus excelsior</i> | SW corner of woodland next to track. | 15 | 280* | EM | 25% crown dieback lean to west, medium diameter deadwood present. | M | S | M | Remove to ground level. | Medium |
