# PLAZA CINEMA RE-DEVELOPMENT, PORT TALBOT

## REMEDIATION VALIDATION ASSESSMENT REPORT

**Report No. Q0045/VR**

**August 2022**

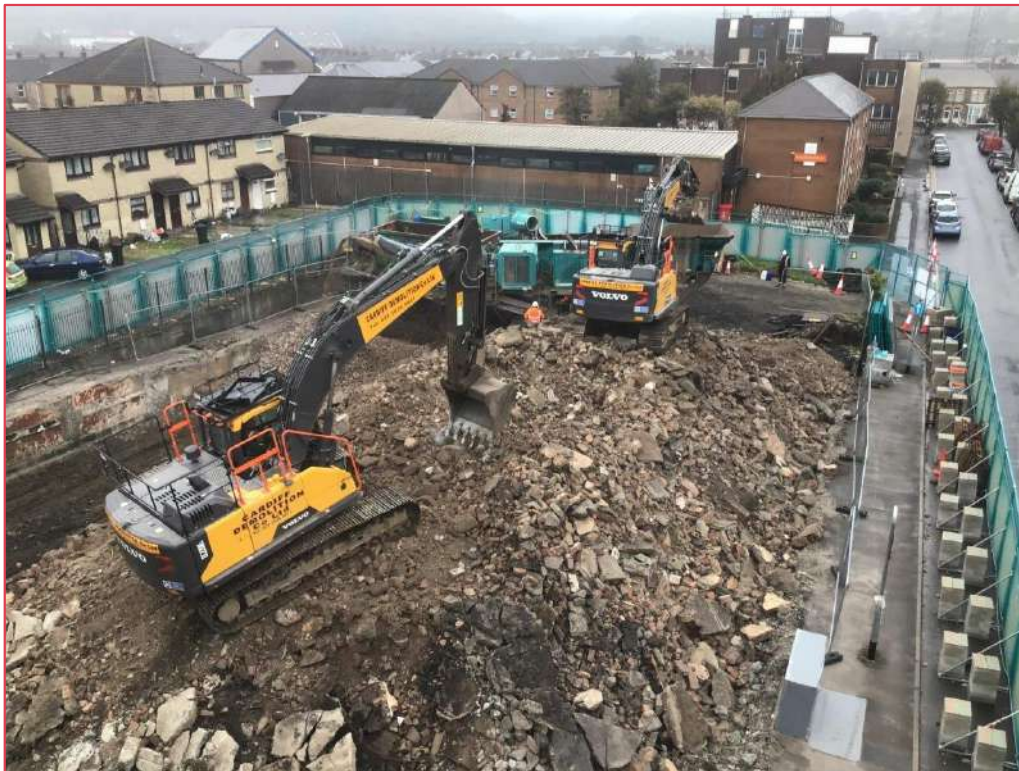
**Photo 1:** Demolition of northern end of existing Plaza building

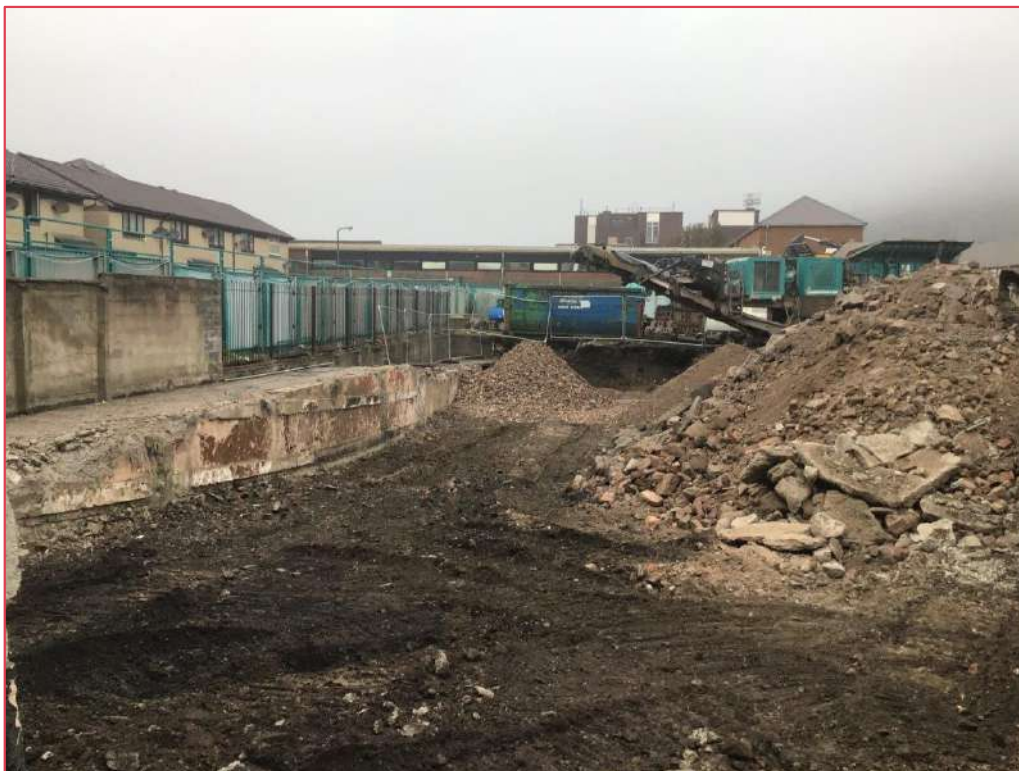
**Photo 2:** Reduced dig of existing soils & demolition stockpile for screening, crushing and offsite disposal

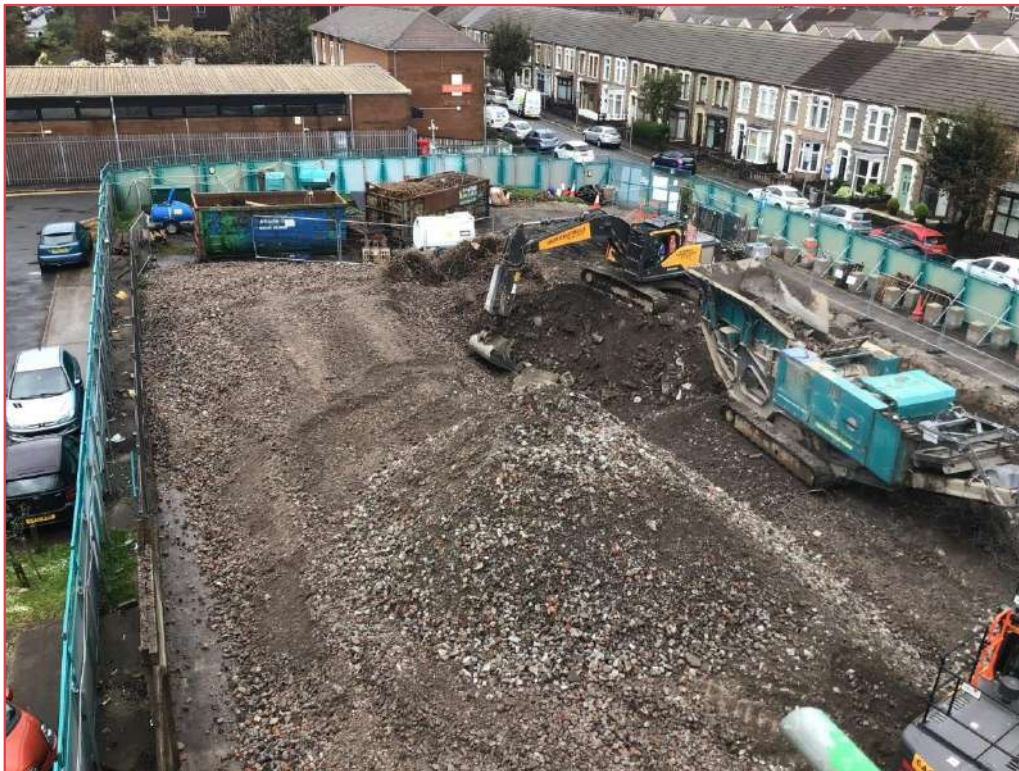
**Photo 3:** Reduced dig ongoing and removal offsite

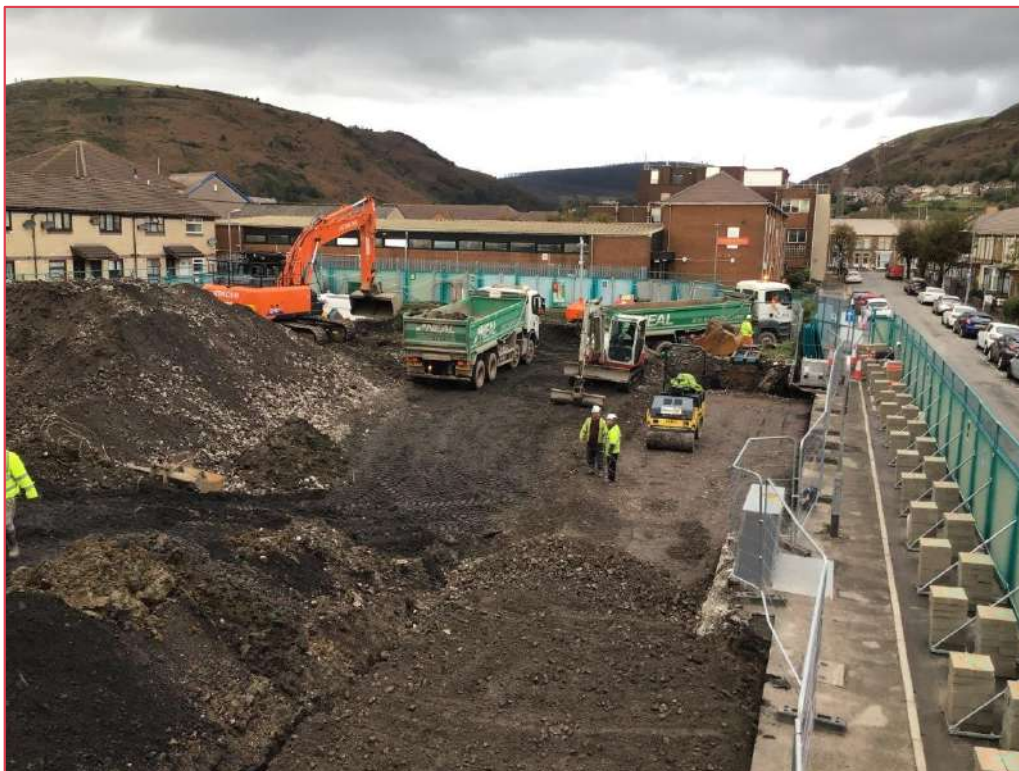
**Photo 4:** Reduced dig ongoing, offsite disposal (Neals) and laying of imported stone

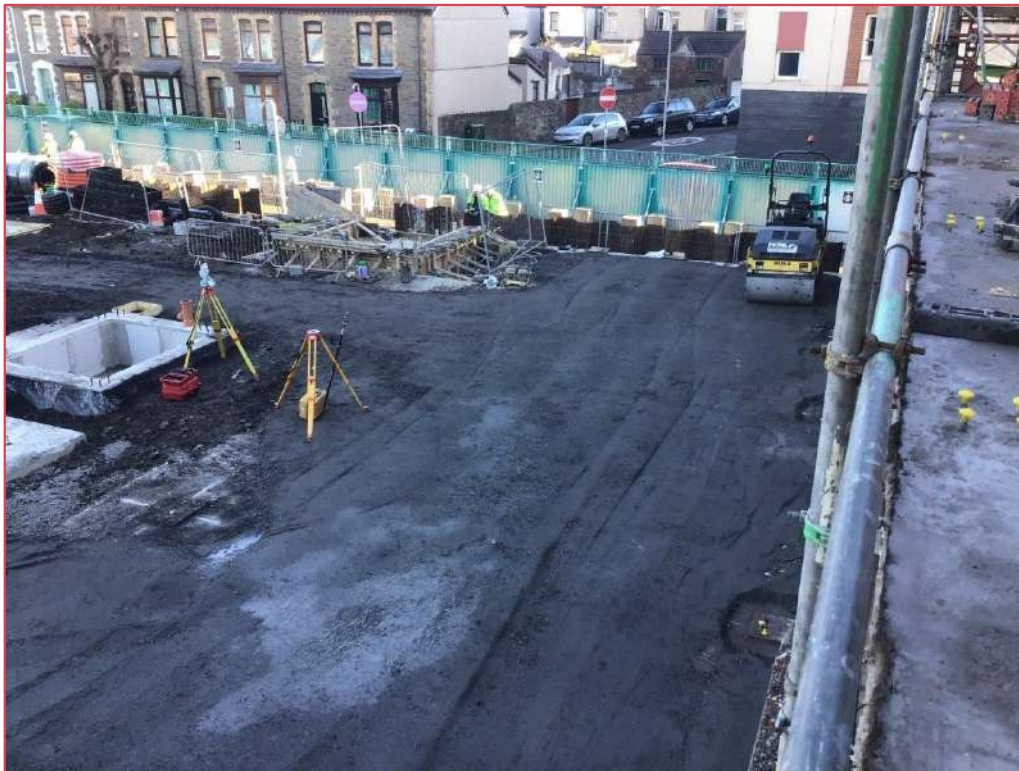
**Photo 5:** Levels being brought up using imported engineered stone

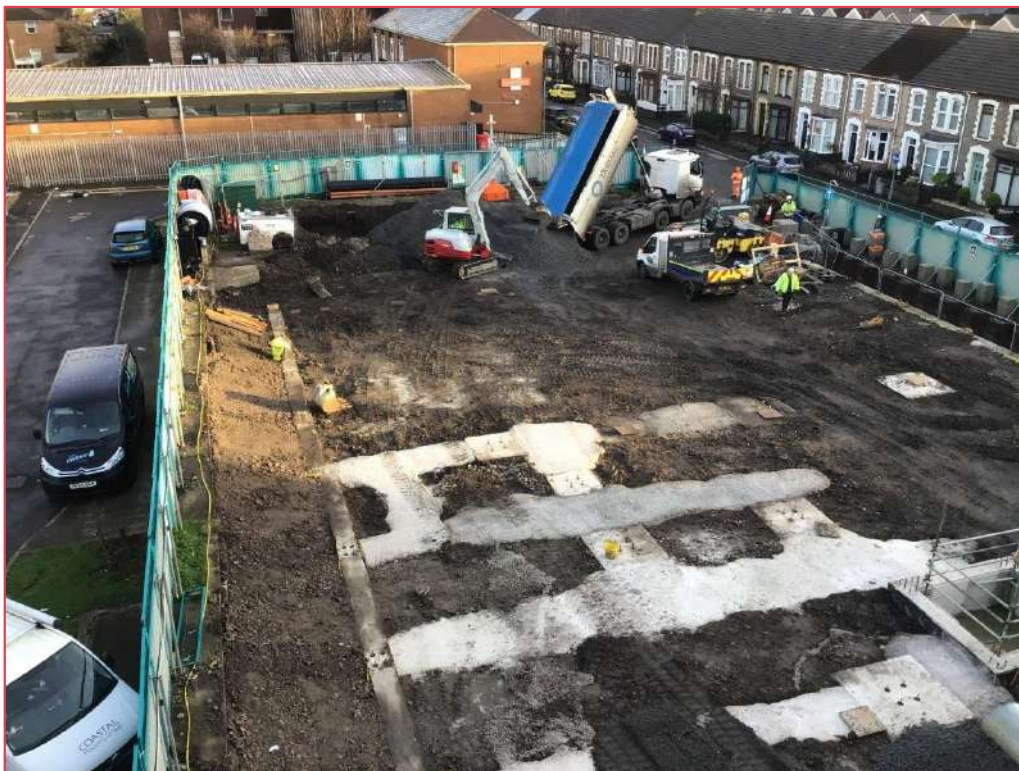
**Photo 6:** New foundations in place for the rebuild of northern Plaza building section

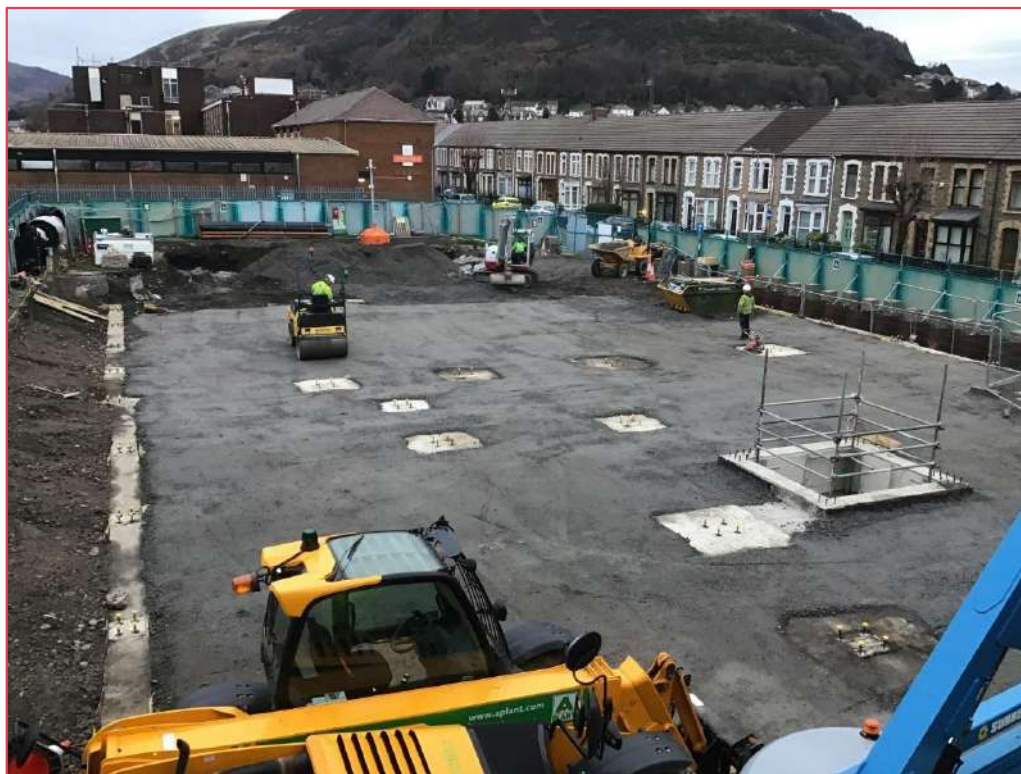
**Photo 7:** Formation back up to level ready for construction of building section and courtyard area top of photo.
