## **Appendix J National Highways Limited Cymmer Tunnel Inspection Report**

# Historical Railways Estate Tunnel Visual Examination Report

| Caerau (Cymmer) Tunnel | Examination Date | Preliminaries |

| Line:<br><br>Bridgend to Abergwynfi | Structure Identifier: BAL/10m 17ch<br><br>Stonework Bridgend Portal and brickwork & stonework lining. |

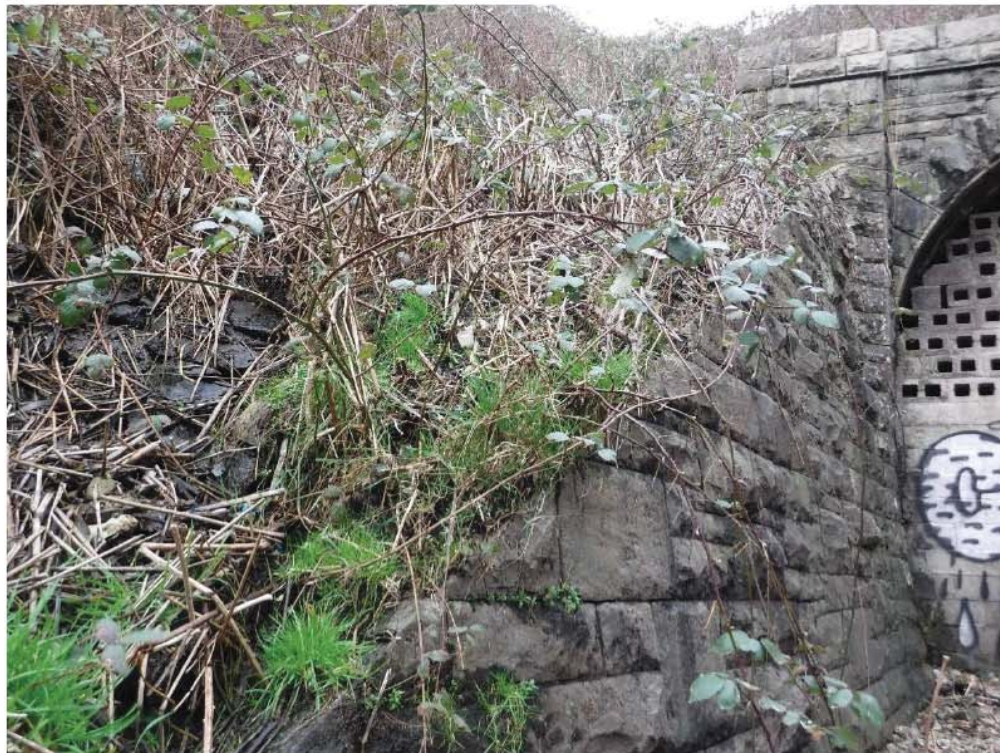
**Photo No.1:** Bridgend Portal Down, Wingwall, Copings missing and loose blocks, area 8sq.m.

**Photo No.1: Bridgend Portal Down, Wingwall, Copings missing and loose blocks, area 8sq.m.**

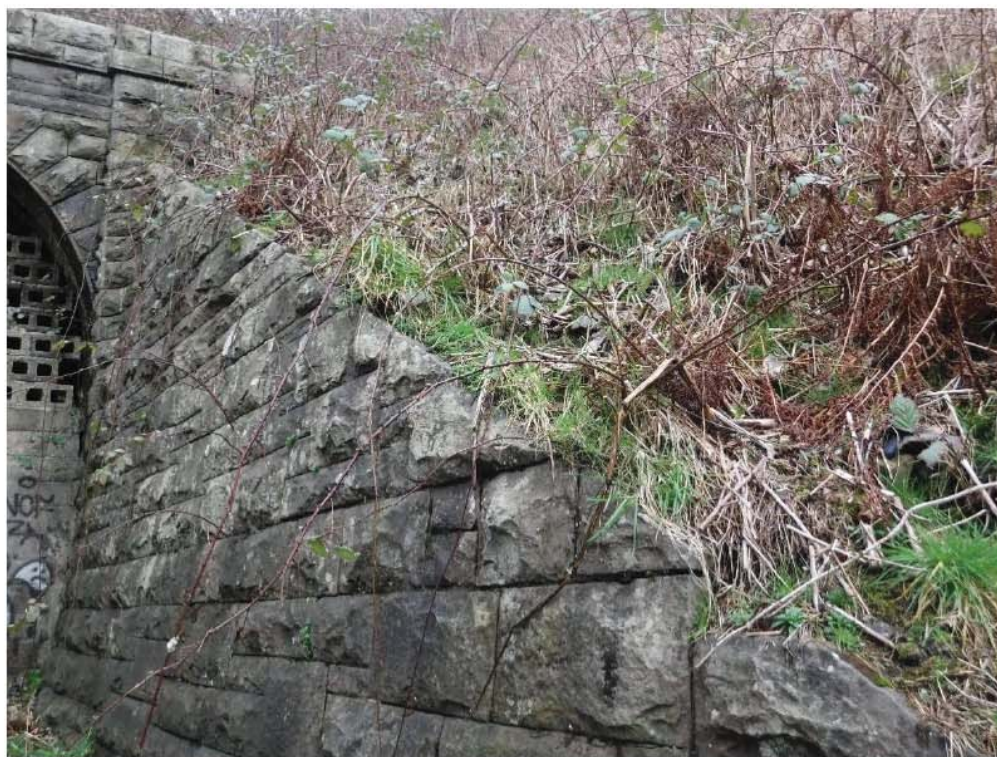
**Photo No.2:** Bridgend Portal Up, Wingwall, Copings missing and loose blocks, area 8sq.m.

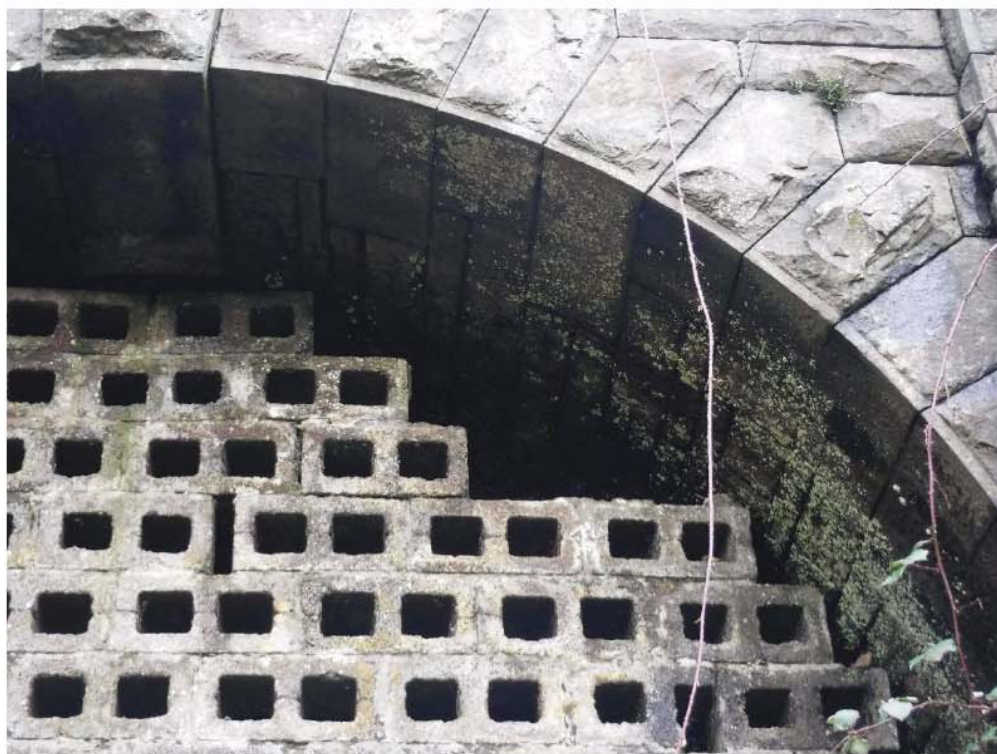
**Photo No.3:** Bridgend Portal Up, missing & loose blockwork, gap allows easy trespass access into tunnel. Bridgend Portal, existing padlock found cut-off on the solum reason unknown, tumblers still operable.

**Photo No.3:** Bridgend Portal Up, missing & loose blockwork, gap allows easy trespass access into tunnel.

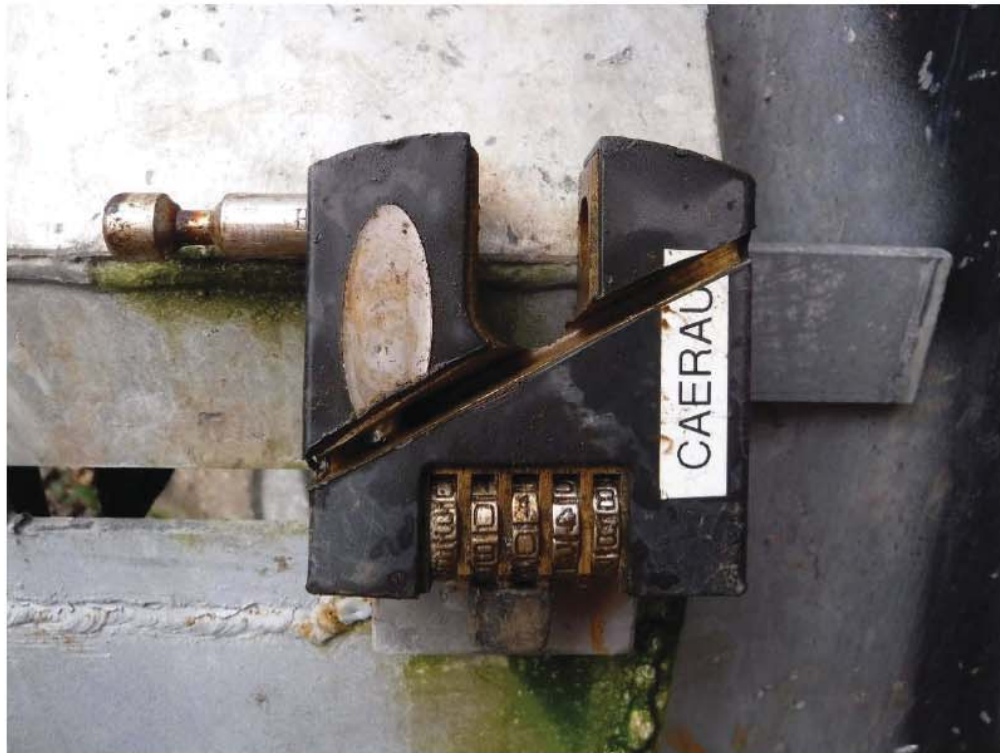
**Photo No.4:** Bridgend Portal, existing padlock found cut-off on the solum reason unknown, tumblers still operable.

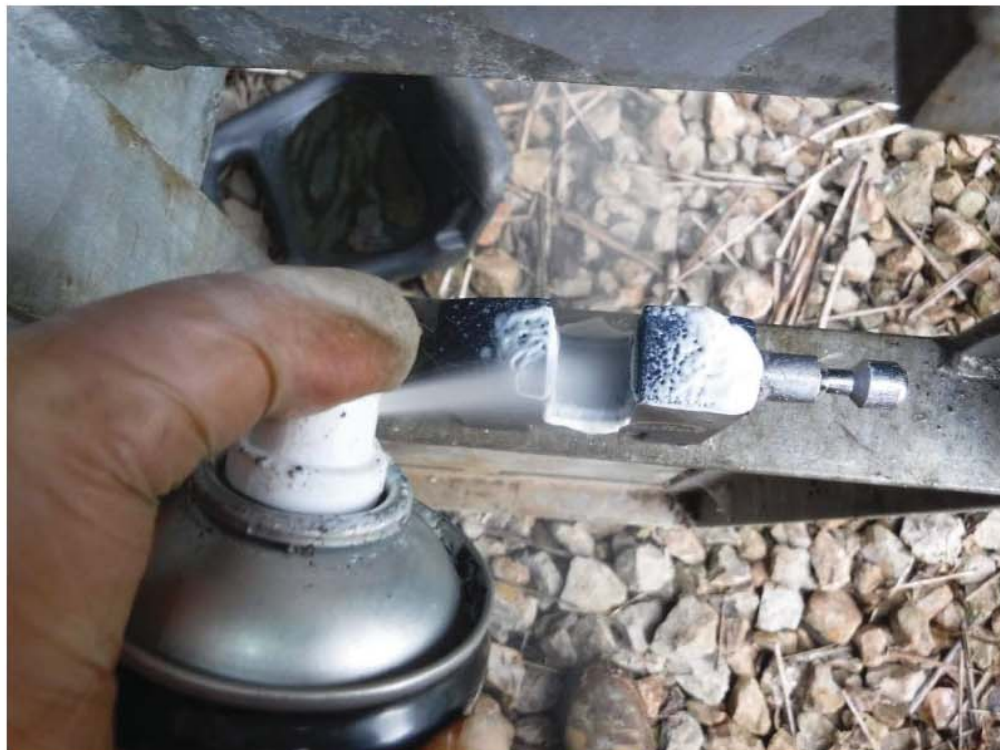
**Photo No.5:** Bridgend Portal, oiling door padlock.

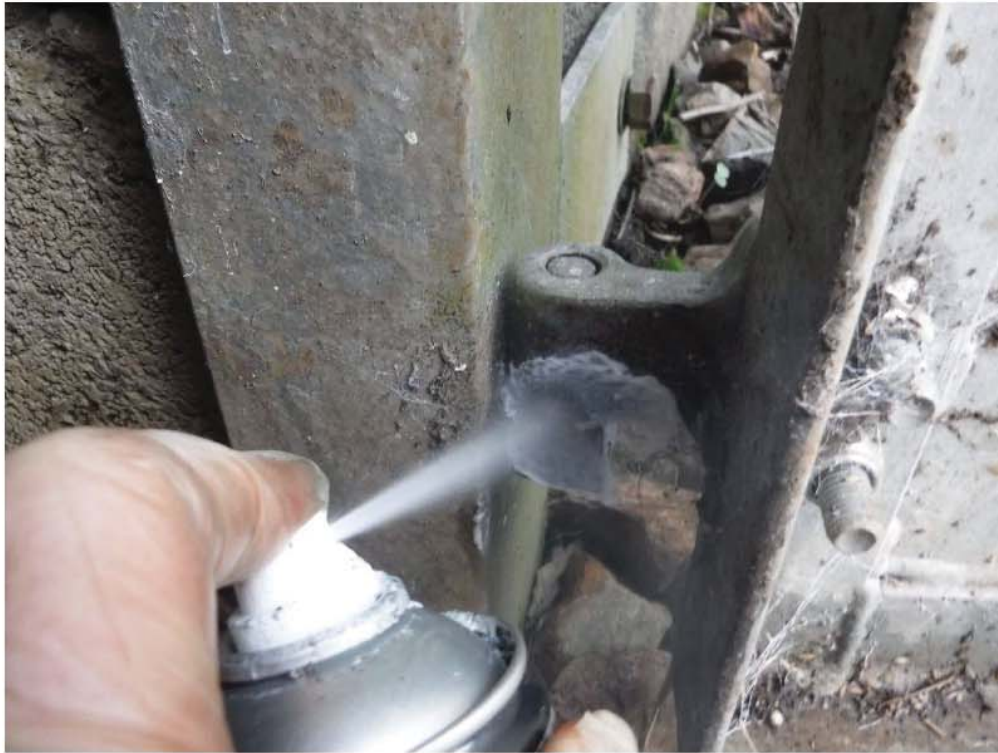
**Photo No.6:** Bridgend Portal, oiling door hinges.

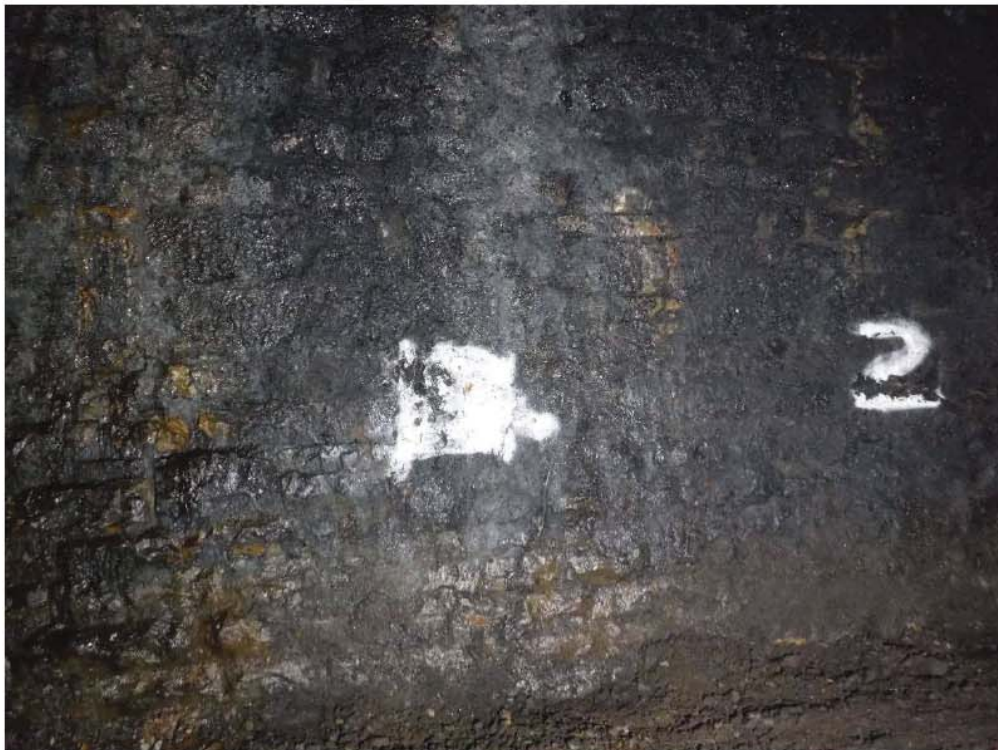
Tablet numbers were fitted along the down sidewall a couple of years ago but new unnecessary numbers have been sprayed along the opposite sidewall at irregular centres, some have also been sprayed over presumably because they were initially measured in error which compounds the mess already made and would leave an equivocal chainage legacy going forward. Seems an unnecessary time-consuming activity adding significant expense for someone and requiring remedial works to remove the mess.

**Photo No.7, 8, 9 & 10:** Full Length of Tunnel, Sidewall Up, unnecessary & unsightly graffiti, large spray paint numbers and numbers sprayed over ostensibly to try to correct an initial measuring.

**Photo No.7:** Full Length of Tunnel, Sidewall Up, unnecessary & unsightly graffiti, large spray paint numbers and numbers sprayed over ostensibly to try to correct an initial measuring.

Remove the white spray paint mess from along the up sidewall - P1.

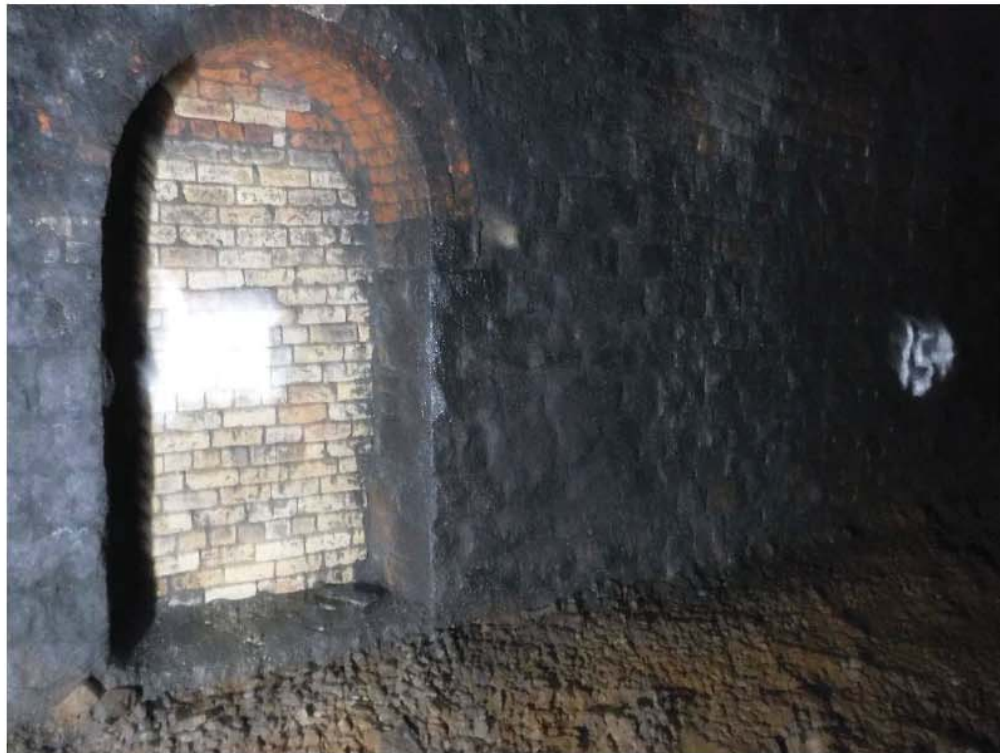
**Photo No.8:** Full Length of Tunnel, Sidewall Up, unnecessary & unsightly graffiti, large spray paint numbers and numbers sprayed over ostensibly to try to correct an initial measuring.

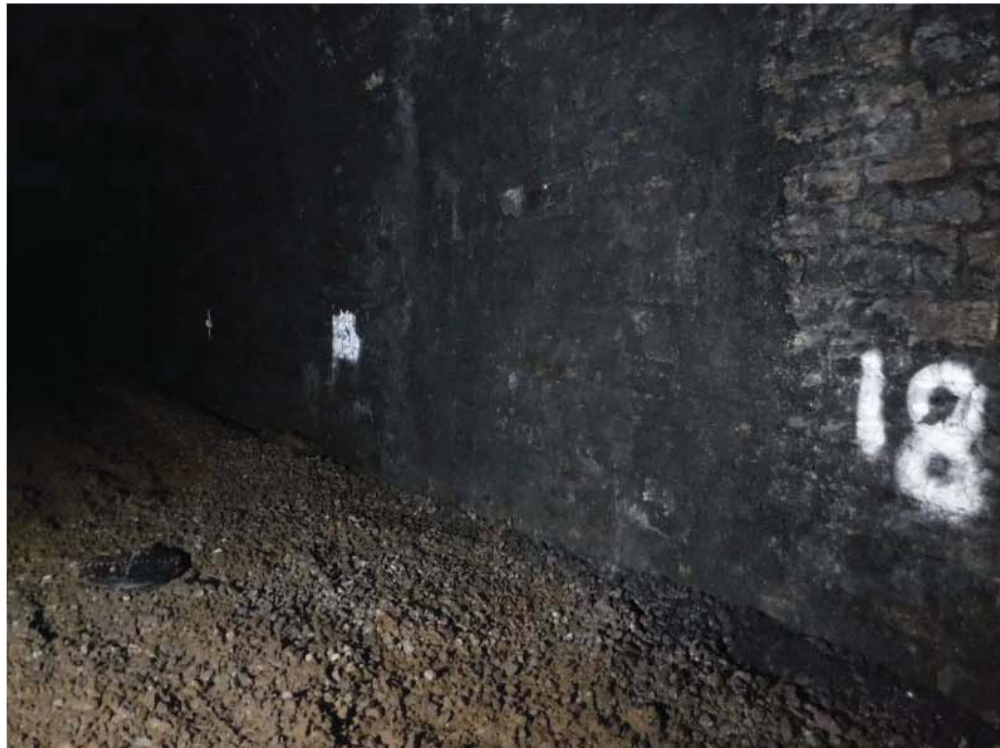
**Photo No.9:** Full Length of Tunnel, Sidewall Up, unnecessary & unsightly graffiti, large spray paint numbers and numbers sprayed over ostensibly to try to correct an initial measuring.

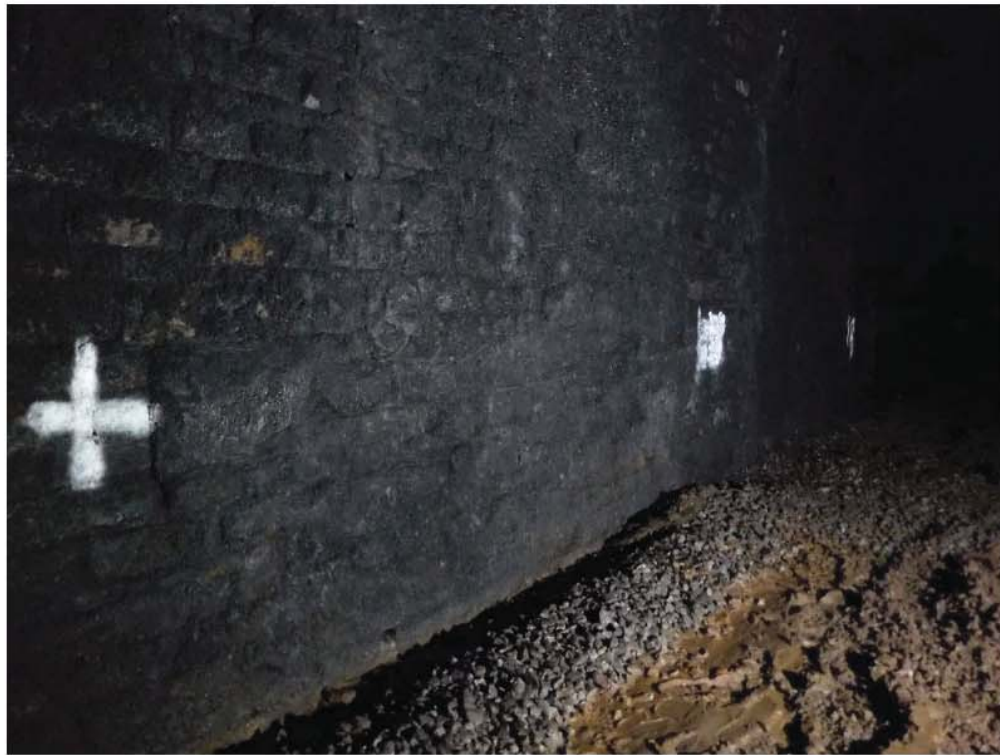
**Photo No.10:** Full Length of Tunnel, Sidewall Up, unnecessary & unsightly graffiti, large spray paint numbers and numbers sprayed over ostensibly to try to correct an initial measuring.

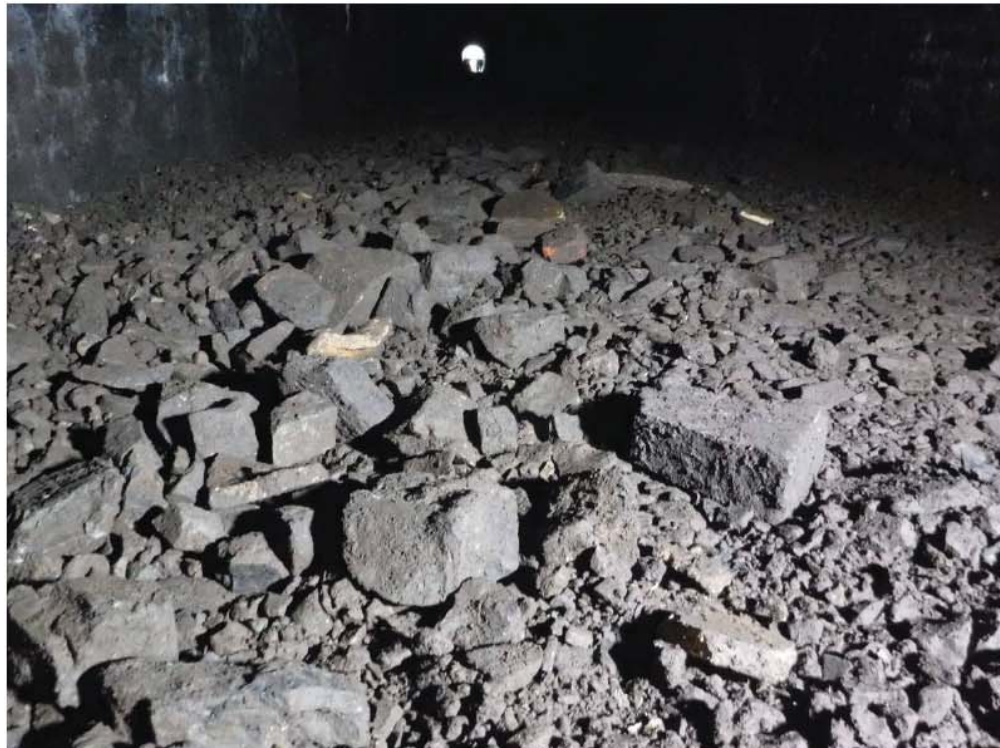
**Photo No.11 & 12:** Full Length of Tunnel, Solum Up & Down, drainage WIP, large ballast, bricks & smashed track drainage pipes churned up during excavation works, poor underfoot conditions, hazard.

**Photo No.11:** Full Length of Tunnel, Solum Up & Down, drainage WIP, large ballast, bricks & smashed track drainage pipes churned up during excavation works, poor underfoot conditions, hazard.

Complete the track drainage mtce/repair works and tidy solum before the next examination - P1.

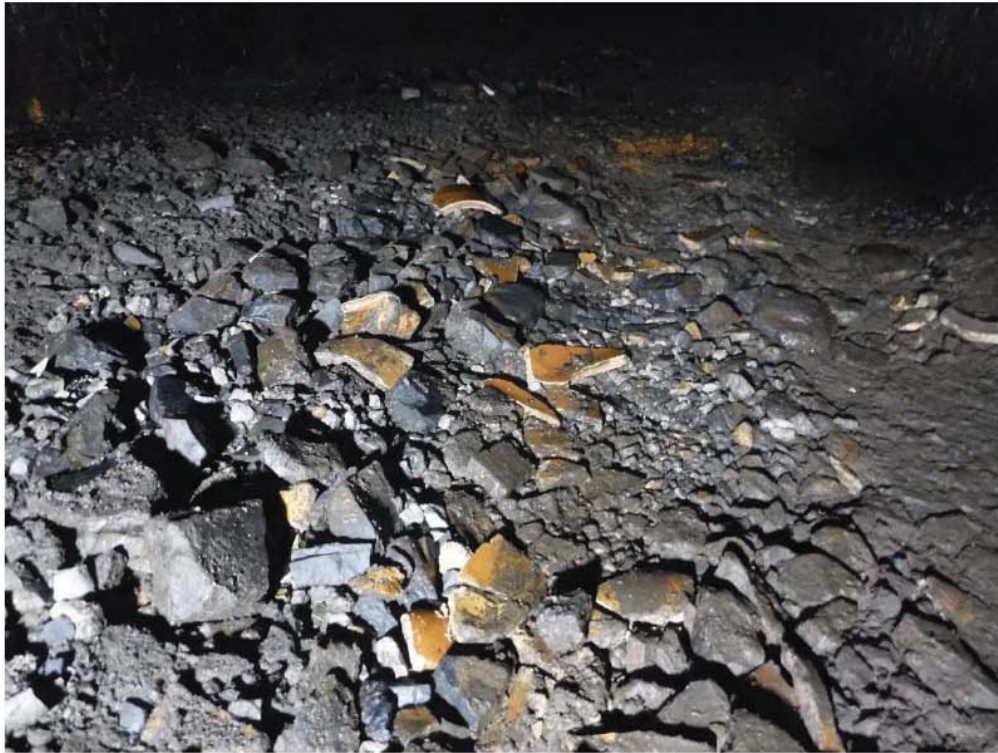
**Photo No.12:** Full Length of Tunnel, Solum Up & Down, drainage WIP, large ballast, bricks & smashed track drainage pipes churned up during excavation works, poor underfoot conditions, hazard.

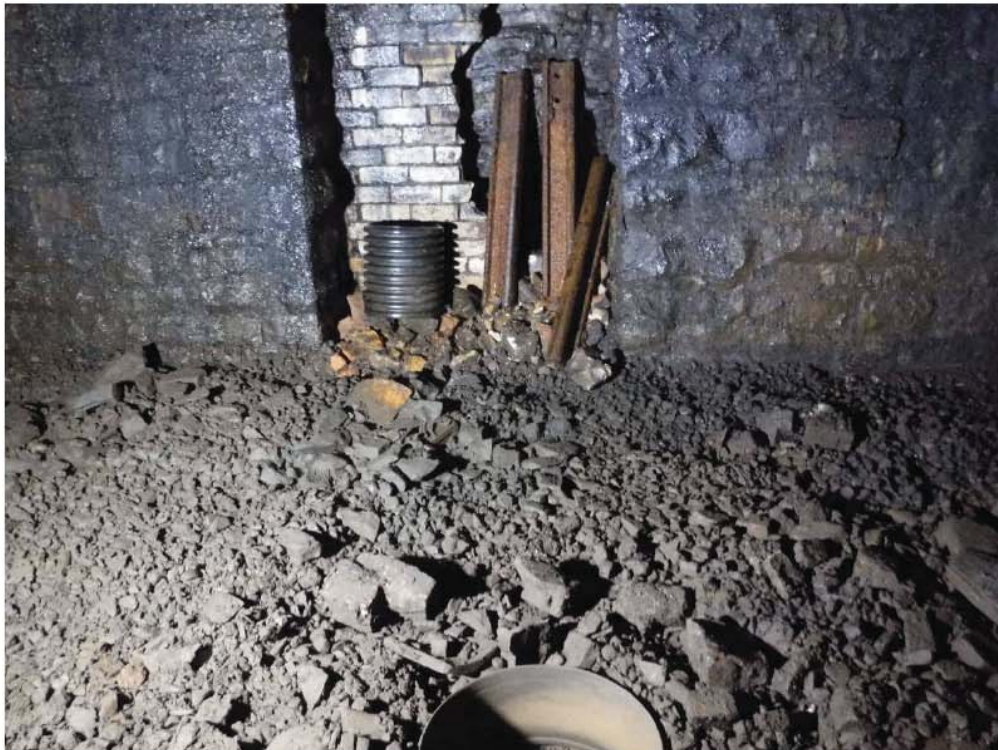
**Photo No.13 & 14:** Full Length of Tunnel, Solum Up & Down, drainage WIP, rail irons from broken out catch-pits & new construction materials found in refuges.

**Photo No.13:** Full Length of Tunnel, Solum Up & Down, drainage WIP, rail irons from broken out catch-pits & new construction materials found in refuges.

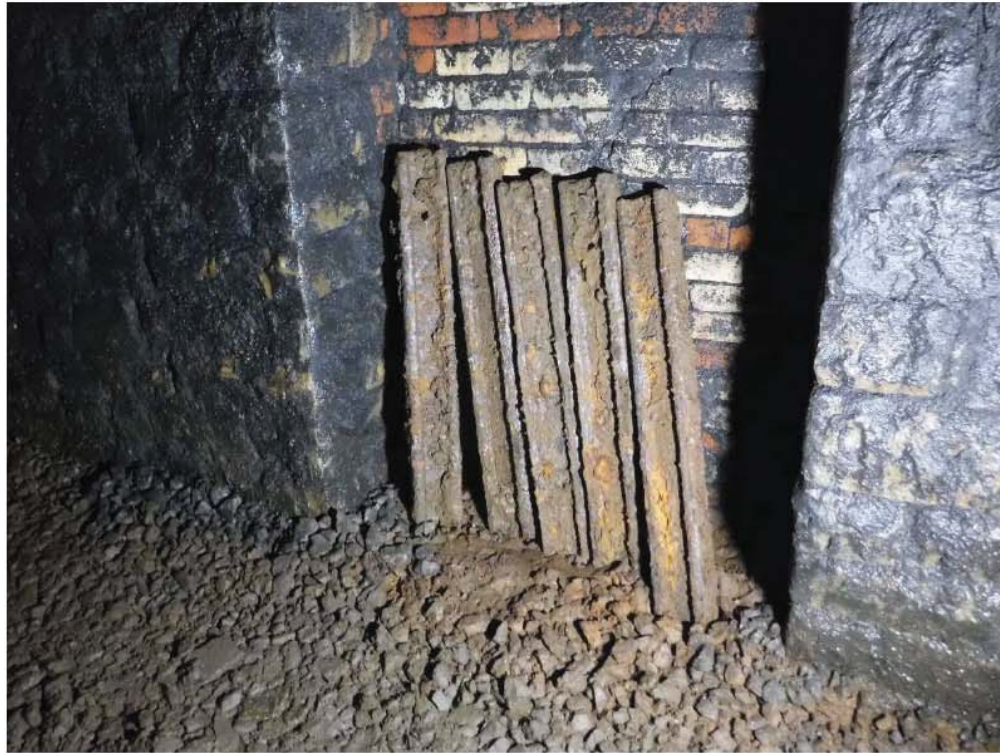
**Photo No.14:** Full Length of Tunnel, Solum Up & Down, drainage WIP, rail irons from broken out catch-pits & new construction materials found in refuges.

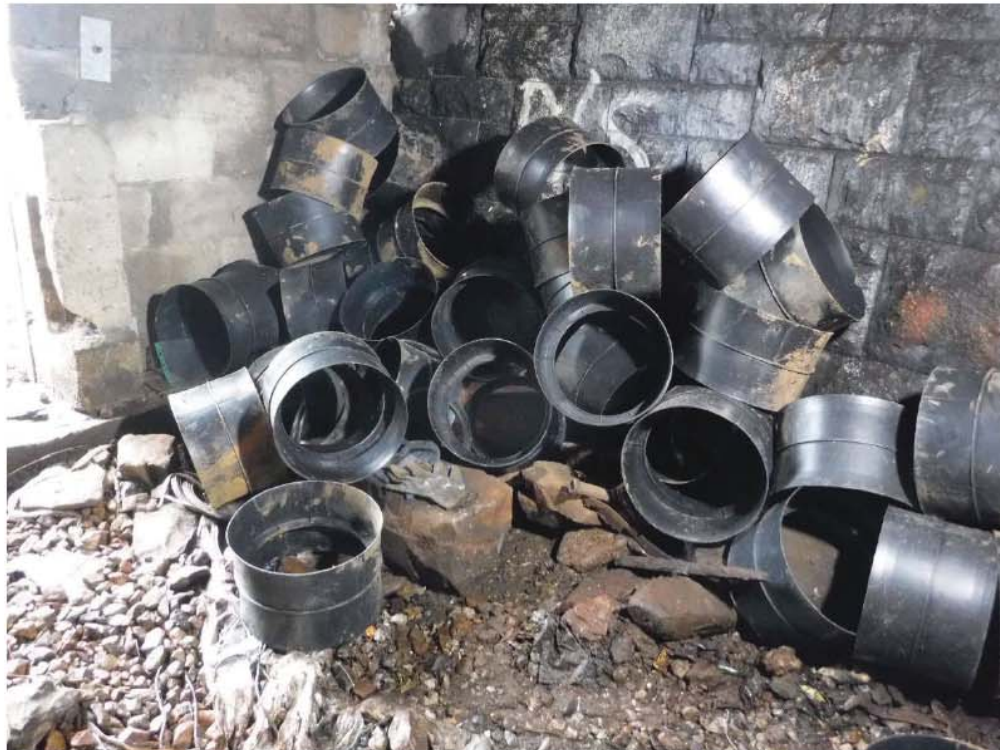
**Photo No.15:** Bridgend Portal, Solum Down, drainage WIP, new construction materials found in cess.

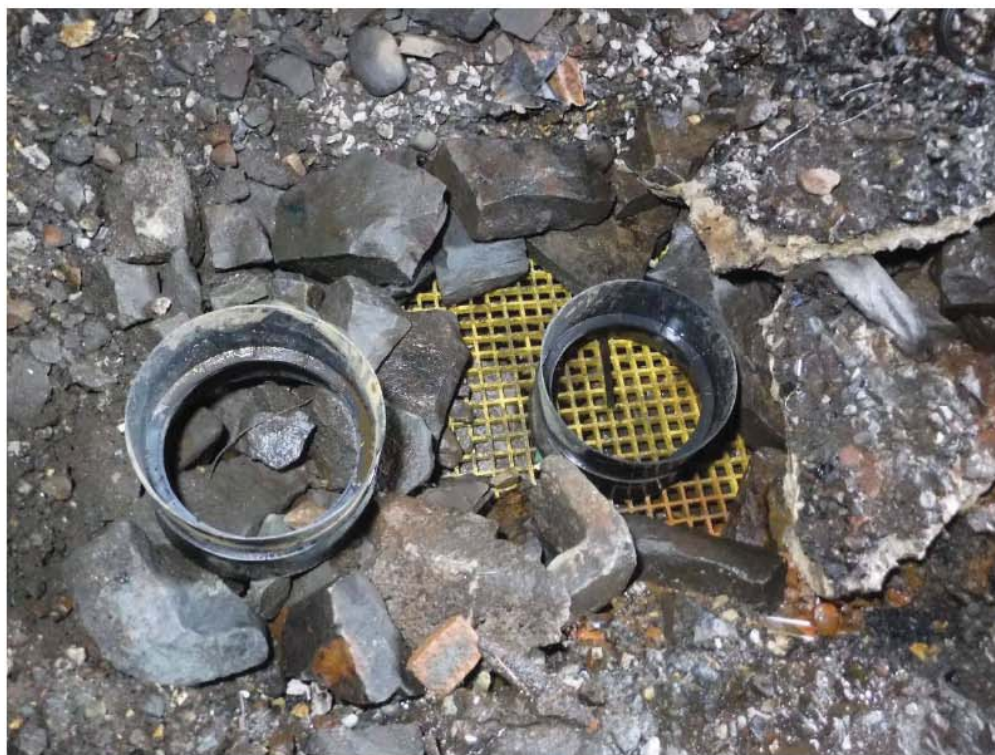
**Photo No.16:** Bridgend Portal, Solum Up & Down, drainage WIP, new cover found in 6'.

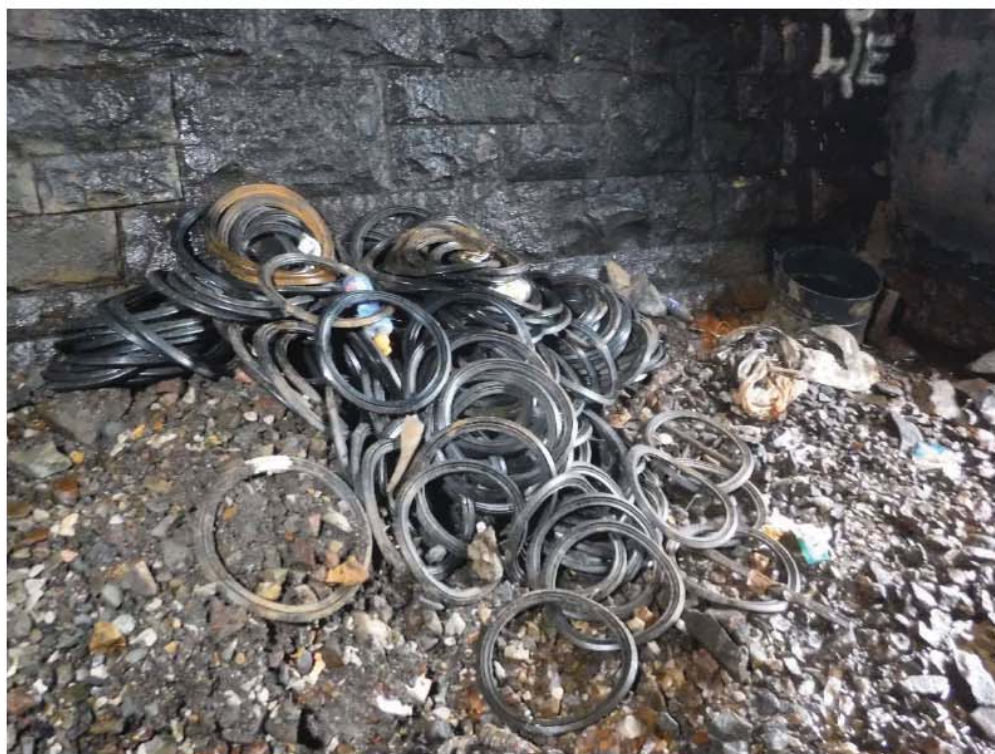
**Photo No.17:** Bridgend Portal, Solum Up, drainage WIP, new construction materials found in cess.

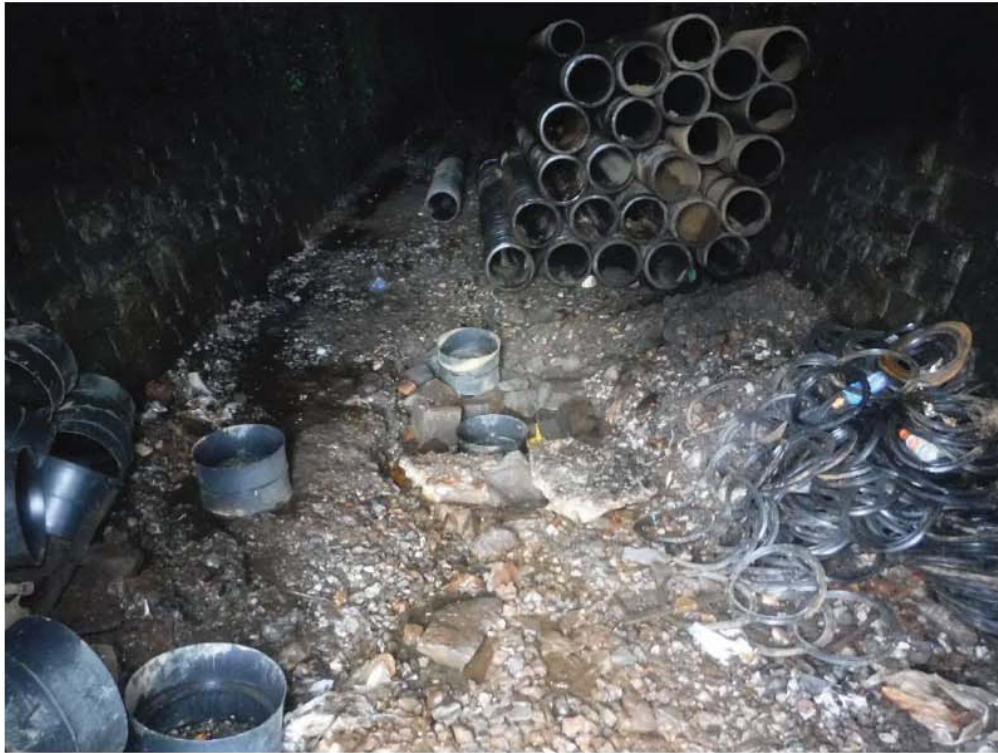
**Photo No.18 & 19:** Bridgend Portal, Solum Down, drainage WIP, old metal door dumped in tunnel hidden by a new stockpile of pipes.

**Photo No.18:** Bridgend Portal, Solum Down, drainage WIP, old metal door dumped in tunnel hidden by a new stockpile of pipes.

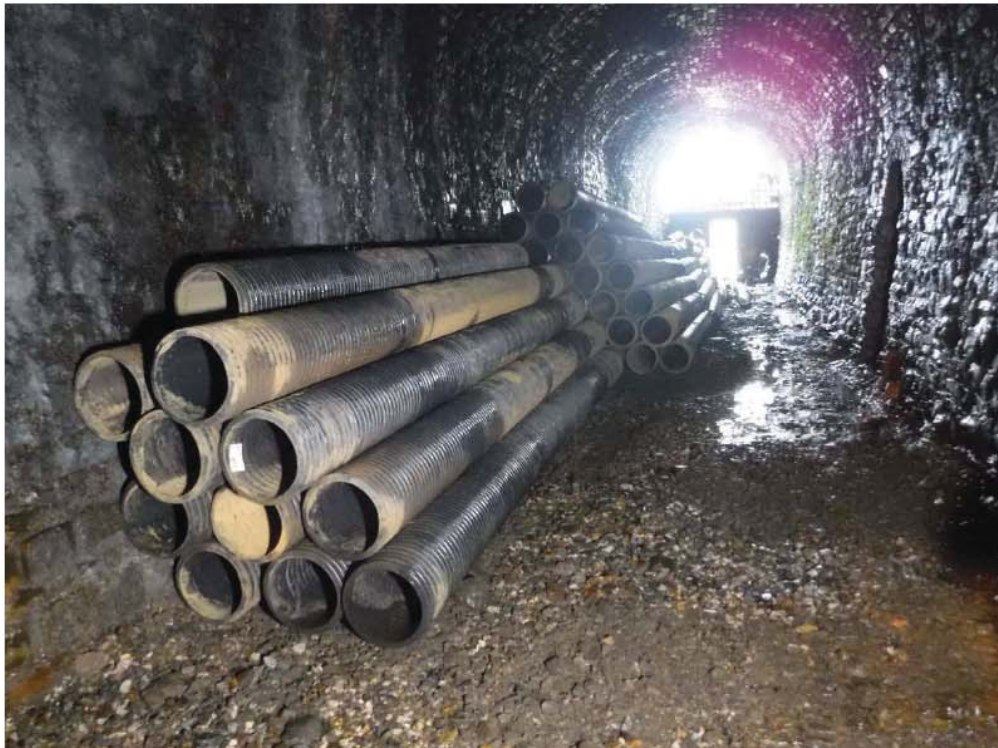
**Photo No.19:** Bridgend Portal, Solum Down, drainage WIP, old metal door dumped in tunnel hidden by a new stockpile of pipes.

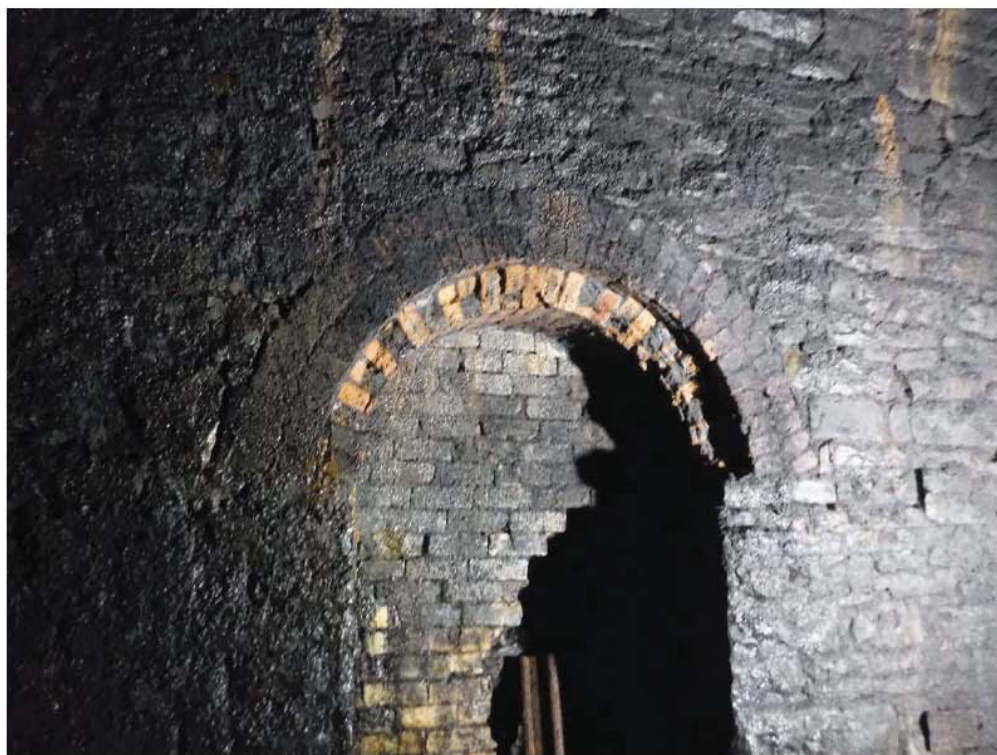
**Photo No.20:** 010+02 Refuge Up, Brickwork, Arch, spalled and missing bricks, depth 100mm, area 1.5sq.m.

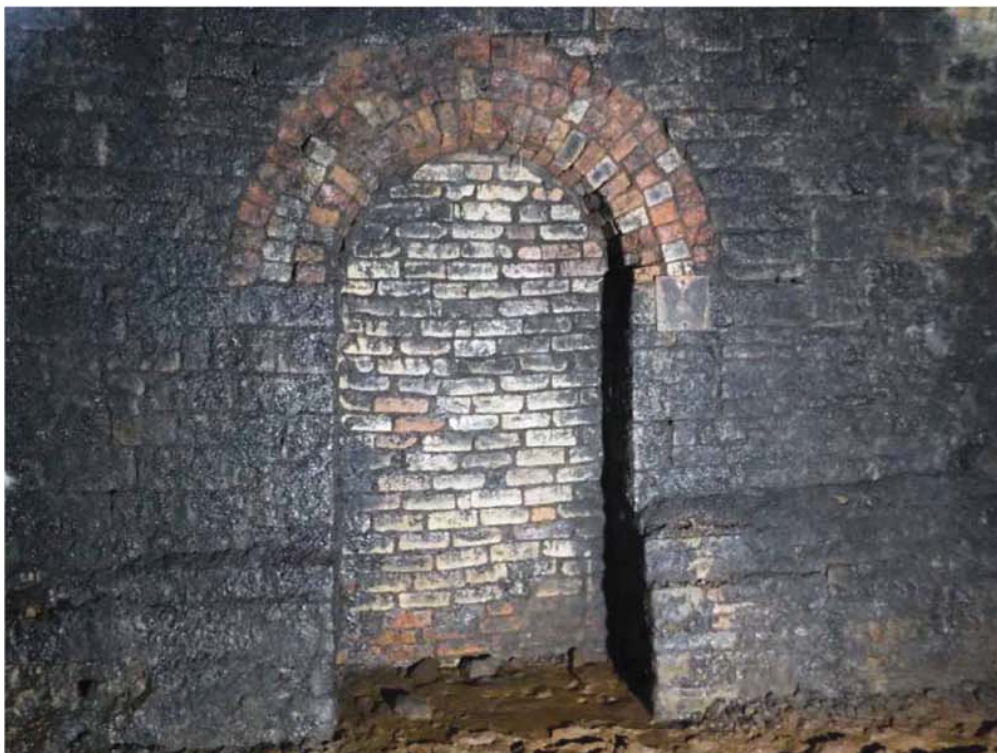
**Photo No.21:** 011+16 Refuge Up, Brickwork, Arch, spalling, depth 75mm, area 1sq.m., damp, light (archive photo).

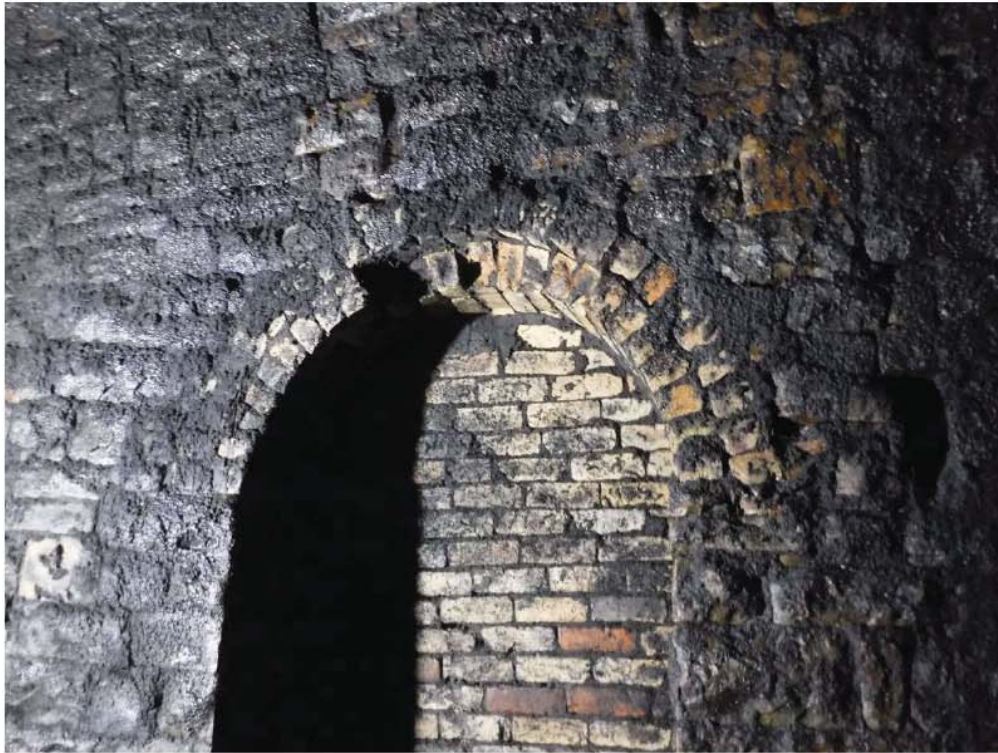
**Photo No.22:** 016+07 Refuge Up, Brickwork, Arch, hollow, area 1sq.m., with missing bricks, depth 100mm, area 0.25sq.m., medium.

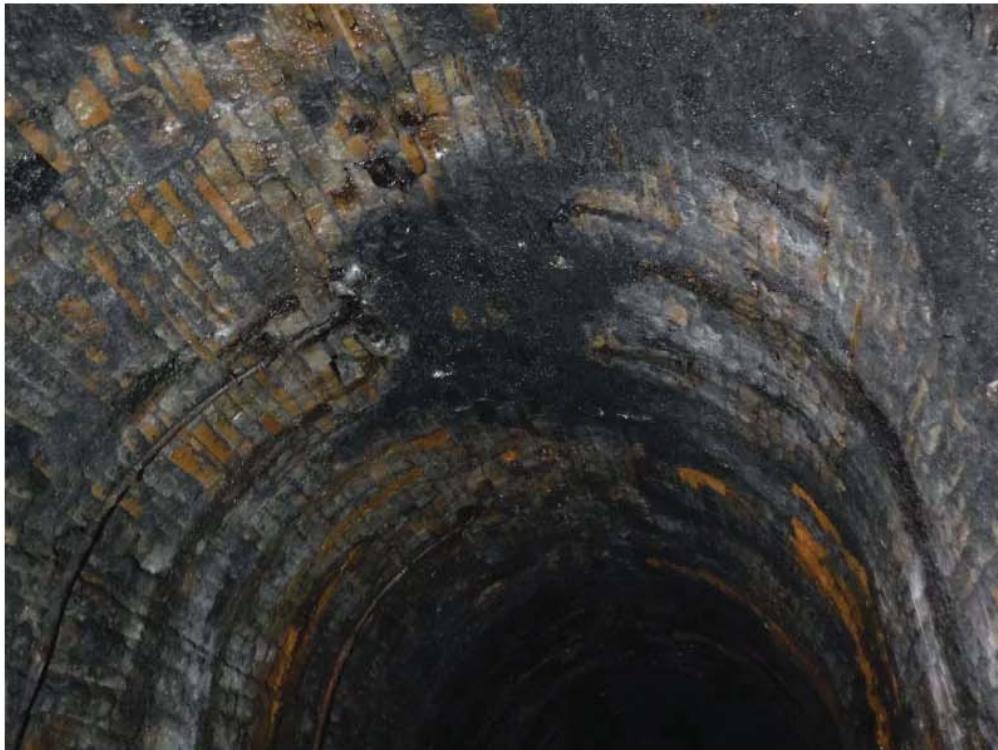
**Photo No.23:** 016+18 Sidewall & Haunch Down, Stonework, 2No. downpipes fitted to Haunch with running water. Possible Hidden Shaft.

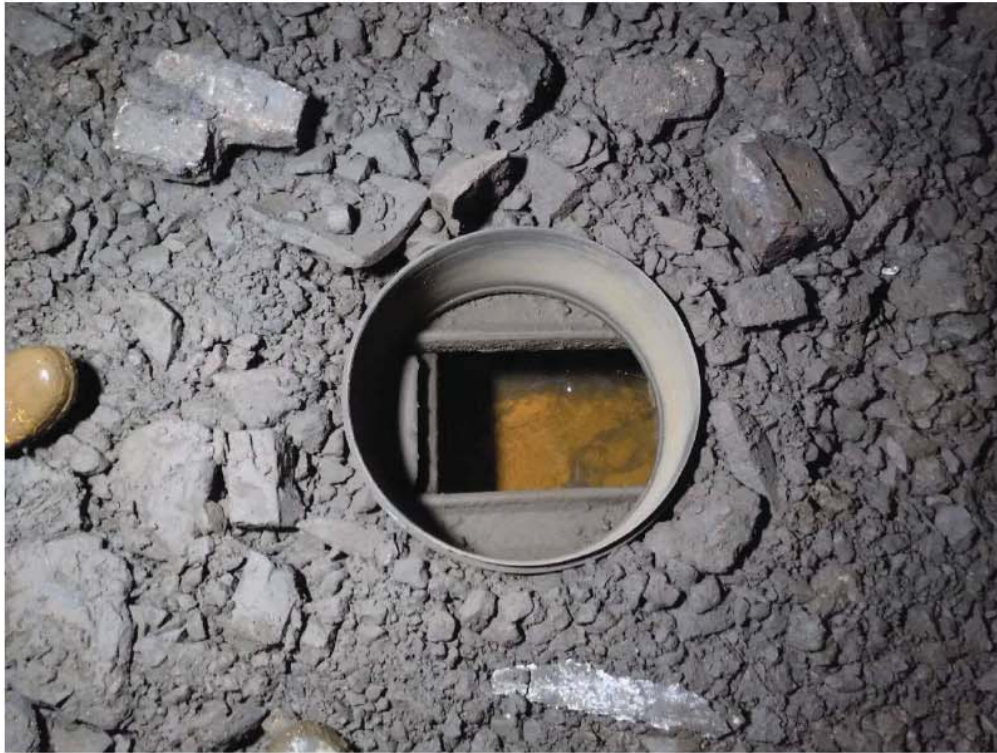
**Photo No.24 to 31:** 000+00 to 038+20 Solum Up & Down, drainage WIP, catch-pits and/or earthenware pipes broken out, new inspection chambers fitted mostly at 1ch centres, some covers missing or displaced.

**Photo No.24:** 000+00 to 038+20 Solum Up & Down, drainage WIP, catch-pits and/or earthenware pipes broken out, new inspection chambers fitted mostly at 1ch centres, some covers missing or displaced.

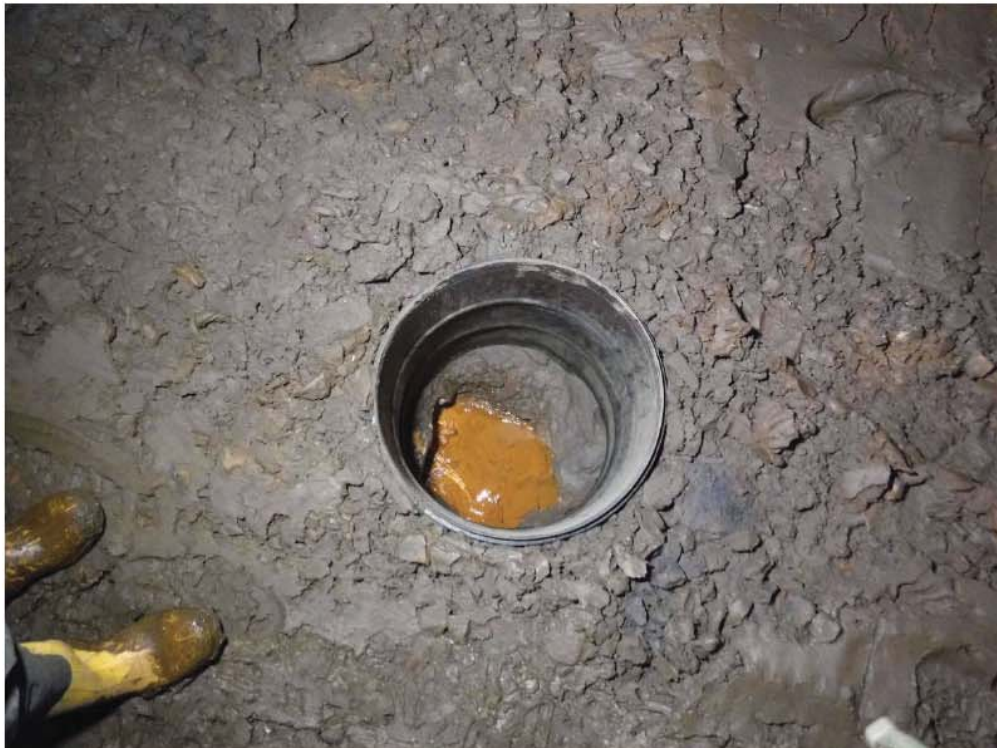
**Photo No.25:** 000+00 to 038+20 Solum Up & Down, drainage WIP, catch-pits and/or earthenware pipes broken out, new inspection chambers fitted mostly at 1ch centres, some covers missing or displaced.

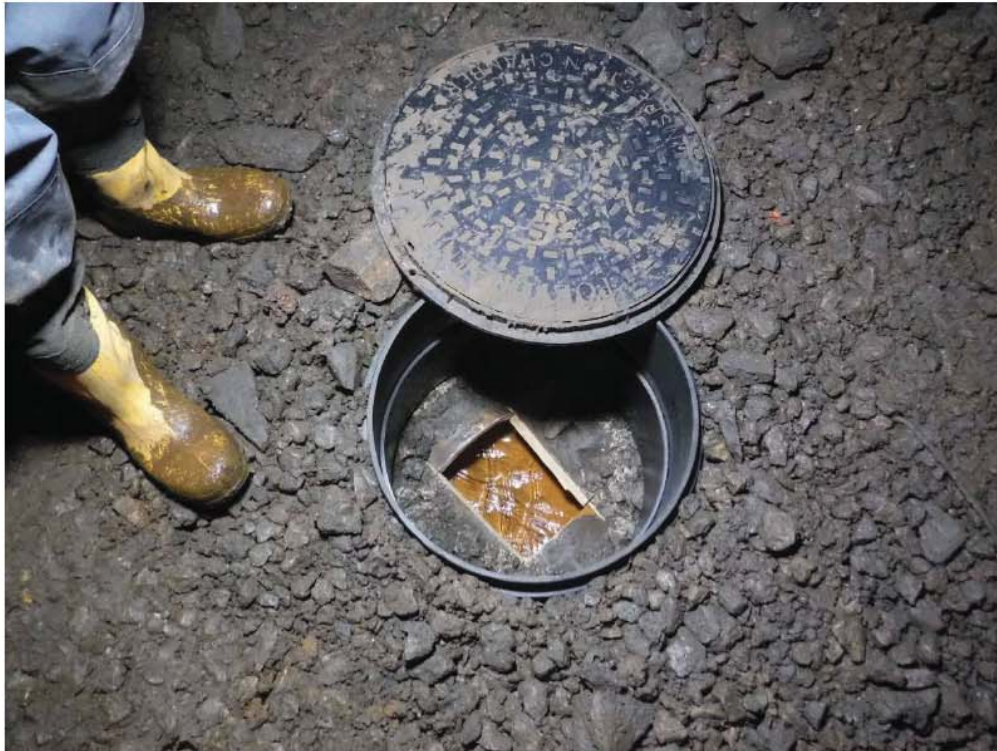
**Photo No.26:** 000+00 to 038+20 Solum Up & Down, drainage WIP, catch-pits and/or earthenware pipes broken out, new inspection chambers fitted mostly at 1ch centres, some covers missing or displaced.

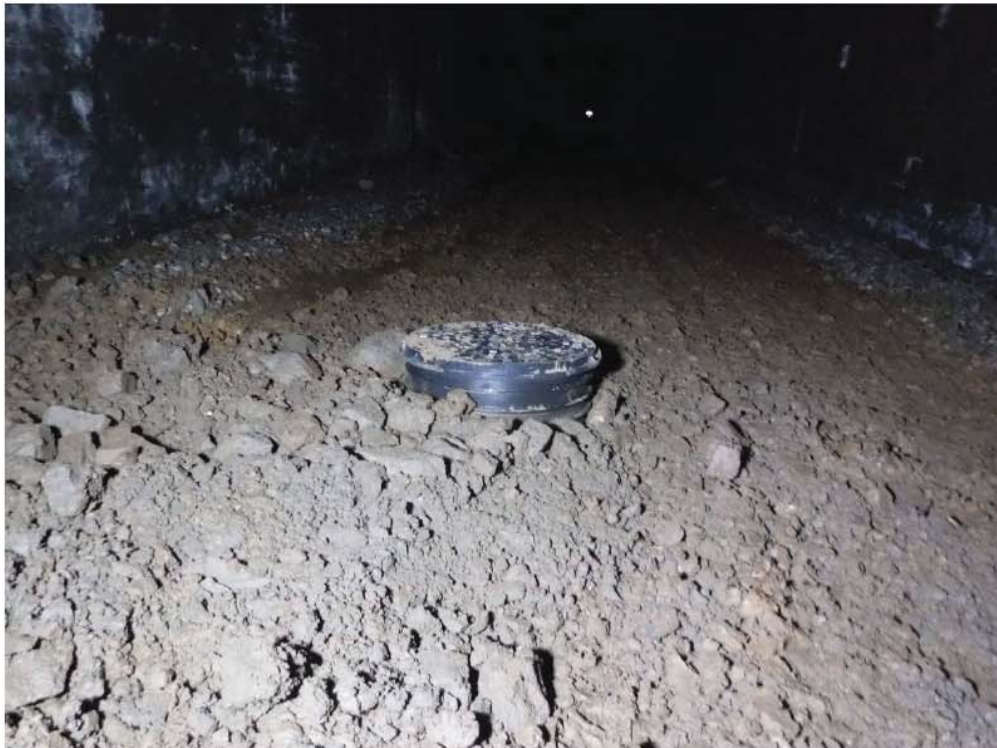
**Photo No.27:** 000+00 to 038+20 Solum Up & Down, drainage WIP, catch-pits and/or earthenware pipes broken out, new inspection chambers fitted mostly at 1ch centres, some covers missing or displaced.

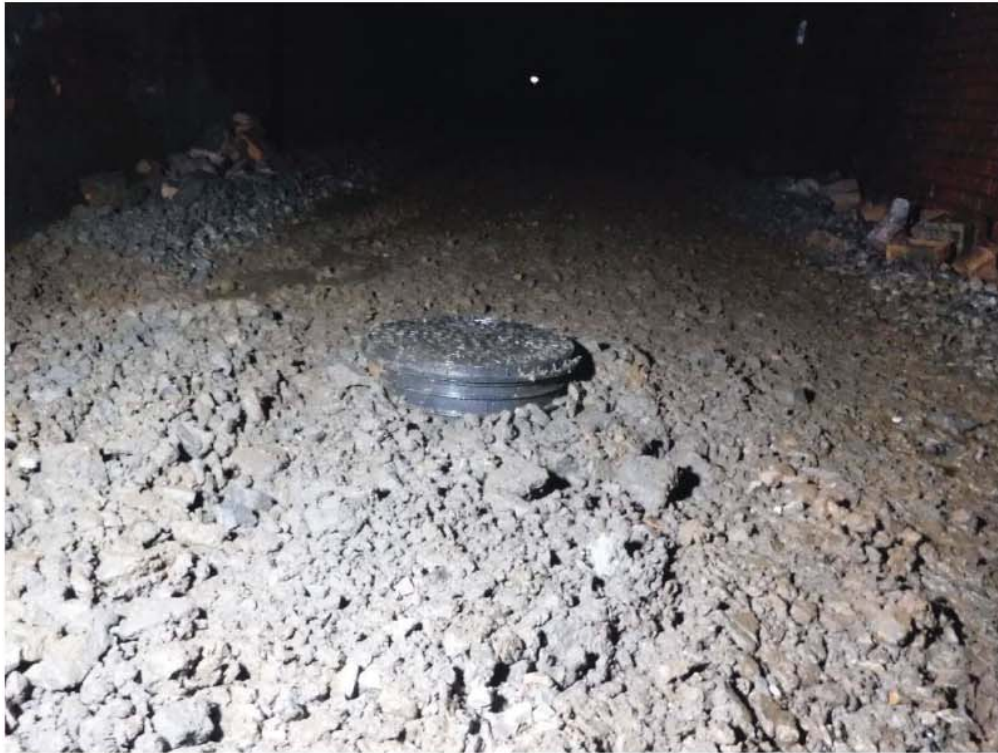
**Photo No.28:** 000+00 to 038+20 Solum Up & Down, drainage WIP, catch-pits and/or earthenware pipes broken out, new inspection chambers fitted mostly at 1ch centres, some covers missing or displaced.
