## **Appendix J National Highways Limited Cymmer Tunnel Inspection Report**

# Historical Railways Estate Tunnel Visual Examination Report

| Caerau (Cymmer) Tunnel | Examination Date | Preliminaries |

| Line:<br><br>Bridgend to Abergwynfi | Structure Identifier: BAL/10m 17ch<br><br>Stonework Bridgend Portal and brickwork & stonework lining. |

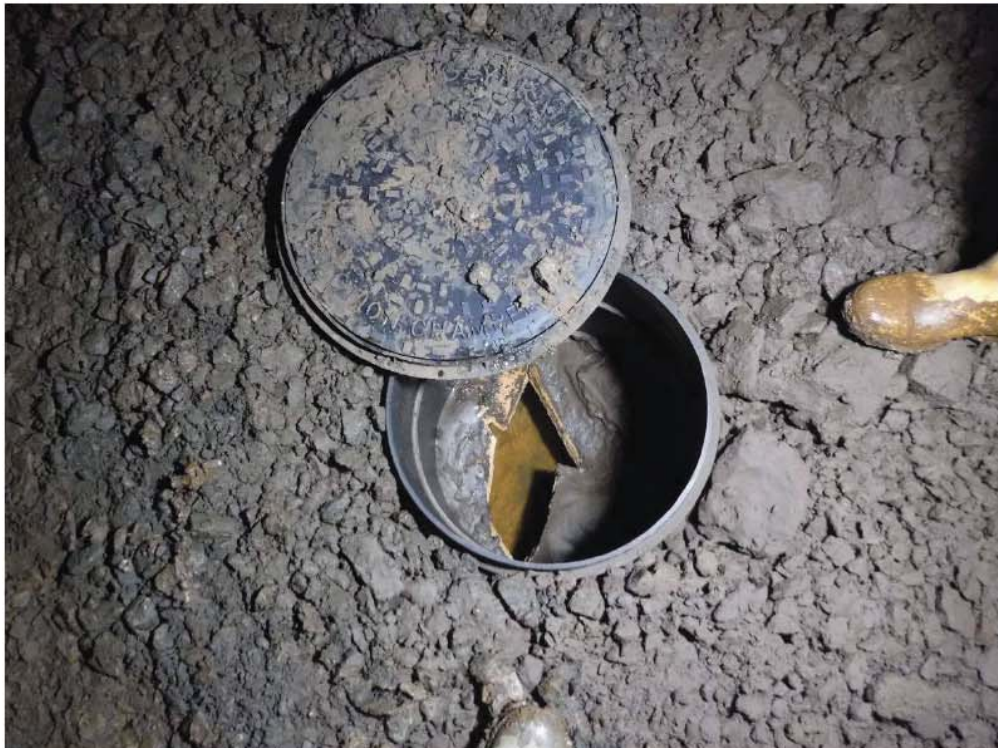
**Photo No.29:** 000+00 to 038+20 Solum Up & Down, drainage WIP, catch-pits and/or earthenware pipes broken out, new inspection chambers fitted mostly at 1ch centres, some covers missing or displaced.

Complete the track drainage mtce/repair works and tidy solum before the next examination - P1.

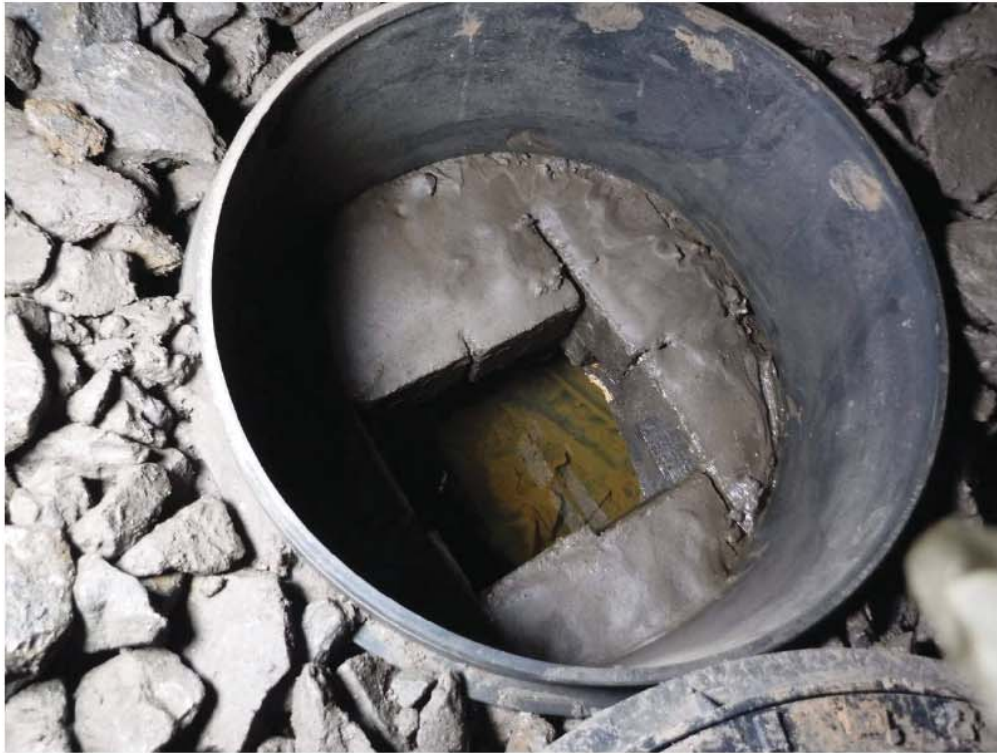
**Photo No.30:** 000+00 to 038+20 Solum Up & Down, drainage WIP, catch-pits and/or earthenware pipes broken out, new inspection chambers fitted mostly at 1ch centres, some covers missing or displaced.

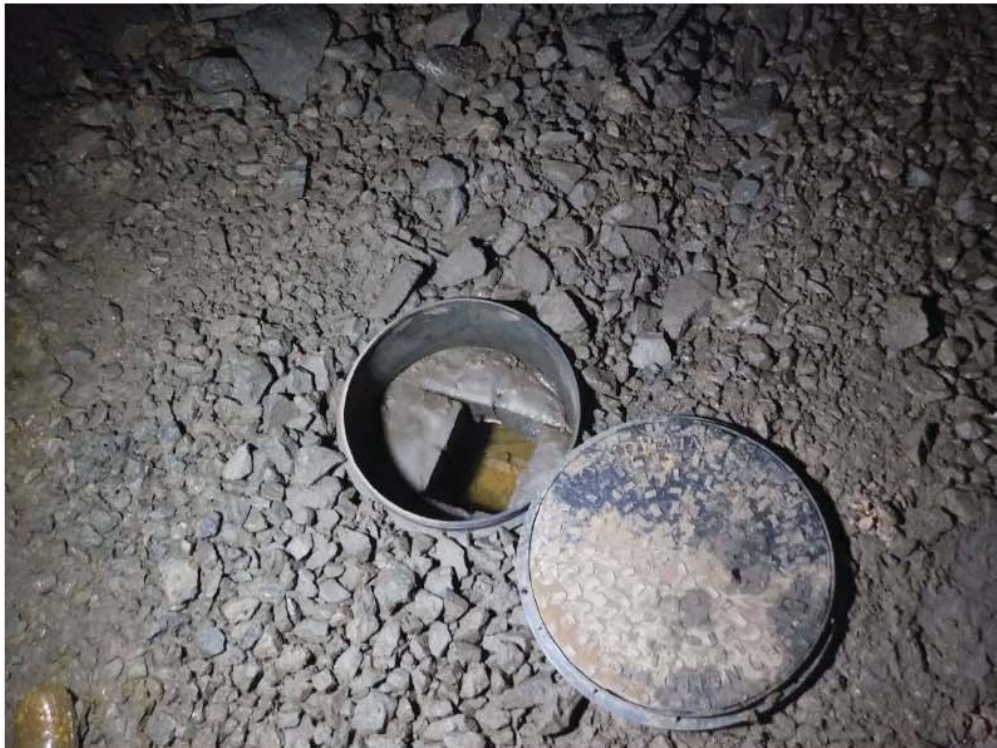
**Photo No.31:** 000+00 to 038+20 Solum Up & Down, drainage WIP, catch-pits and/or earthenware pipes broken out, new inspection chambers fitted mostly at 1ch centres, some covers missing or displaced.

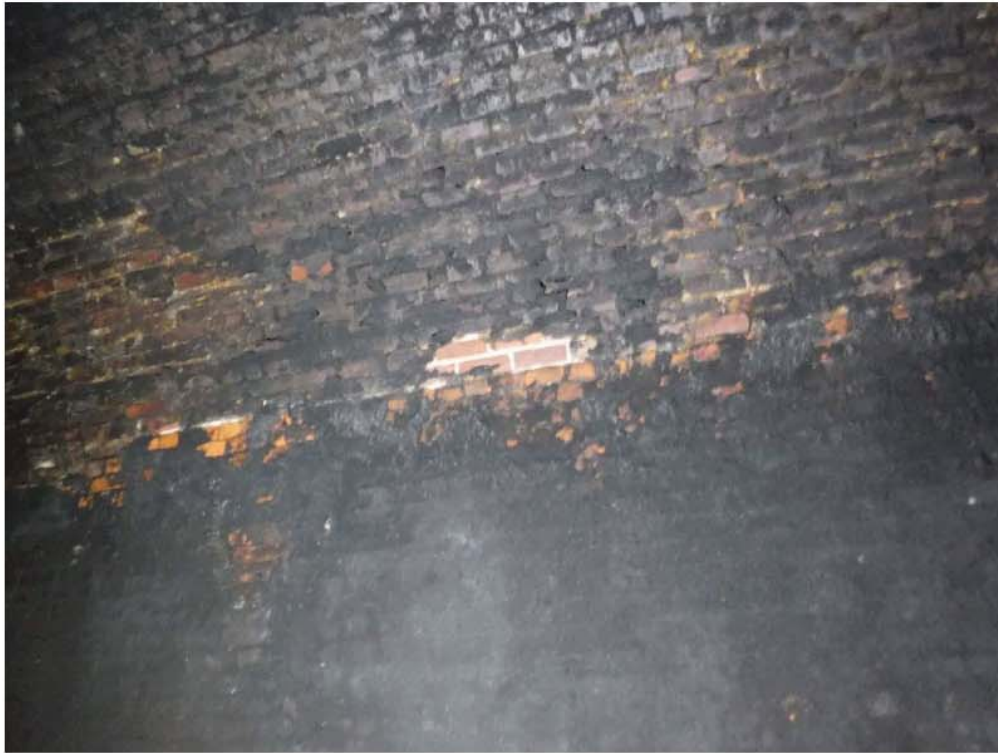
**Photo No.32:** 042+13 to 043+20 Low Haunch Up & Down, Brickwork, longitudinal cracking, width 1mm, length 27m. Various bricks crushed and spalled to downside, depth 25mm, area 3sq.m.

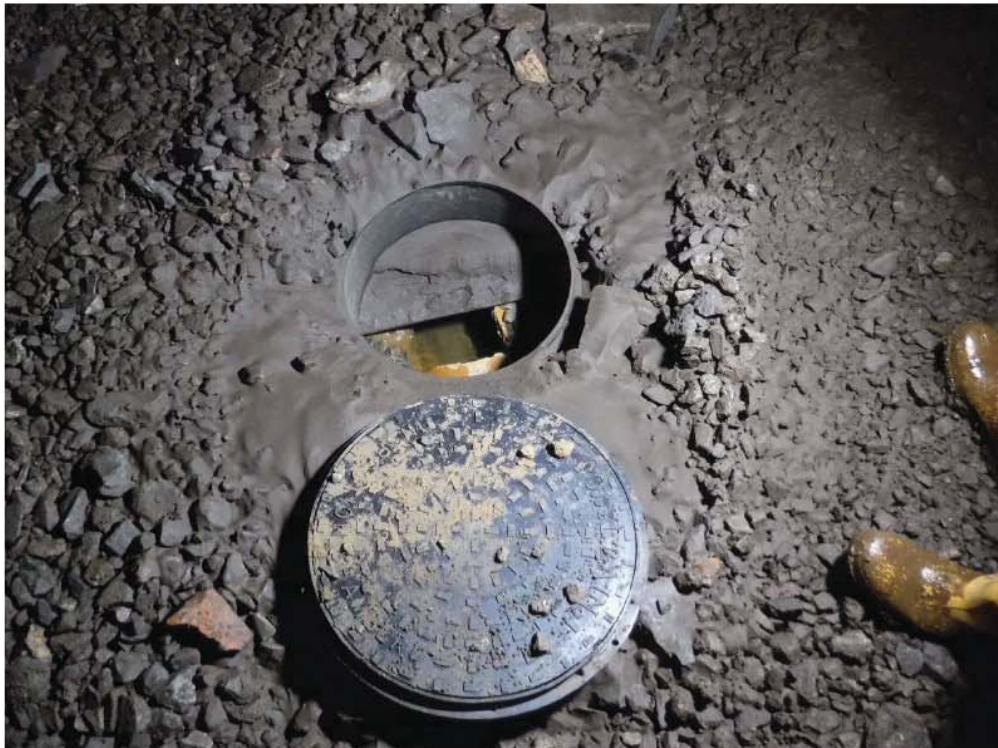
**Photo No.33:** 043+17 Solum Up & Down, Open Catch-pit to six-foot blocked, new flooding from 040+15 to 050+11 flowing northwards. Water subsided, new chamber, shallow mud/silt.
