**Geomorphology  
Assessment and Ground  
Investigation Scoping  
Report (GISR)**

# Proposed Adventure Park Afan Valley Resort

## Geomorphology Assessment and Ground Investigation Scoping Report (GISR)

Report Reference: ESP.8053.3708-03

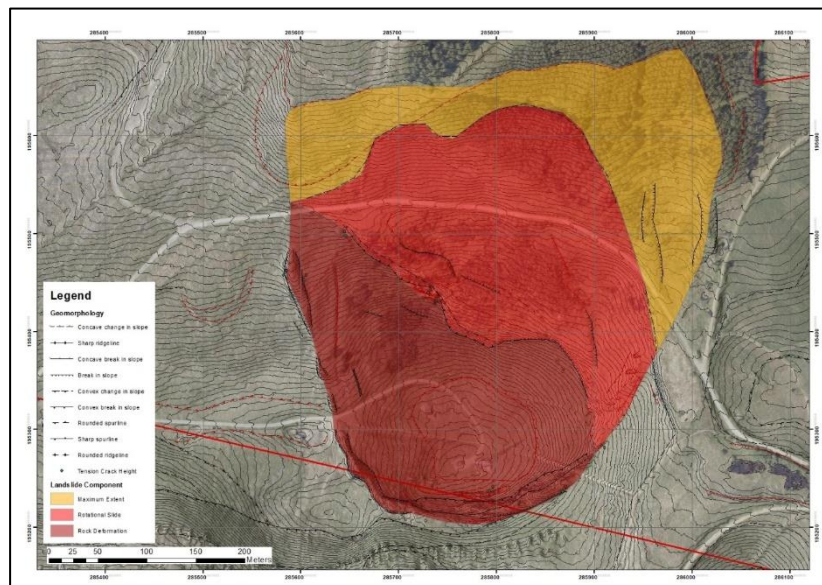
- 4.53 A landslide complex has been identified in the central portion of the site which broadly corresponds to the previous mapped BGS landslide (Ref. AA-17). The landslide complex has been interpreted as comprising three separate components (Insert 5).

**Insert 5: Central Landslide Complex**

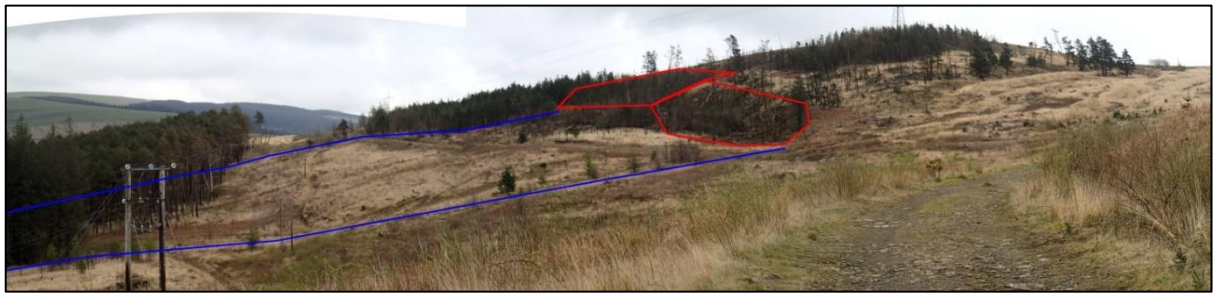
- 4.54 **Landslide 1:** This broadly coincides BGS mapped landslide AA-17. It comprises a rotational landslide with a northwest-southeast trending main scarp (Insert 6) and associated debris. To the rear of the main scarp are two fissures (Insert 7) extending into rock. The height of the fissures at the main scarp measured between 1.0m and 4.0m. Joints within the exposed scarp were measured as dipping between 20 and 22° towards the northwest and southeast.

- 4.56 The landslide was observed as being degraded with no significant evidence to indicate recent movement identified. The mapped toe of the landslide may be less visible/degraded due to anthropogenic influences (forestry and other man activities). The approximate mapped toe of the landslide is indicated below in blue, however the geomorphological mapping indicates the toe to extent downslope (north) within the forested area.

*Insert 6: Rotational landslide. Approximate locations of Main Scarp (Red) and Toe (Blue) (Photo P1)*

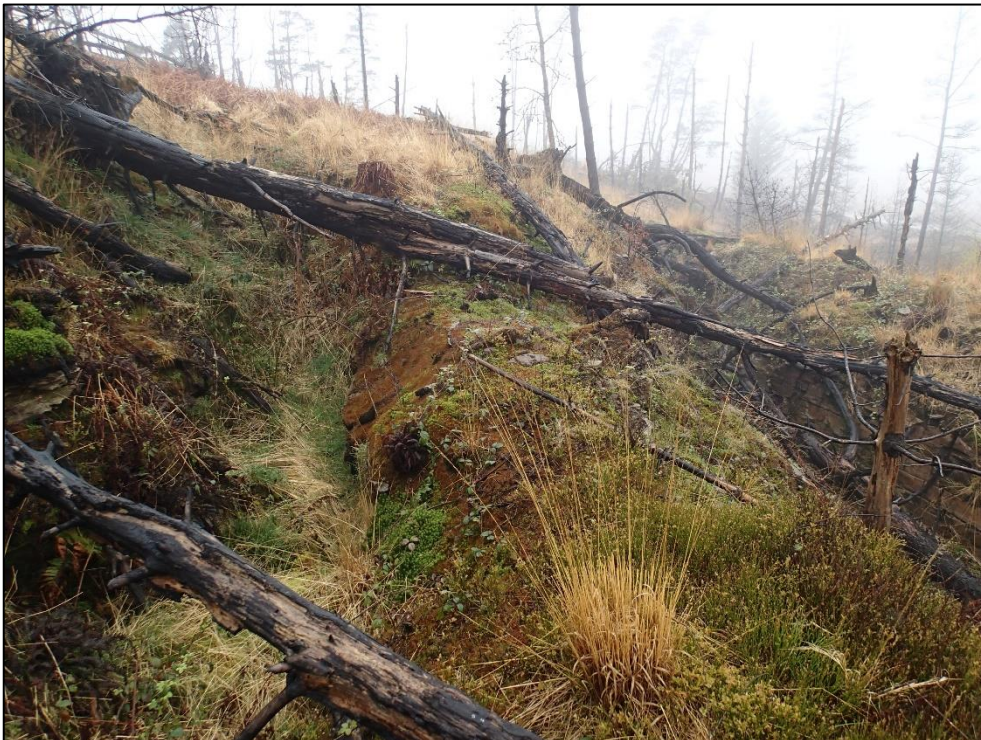
- 4.55 The LiDAR review and API identified these fissures which coincide with the scarps recorded on the topographical maps, indicating they were present in 1877-78.

*Insert 7: Fissure above Main Scarp of Rotational Landslide (Photo P2)*

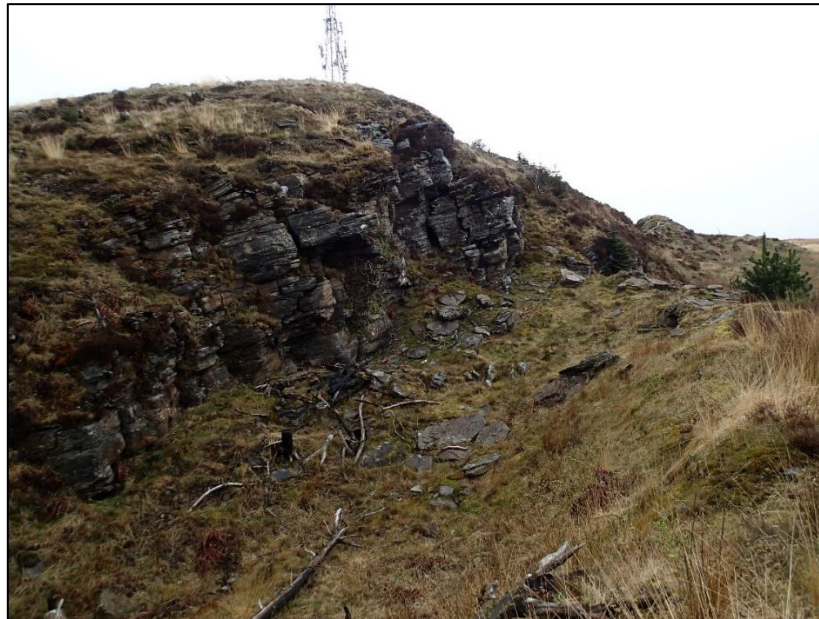
with an arcuate scarp feature (Insert 8). Its surface expression varies from fissures in rock to linear topographical depressions (Insert 9) with no associated rock outcrop. These have been interpreted as defining the upper most extent of the landslide complex.

- 4.58 No mappable geological units were crossing within the rock fissures associated with the upper arcuate scarp, so the actual sense and scale of displacement was not measurable. The dip of the bedding varied from 3° to 22° and the direction from 224 to 354. The regional dip is shown on the geological map as being 10° to north-northwest. Rock measurements are displayed on Figure 8b.

**Insert 8:** 12m High rock scarp with dilated rock mass associated rock fall, west end of main scarp. (Photo P3)

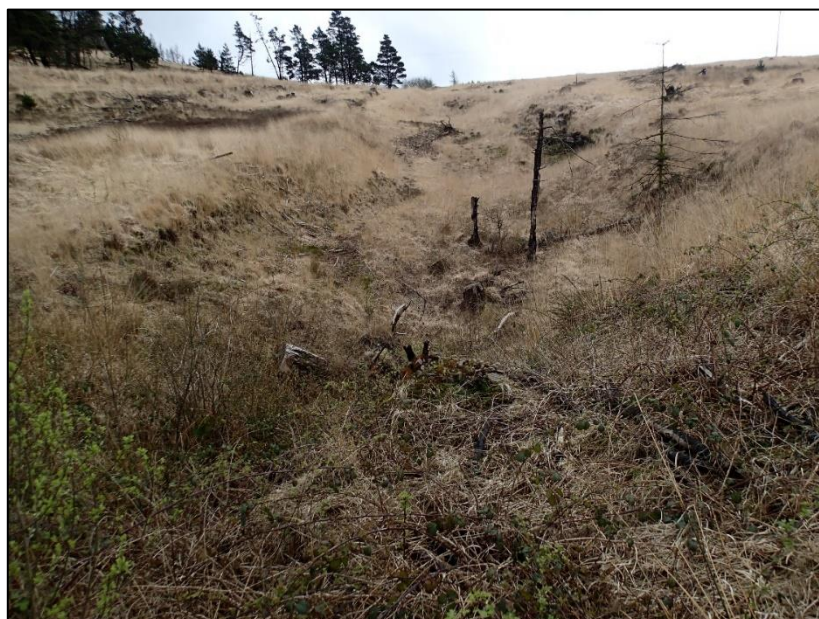
**Insert 9:** Interpreted lowest extent of landslide complex, right flank, 3m to 4m scarp very degraded. (Photo P4)

- 4.59 It is considered that this forms a large deeper translational landslide likely associated with slip planes at depth where seatearth and mudstones may be present.

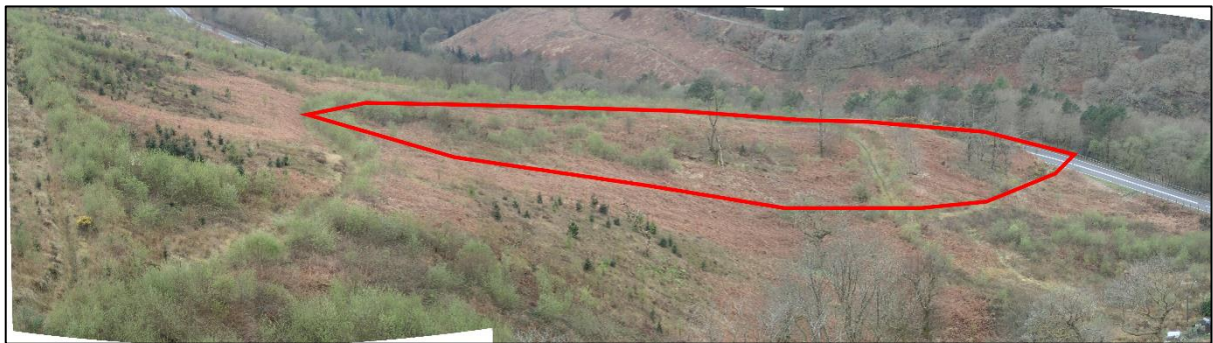
- 4.62 **Northwest Landslide** BGS mapped landslide AA-18 in the northwest portion was inspected. Whilst a broad lobate feature (insert 10) is present within the central portion of the feature, there was no conclusive evidence from the geomorphology that this comprises a landslide. However, the road cutting through the toe of the feature suggest the lobe comprises angular cobbles and boulders of sandstone in cohesive matrix. This contrasts with the colluvium noted in slope cuttings within the site which typically comprises soft to firm silty clay with much medium to coarse angular gravel and cobbles of sandstone.

*Insert 10: Lobate feature associated with NLD Feature 3633 (Photo P5)*

- 4.63 This possible landslide in the northwest should be investigated further to allow an updated assessment to be completed. We have provided recommendations for its investigation which will allow for this updated assessment and will also provide ground conditions for future road design in this area.

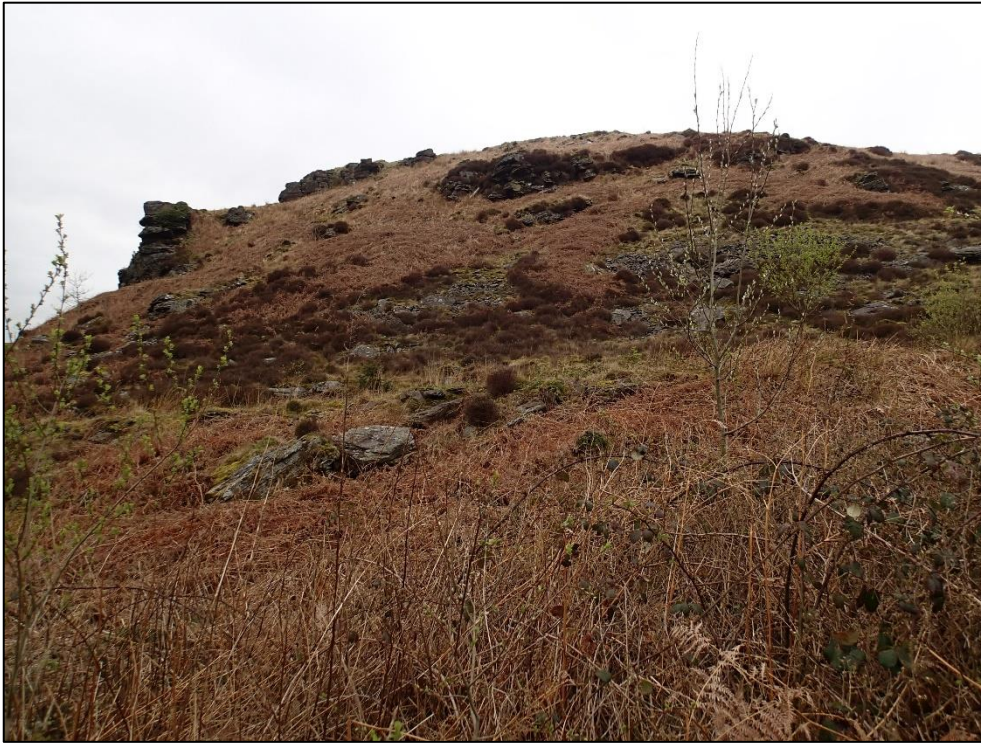
- 4.65 **Rock Fall:** Rock outcrops are associated with the northwest trending ridge line in the north of the site, and these have generated rockfall (Insert 11). These appear to be relatively infrequent, probably occurring every 10 to 100 years. No evidence of recent rockfall, e.g., recent ground disturbance, was observed.

*Insert 11: Rock outcrops and associated rock fall (Photo P6).*

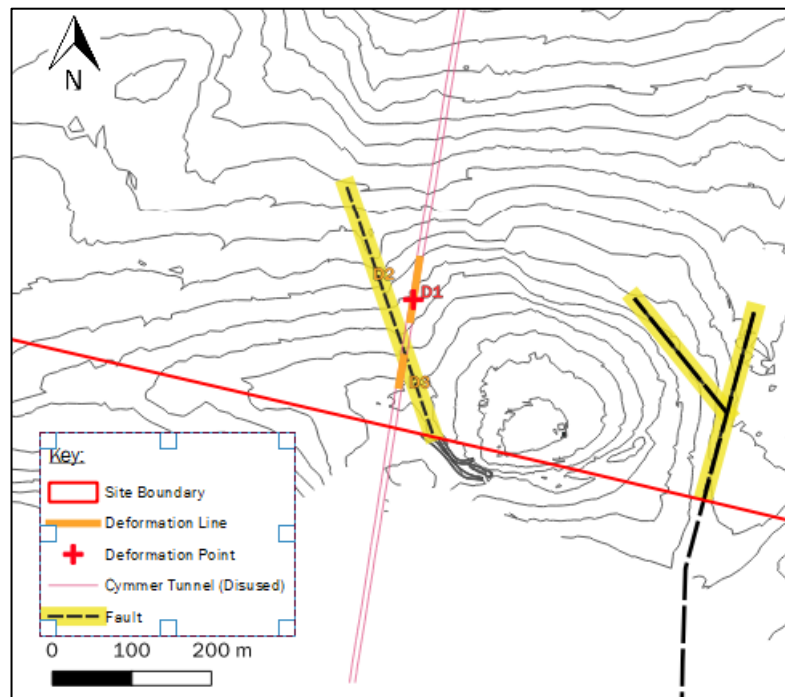
- **Ref: Photo 36, 046+10:** Refuge down, brickwork, spalling, depth 100mm, area 2m<sup>2</sup> vertical fractures, length 1.6m to both quoins, hollow. (**Deformation Line 2**);

- **Ref: Photo 32, 042+13 – 042+20:** Low Haunch Up and Down, brick work, longitudinal cracking, 27m, 1mm width. Various bricks crushed and spalled to downside, depth 25mm, area 3m<sup>2</sup>. (**Deformation Line 3**).

**Insert 14:** Records of deformation relative to Cymmer Tunnel (Balfour Beatty, 2020)

- 4.154 As shown in Insert 14, the position of the deformation points coincides with a possible fault identified and where a significant surface tension crack/fissure has been observed on-site. The depth of the tunnel at this location relative to ground level is unknown at this stage.
